**BEFORE THE STATE CORPORATION COMMISSION
OF THE STATE OF KANSAS**

PRE-FILED REBUTTAL TESTIMONY OF

TROY RUSSELL

KCC DISTRICT III OFFICE FIELD REPORT PHOTO ID FORM

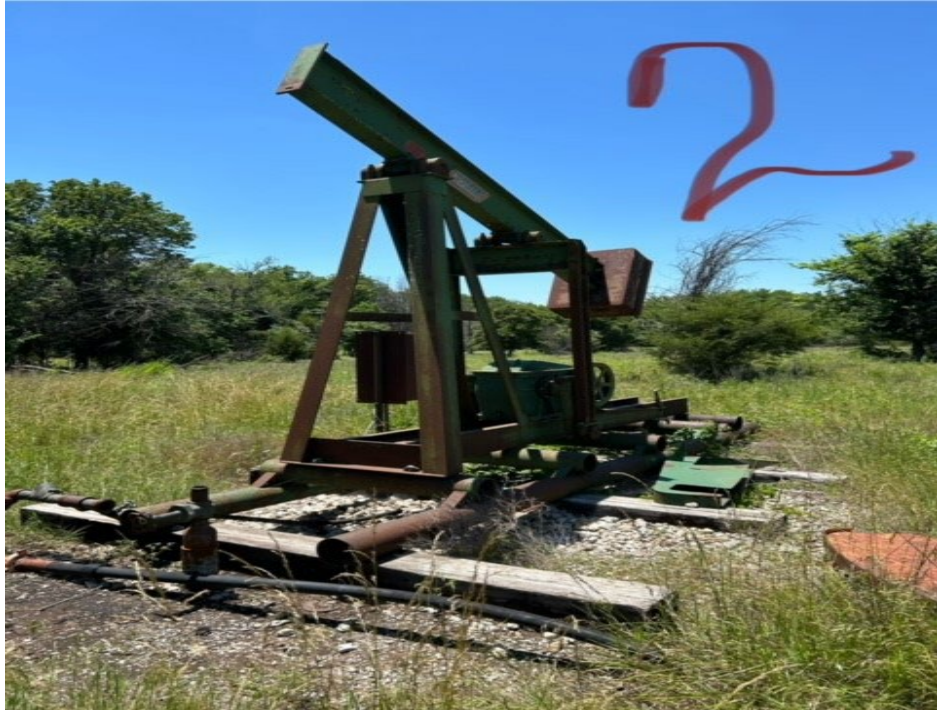
Picture taken to show the Tom Appleby #2 is not capable of production. Production casing was shut in with a gate valve.

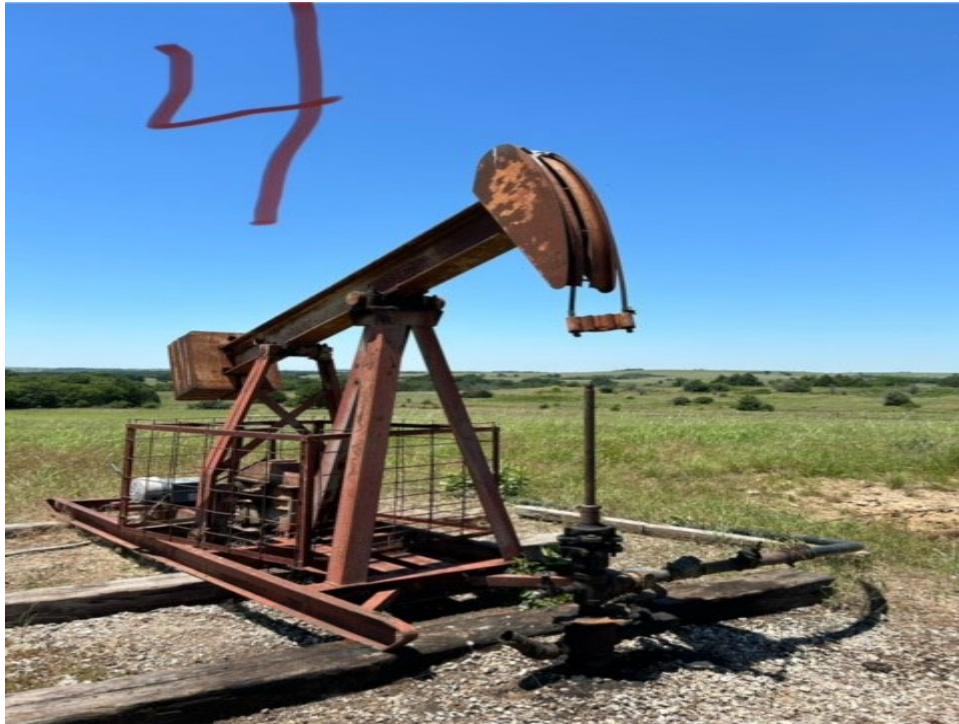
Picture taken to show the Tom Appleby #4 is not capable of production. Bridal cable is not attached to the pumping string.

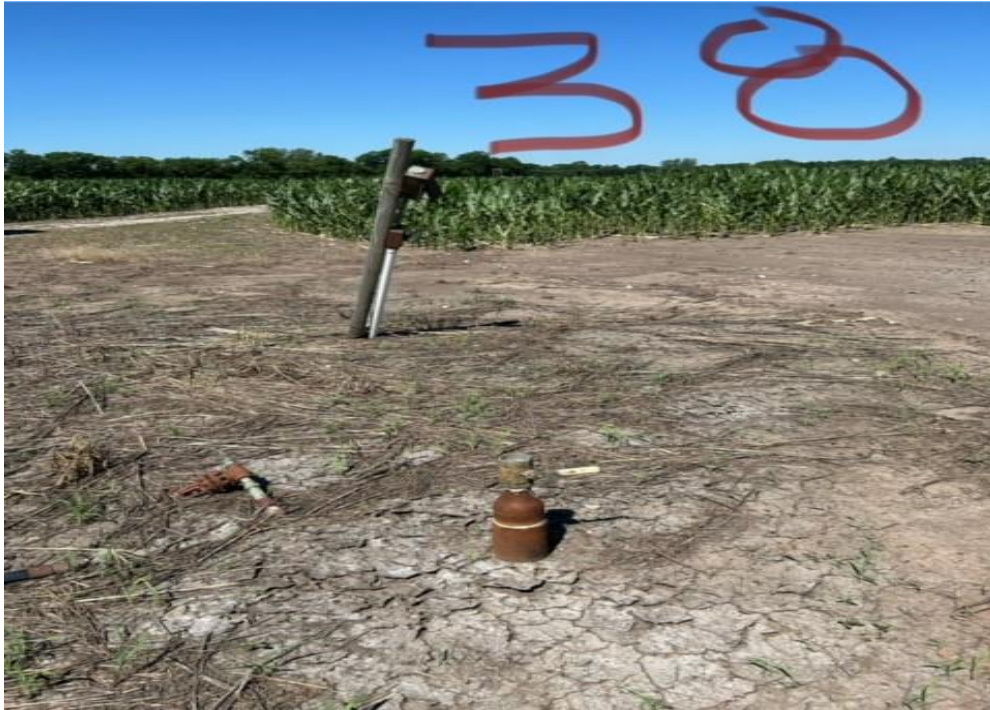
Picture taken to show the DeArmond #38 is not capable of production. Production casing is shut in with a swedge and valve. CP-111 Temporary Abandonment (TA) application was approved for this well on 10/25/2023. After reviewing the CP-111 application, District staff will require a casing integrity test for this well due to high fluid level.

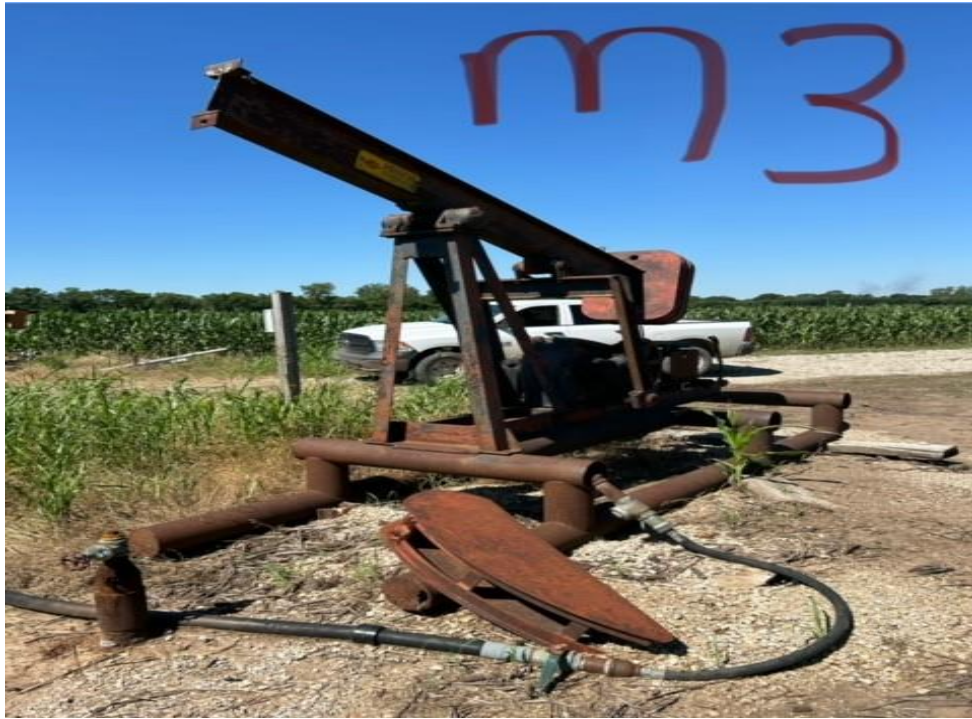
Picture taken to show the DeArmond #M-3 is not capable of production. Production casing is shut in with a swedge and valve. CP-111 Temporary Abandonment (TA) application was approved for this well on 10/25/2023. After reviewing the CP-111 application, District staff will require a casing integrity test for this well due to high fluid level.

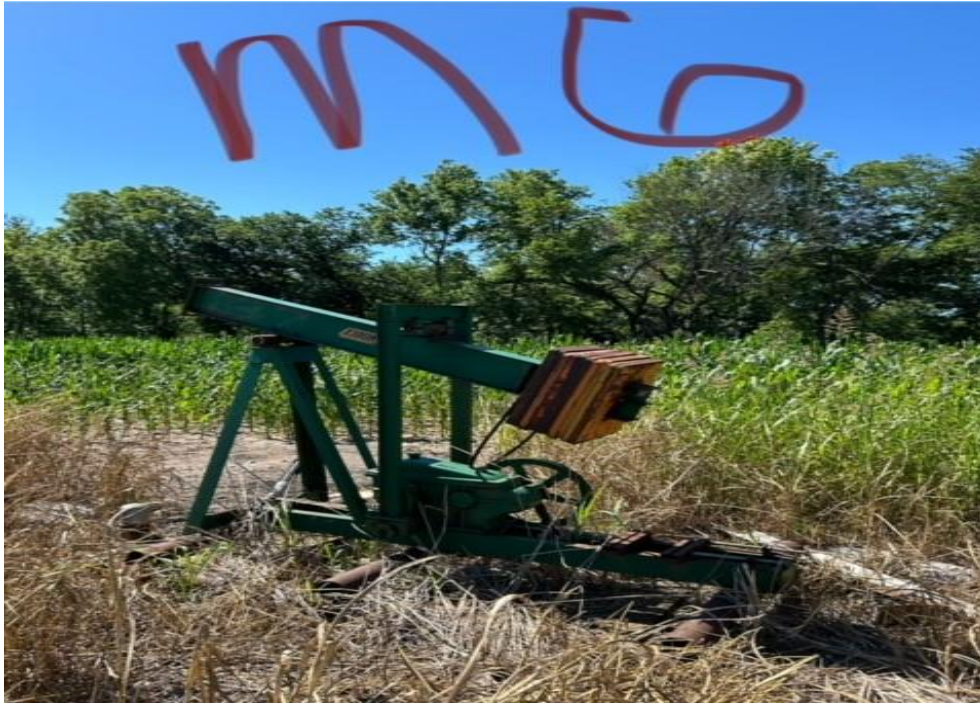
Picture taken to show the DeArmond #M-6 is not capable of production. Production casing is shut in with a bull plug.

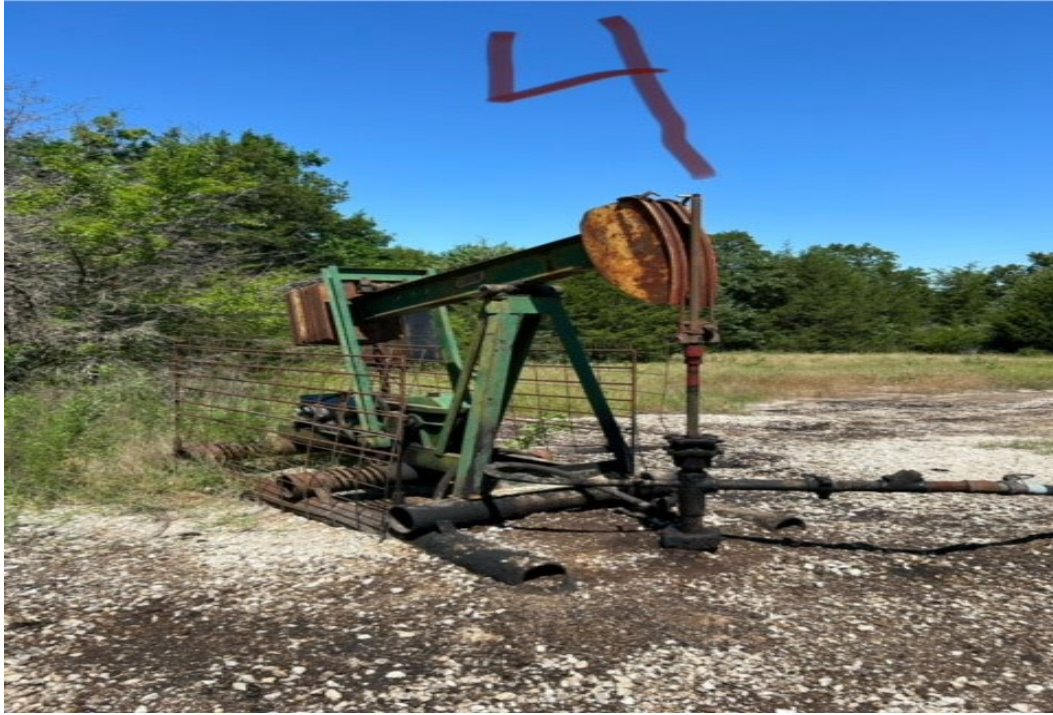
Picture taken to show the McFarlane-Delong #4 that appears to be capable of production if the lease has power. Picture also shows oil stain from a previous spill.

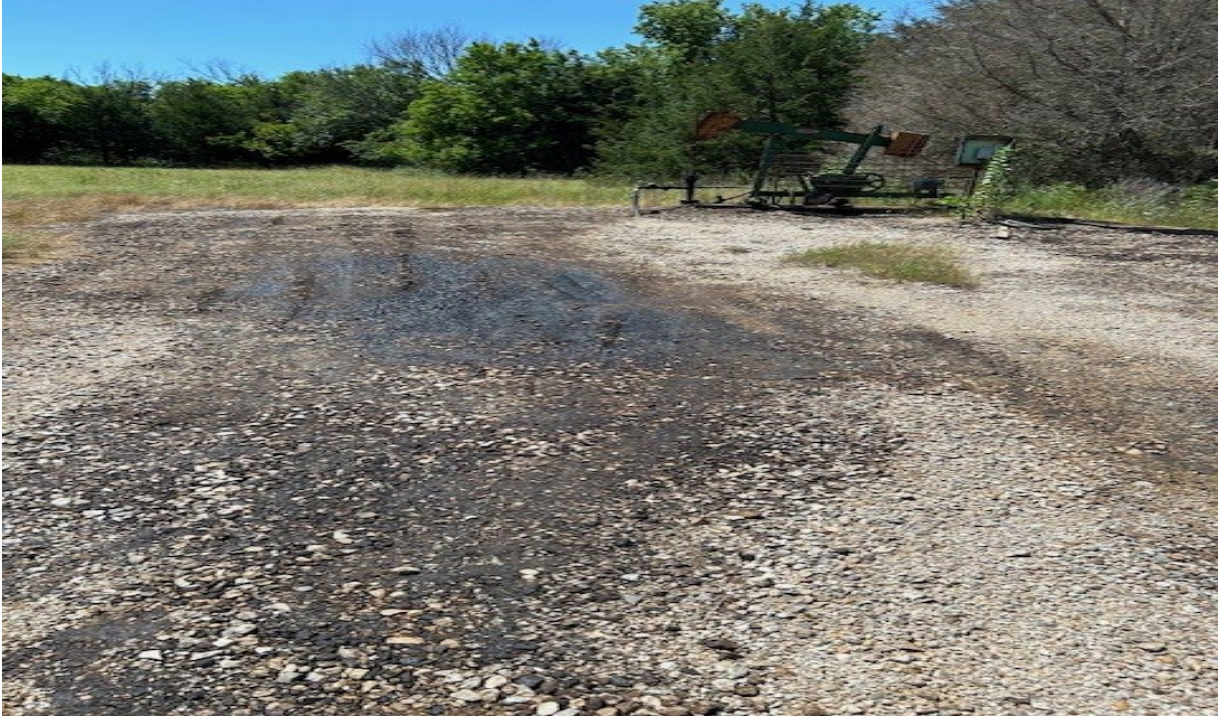
Picture taken to show the McFarlane-DeLong #4 that appears to be capable of production if the lease has power. Picture also shows oil stain from a previous spill.

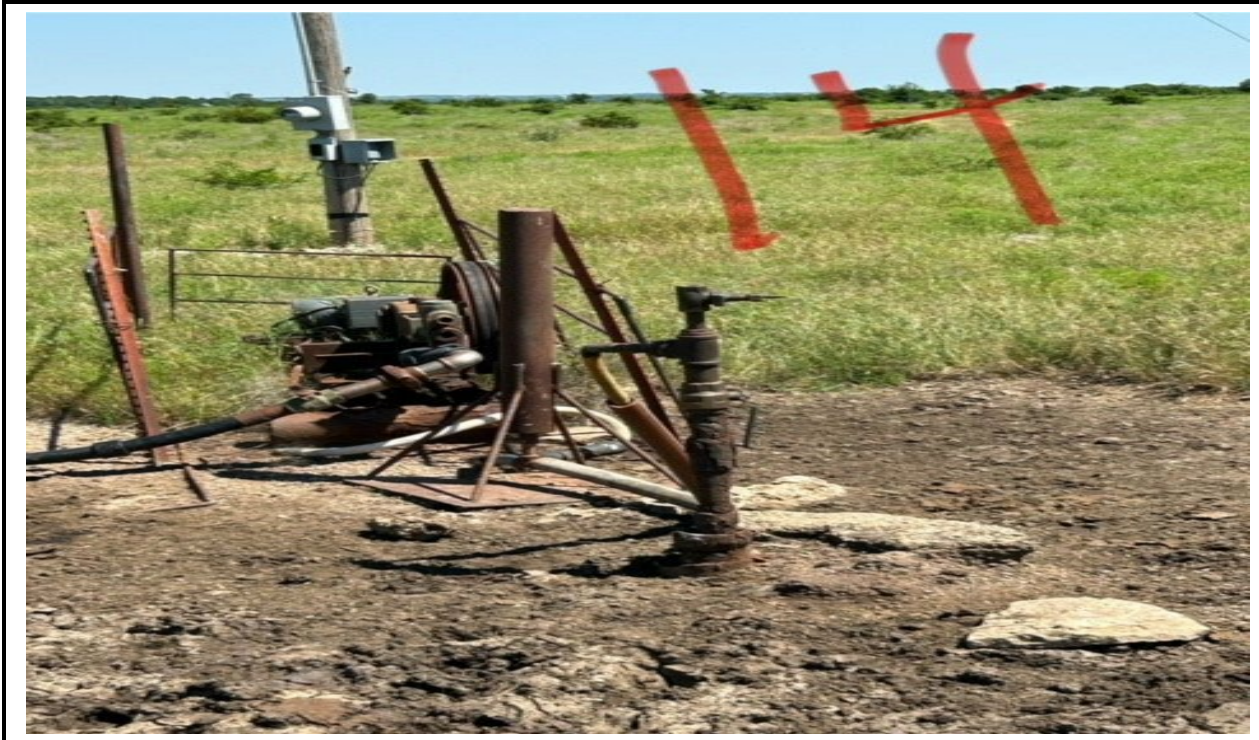
Picture taken to show the Flossie-White #14 that is hooked up at the well head but the injection line coming from the pump is disconnected. Also the hose hooked to well head appears to need replaced.

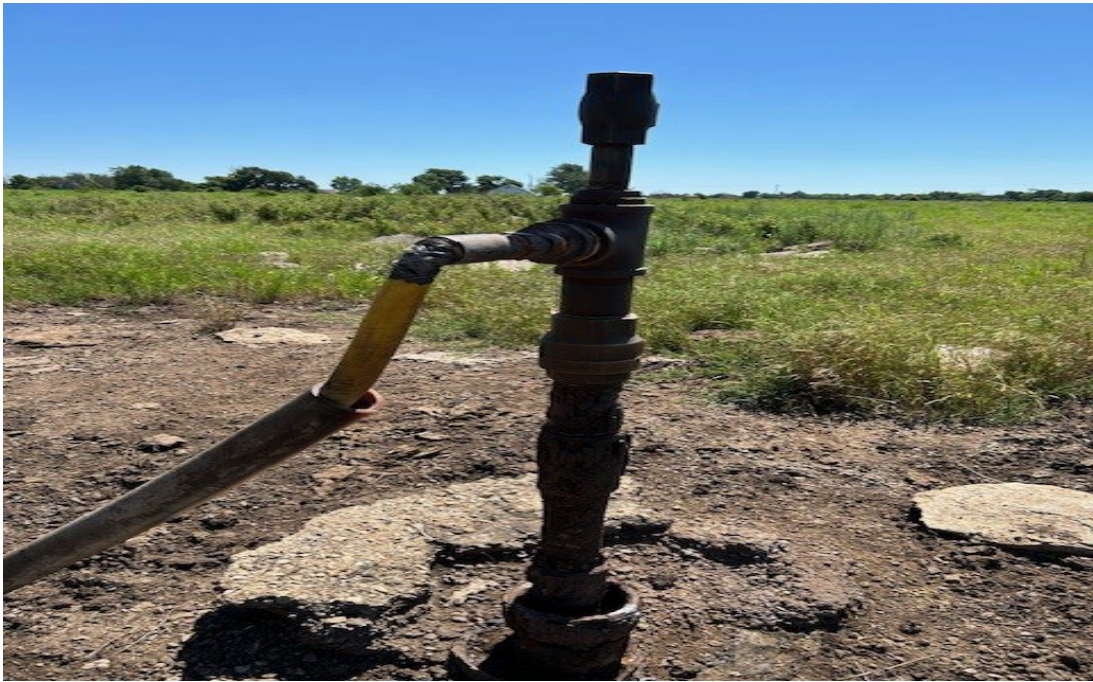
Picture taken to show the Flossie-White #14 that is hooked up at the well head but the injection line coming from the pump is disconnected. Also the hose hooked to well head appears to need replaced.

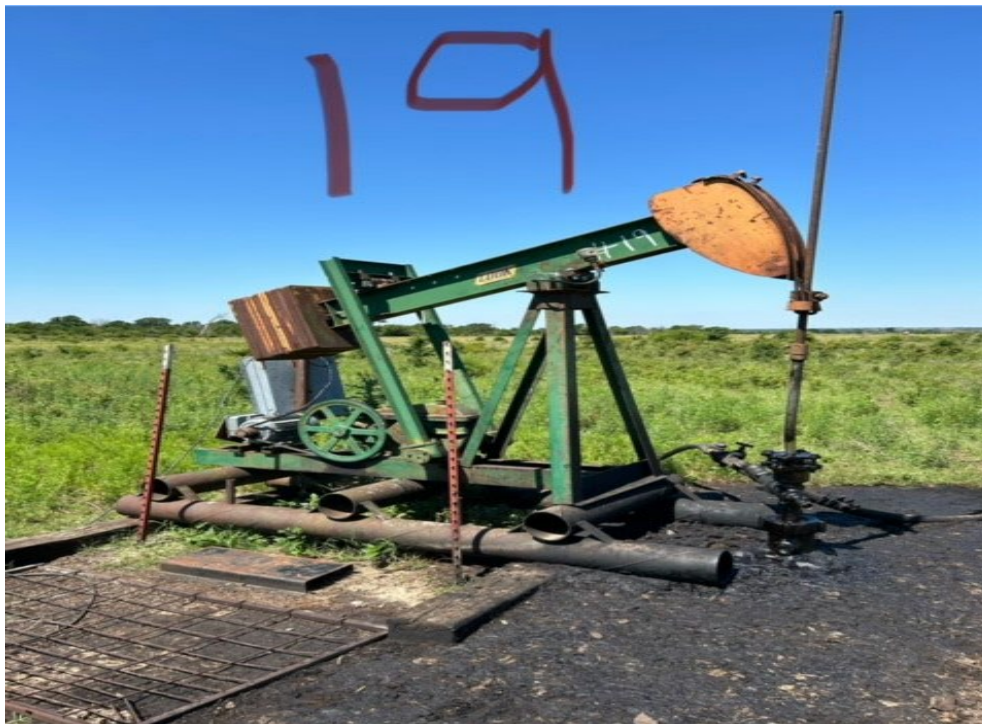
Picture taken to show the Flossie-White #19 that appears to be capable of production if the lease has power. Picture also shows oil stain from an on-going spill. Fluids leaking from the well head. Operator will need to fix the stuffing box to eliminate the leakage and remediate the contaminated soil.

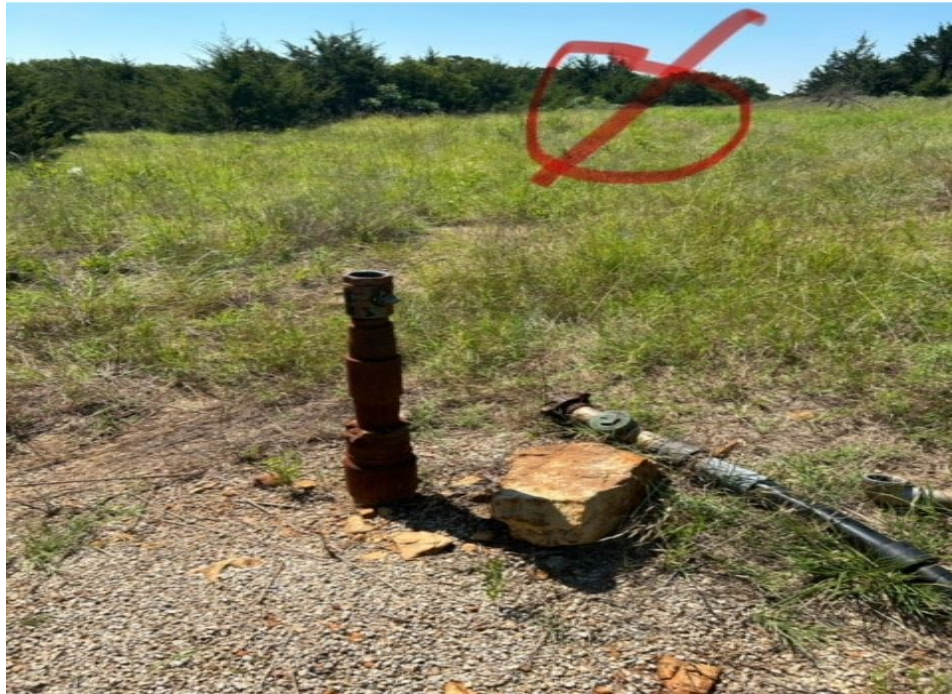
Picture taken to show the Sears #0 that is shut in with a swedge and valve. CP-111 Temporary Abandonment (TA) application will be required.

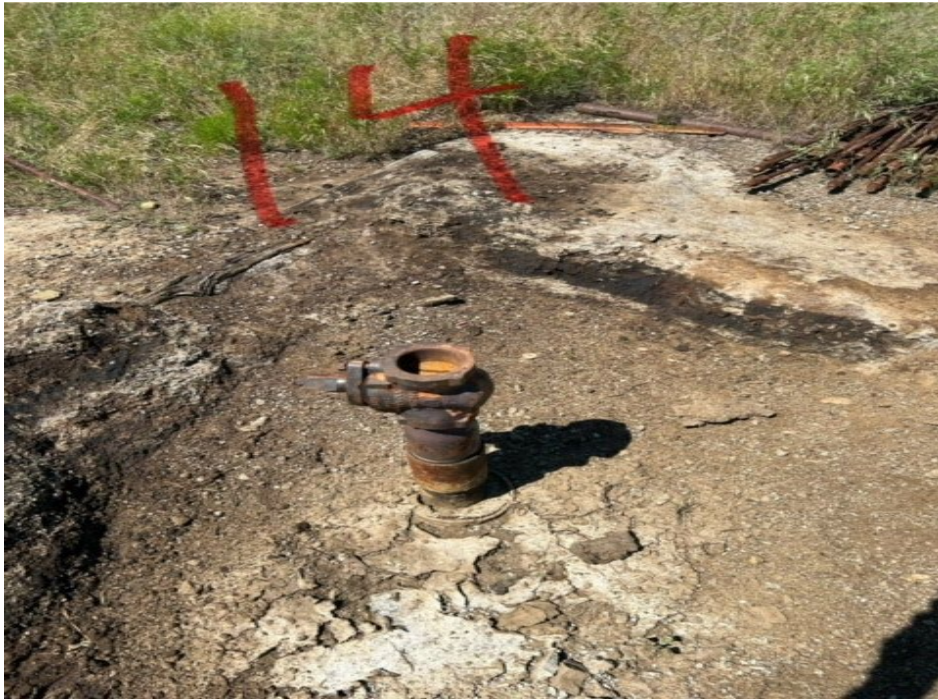
Picture taken to show the Sears #14 is not capable of production and casing was shut in with a swedge and valve. Temporary Abandonment (TA) application was denied on 12/16/2022. Well remains out of compliance with K.A.R. 82-3-111.

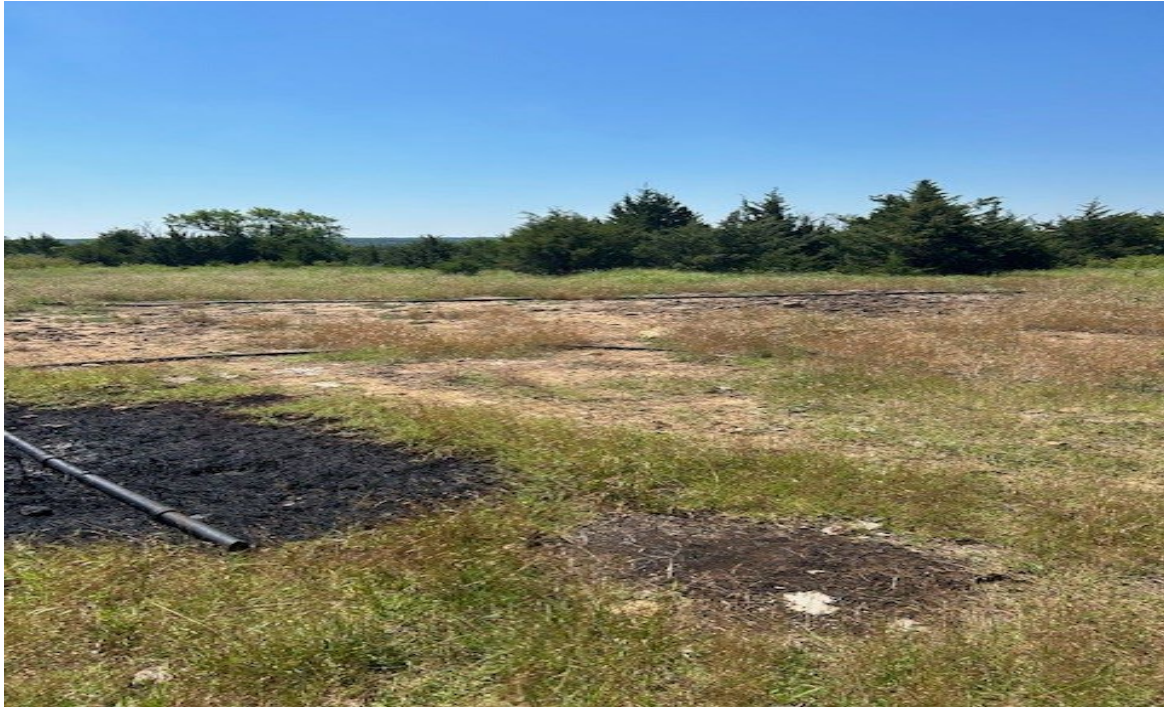
Picture taken to show a spill just east of the Sears #14. Spill appears to have occurred from a lead line leak. Operator will need to clean up the spill and remediate the soil.

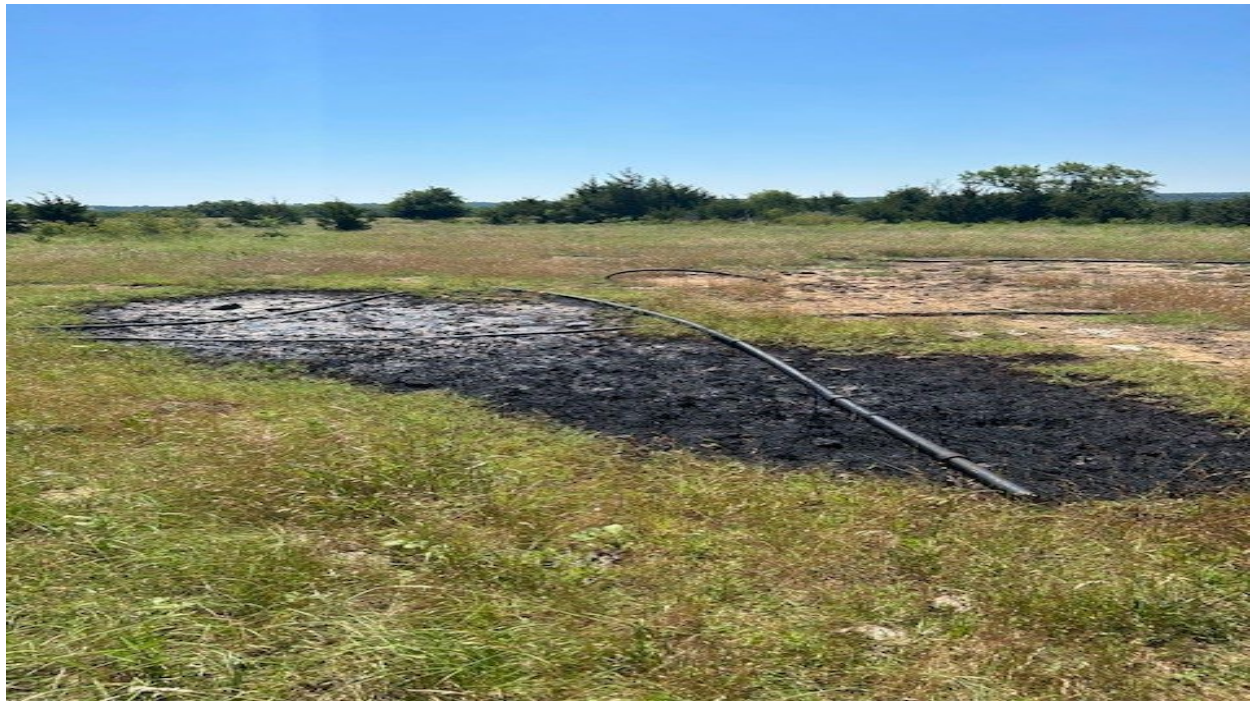
Picture taken to show a spill just east of the Sears #14. Spill appears to have occurred from a lead line leak. Operator will need to clean up the spill and remediate the soil.

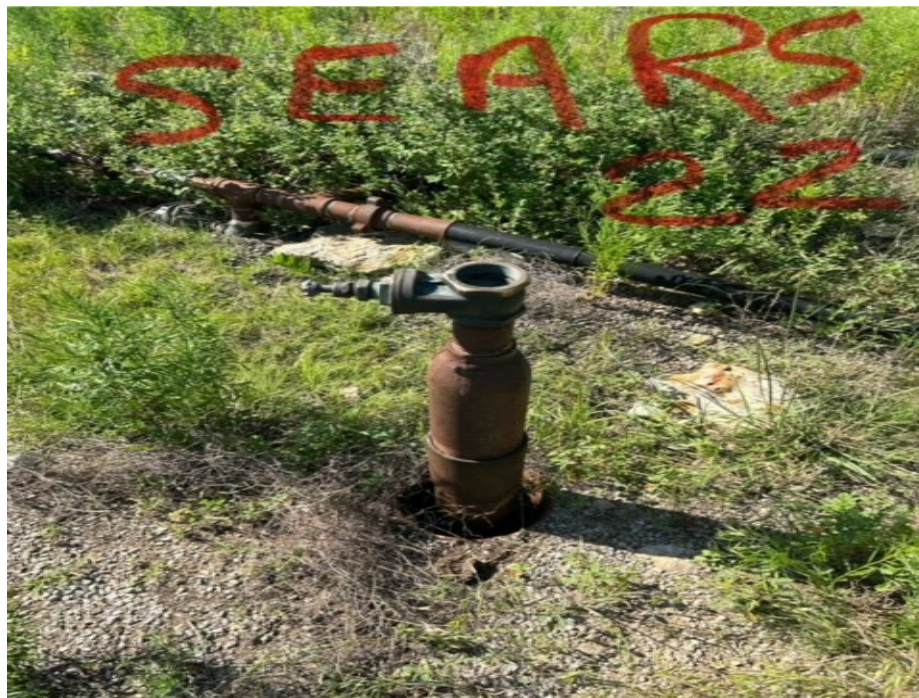
Picture taken to show the Sears #22 is not capable of production. The casing is shut-in with a swedge and valve. This well is listed on McCann Petroleum, Inc. (KLN 7638) well inventory and listed as "PL" status on RBDMS. McCann Petroleum, Inc. license was suspended on 1/26/2016. Operator will need transfer this well to Quito, Inc. and then file a CP-111 Temporary Abandonment (TA) application.

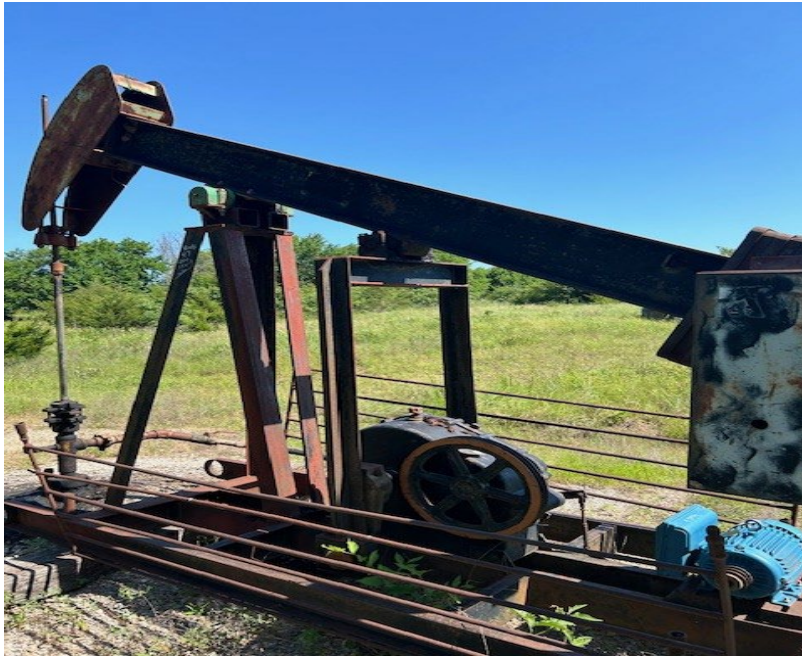
Picture taken to show the Sears #24 is not capable of production as pump jack is not fully equipped. Belt is missing.

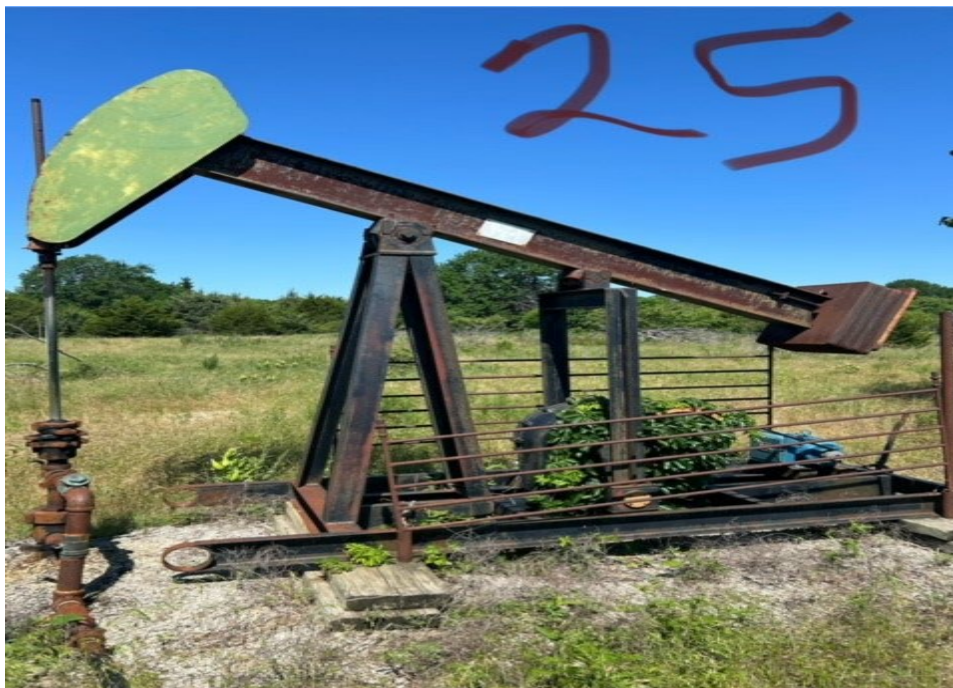
Picture taken to show the Sears #25 appears to be capable of production if lease has power. This well is listed on McCann Petroleum, Inc. (KLN 7638) well inventory and listed as "PL" status on RBDMS. McCann Petroleum, Inc. license was suspended on 1/26/2016. Operator will need transfer this well to Quito, Inc. before operator can produce.

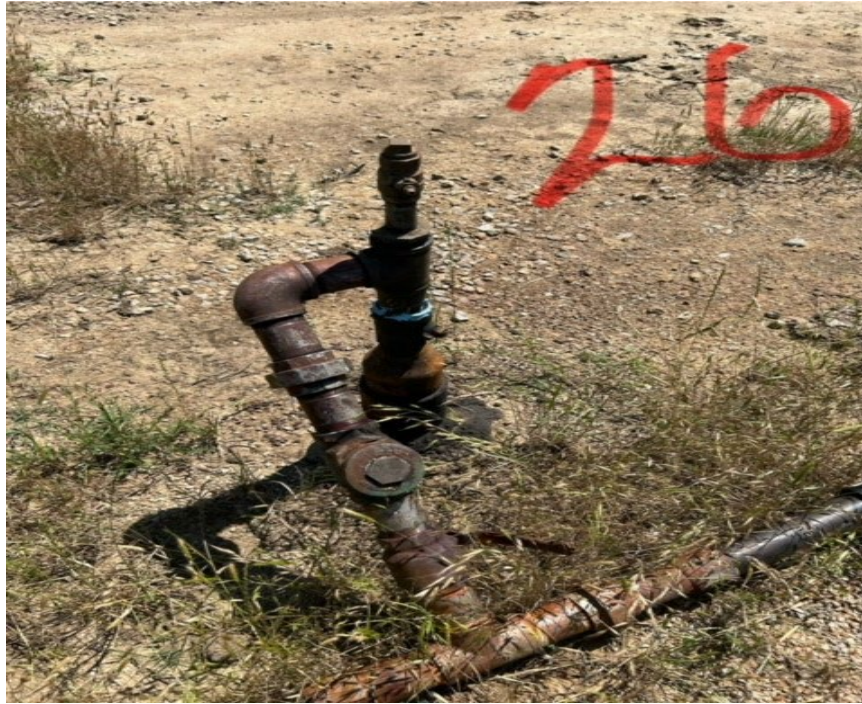
18 Additionally, Staff found unreported spills which require remediation at the following sites.
19 At the Sears #26, there is a significant brine impacted area that appears to have been the result
20 of a failure in a brine line to the EOR well. The impacted area is approximately 200 feet in
21 length and varies in width from 10 to 20 feet. In the vicinity of the Sears #14, there is a crude
22 oil saturated area approximately 20 feet by 10 feet which has not been reported. Lastly, at the
23 Sears #32, there are large brine impacted areas to the north and west of the wellhead.

Picture taken to show the Sears #26 is hooked up for injection purposes. Staff found a large kill area from a recent spill that will need to be remediated.

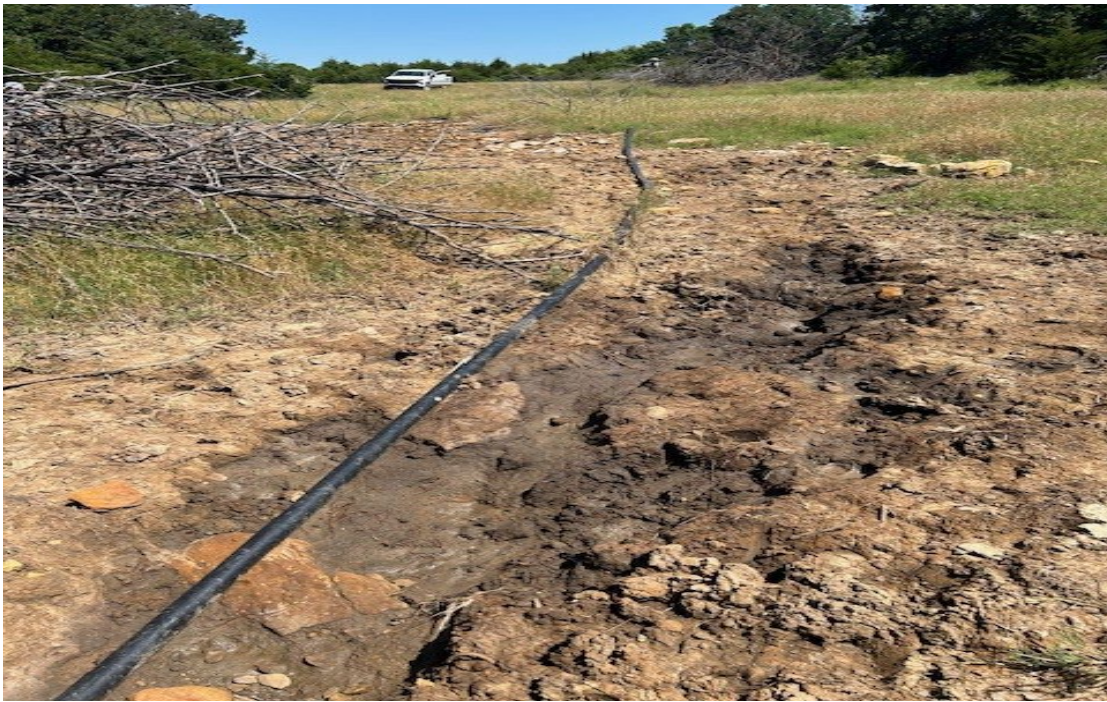
Picture taken to show part of the spill area. This picture was taken looking north of the Sears #26 well location. Appears operator had an injection line leak causing spill. No spill report was reported to the District #3 office. Operator will need to remediate the contaminated area.

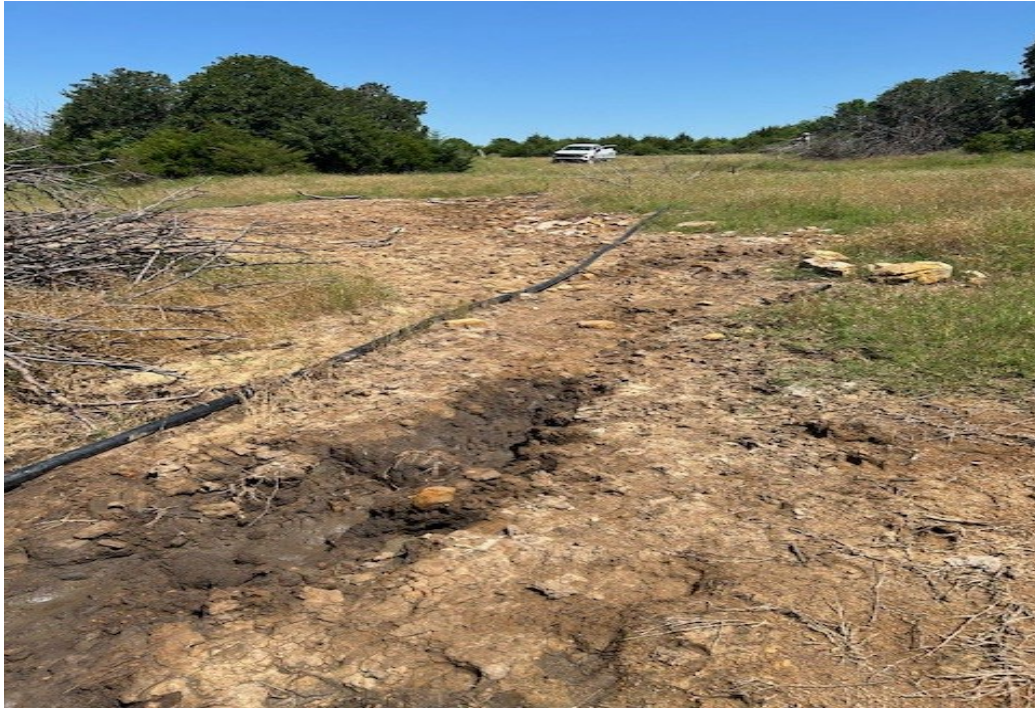
Picture taken to show part of the spill area. This picture was taken looking north of the Sears #26 well location. Appears operator had an injection line leak causing spill. No spill report was reported to the District #3 office. Operator will need to remediate the contaminated area.

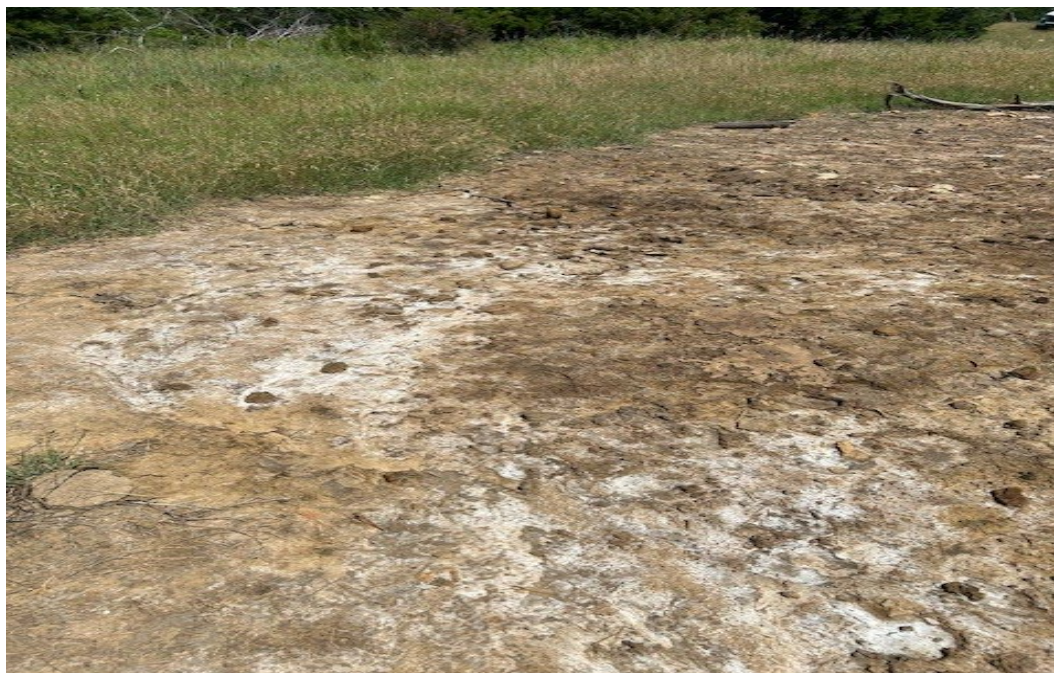
Picture taken to show part of the spill area. This picture was taken looking west to southwest of the Sears #26 well location. Appears operator had an injection line leak causing spill. No spill report was reported to the District #3 office. Operator will need to remediate the contaminated area.

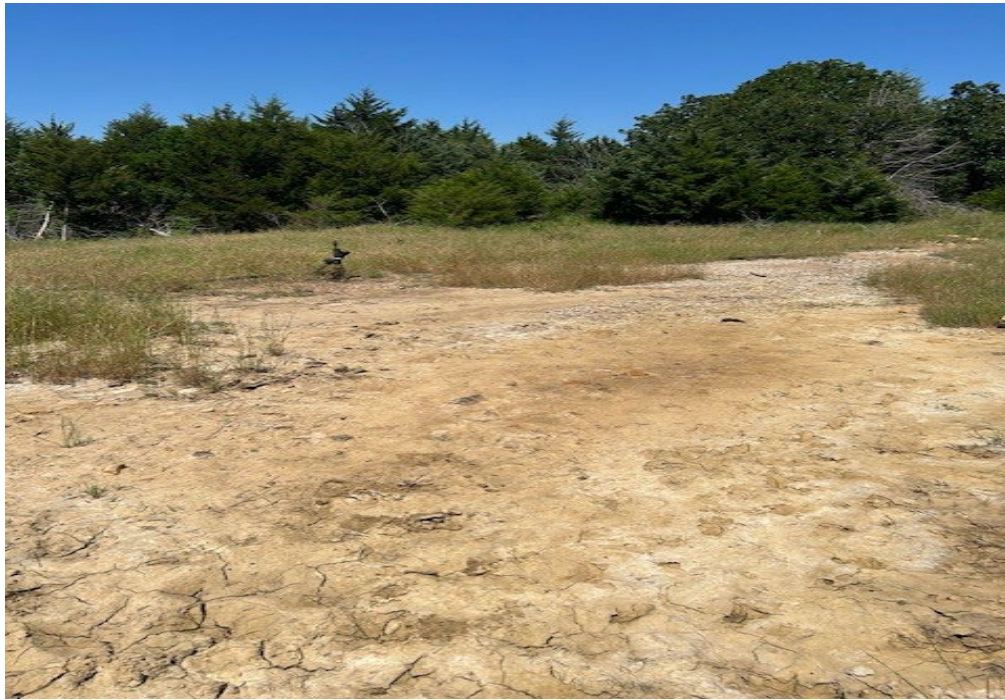
Picture taken to show part of the spill area. This picture was taken looking south to southeast of the Sears #26 well location. Well can actually be seen in top left portion of the picture. Appears operator had an injection line leak causing spill. No spill report was reported to the District #3 office. Operator will need to remediate the contaminated area.

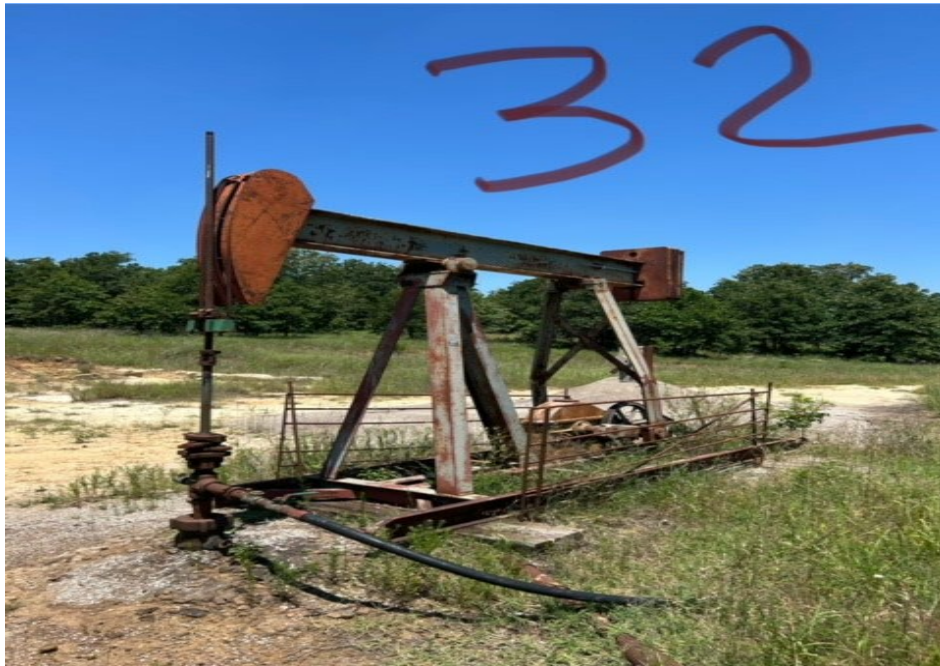
1 Approximately 10 cubic yards of grayish shale material from an unknown source has been
2 dumped to the north of the well partially covering the brine impacted area. There appears to
3 have been no remedial activity to the west of the wellhead and or gypsum amendments utilized
4 on any of the brine impacted soils near this well. Photographs of the spills Staff visually
5 observed at the Sears lease are included with *Exhibit TR-10*.

Picture taken to show the Sears #32 that appears to be capable of production if the lease has power. Picture also shows scar area from a previous spill. There appears to be no remedial activity at this location.

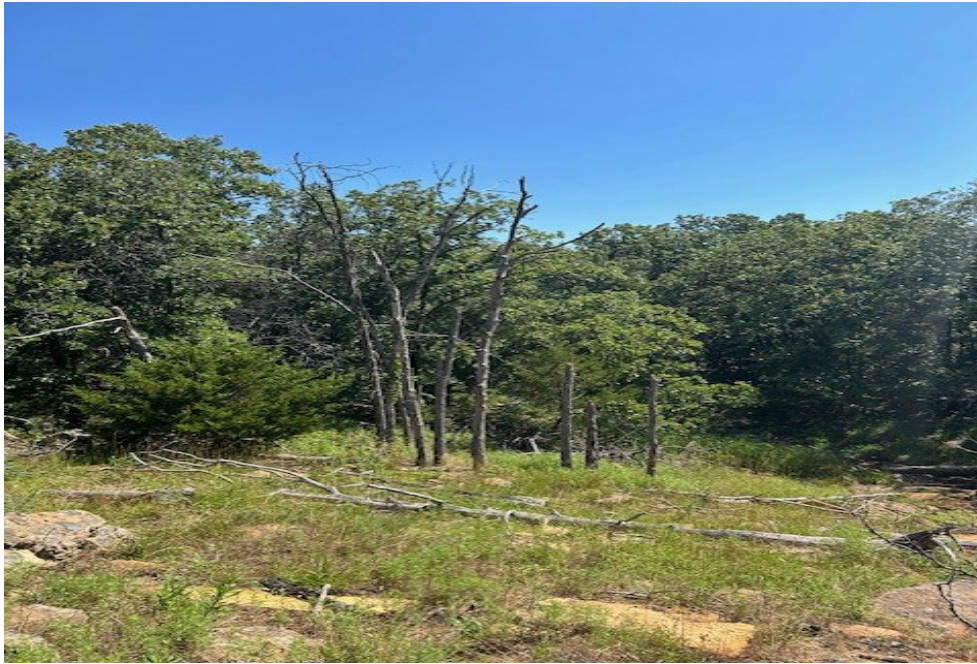
Picture taken to show the spill path that runs northeast of the Sears #33.

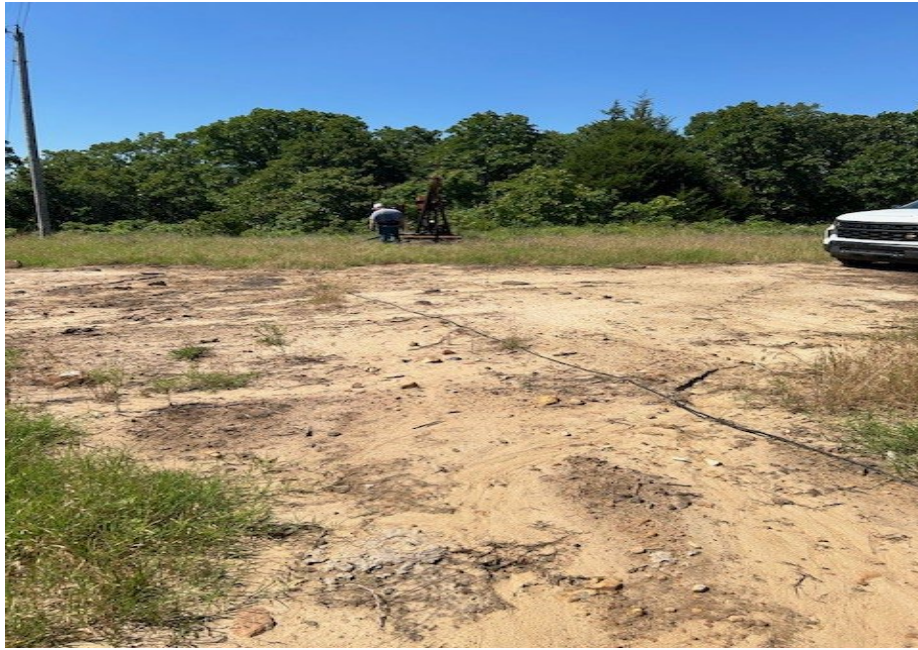
Picture taken looking South towards the Sears #33. Operator will need to remediate affected soil.

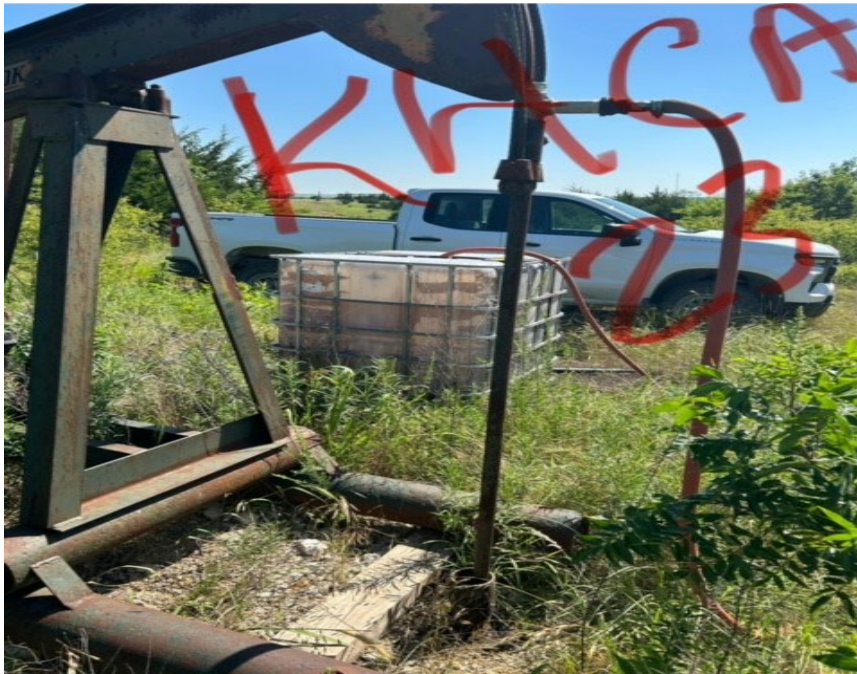
Picture taken to show the Sears #KHCA-23 appears to be capable of production. Appears operator was trying to produce this well into a plastic tote. You can see the pumping hose running was the pumping string into the top of the plastic tote.

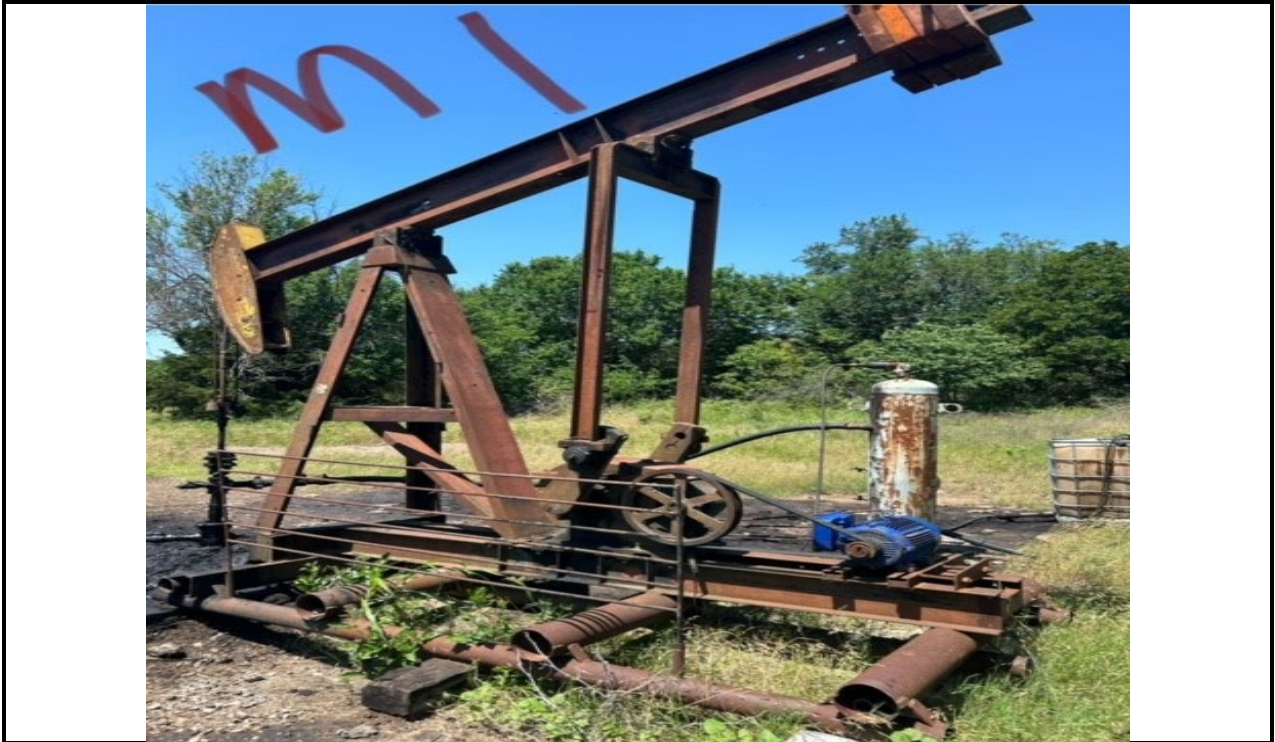
Picture taken to show the Sears #M-1 that appears to be capable of production if the lease has power. Picture also shows scar area from a previous spill. Operator will need to apply additional remedial treatments.

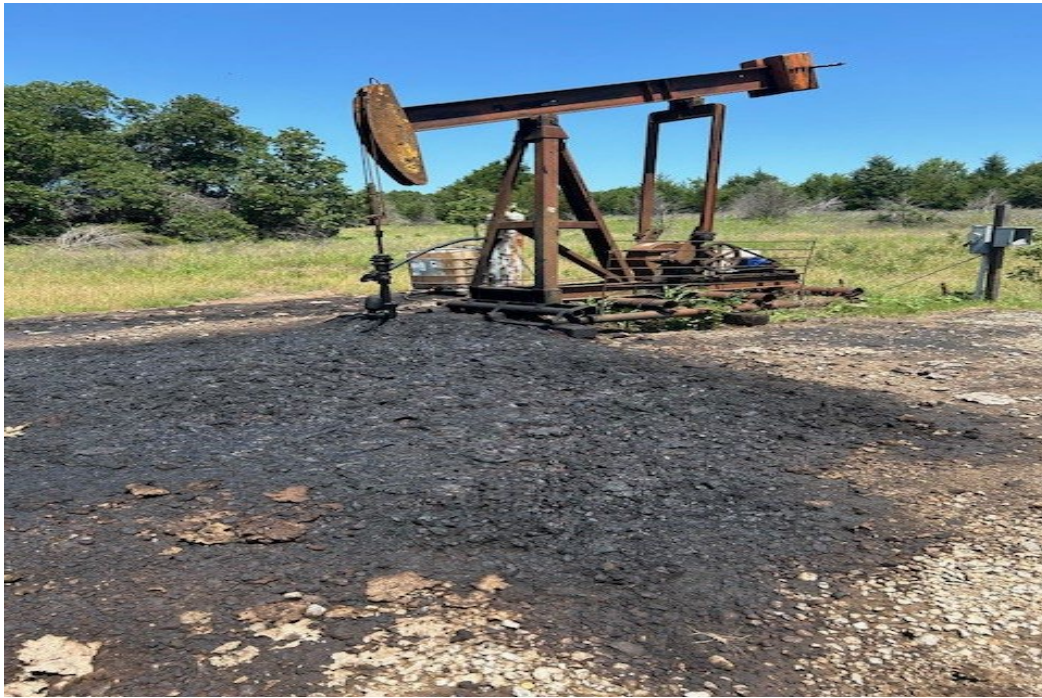
Picture taken to show the Sears #M-1 that appears to be capable of production if the lease has power. Picture also shows crude oil saturated soil from a previous spill. Operator will need to apply additional remedial treatments.
