**BEFORE THE STATE CORPORATION COMMISSION  
OF THE STATE OF KANSAS**

In the Matter of the Complaint Against                     )  
KCP&L by Stephen and Karen                     )     Docket No. 15-KCPE-544-COM  
Gradwohl.                     )

**NOTICE OF FILING OF STAFF REPORT & RECOMMENDATION**

**SUBJECT:** 15-KCPE-544-COM: In the Matter of the Complaint Against Kansas City Power & Light by In the Matter of the Complaint by Stephen and Karen Gradwohl

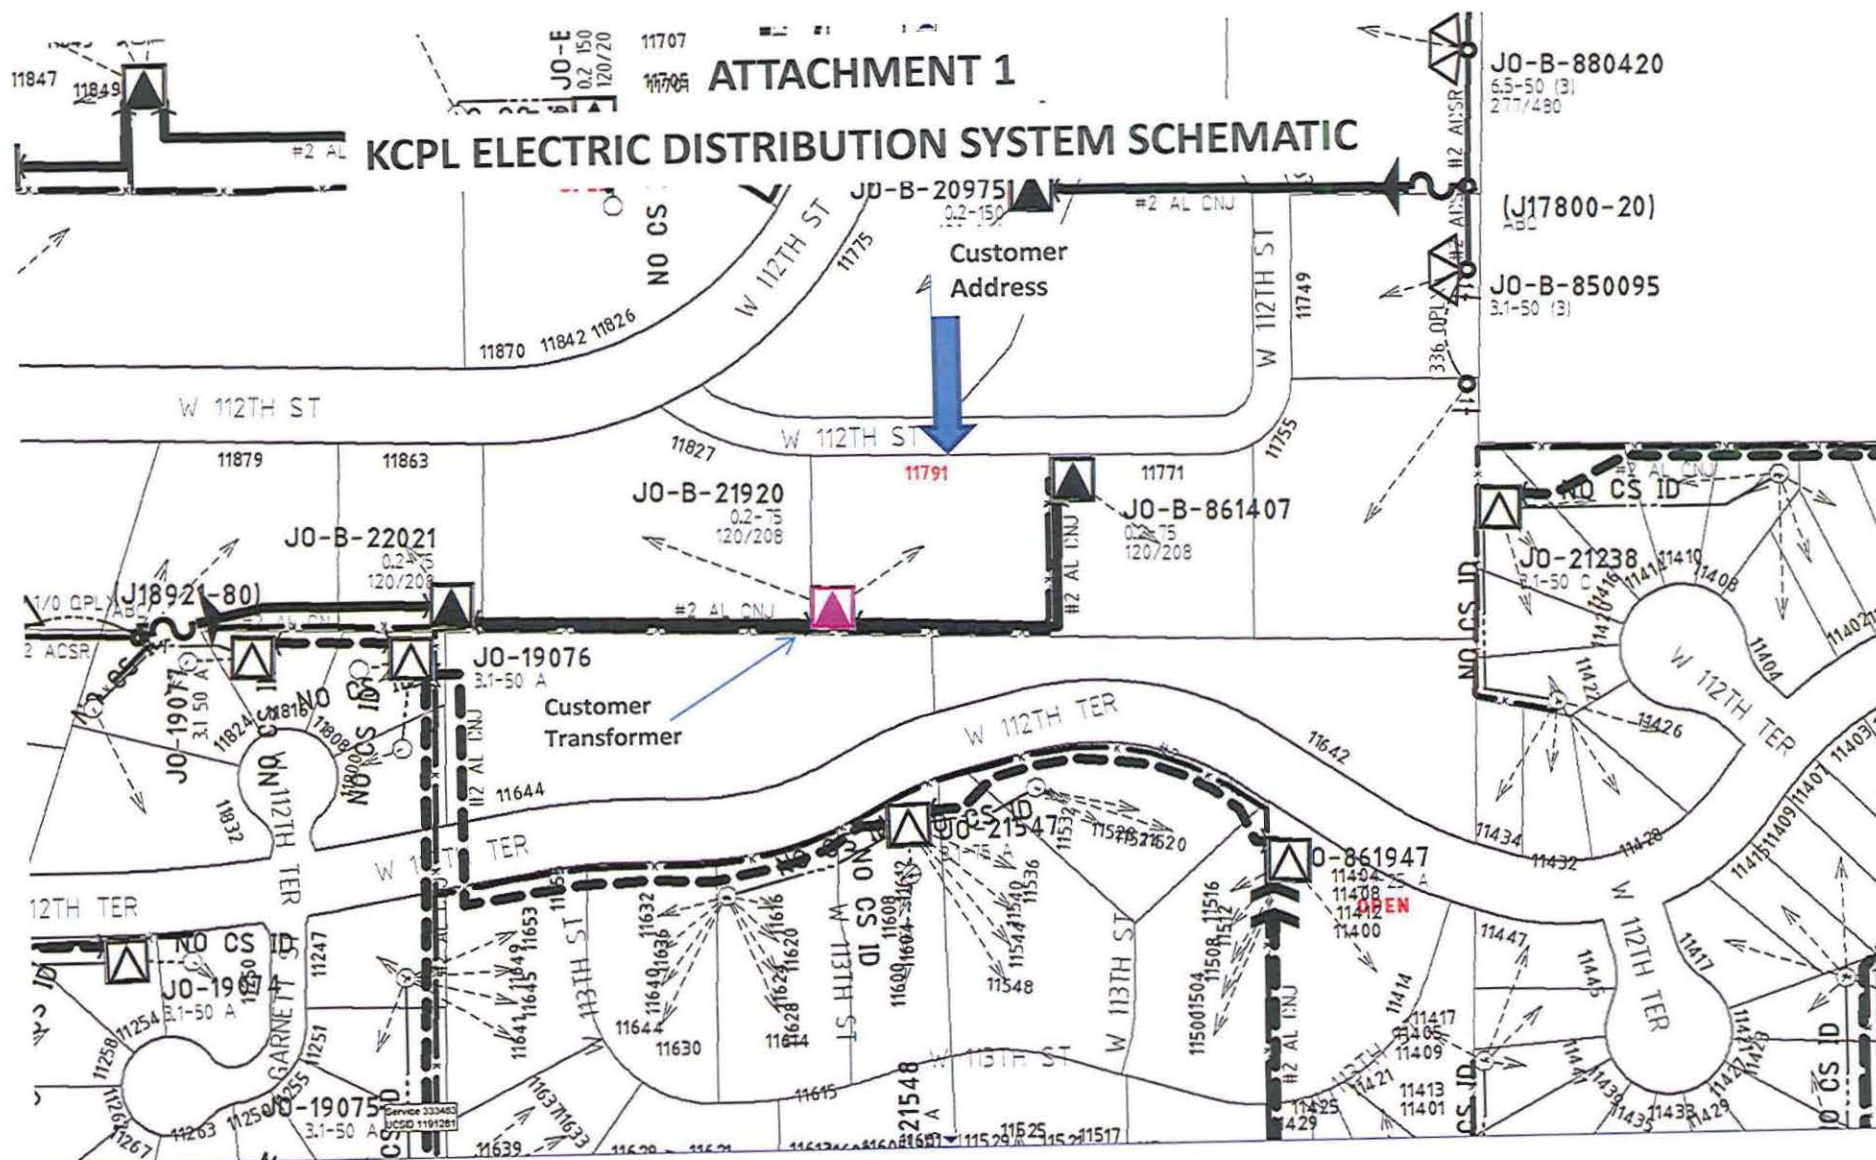
## KCPL ELECTRIC DISTRIBUTION SYSTEM SCHEMATIC

Description of site: The Complainants’ building address is a commercial customer of KCPL that is provided electrical service through an underground distribution system. Attachment 1 provides a map of the electrical facilities in the vicinity of this building. Electric service to the building originates from a transformer located southwest of the building. The secondary electric system connects to a current transformer cabinet inside the office building. The current transformer is the property of KCPL and an integral component of the KCPL electric metering system. From the current transfer cabinet, an additional conductor runs through the building and is connected to the meter which is located on the outside of the building. The electric primary conductor for the area runs in utility easements located on the south and east sides of the building. Under the terms of its tariff, KCPL’s Point of Service to this building is located at the secondary taps on the transformer located southwest of the building.<sup>4</sup>

KUUDPA requires an operator of an underground utility to provide locates of the tolerance zone of its buried facilities upon request from an excavator. The tolerance zone is defined as the horizontal distance within 25 inches of the outside diameter of the buried facility.<sup>5</sup> KCPL received a valid request for locates and performed locates of the buried electric facilities in the area scheduled for excavation. As discussed above, the KCPL locator failed to accurately locate the tolerance zone of the Complainant's electric service. The KCPL locator also added confusion to the locate request by indicating the presence of buried electric utilities where none existed.<sup>6</sup>

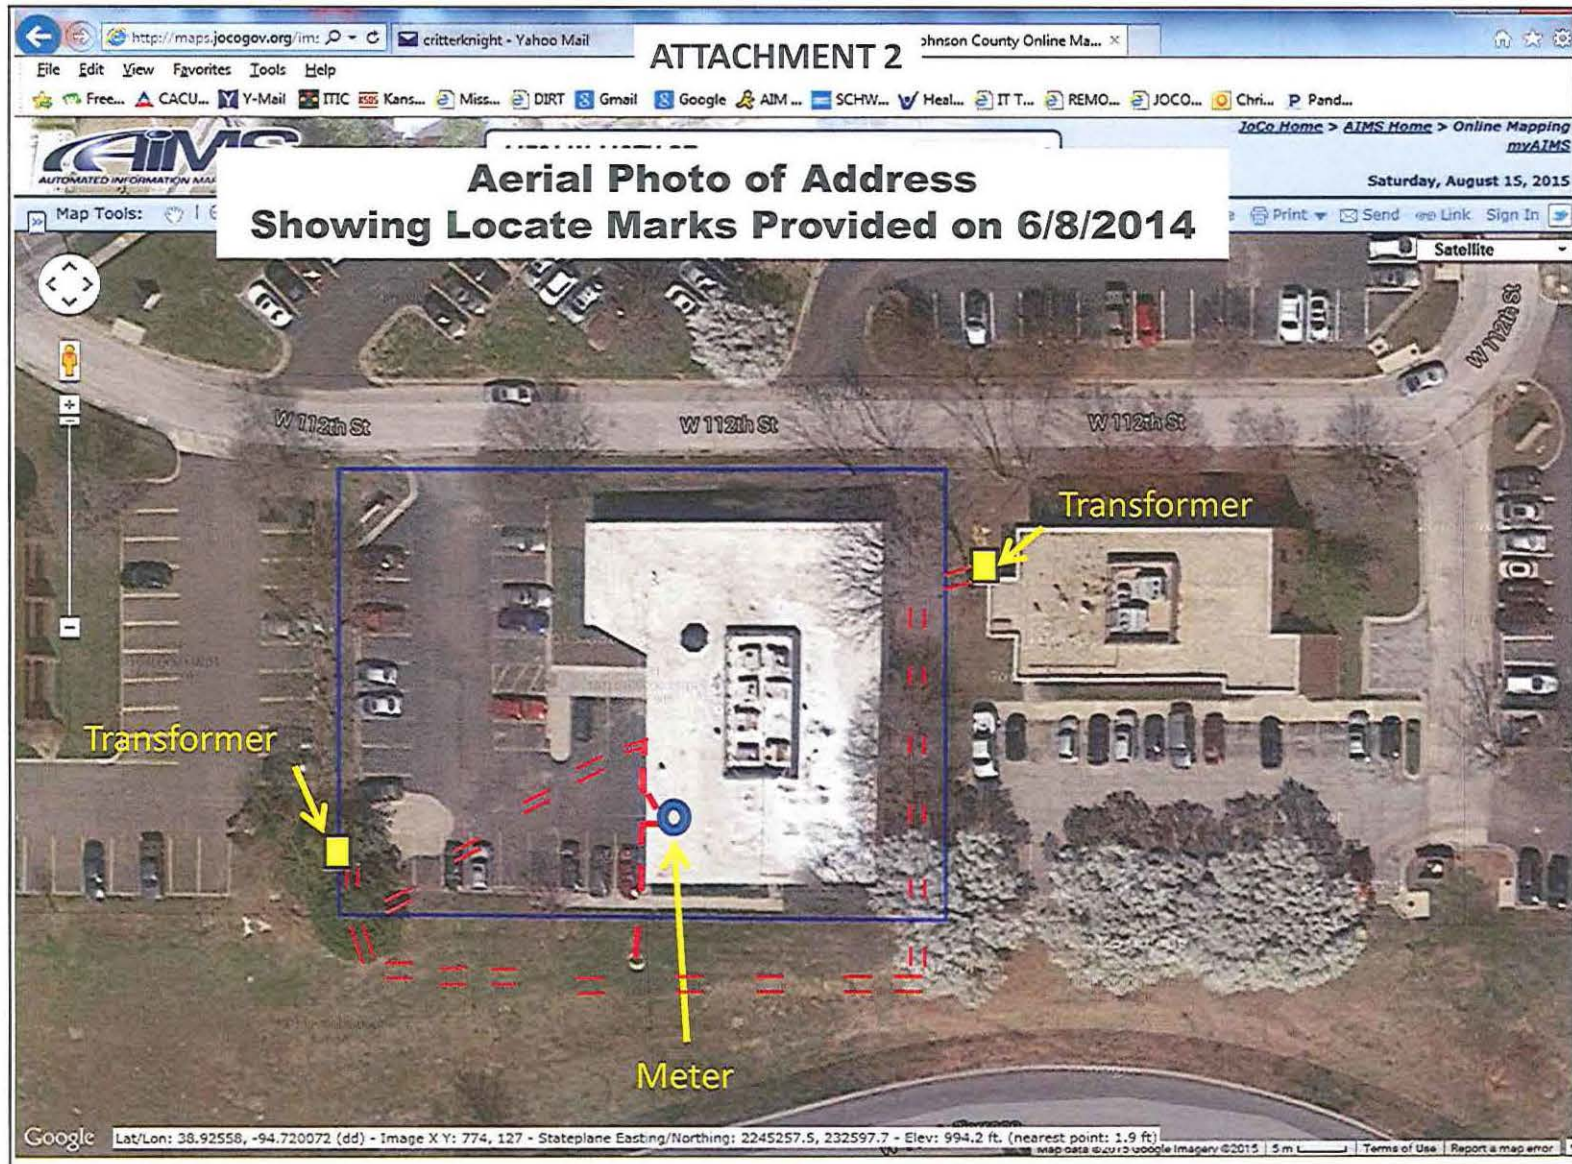
damage had noted no KCPL property had been excavated and damaged. As shown in Attachments 2 and 4, the locate marks leading to the electric meter identified KCPL's conductors to be in a location where no damage had occurred. Because of the uncertainty as to the operator of the buried facilities or which facilities served the building, Staff elected to close its original investigation.

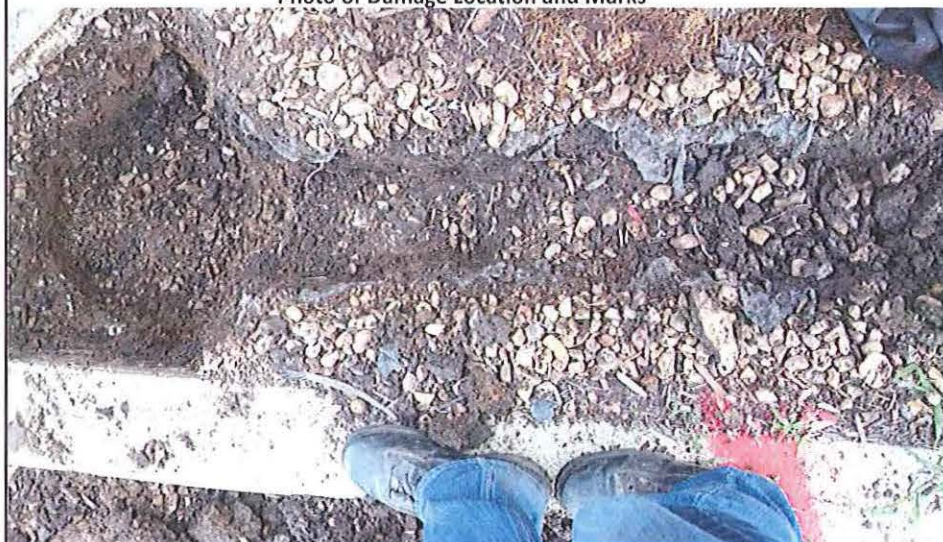
ATTACHMENT 3  
Photo of Damage Location and Marks

June 18, 2014	Duarte notifies Staff of damage and requests Staff to investigate.
June 18, 2014	Staff conducts on-site investigation and concludes KCPL is at fault for providing inaccurate locates with marks approximately 2 feet beyond the allowed tolerance.
July 15, 2014	Staff issued a probable noncompliance to KCPL alleging KCPL was in violation of K.S.A. 66-1806.
August 25, 2014	KCPL responds to Staff's allegation and states the line in question
September 2, 2014	Staff closed its investigation into the matter because of uncertainty over the ownership of the damaged facility and the locate marks showing two different paths for electrical conductors serving the building in question.
May 15, 2015	Complainants file complaint requesting Staff investigate KCPL's failure to provide accurate locates.
July 16, 2015	Staff, KCPL personnel, and KCPL contract locator meet on site. Locator demonstrates the ability to accurately mark the service line from the transformer to the building. Original locate marks from one year earlier demonstrate the inaccuracy of the marks. Locator also incorrectly indicates an additional service drop to the building meter. <sup>2</sup>

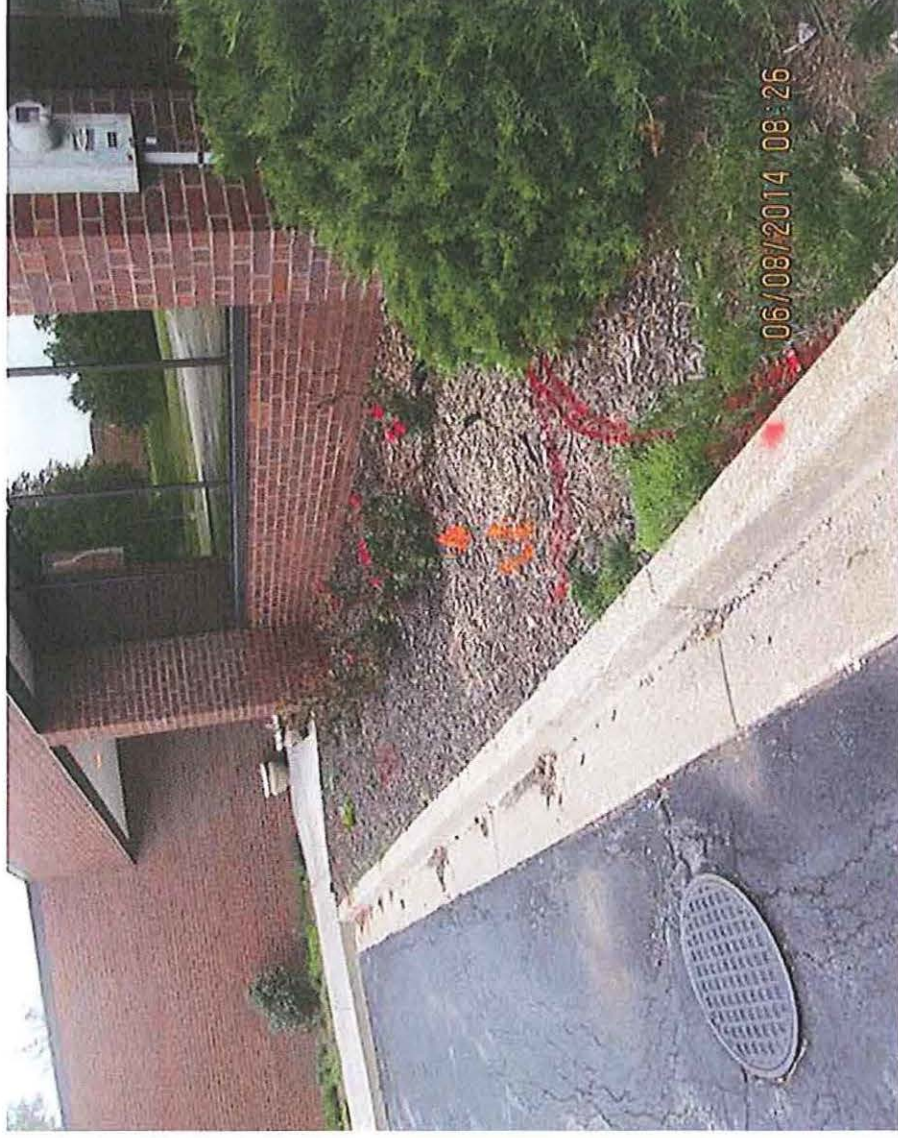
**ATTACHMENT 4**  
**Photo of Original Locate Marks**

Property of United States Infrastructure Corporation  
Photo taken on 6/8/2014 8:26:50 AM
