THE STATE CORPORATION COMMISSION OF THE STATE OF KANSAS

In the matter of the failure of Benjamin M. Giles ("Operator") to comply with K.A.R. 82-3-104 and K.A.R. 82-3-111 at the Flying J Geer #2 OWWO well in Butler County, Kansas.	Docket No.: 17-CONS-3684-CPEN CONSERVATION DIVISION License No.: 5446
In the matter of the failure of Benjamin M. Giles ("Operator") to comply with K.A.R. 82-3-111 at the Paulsen #1 in Butler County, Kansas.	Docket No.: 18-CONS-3057-CPEN CONSERVATION DIVISION License No.: 5446
In the matter of the failure of Benjamin M. Giles ("Operator") to comply with K.A.R. 82-3-604 at the Ralston Lease Tank Battery in Butler County, Kansas.	Docket No.: 18-CONS-3160-CPEN CONSERVATION DIVISION License No.: 5446
In the matter of the failure of Benjamin M. Giles ("Operator") to comply with K.A.R. 82-3-104 and K.A.R. 82-3-111 at the Wright #1 OWWO well in Butler County, Kansas.	Docket No.: 18-CONS-3167-CPEN CONSERVATION DIVISION License No.: 5446

PRE-FILED TESTIMONY OF JONATHAN HILL

APRIL 23, 2018

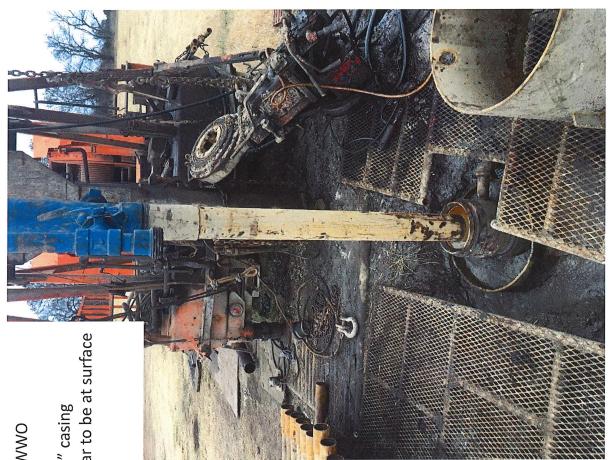
Ben Giles – Wright 1 OWWO SW 32-25S-4E Cementing head on 5.5" casing Cement does not appear to be at surface in 5.5" annulus 11/13/2017

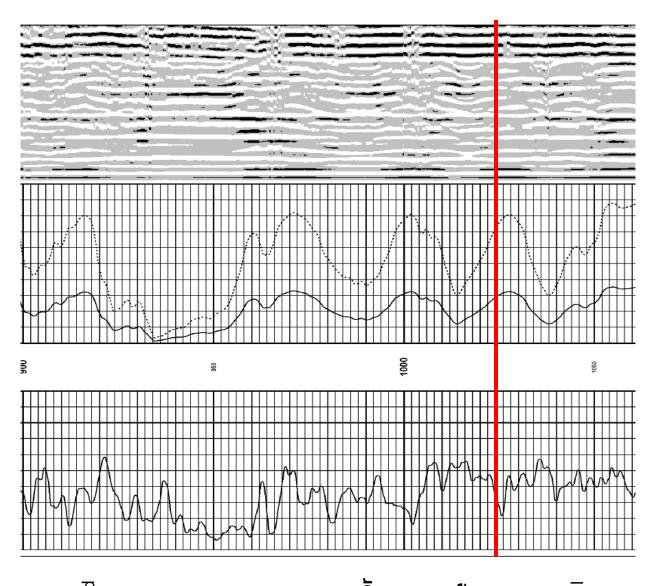
Benjamin Giles – Flying J Geer #2 Cement Bond Log (900'- 1060')

- There are 2 123' consecutive and identical sections of all curves in this log between the depths of 776' to 899' (Blue), and 899' to 1022' (Red).
- The only known ways for this to occur is for the log to be manipulated by either 'splicing', a computer simulated run, or the raw data was altered at the completion of the logging run.
- There are no explanations or comments about this in the log, or by the operator, as to why this -- and for what purpose-- has occurred.
- Altering the data presented in the log, with no explanations, also results the questioning the validity of the entire log.
- The next sides display the identical sections in greater detail
