**BEFORE THE STATE CORPORATION COMMISSION
OF THE STATE OF KANSAS**

**NOTICE OF FILING OF STAFF'S
REPORT AND RECOMMENDATION**

**REPORT AND RECOMMENDATION
UTILITIES DIVISION**

SUBJECT: Docket No. 17-KGSG-069-GIP: In the Matter of the General Investigation Into the Operations of Kansas Gas Service, Inc., A Division of One Gas, Regarding the Natural Gas Incident that Occurred at 918 West 5th Street, Newton, Kansas

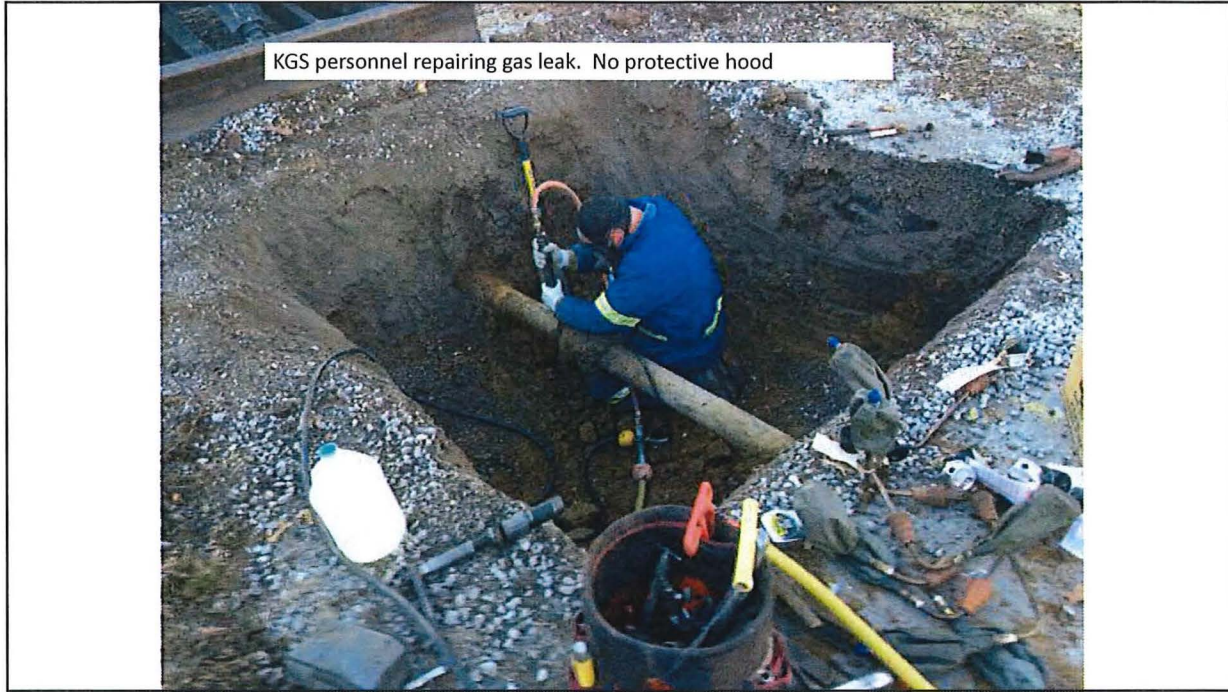
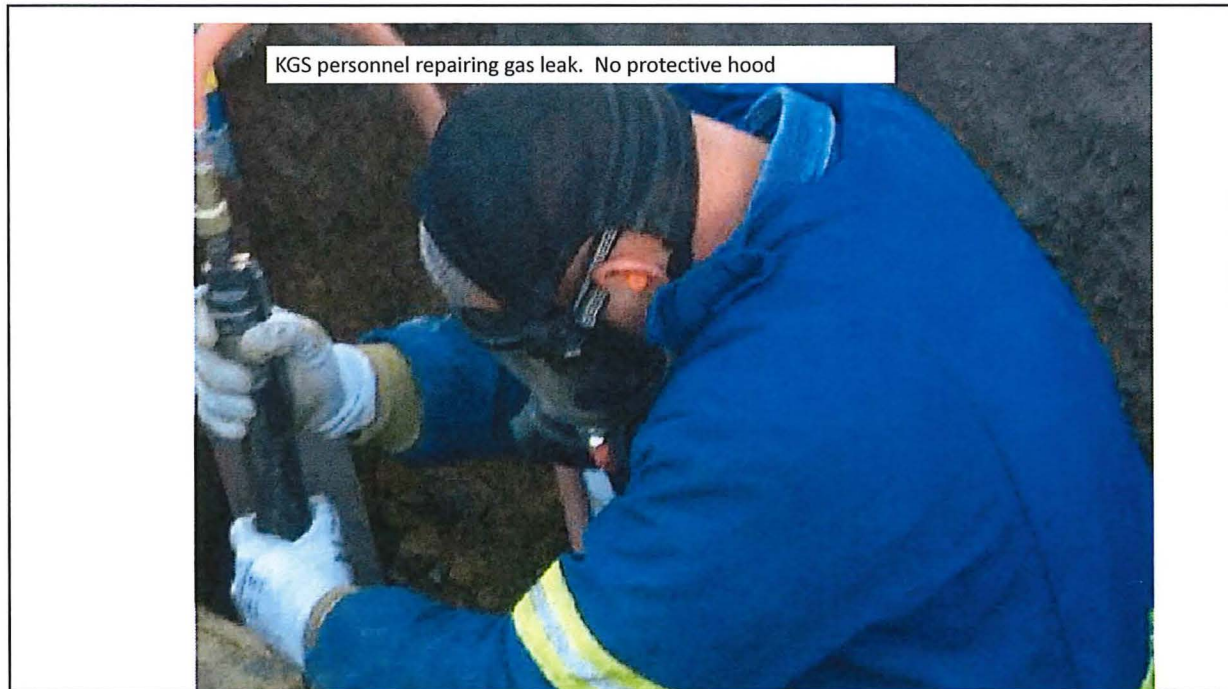
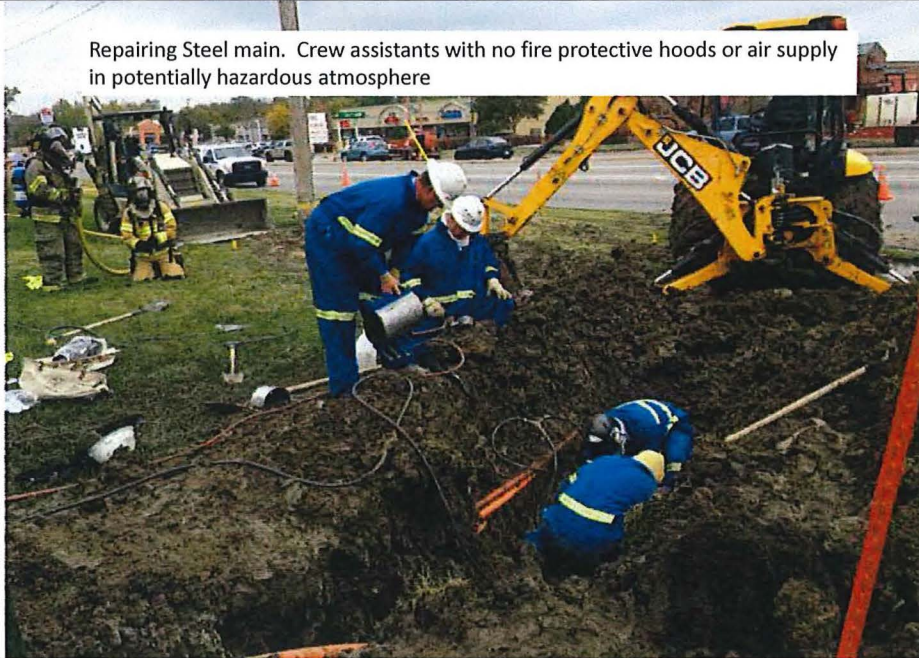
Repairing Steel main. Crew assistants with no fire protective hoods or air supply in potentially hazardous atmosphere

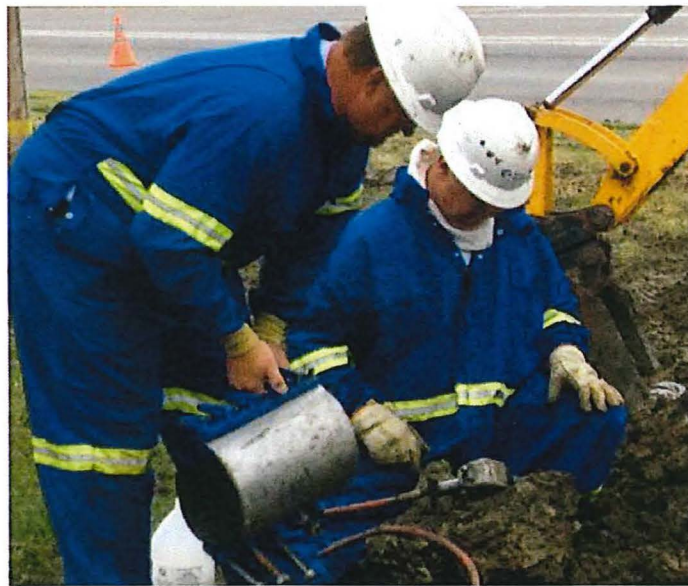
Repairing 8" main. Crew assistants with no fire protective hoods or air supply in potentially hazardous atmosphere

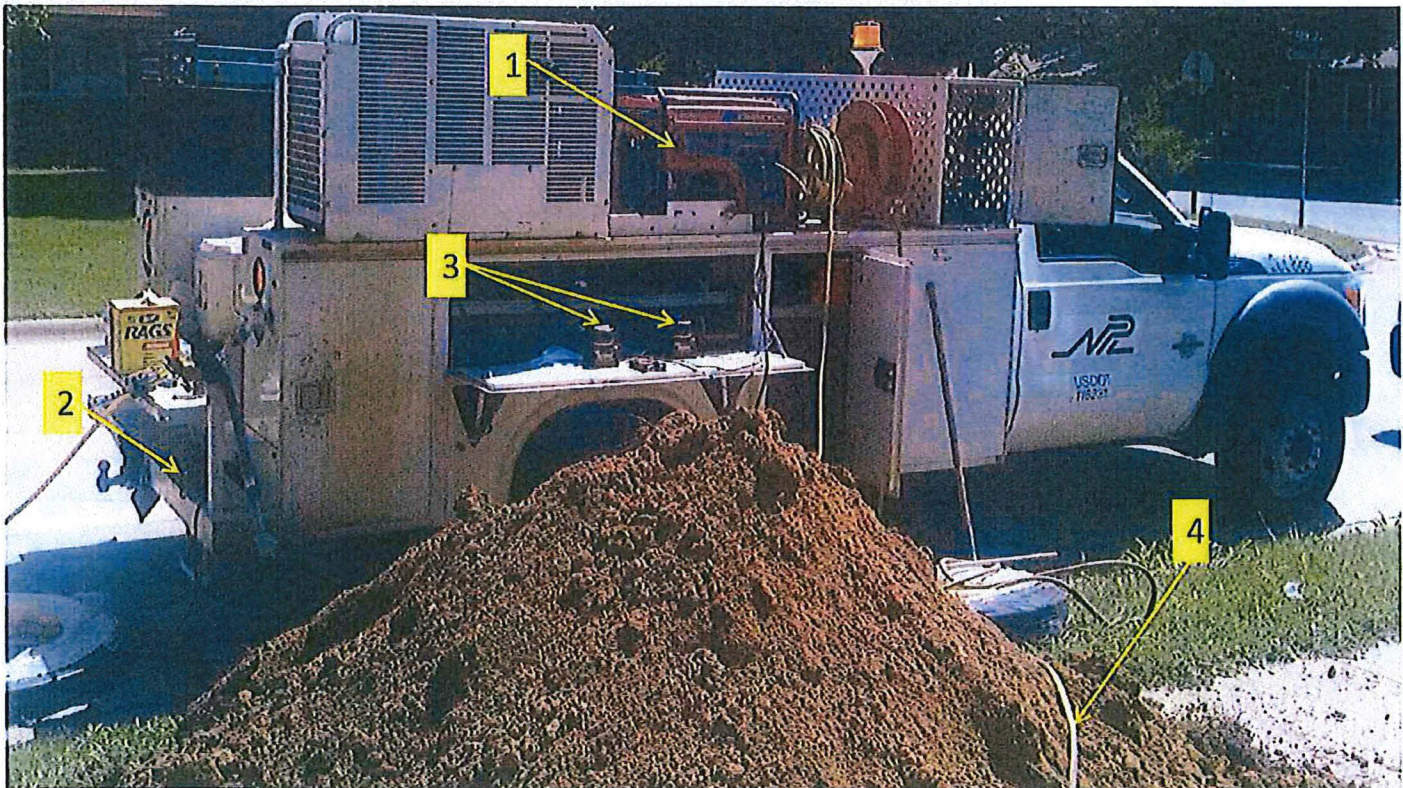
Wind blowing towards the crew truck. Generator was running, several points of ignition during time of incident. 1. Generator 2. Mini-mac 3. Rechargeable batteries 4. Extension cord present
