In the Matter of the General Investigation Into)
the Operations of Kansas Gas Service, a)
Division of ONE Gas, Inc., Regarding the) Docket No. 18-KGSG-126-GIP
Natural Gas Incident that Occurred at 4550 SE)
29th Street in Topeka, Shawnee County,)
Kansas.)

ORDER CLOSING GENERAL INVESTIGATION

MEMORANDUM

Subject: Docket 18-KGSG-126-GIP: In the Matter of the General Investigation into the Operations of Kansas Gas Service, a Division of ONE Gas, Inc., Regarding the Natural Gas Incident that Occurred at 4550 S.E. 29th Street in Topeka, Shawnee County, Kansas

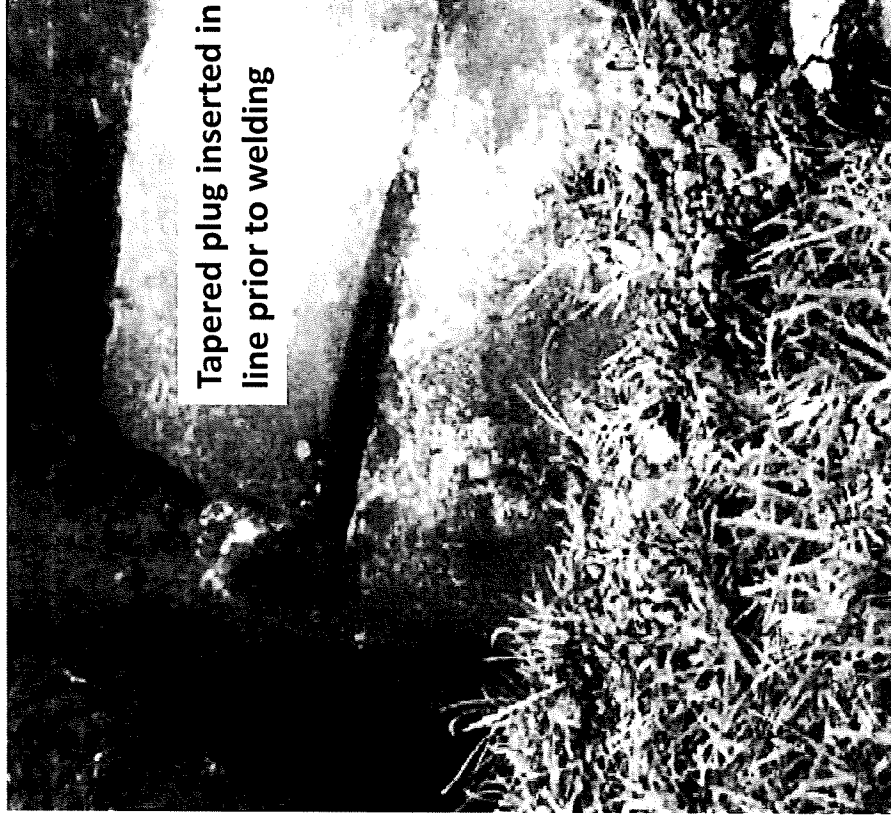
As shown in Exhibit 1, the tapered plug is designed to provide a gas tight seal for a relatively round hole in a pipe wall. The pin is configured with self-tapping threads which allows it to grip the edges of the opening. The tapered design allows a given plug to fit a variety of different size openings and provides a seal as the pin is tightened into the hole. Exhibit 2 provides a photo of the pin installation which was performed at the site of the incident after the incident occurred.

In the KGS repair practice, after the pin is tightened into the hole, the pin is welded in place in order to make the repair permanent. In this case, the "hole" in the pipe wall was a threaded tap hole directly in the body of the mainline from which the original service had been removed. The NPL personnel had installed the plug and tightened it to the point that no gas was leaking from the fitting. As the welder was cleaning the pipe to prepare it for welding, the vigorous action of the rotating steel brush evidently caused the pin's self-tapping threads to pull loose from the pipe fitting.

Tapered plug inserted in main
line prior to welding

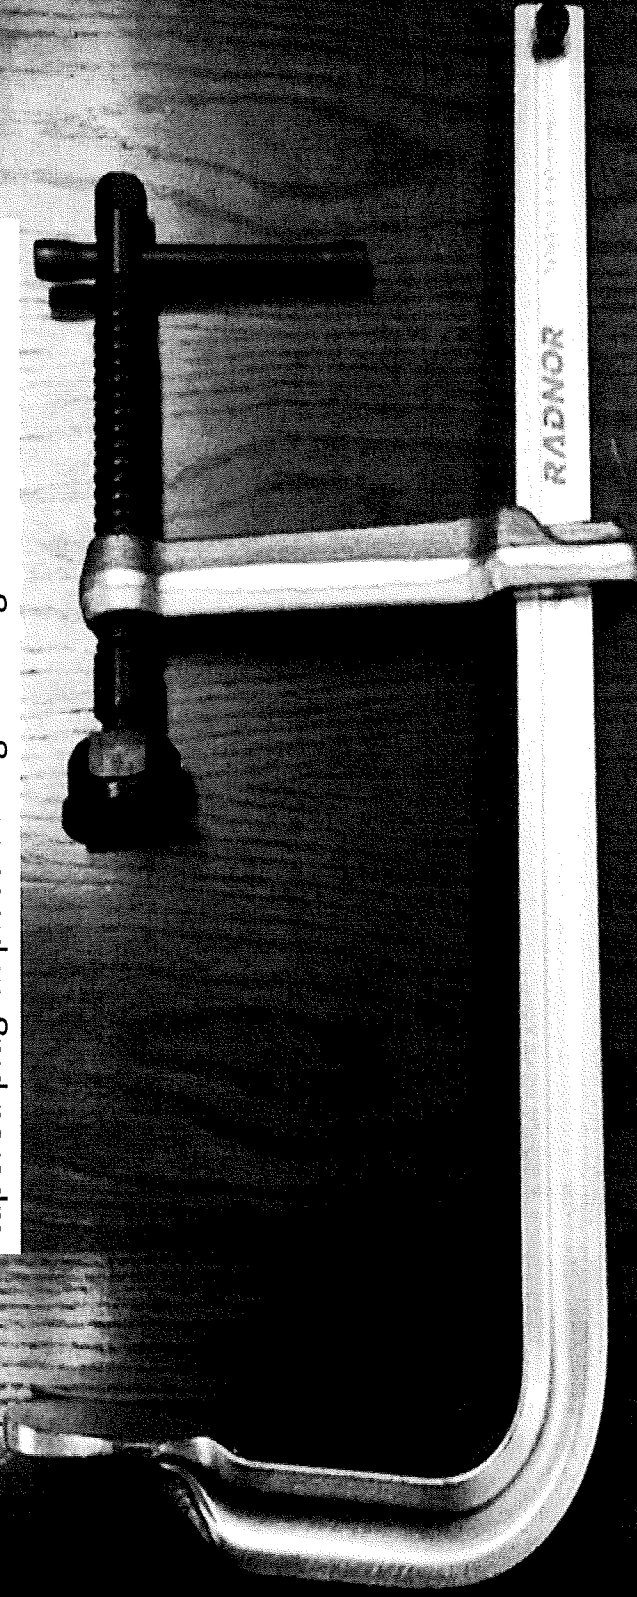
Exhibit 3

External clamping device to be used by KGS to hold tapered plug in place during welding.

the considered scenarios, it is the preferred repair method. In order to minimize the possibility of a pin becoming dislodged before it is welded in place, KGS and NPL have proposed to modify the repair procedure to require the use of an external clamp that will hold the pin in place until it can be welded. A photo of the pin clamping device is attached as Exhibit 3. At this time, the procedure modification is under review by KGS management. Although the use of tapered pins to repair gas leaks is standard industry practice, Staff agrees with KGS that the use of the external clamping device will enhance the safety of the procedure.
