NOTICE OF PENALTY ASSESSMENT
21-CONS-3032-CPEN

August 27, 2020

Re: Unreported Spills and Failure to Cleanup Spills on the South Kempnich lease located in Section 22, Township 20 South, Range 20 East, Anderson County, Kansas.

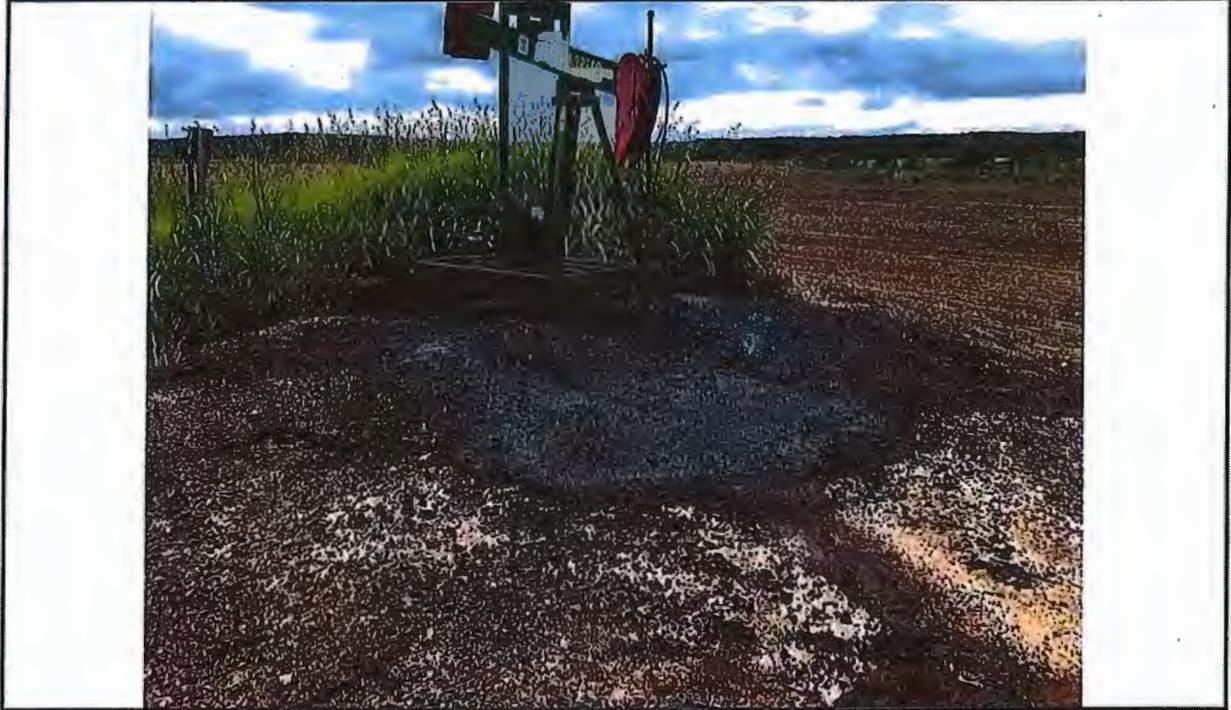
Operator: Tailwater, Inc.	KLN: 32461
Lease: South Kempnich	Legal: 22-20-20E
County: Anderson	PIC ID#: 4-T
Subject: 4-T	PIC Orientation:
FSL: 2498	Latitude: 38.294950
FEL: 4193	Longitude: -95.190450
API#: 15-003-24648-00-00	
Date: 7/15/2019	Time: 12:40 PM
Staff: Ryan Duling and Kelth Carswell

Additional Information: This picture is of well location 4-T. This location has a 10' by 10' spill. The well is leaking up the production string and is not equipped with a stuffing box. The well is equipped for production but was not producing at the time of the lease inspection.

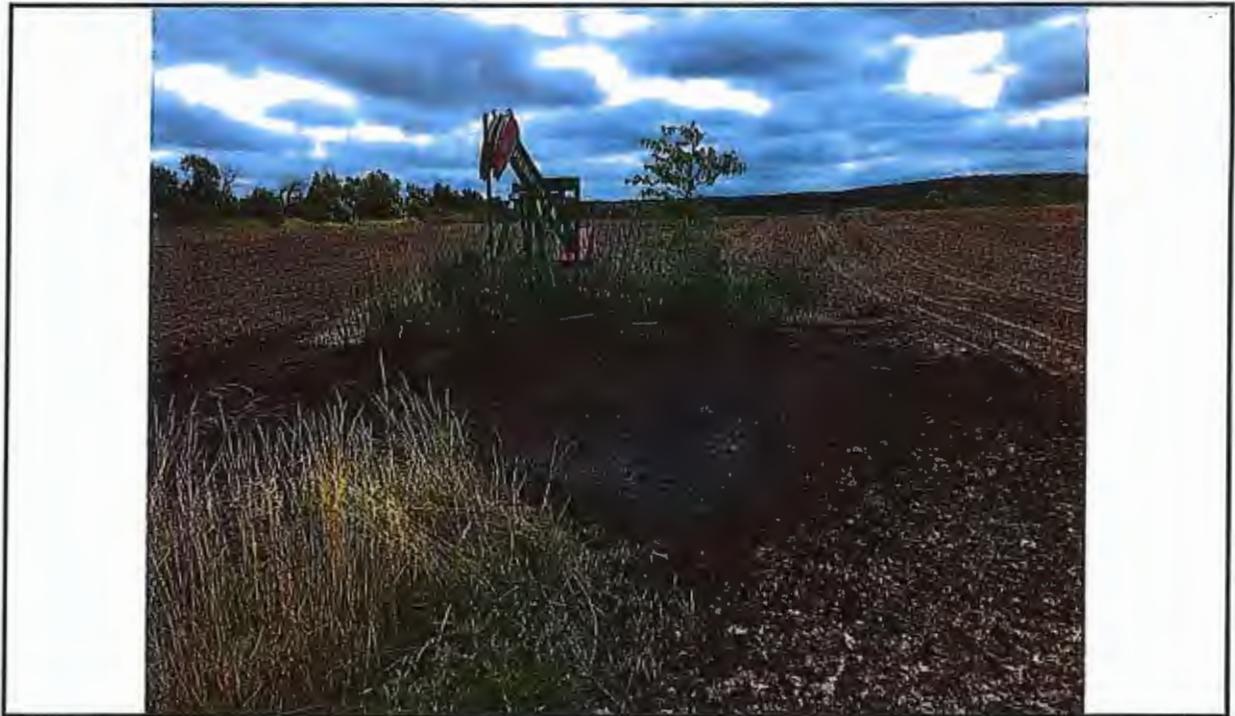
Operator: Tailwater, Inc.
Lease: South Kempnich
County: Anderson
Subject: 5-T
FSL: 2356
FEL: 3873
API#: 15-003-24649-00-00
Date: 7/15/2019
Staff: Ryan Duling and Keith Carswell

Additional Information: This picture is of well location 5-T. This location has a 20' by 20' new spill. The well is leaking up the production string and is not equipped with a stuffing box. At the time of inspection well was not equipped for production. The bridle was unhooked.

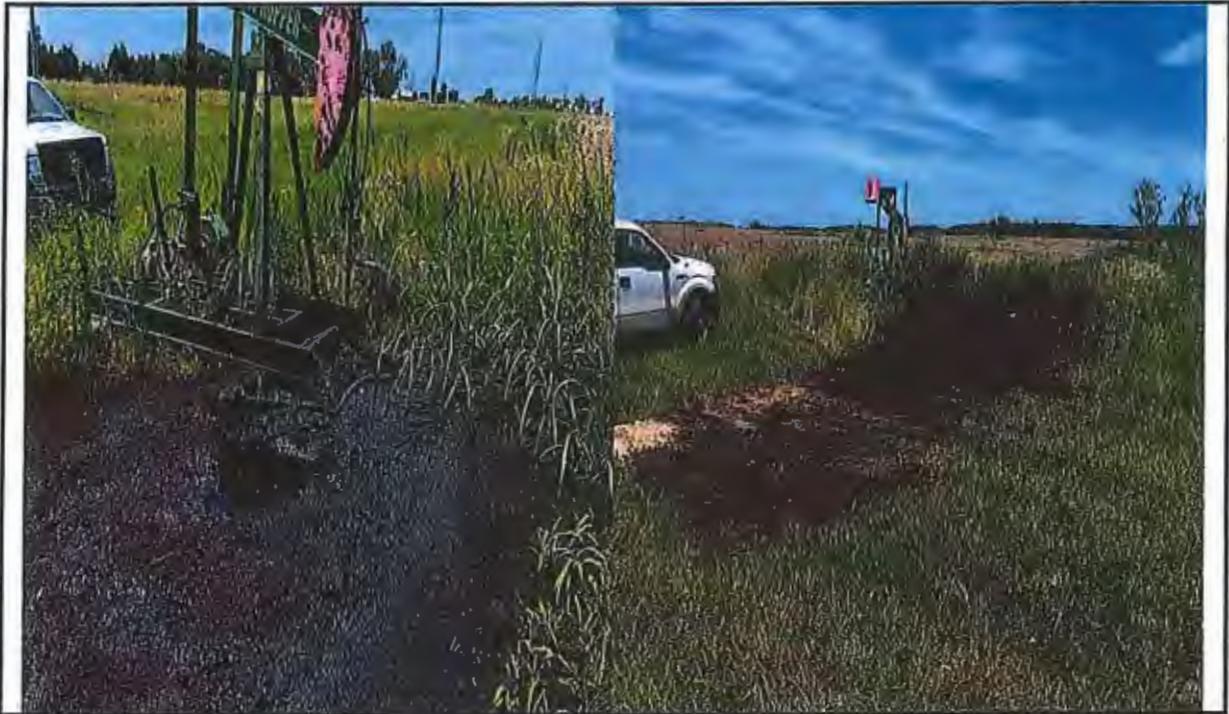
Operator:	Tallwater, Inc.
Lease:	South Kempnich
County:	Anderson
Subject:	7-T
FSL:	2056
FEL:	5160
API#:	15-003-24651-00-00
Date:	7/11/2019
Staff:	Ryan Duling and Keith Carswell

Additional Information: This picture is of well location 7-T. This location has a 20' by 50' spill. The well is leaking up the production string and is not equipped with a stuffing box. The well is equipped for production but was not producing at the time of the lease inspection.

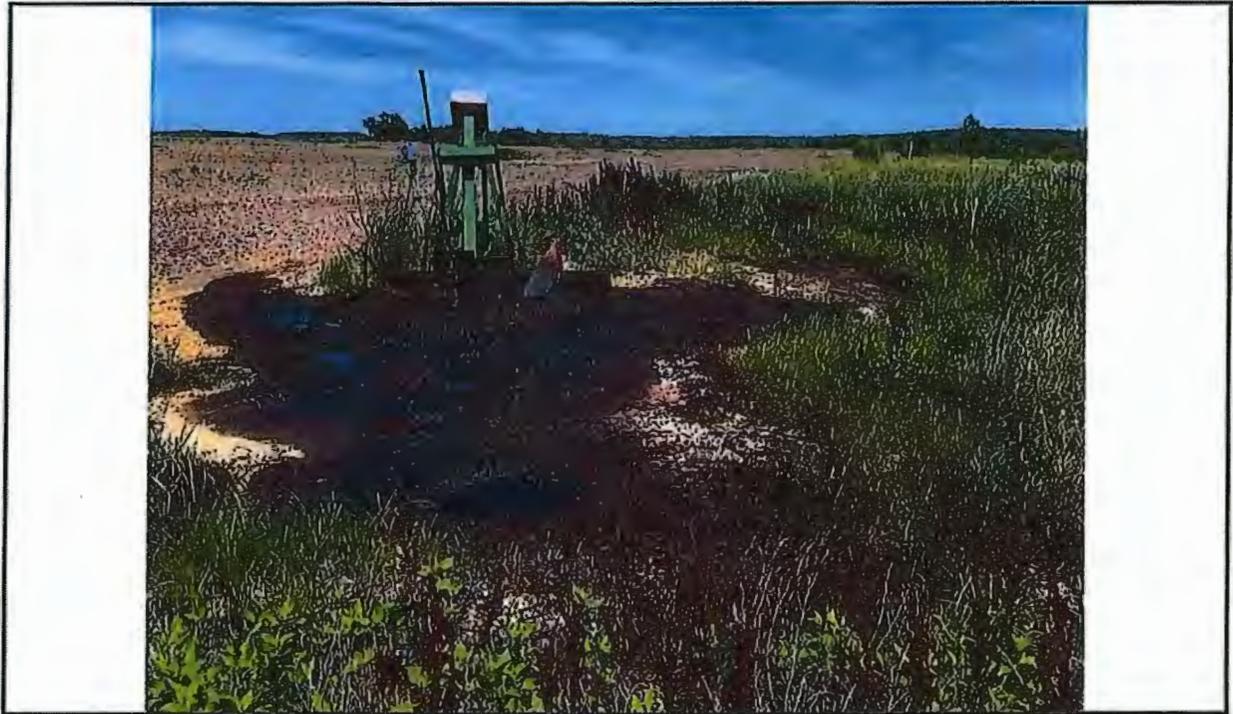
Operator: Tailwater, Inc.
Lease: South Kempnich
County: Anderson
Subject: 8-T
FSL: 2036
FEL: 4849
API#: 15-003-24652-00-00
Date: 7/11/2019
Staff: Ryan Duling and Kelth Carswell

Additional Information: This picture is of well location 8-T. This location has a 30' by 30' new spill. The well is leaking up the production string and is not equipped with a stuffing box. At the time of inspection well was not equipped for production. The pump jack was broke.

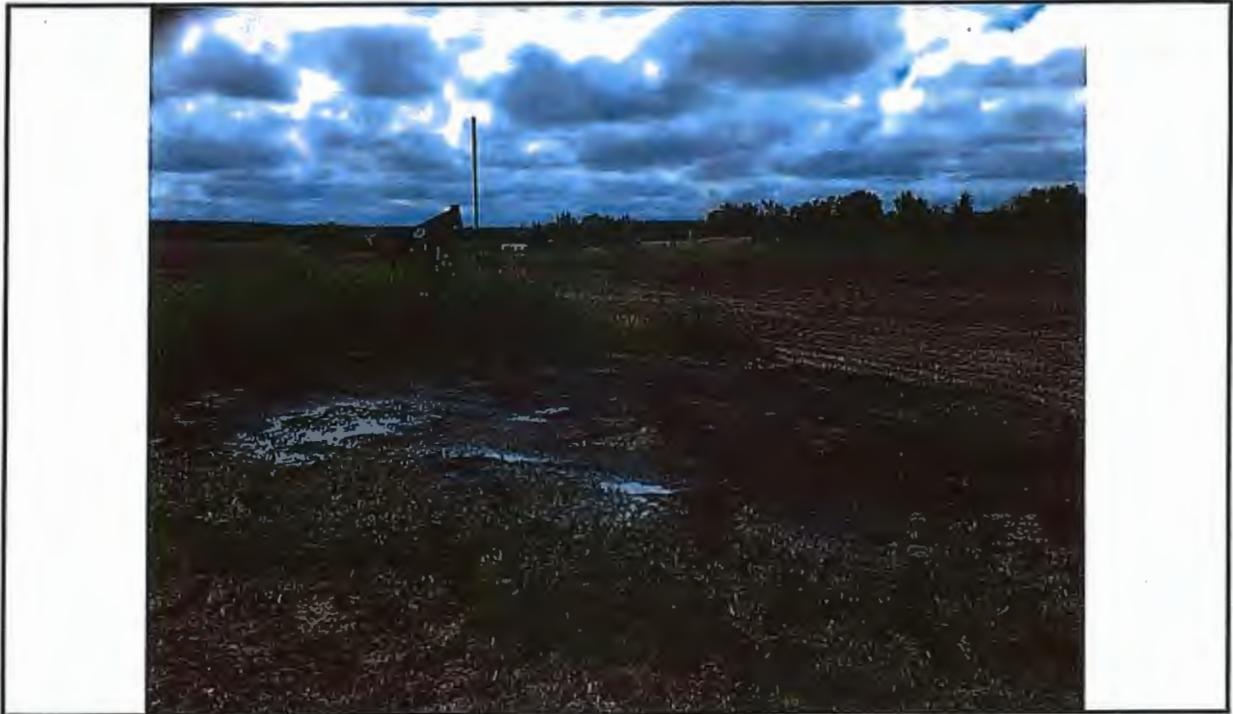
Operator: Tailwater, Inc.
Lease: South Kempnich
County: Anderson
Subject: 9-T
FSL: 2173
FEL: 4538
API#: 15-003-24653-00-00
Date: 7/15/2019
Staff: Ryan Duling and Keith Carswell

Additional Information: This picture is of well location 9-T. This location has a 20' by 30' new spill. The well is leaking up the production string and is not equipped with a stuffing box. At the time of inspection well was not equipped for production. The pump jack was broke.

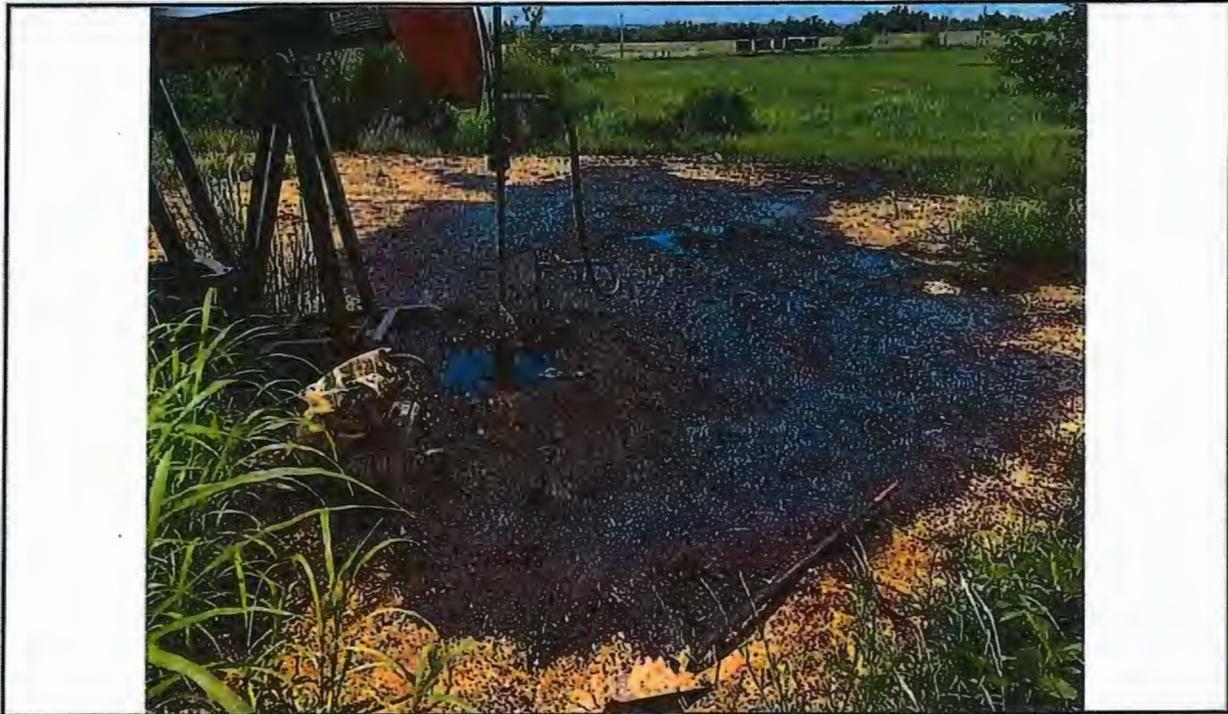
Operator: Tailwater, Inc.	KLN: 32461
Lease: South Kempnich	Legal: 22-20-20E
County: Anderson	PIC ID#: 13-T
Subject: 13-T	PIC Orientation:
FSL: 1923	Latitude: 38.293350
FEL: 3591	Longitude: -95.188350
API#: 15-003-24687-00-00	
Date: 7/11/2019	Time: 2:53 PM
Staff: Ryan Duling and Keith Carswell

Additional Information: This picture is of well location 13-T. This location has a 30' by 60' new spill and 70' by 100' old spill. The well is leaking up the production string and is not equipped with a stuffing box. The well is equipped for production but was not producing at the time of the lease inspection.

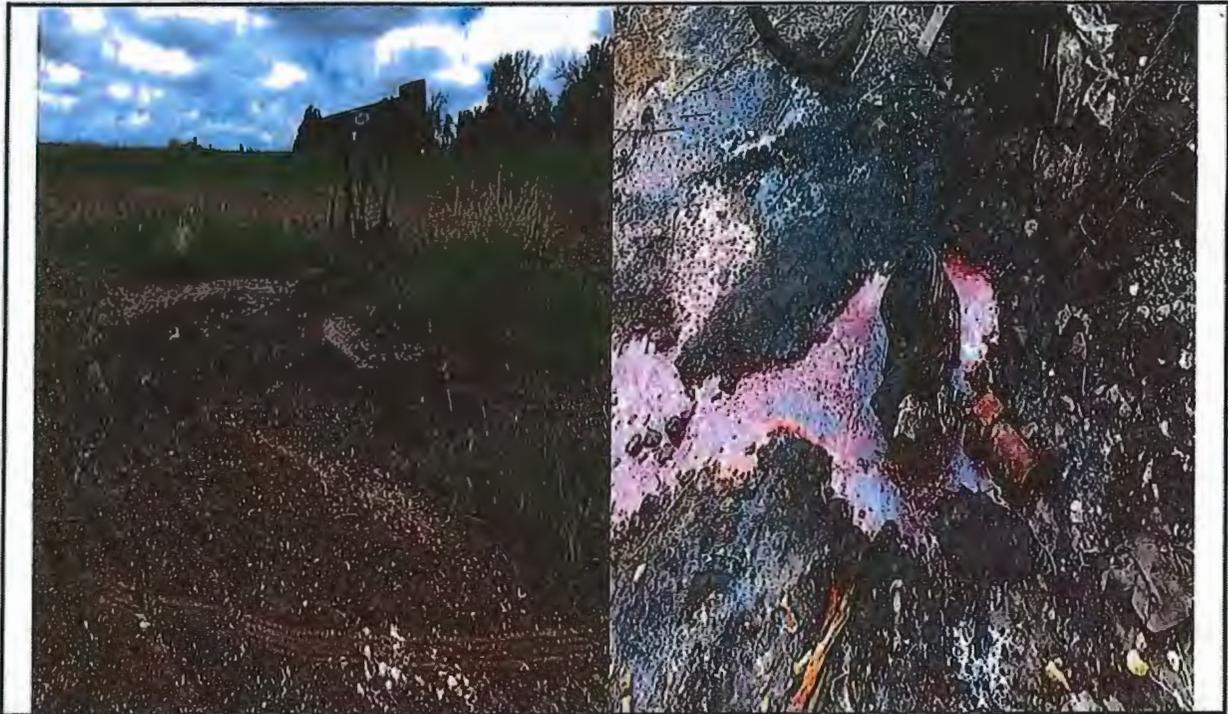
Operator: Tailwater, Inc.
Lease: South Kempnich
County: Anderson
Subject: 14-T
FSL: 2446
FEL: 3206
API#: 15-003-25017-00-00
Date: 7/15/2019
Staff: Ryan Duling and Keith Carswell

Additional Information: This picture is of well location 14-T. This location has a 20' by 10' new spill. The well is leaking up the production string and is not equipped with a stuffing box. At the time of inspection well was not equipped for production. The pump jack was tore apart. No pumping string in well. Well has a rag stuffed in the casing.

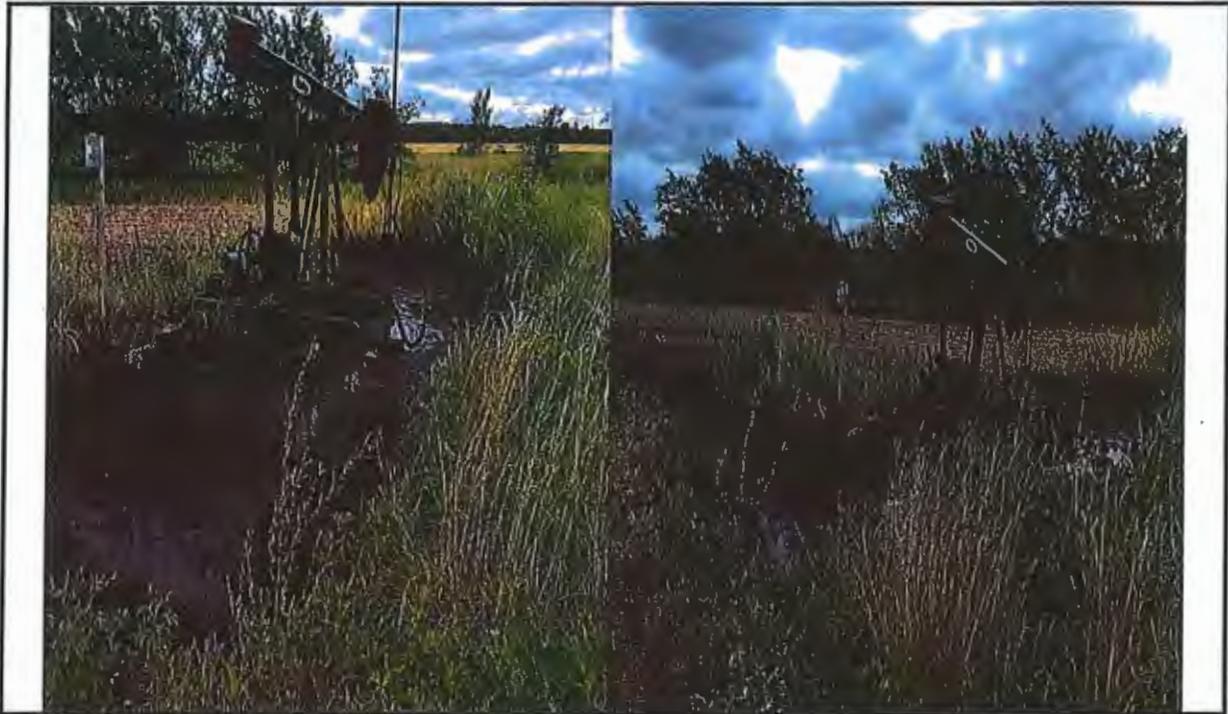
Operator: Tallwater, Inc.
Lease: South Kempnich
County: Anderson
Subject: 15-T
FSL: 2110
FEL: 3256
API#: 15-003-25018-00-00
Date: 7/15/2019
Staff: Ryan Duling and Keith Carswell

Additional Information: This picture is of well location 15-T. This location has a 30' by 75' spill. The well is leaking up the production string and is not equipped with a stuffing box. The well is equipped for production but was not producing at the time of the lease inspection.

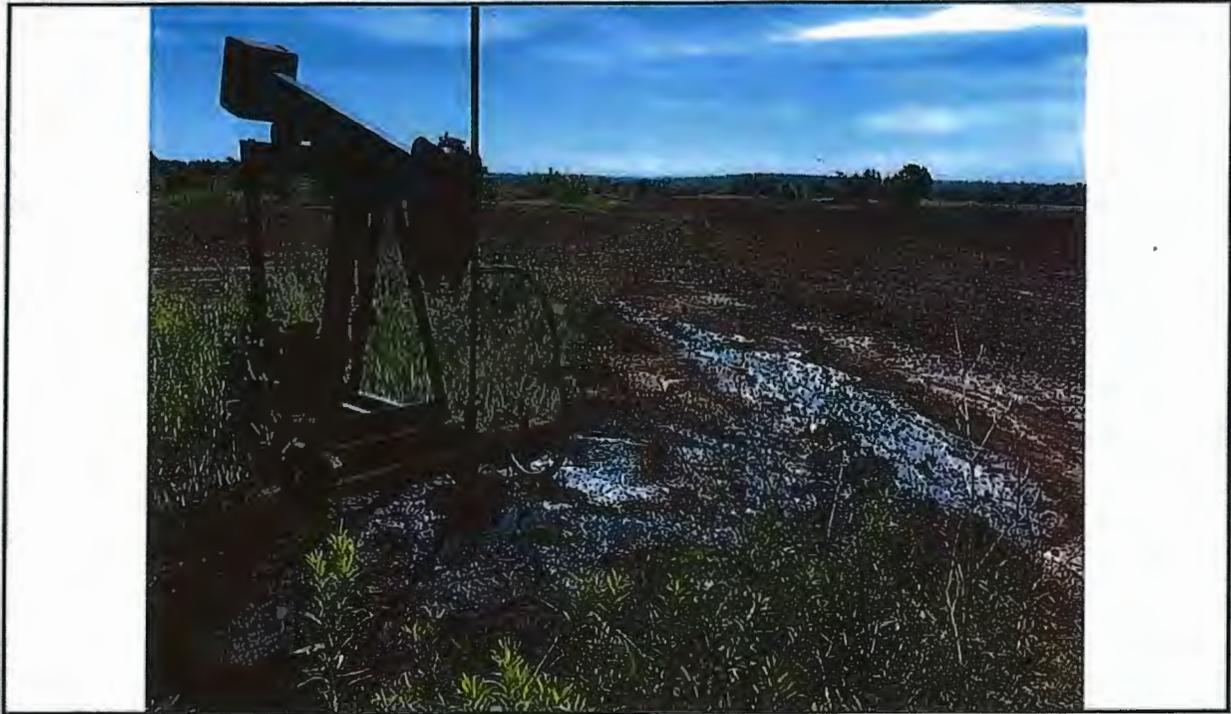
Operator: Tailwater, Inc.
Lease: South Kempnich
County: Anderson
Subject: 16-T
FSL: 1705
FEL: 5136
API#: 15-003-25019-00-00
Date: 7/11/2019
Staff: Ryan Duling and Keith Carswell

Additional Information: This picture is of well location 16-T. This location has a 10' by 30' spill. The well is leaking up the production string and is not equipped with a stuffing box. The well is equipped for production but was not producing at the time of the lease inspection.

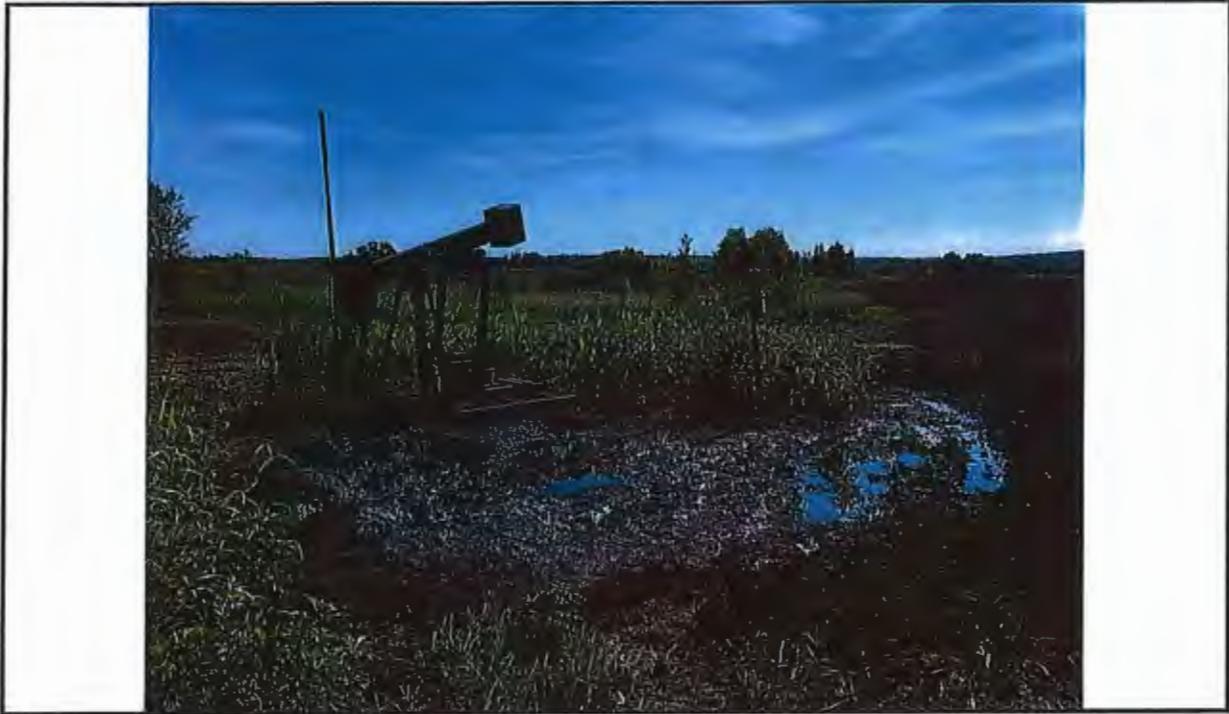
Operator: Tailwater, Inc.	KLN: 32461
Lease: South Kempnich	Legal: 22-20-20E
County: Anderson	PIC ID#: 17-T
Subject: 17-T	PIC Orientation:
FSL: 1741	Latitude: 38.292890
FEL: 4812	Longitude: -95.192602
API#: 15-003-25020-00-00	
Date: 7/11/2019	Time: 9:57 AM
Staff: Ryan Duling and Keith Carswell

Additional information: This picture is of well location 17-T. This location has a 20' by 30' new spill. The well is leaking up the production string and is not equipped with a stuffing box. At the time of inspection well was not equipped for production. The pump jack did not have a motor.

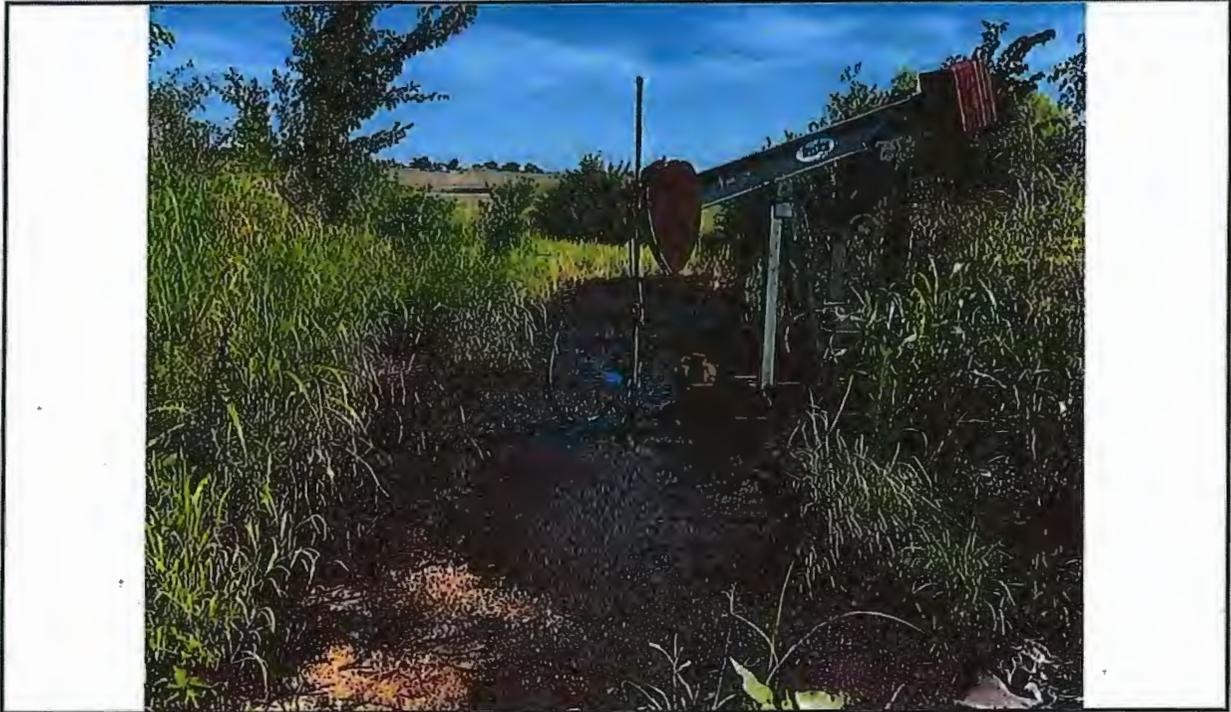
Operator: Tailwater, Inc.
Lease: South Kemprich
County: Anderson
Subject: 18-T
FSL: 1807
FEL: 4492
API#: 15-003-25021-00-00
Date: 7/11/2019
Staff: Ryan Duling and Keith Carswell

Additional Information: This picture is of well location 18-T. This location has a 20' by 100' spill. The well is leaking up the production string and is not equipped with a stuffing box. The well is equipped for production but was not producing at the time of the lease inspection.

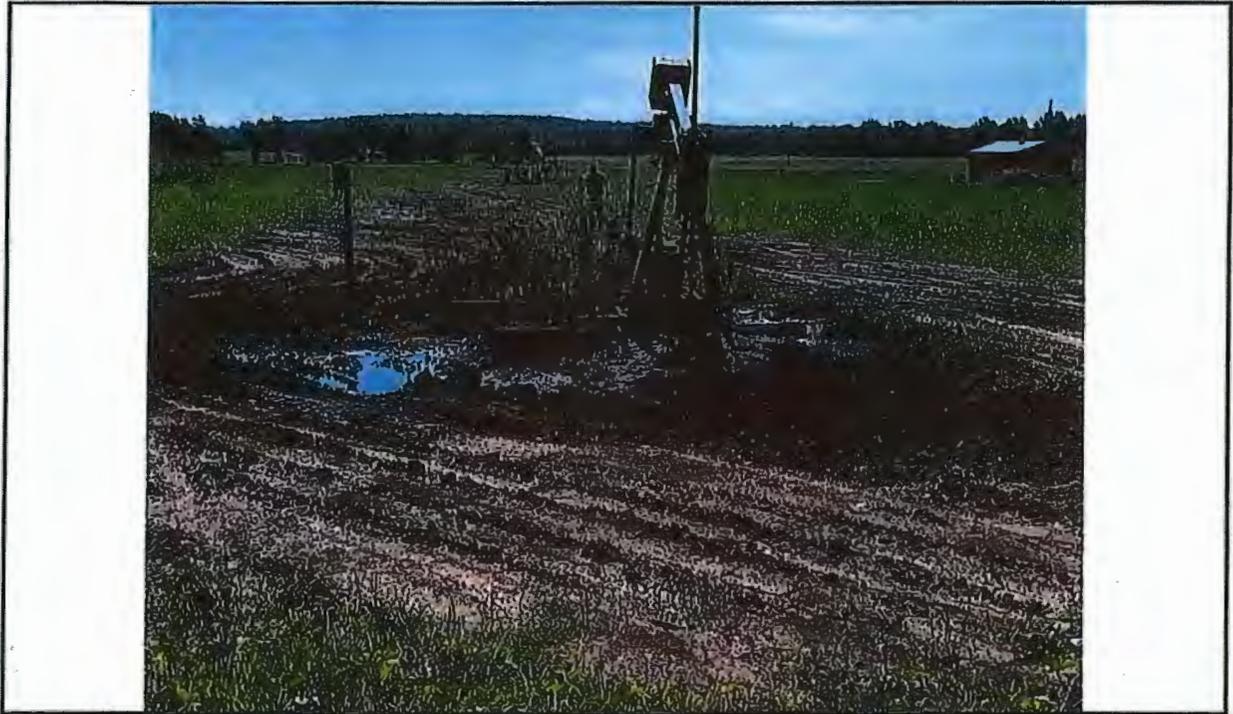
Operator: Tailwater, Inc.
Lease: South Kempnich
County: Anderson
Subject: 20-T
FSL: 1607
FEL: 3832
API#: 15-003-25023-00-00
Date: 7/11/2019
Staff: Ryan Duling and Keith Carswell

Additional information: This picture is of well location 20-T. This location has a 20' by 20' new spill and 40' by 450' old spill. The well is leaking up the production string and is not equipped with a stuffing box. The well is equipped for production but was not producing at the time of the lease inspection.
