**BEFORE THE STATE CORPORATION COMMISSION
OF THE STATE OF KANSAS**

In the matter of the failure of Tailwater, Inc.)	Docket No. 21-CONS-3032-CPEN
(Operator) to comply with K.A.R. 82-3-603 at)	
the South Kempnich Lease in Anderson County,)	CONSERVATION DIVISION
Kansas.)	
_____)	License No. 32461

PRE-FILED DIRECT TESTIMONY

KEITH CARSWELL

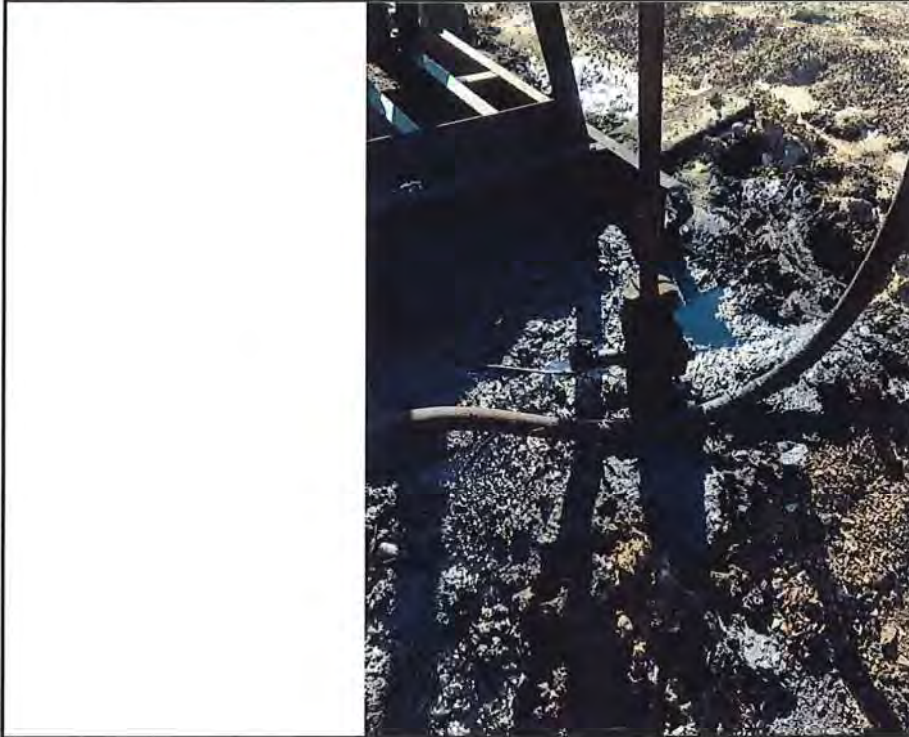
This is an updated picture of the South Kempnich well #20-T. The well is abandon and is not shut with the proper surface control, the well continues to leak crude oil on the ground.

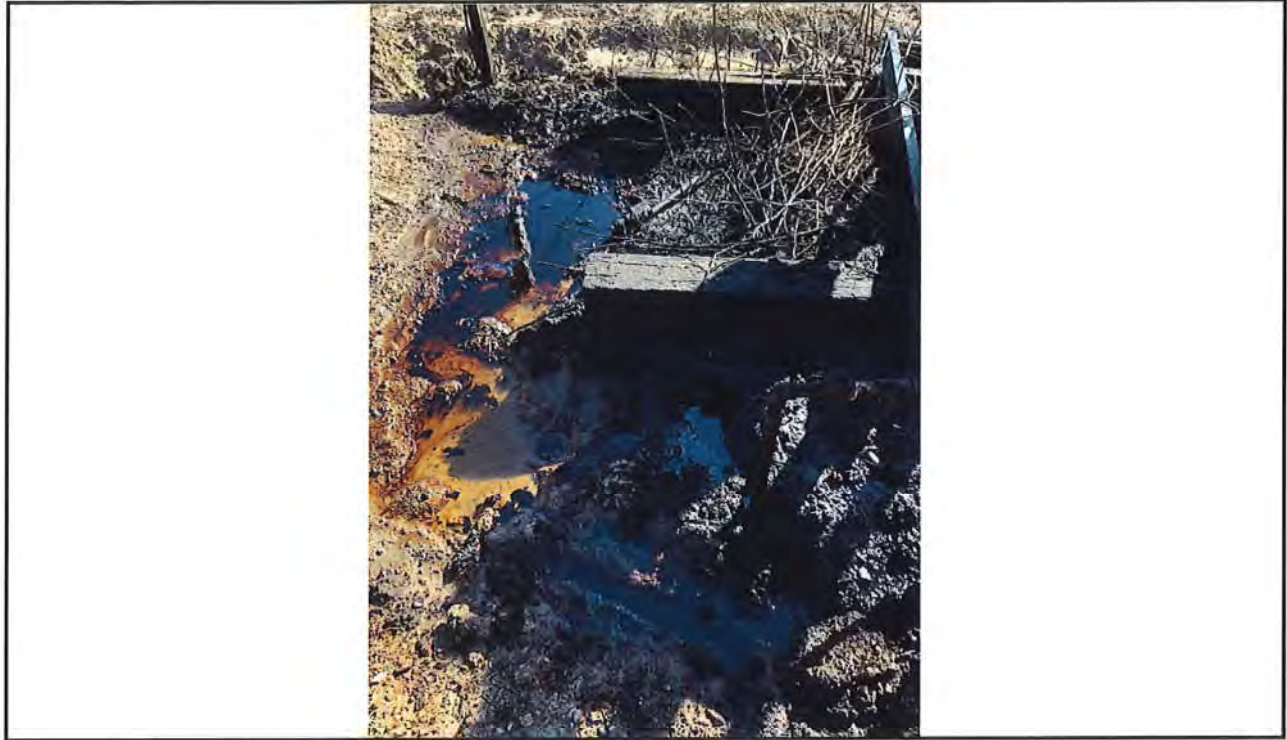
This is an updated picture of the South Kempnich well #20-T. The well is abandon and is not shut with the proper surface control, the well continues to leak crude oil on the ground.

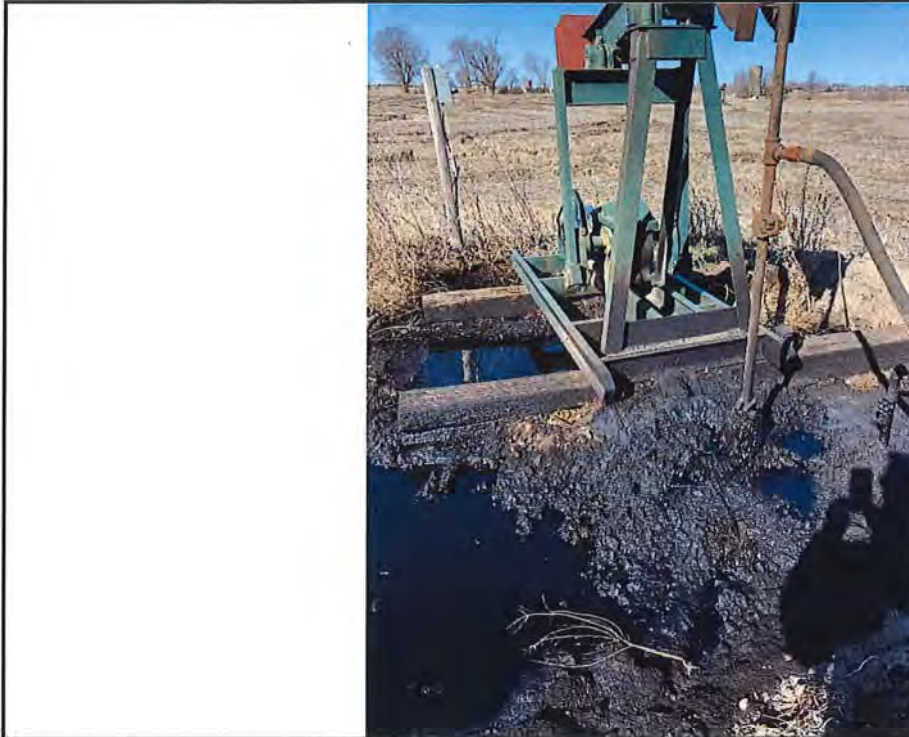
This is an updated picture of the South Kempnich well #26-T. The well is abandon and is not shut with the proper surface control, the well continues to leak crude oil on the ground.

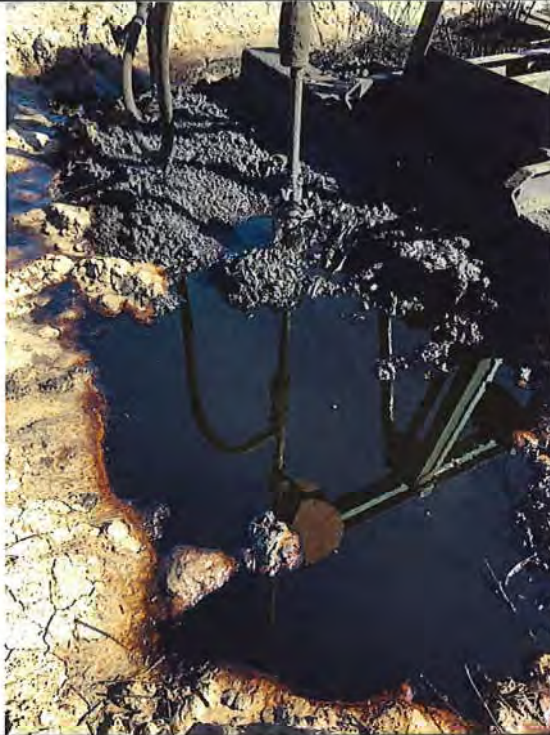
This is an updated picture of the South Kempnich well #27-T. The well is abandon and is not shut with the proper surface control, the well continues to leak crude oil on the ground.

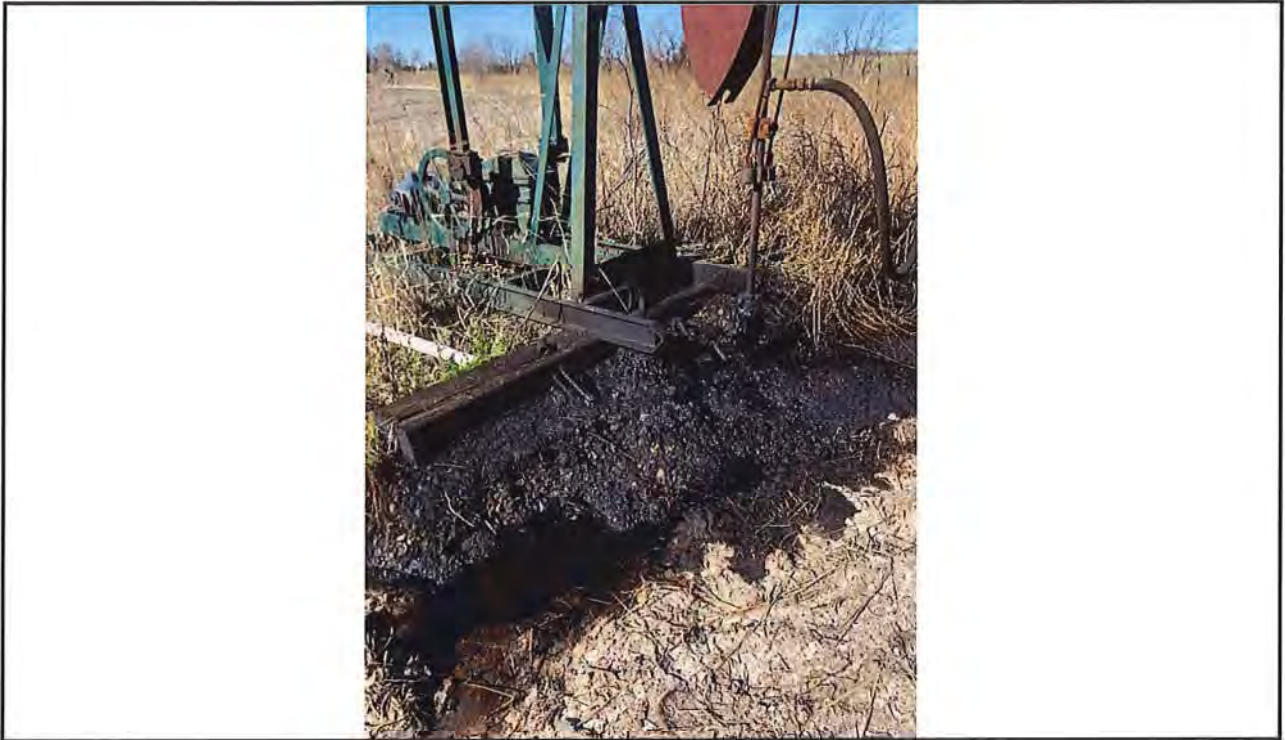
This is an updated picture of the South Kempnich well #30-T. The well is abandon and is not shut with the proper surface control, the well continues to leak crude oil on the ground.

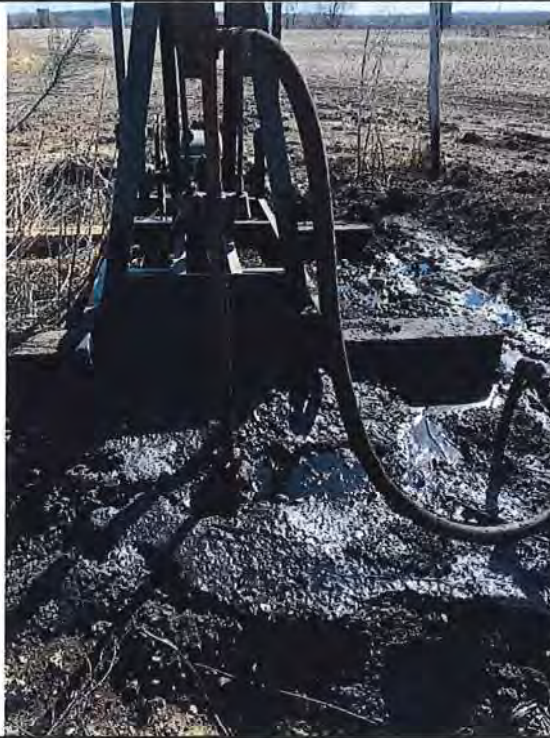
This is an updated picture of the South Kempnich well #17-T. The well is abandon and is not shut with the proper surface control, the well continues to leak crude oil on the ground.

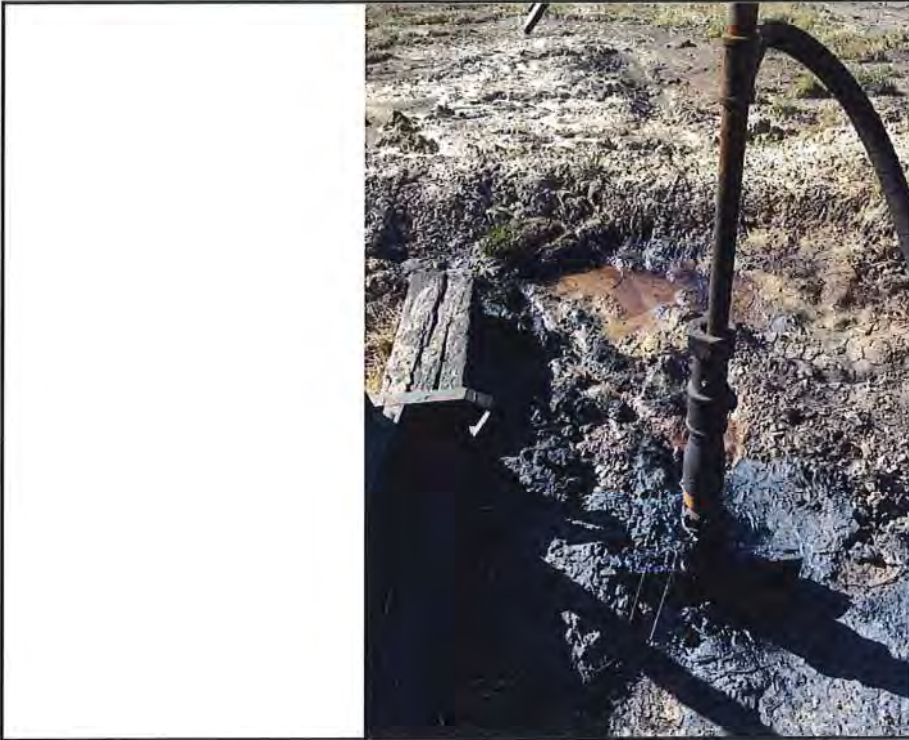
This is an updated picture of the South Kempnich well #23-T. The well is abandon, the well is not shut in with the proper surface control and continues to leak crude oil and saltwater on the ground.

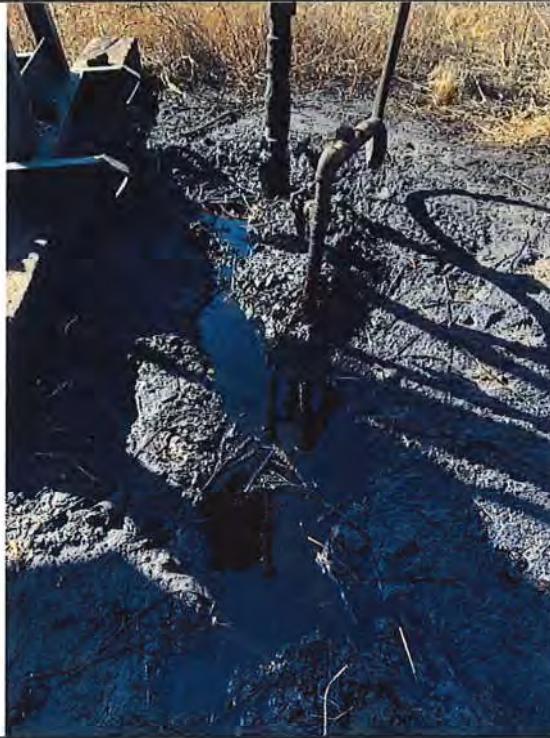
This is an updated picture of the South Kempnich well #24-T. The well is abandon, the well is not shut in with the proper surface control and continues to leak crude oil and saltwater on the ground.

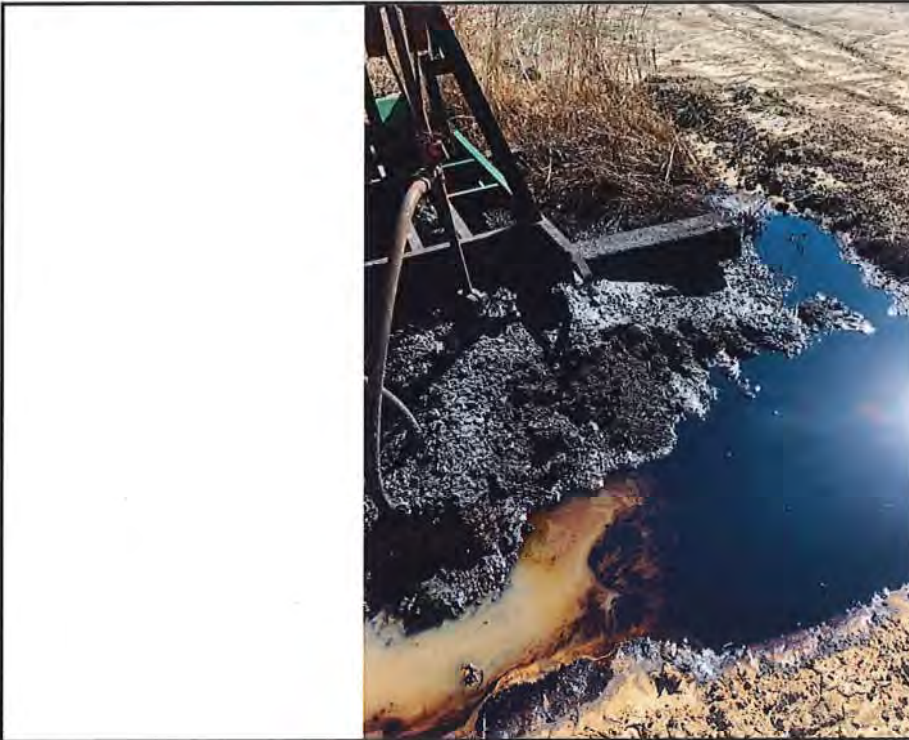
This is an updated picture of the South Kempnich well #4-T. The well is abandon and is not shut with the proper surface control, the well continues to leak crude oil and salt water on the ground and saturate the soil in front of and South of the well. The operator has done nothing to stop the spillage since the last inspection and has made no effort to clean up the spillage.

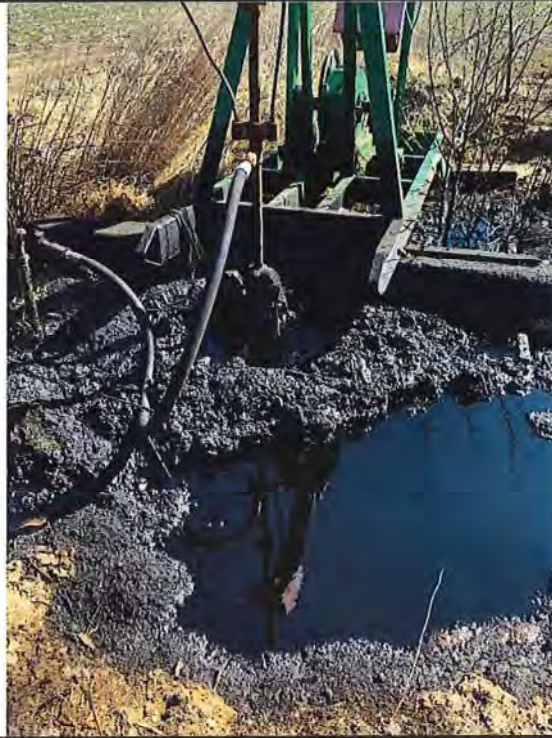
This is an updated picture of the South Kempnich well #5-T. The well is abandon and is not shut with the proper surface control, the well continues to leak crude oil on the ground and saturate the soil in front of and South of the well. The operator has done nothing to stop the spillage since the last inspection and has made no effort to clean up the spillage.

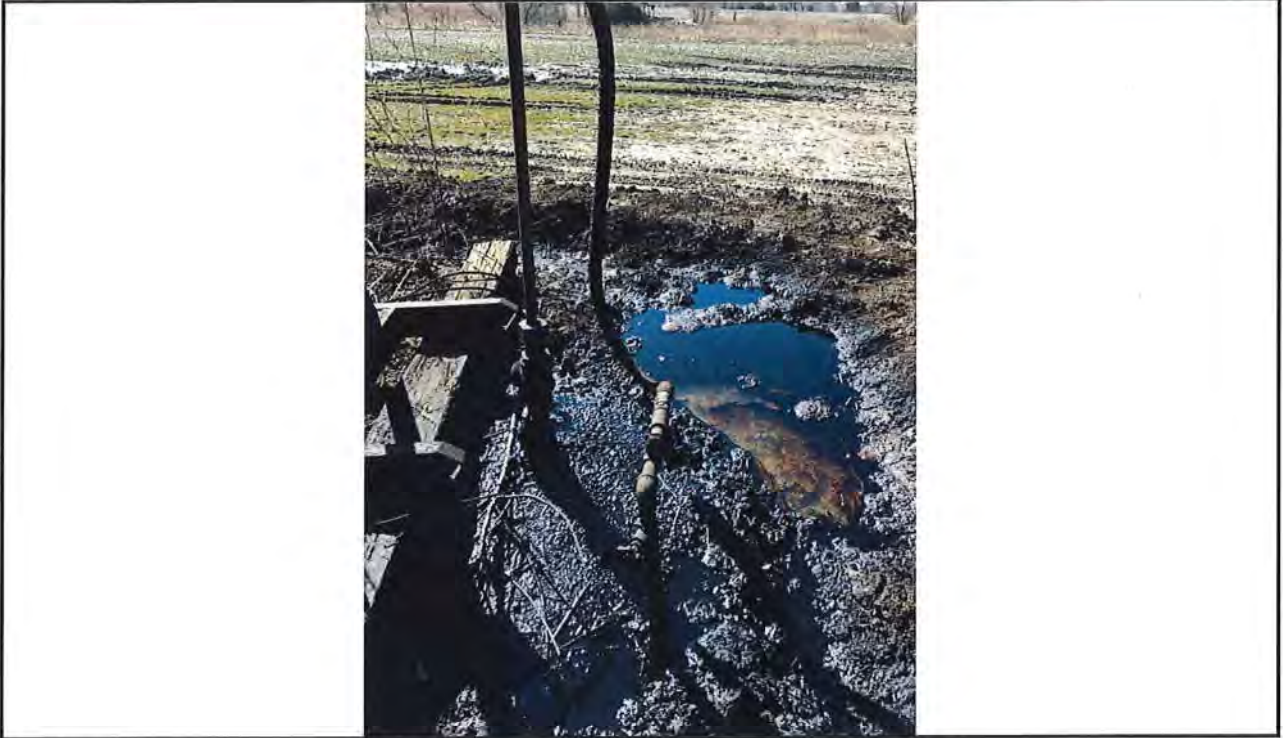
This is an updated picture of the South Kempnich well #9-T. The well is abandon, the well is not shut in with the proper surface control and continues to leak crude oil and salt water on the ground and saturate the soil in the area in front of the well.

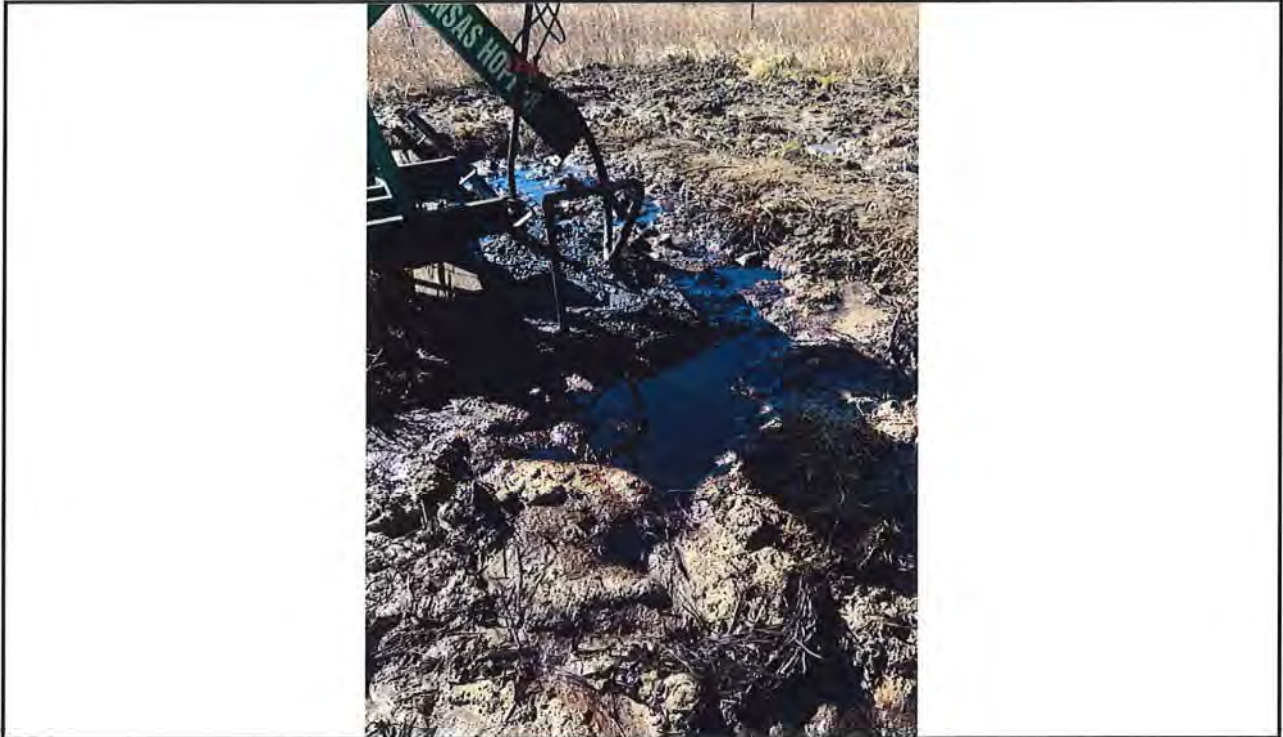
This is an updated picture of the South Kempnich well #8-T. The well is abandon, the well is not shut in with the proper surface control and continues to leak crude oil on the ground and saturate the soil in the area in front and South of the well.

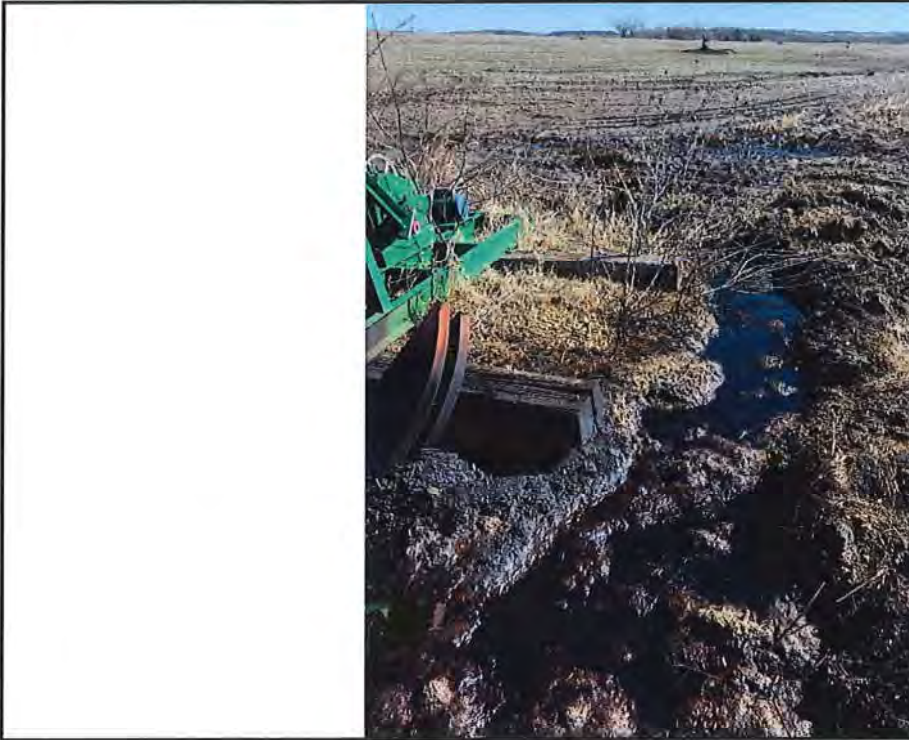
This is an updated picture of the South Kempnich well #8-T. The well is abandon, the well is not shut in with the proper surface control and continues to leak crude oil on the ground and saturate the soil in the area in front and South of the well.

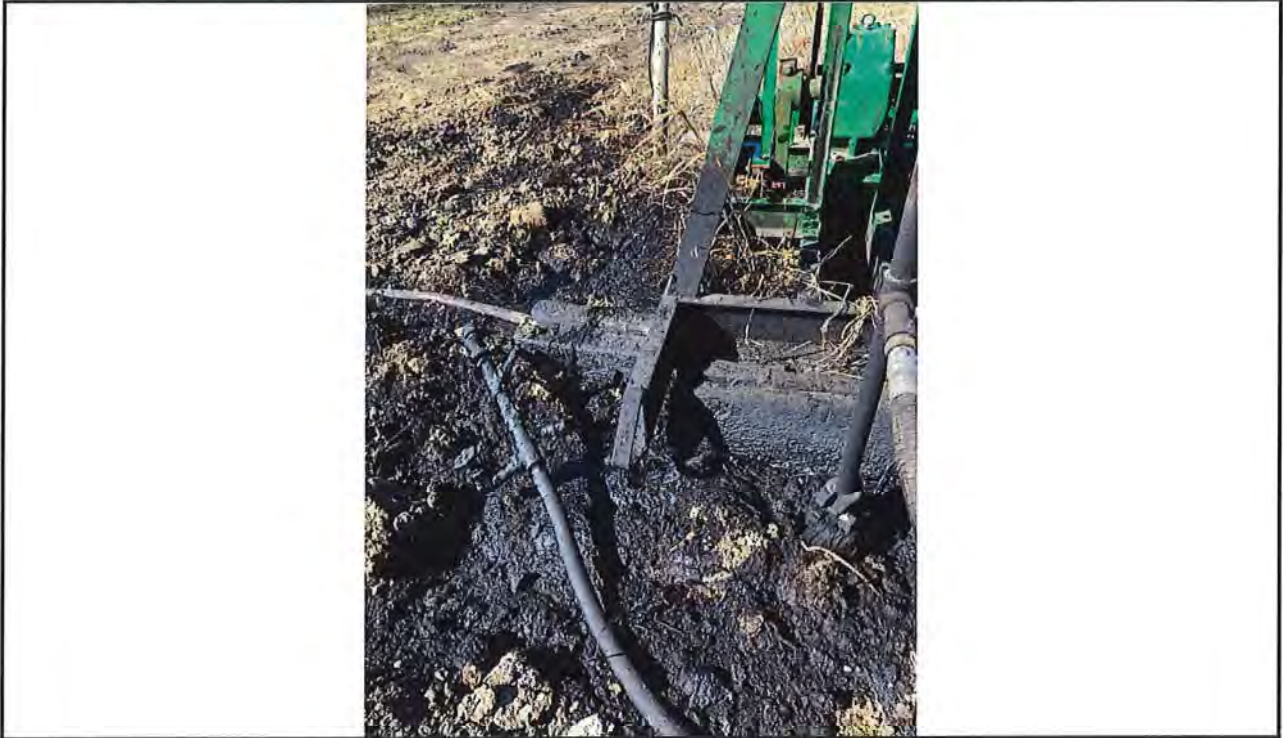
This is an updated picture of the South Kempnich well #7-T. The well is abandon, the well is not shut in with the proper surface control and continues to leak crude oil on the ground and saturate the soil in the area in front of the well and South and West of the well.

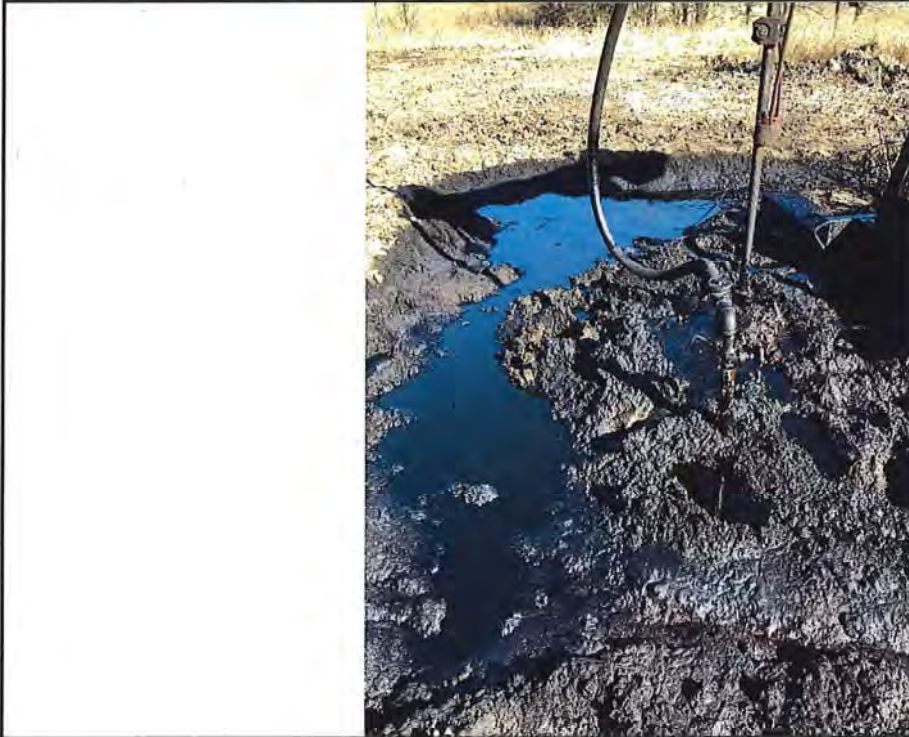
This is an updated picture of the South Kempnich well #22-T. The well is abandon and is not shut with the proper surface control, the well continues to leak crude oil on the ground.
