**THE STATE CORPORATION COMMISSION  
OF THE STATE OF KANSAS**

In the matter of the failure of Ace Energy, )     Docket No.: 23-CONS-3087-CPEN  
LLC (Operator) to comply with K.A.R. 82-3- )  
400 at the Gale Mullen #C43, Gale Mullen )     CONSERVATION DIVISION  
#E43, Gale Mullen #I43, Mullen #I-22A, and )  
Underwood 6 #R90 wells in Crawford )     License No.: 34998  
County, Kansas. )

**PENALTY ORDER**

Inspection Date: 07/13/2022 District: 3 Incident Number: 8024

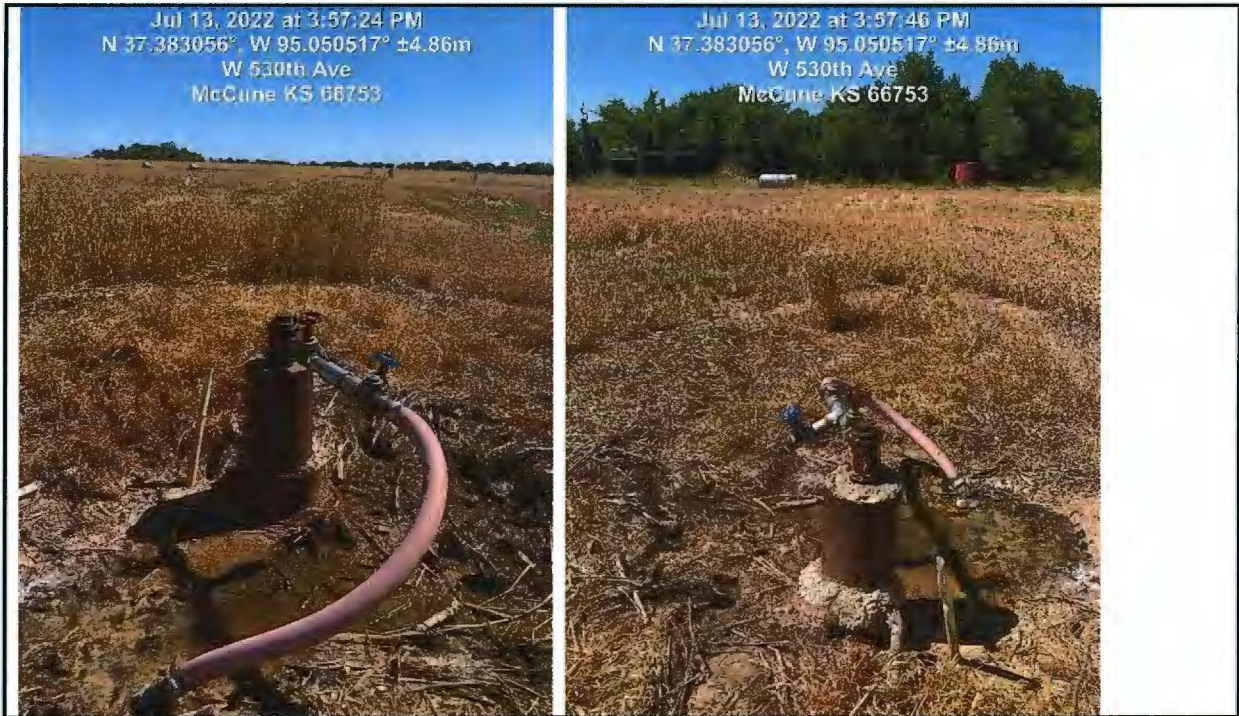
Gale Mullen I43 API# 15-037-01542-00-00 5043 FSL 323 FEL Latitude: 37.383030 Longitude: -95.050509 NE NE NE. Gale Mullen I43 is an active unauthorized enhanced oil recovery (EOR) well that is constructed with 8" surface casing, 5 1/2" casing and 2" production casing. The well is equipped with a check valve and the injection line is hooked up to the well head. Cement is present between the surface casing and production casing. At the time of my investigation the injection line had a small drip causing a wet spot on the ground. I have attached two photos showing the leak with this report. Also the line was cool to the touch indicating that fluids were traveling through the flow lines. On July 26, 2022, I took photos showing the check valve which allows fluids to travel towards the well head. I have also attached those photos to this report. This well will need to be disconnected and a casing integrity test will be required before temporary abandonment can be approved.

Operator: Ace Energy LLC dba	KLN: 34998
Lease: Gale Mullen	Legal: Sec. 1-31-21E NE NE NE
County: CR	PIC ID#: 1
Subject: I 43	PIC Orientation: 1 South, 1 North
FSL: 5043	Latitude: 37.383030
FEL: 323	Longitude: -95.050509
API#: 15-037-01542-00-00	
Date: 7-13-2022	Time: 3:57PM
Staff: Brad Bohrer

**Additional Information:** The I 43 is an active unauthorized injection well. That is constructed with 8" surface casing, 5 ½" casing, 2" production, check valve, hose hooked up, cement present between surface casing and casing.

I will refer this report to District #3 Compliance Officer Ryan Duling for review. It is my recommendation that temporary abandonment status that was approved on July 12,2022, be revoked for the Mullen I43, Mullen E43, Mullen F41 and Mullen C43. Those four wells need to be added to Ace Energy LLC Settlement Agreement in Docket 22-CONS-3124-CPEN. Furthermore, I recommend that Ace Energy be considered for penalty recommendations for the following active unauthorized enhanced recovery (EOR)wells: Gale Mullen I43, Gale Mullen E43, Gale Mullen C43 and Mullen I-22A.

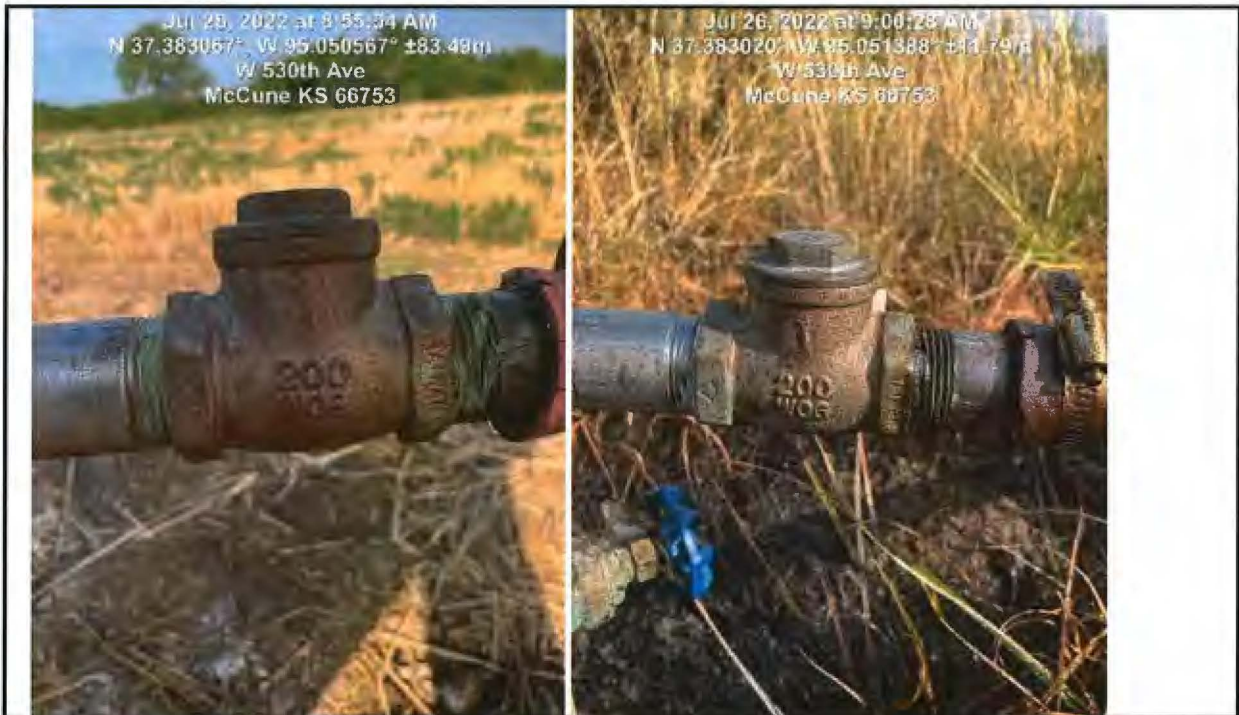
Operator: Ace Energy LLC dba	KLN: 34998
Lease: Gale Mullen	Legal: Sec. 1-31-21E NE NE NE
County: CR	PIC ID#: 498,499
Subject: I 43	PIC Orientation: 2 North
FSL: 5043	Latitude: 37.383030
FEL: 323	Longitude: -95.050509
API#: 15-037-01542-00-00	
Date: 7-26-2022	Time: 8:55,9:00am
Staff: Brad Bohrer

**Additional Information:** I 43 is an active unauthorized injection well. That is constructed with 8" surface casing, 5 ½" casing, 2" production, check valve, hose hooked up, cement present between surface casing and casing. In these two photos you can see the arrow on the check valve is pointed at the steel plumbing which is at the well head.

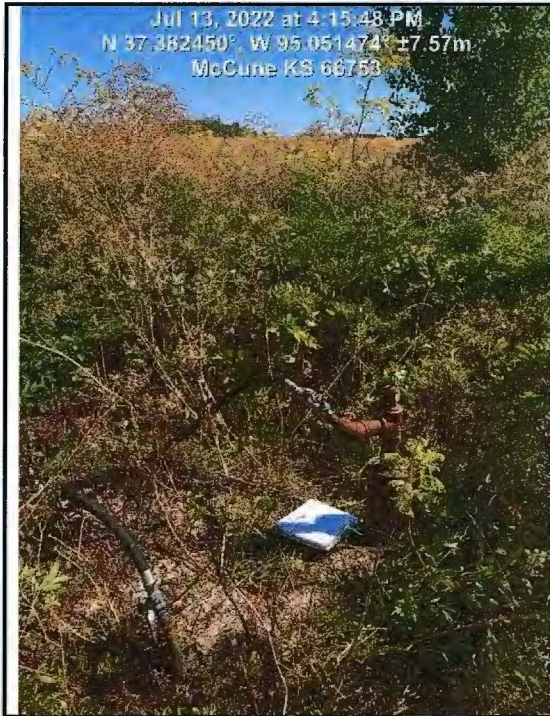
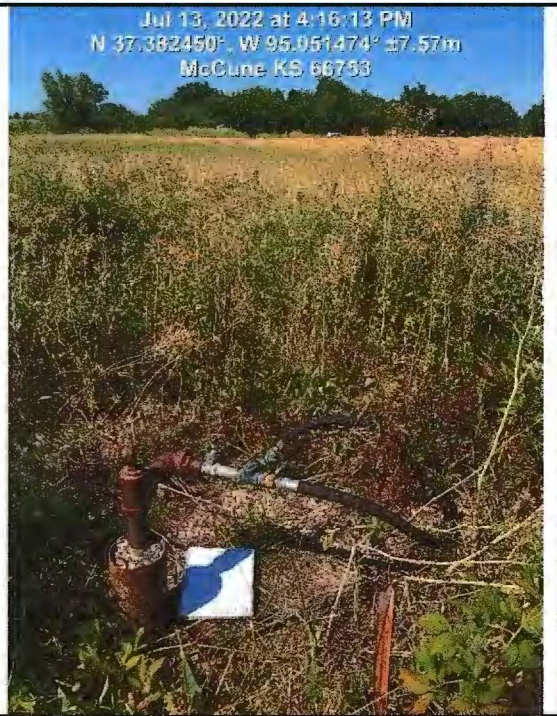
Gale Mullen E43 API# 15-037-01540-00-00 4828 FSL 628 FEL Latitude: 37.382439 Longitude: -95.051562 NE NE NE. Gale Mullen E43 is an active unauthorized enhanced oil recovery (EOR) well that is constructed with 7" surface casing and 2" production casing. The well is equipped with a check valve and the injection line is hooked up to the well head. The check valve indicates the flow of fluids toward the well head. Cement is present between the surface casing and production casing. The line was cool to the touch indicating fluids were traveling through the flow line. Also, the gate valves were open and one of the gate valve had a small drip. Research found that this well was denied temporary abandonment on June 30, 2021, for being shut in over 10 years. The temporary abandonment status the was approved July 12, 2022, and will need to be revoked since the operator never contacted the KCC District #3 office that the well was ever put back into production. The shut in date should have been December 1, 2010. This well will need to be disconnected and a casing integrity test will be required before temporary abandonment can be approved. I took two photos of this well and the photos are attached to this report.

**Additional Information:** The Gale Mullen E 43 is active unauthorized injection well that is constructed with 7" surface casing, 2" production casing, check valve, hose hooked up, cement present between surface casing and casing.

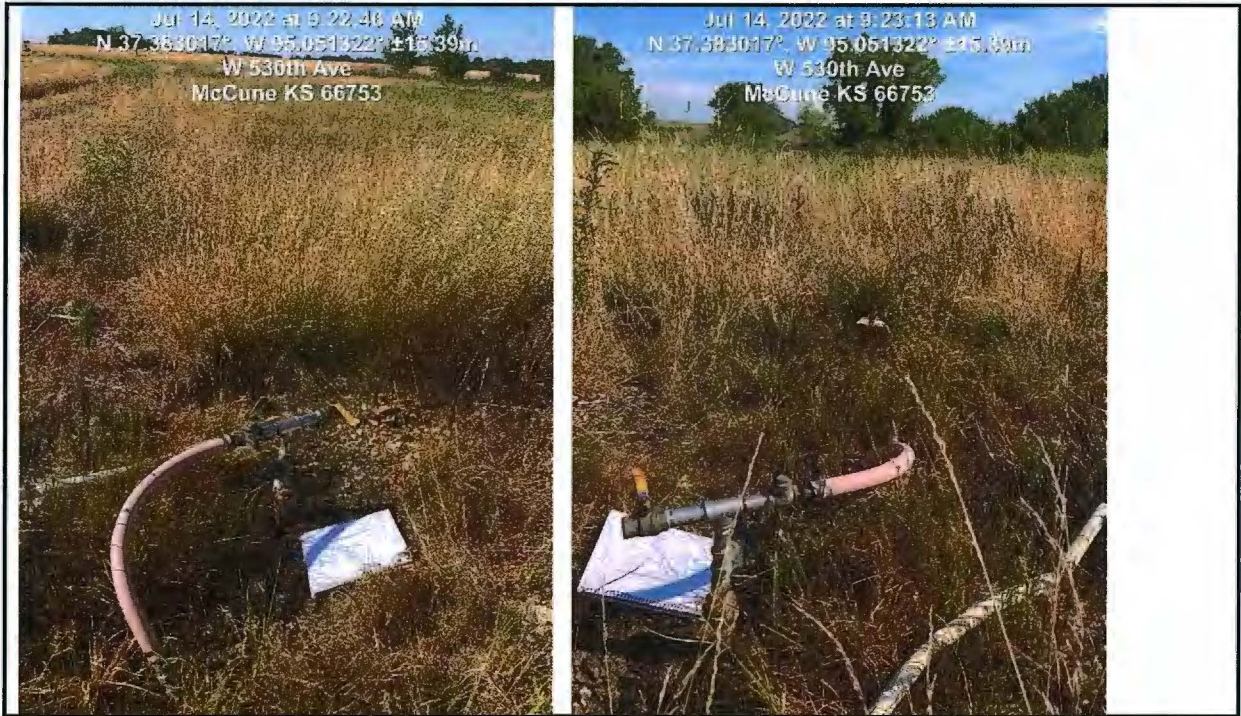
Gale Mullen C43 API# 15-037-01539-00-00 5030 FSL 569 FEL Latitude: 37.382994 Longitude: -95.051358 NE NE NE. Gale Mullen C43 is an active unauthorized enhanced oil recovery (EOR) well that is constructed with 2" production casing. The well is equipped with a check valve and the injection line is hooked up to the well head. Two photos were taken on July 14, 2022, and those photos are attached to this report. On July 26, 2022, I returned to verify that the valves on the flow line were open and that the check valve was installed allowing fluids to travel towards the well head. Also while on location, I noticed spray of free fluids next to the well in the grass which appears to have come from the bleeder valve. This indicates operator staff had recently opened the valve to confirm that fluid is traveling to this well. I took two photos and those photos are also attached to this report. This well will need to be disconnected and a casing integrity test will be required before temporary abandonment can be approved.

Operator: Ace Energy LLC dba	KLN: 34998
Lease: Gale Mullen	Legal: Sec. 1-31-21E NE NE NE
County: CR	PIC ID#: 4
Subject: C 43	PIC Orientation: 1 South, 1 North
FSL: 5030	Latitude: 37.382994
FEL: 569	Longitude: -95.051358
API#: 15-037-01539-00-00	
Date: 7-14-2022	Time: 9:22 am, 9:23 am
Staff: Brad Bohrer

**Additional Information:** The C 43 is an active unauthorized injection well that is constructed with 2" production casing, check valve, no cement present at surface, hose hooked up.

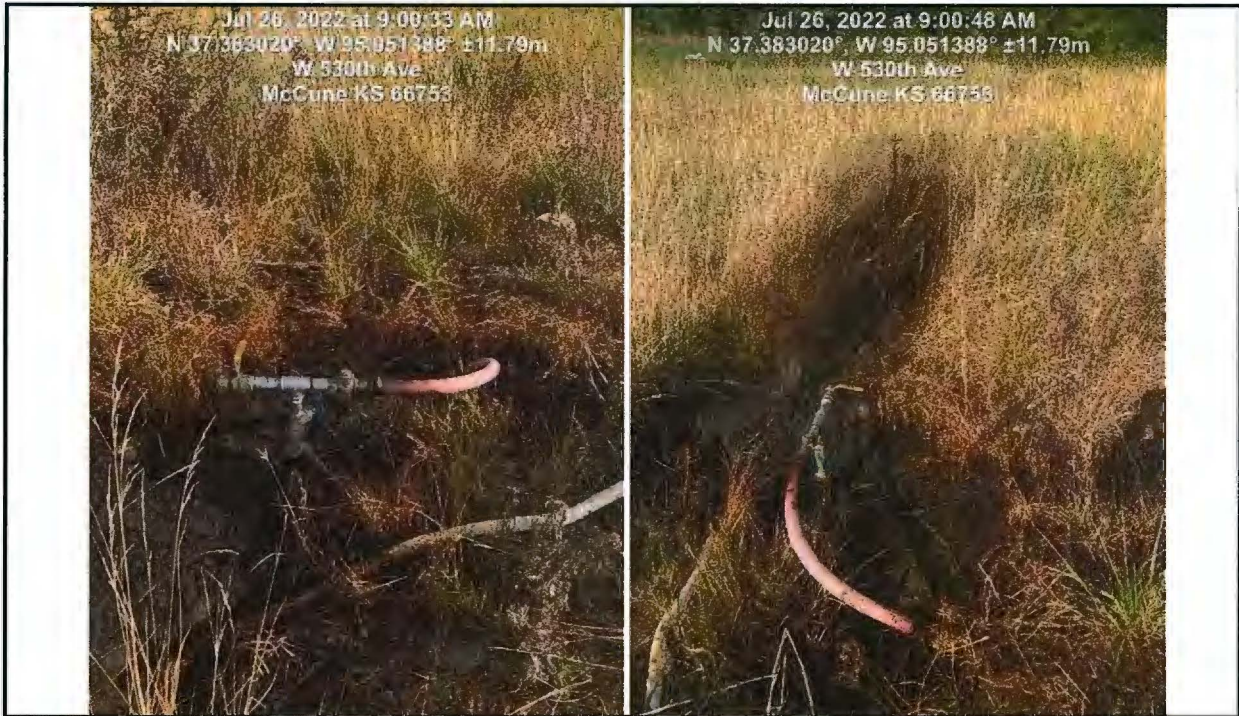
**Additional Information:** C 43 is an active unauthorized injection well that is constructed with 2" production casing, check valve, no cement present at surface, hose hooked up. You can see a spray of free fluid next to the well in the grass this fluid appears to have come from the bleeder valve. This indicates operator staff has recently opened the valve to confirm that fluid is traveling to this well.

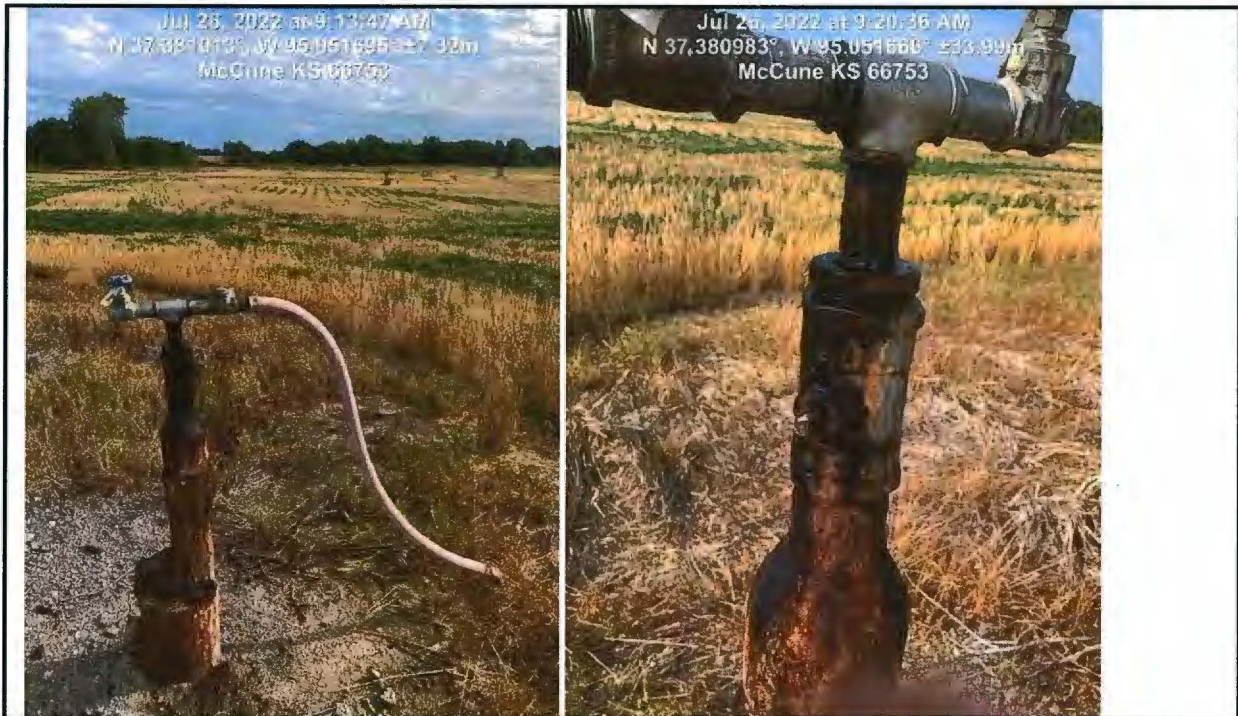
Mullen I- 22A API#: 15-037-22385-00-00 4304 FSL 673 FEL Lat. 37.381000 Long: -095.051720 SW NE NE. Mullen I -22A is an active unauthorized enhanced oil recovery (EOR) well that is constructed with 8 5/8" surface casing and 4 1/2" production casing. The well is equipped with a check valve and the injection line is hooked up to the well head. Cement is present between the surface casing and production casing. During my lease inspection, the ball valve at the well head was open and the check valve was installed for fluids to travel towards the well head. On July 26, 2022, I noticed a oil stain on the ball valve that appears to be coming from the bushing seeping from the ball valve. Research found this well was drilled as an enhanced oil recovery (EOR) well but was never permitted. This well will need to be disconnected and a casing integrity test will be required before temporary abandonment can be approved. I took two photos of the well and those photos are attached to this report.

Operator: Ace Energy LLC dba	KLN: 34998
Lease: Mullen	Legal: 1-31-21E SW NE NE
County: CR	PIC ID#: 506,510
Subject: Mullen I-22A	PIC Orientation: 2 South
FSL: 4304	Latitude: 37.381000
FEL: 673	Longitude: -095.051720
API#: 15-037-22385-00-00	
Date: 7-26-2022	Time: 9:13,9:20 AM
Staff: Brad Bohrer

**Additional Information:** I -22A is an active unauthorized injection well that is constructed with 8 1/2" surface casing, 4 1/2" casing, swedge, ball valve, check valve, hose hooked up, cement present between surface casing and casing. In these two pictures you can see the oil seeping from the bushing and covering the swedge and valve.

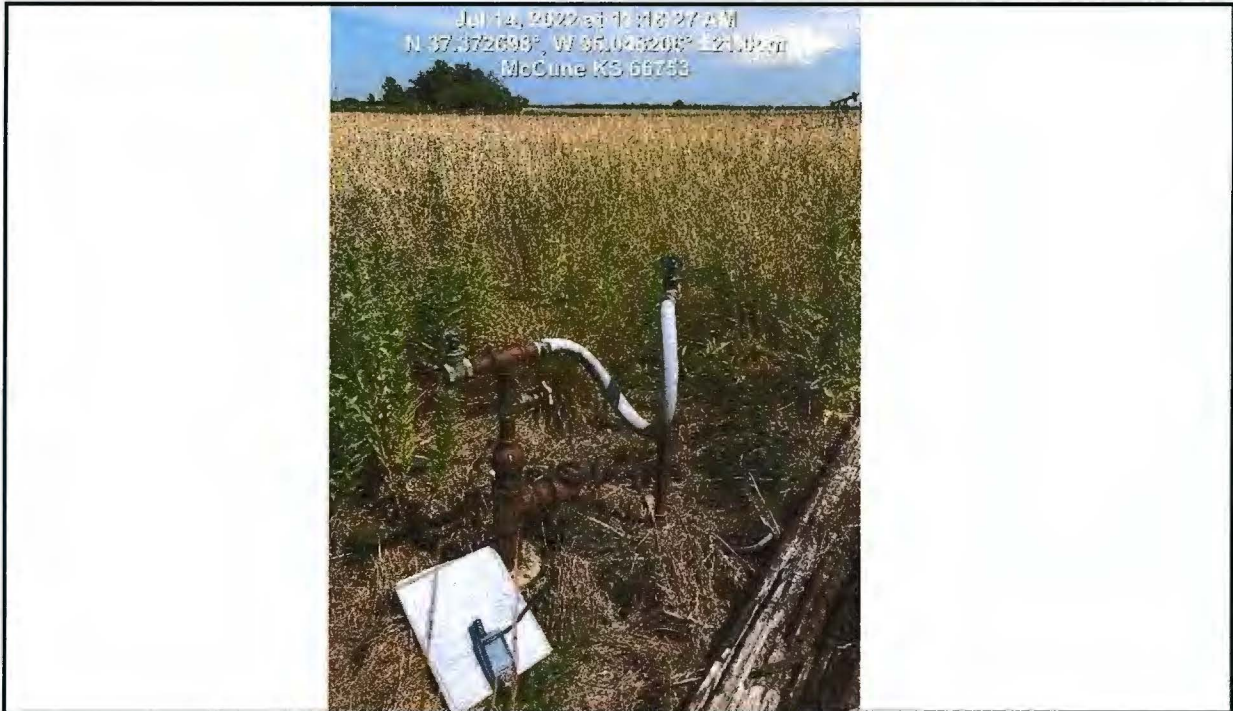
Underwood 6 #R90 API #15-037-01516-00-00 1291 FSL 4807 FEL Lat. 37.372700 Long,-95.048200 NW SW SW. Underwood 6# R90 is an active unauthorized enhanced oil recovery (EOR) well that is constructed with 7 " Surface casing and 2" production casing. The injection line is hooked to the well head and the valves are open. Cement is present between the surface casing and production casing. I took a photo of the well and attached the photo to this report.

**Additional Information:** The R90 is an active unauthorized injection well that is constructed 7" Surface casing, 2" production casing, valves, hose hooked up, cement present between surface casing and production casing.

I will refer this report to the District #3 Compliance Officer Ryan Duling for review. It is my recommendation that Ace Energy be considered for penalty recommendation on the Underwood 6 #R90 for using an unauthorized enhanced recovery well. It is my further recommendation that the temporary abandonment status for the Underwood 6 #R90 be revoked and a casing integrity test (CIT) be required before the temporary abandonment be approved since the well is constructed as an enhanced recovery well. Furthermore, Ace Energy should file a temporary abandonment application for the Underwood 6 #Q89 since the well is inactive and shut in with a valve.
