**THE STATE CORPORATION COMMISSION  
OF THE STATE OF KANSAS**

In the Matter of the Complaint Against Kansas )  
City Power & Light by Jamie Littich ) Docket No. 16-KCPE-195-COM

**REPLY TO KCPL'S REPLY**

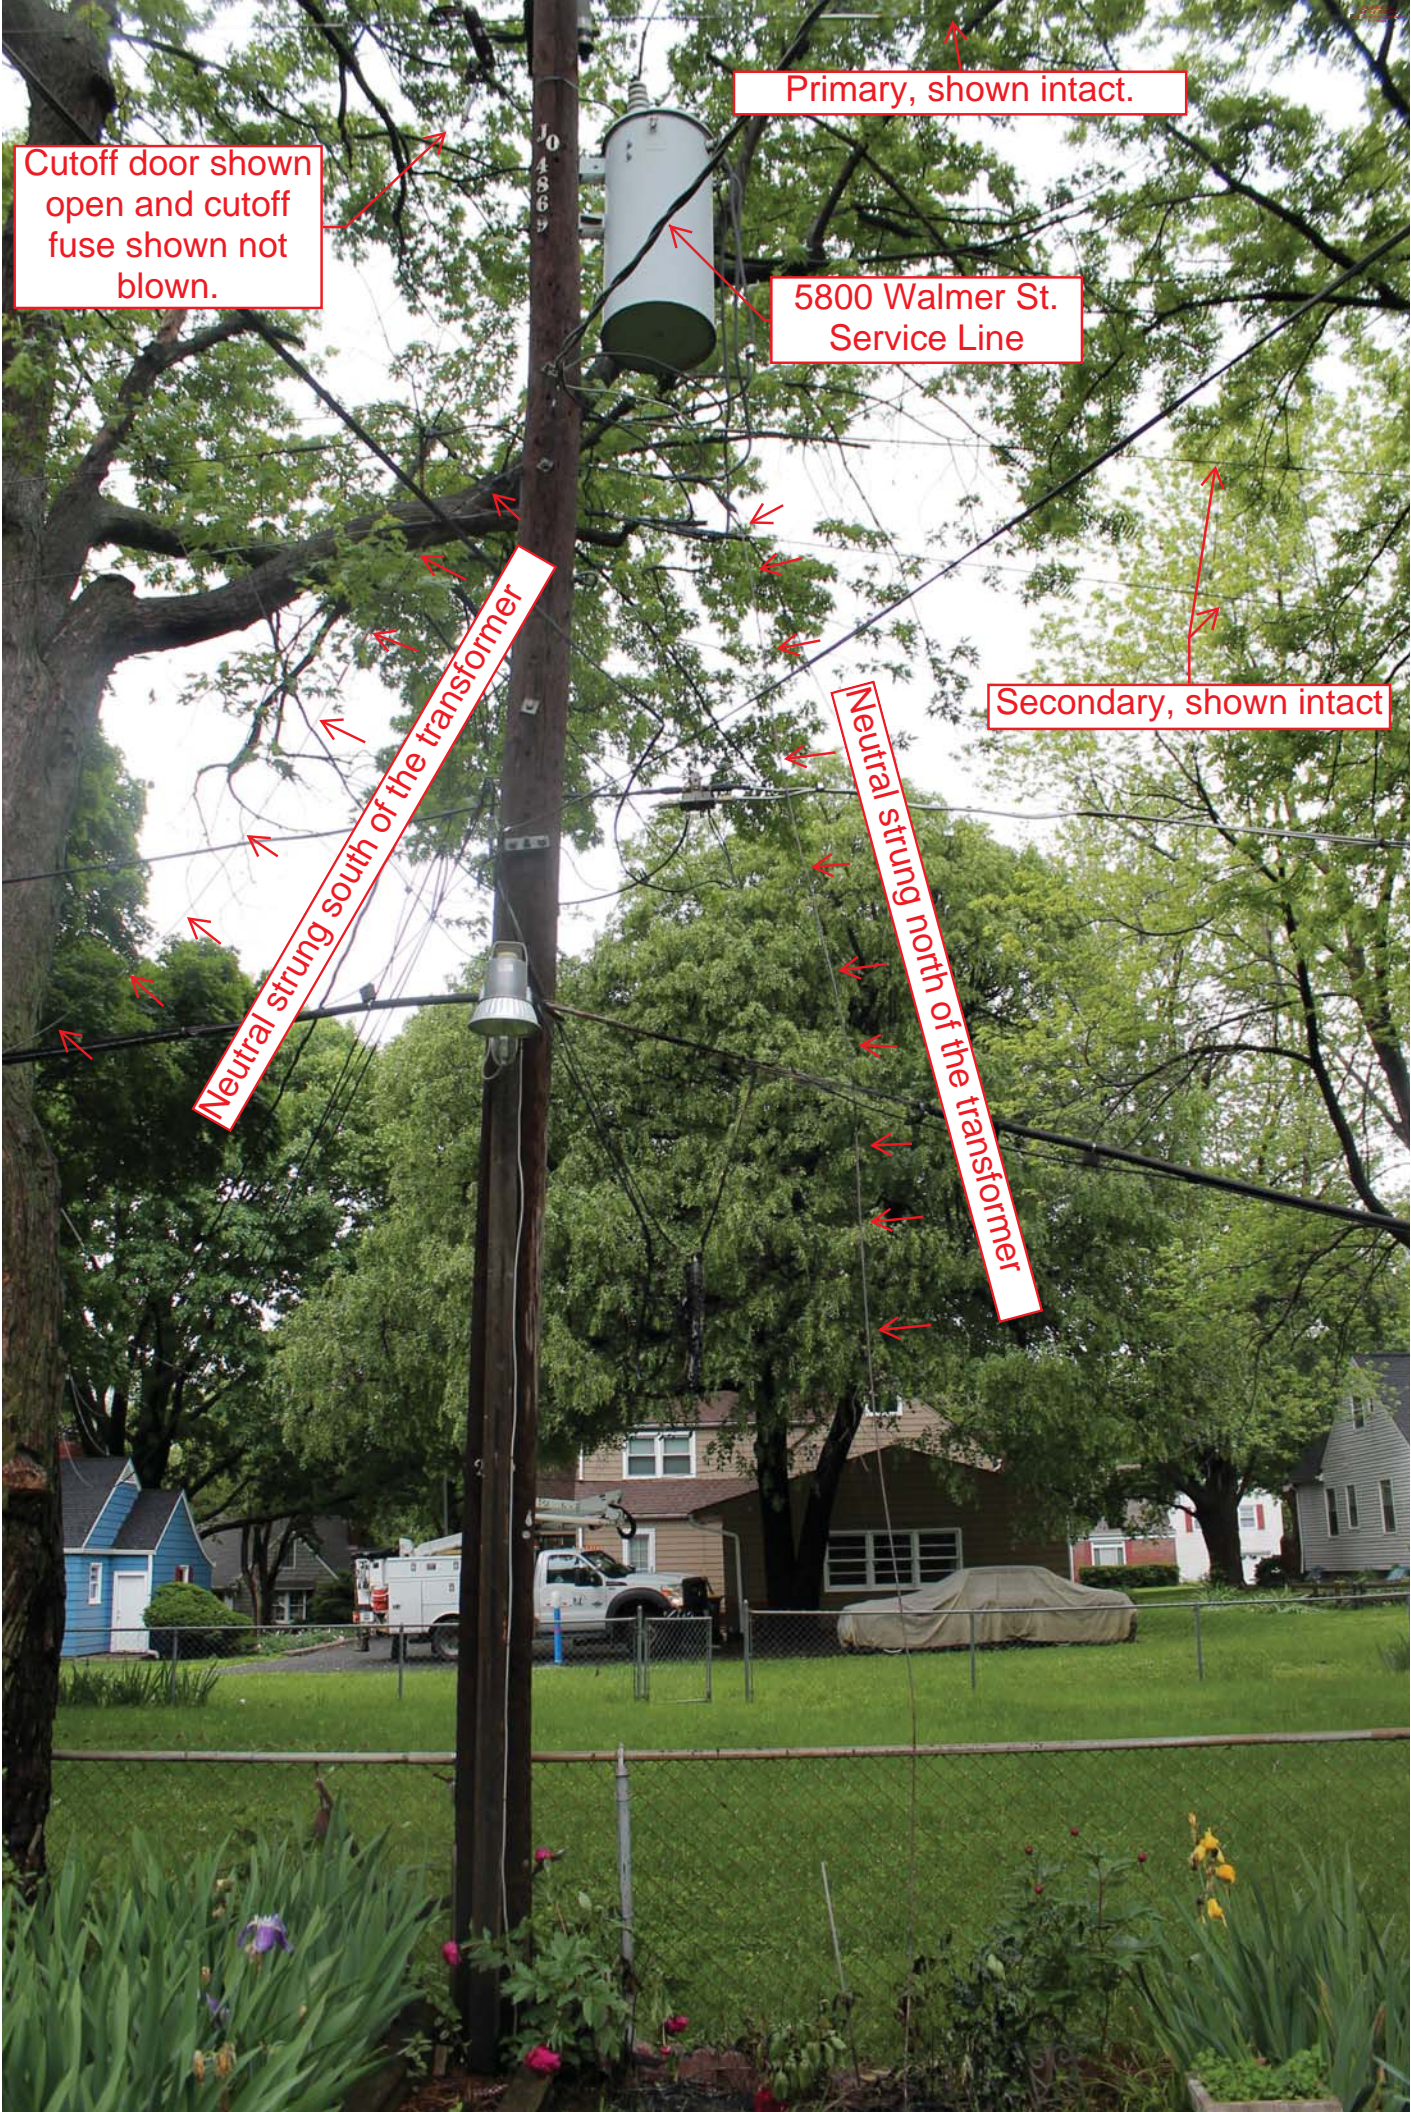
**EXHIBIT A: The Consolidated Fire Department #2 (CFD2) Photo time stamped 5/20/15 10:25 AM**

This photo is a depiction of items downstream of KCPL circuit 6849 on pole JO 4829. Please observe:

1. The primary conductor intact in both north and south directions of the lateral.
2. Both secondary conductors intact in both north and south directions of the lateral.
3. The neutral to have fallen in both north and south directions of the lateral. Take special care to note the position of each neutral conductor.
4. The cutoff door in an open state and the fuse in an unblown condition.
5. The secondary service to the 5800 Walmer Street house intact.

Primary, shown intact.

Cutoff door shown open and cutoff fuse shown not blown.

5800 Walmer St. Service Line

Secondary, shown intact

Neutral strung south of the transformer

Neutral strung north of the transformer

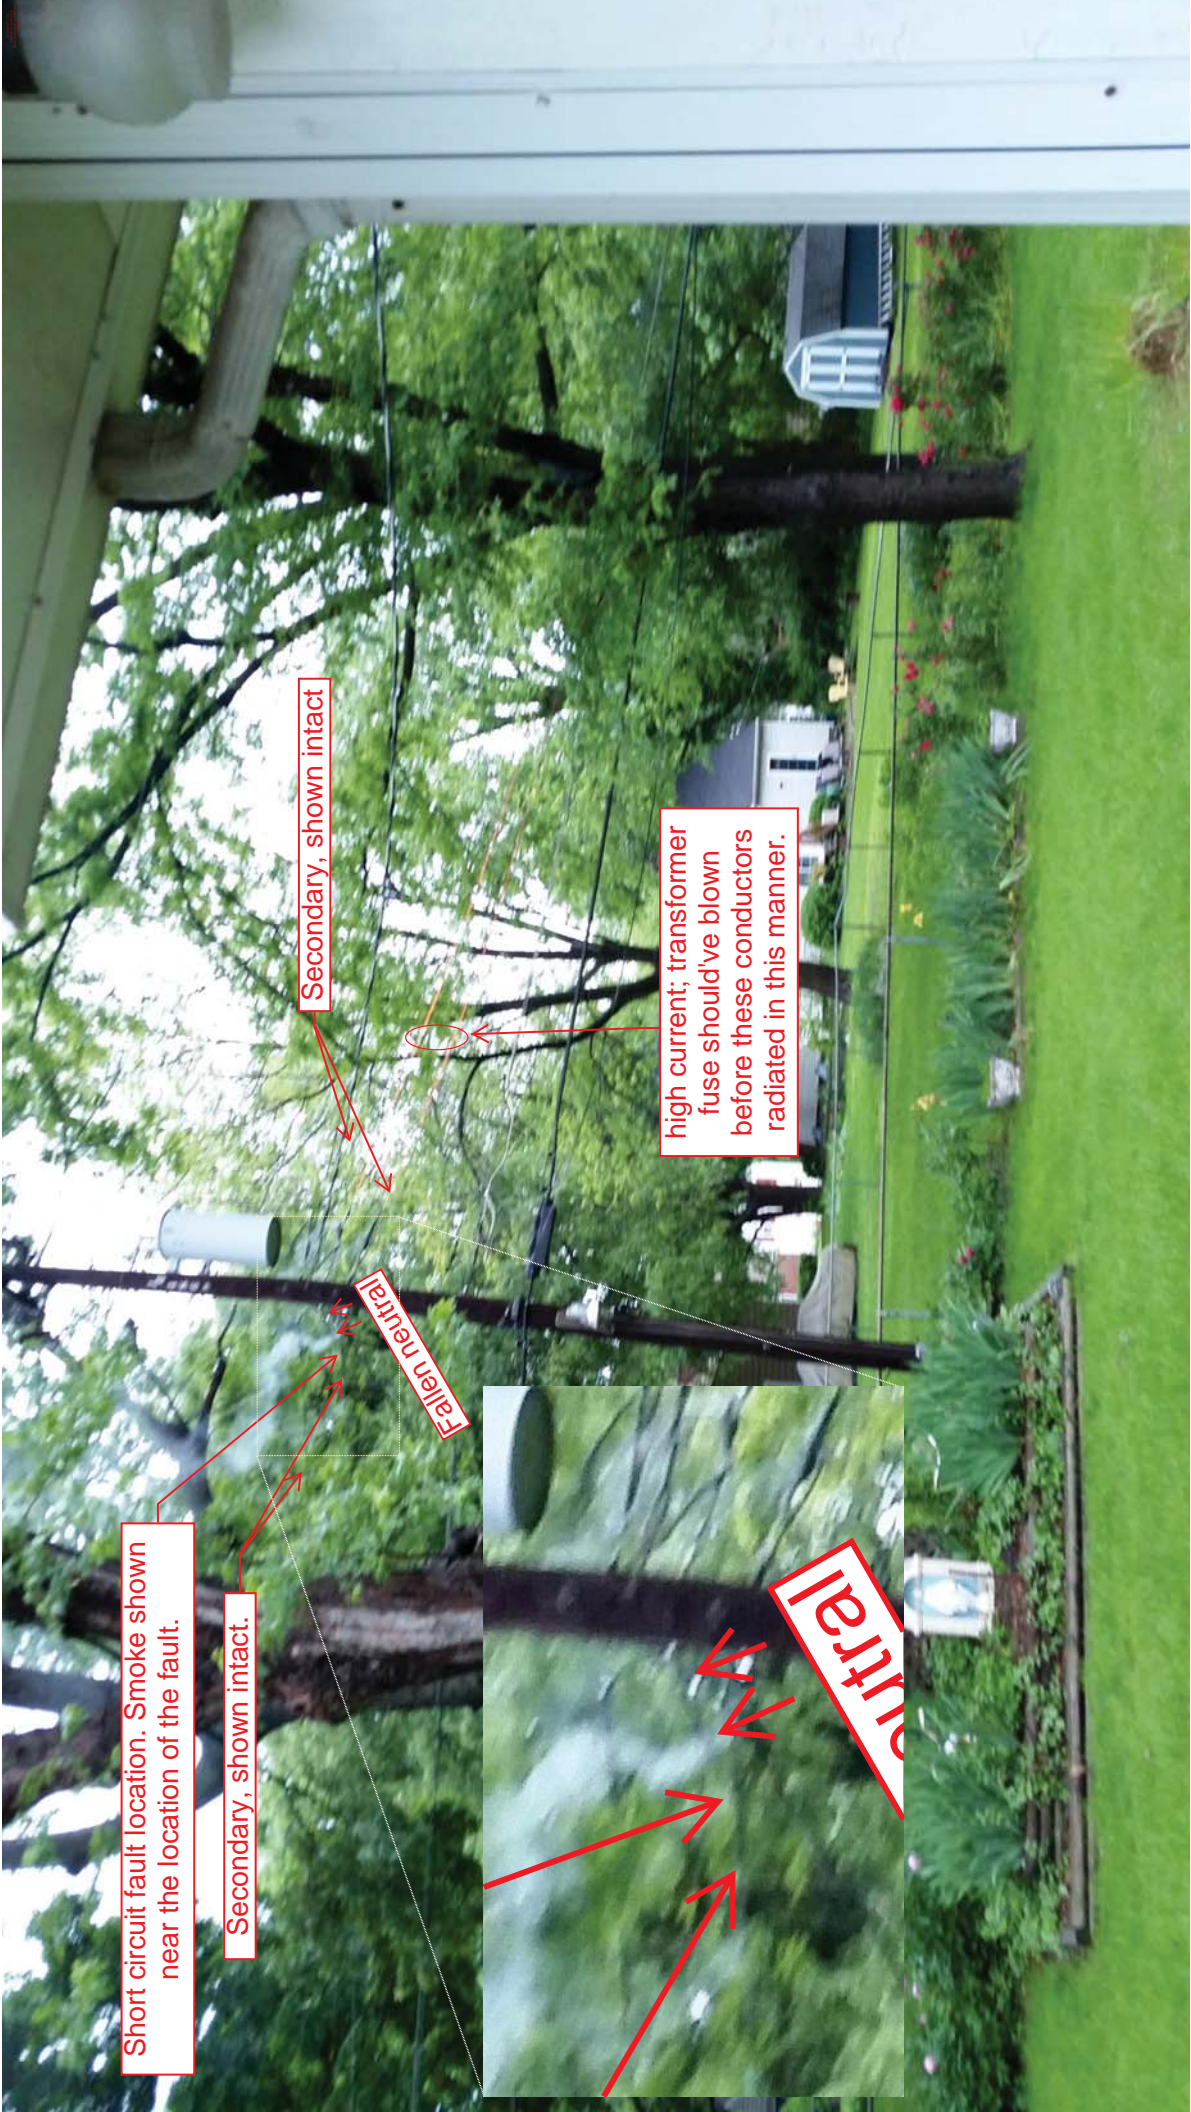
**EXHIBIT C.1: 5800 Walmer Fire Escape Photo #1, time stamped 5/20/15 8:46:03 AM (-25 s from Ex.B)**

photo shows the northbound (cardinal directions provided here and after are with relation to the transformer on pole JO 4829) neutral and secondary intact and radiating as if in a low impedance fault condition. The southbound secondary is shown intact but the southbound neutral is absent of its normal location and appears to be in a hanging position consistent with Exhibit A. Given the amount of smoke localized behind the area of the lower secondary conductor and hanging southbound neutral, this photo is believed to show at least one short circuit (low impedance) fault location. In this scenario, the transformer fuse should have functioned prior to the secondary conductor and neutral radiating red.

Short circuit fault location. Smoke shown near the location of the fault.

Secondary, shown intact.

Secondary, shown intact

high current; transformer fuse should've blown before these conductors radiated in this manner.

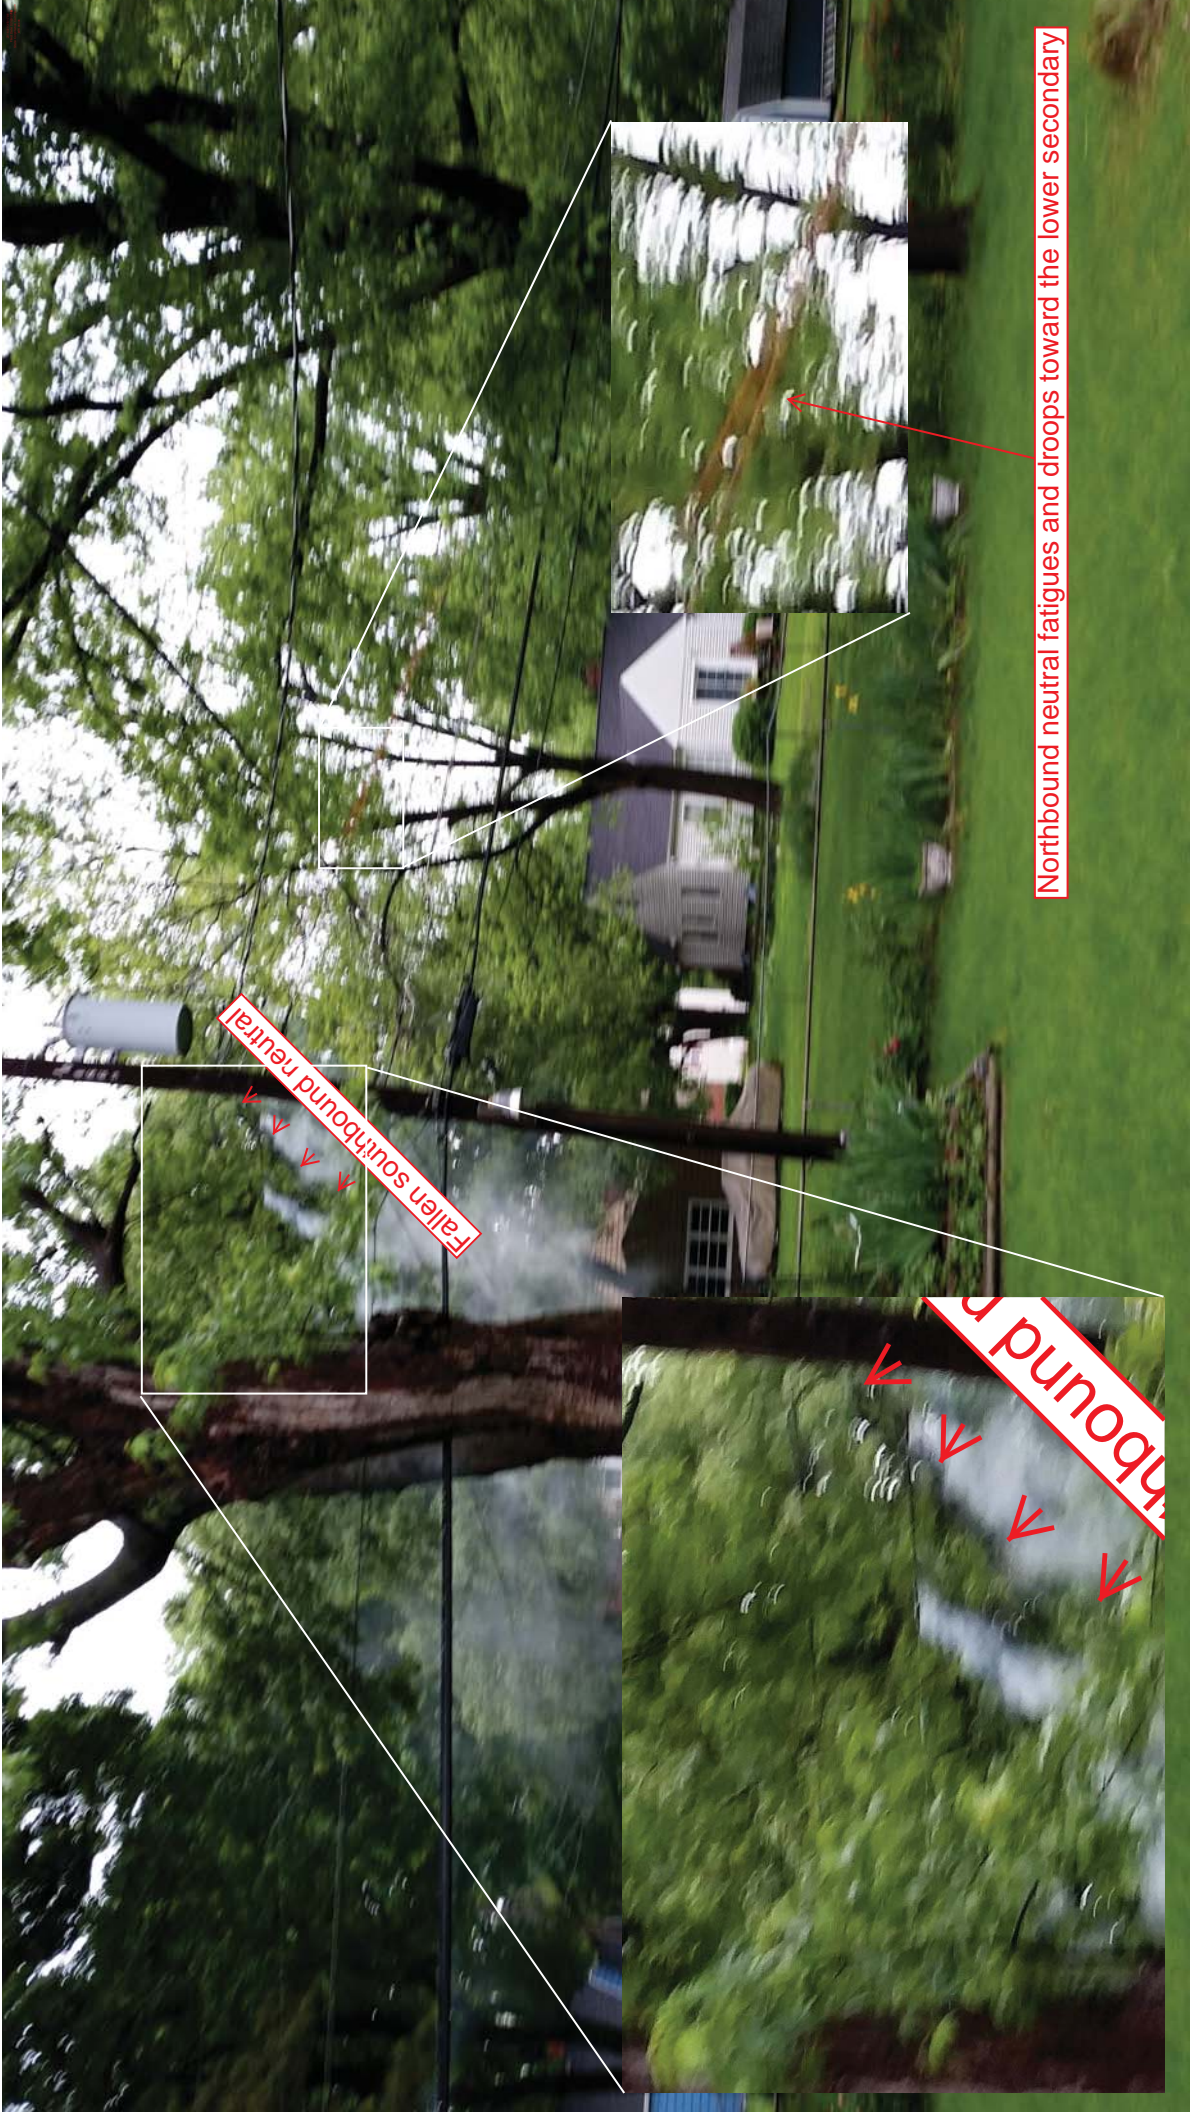
**EXHIBIT C.2: 5800 Walmer Fire Escape Photo #2, time stamped 5/20/15 8:46:25 AM (-3 s from Ex.B)**

The 5800 Walmer St. homeowner's second photo shows a continuation of a sustained short circuit fault. The northbound neutral is shown to be falling toward the lower, northbound secondary.

Northbound neutral fatigues and droops toward the lower secondary

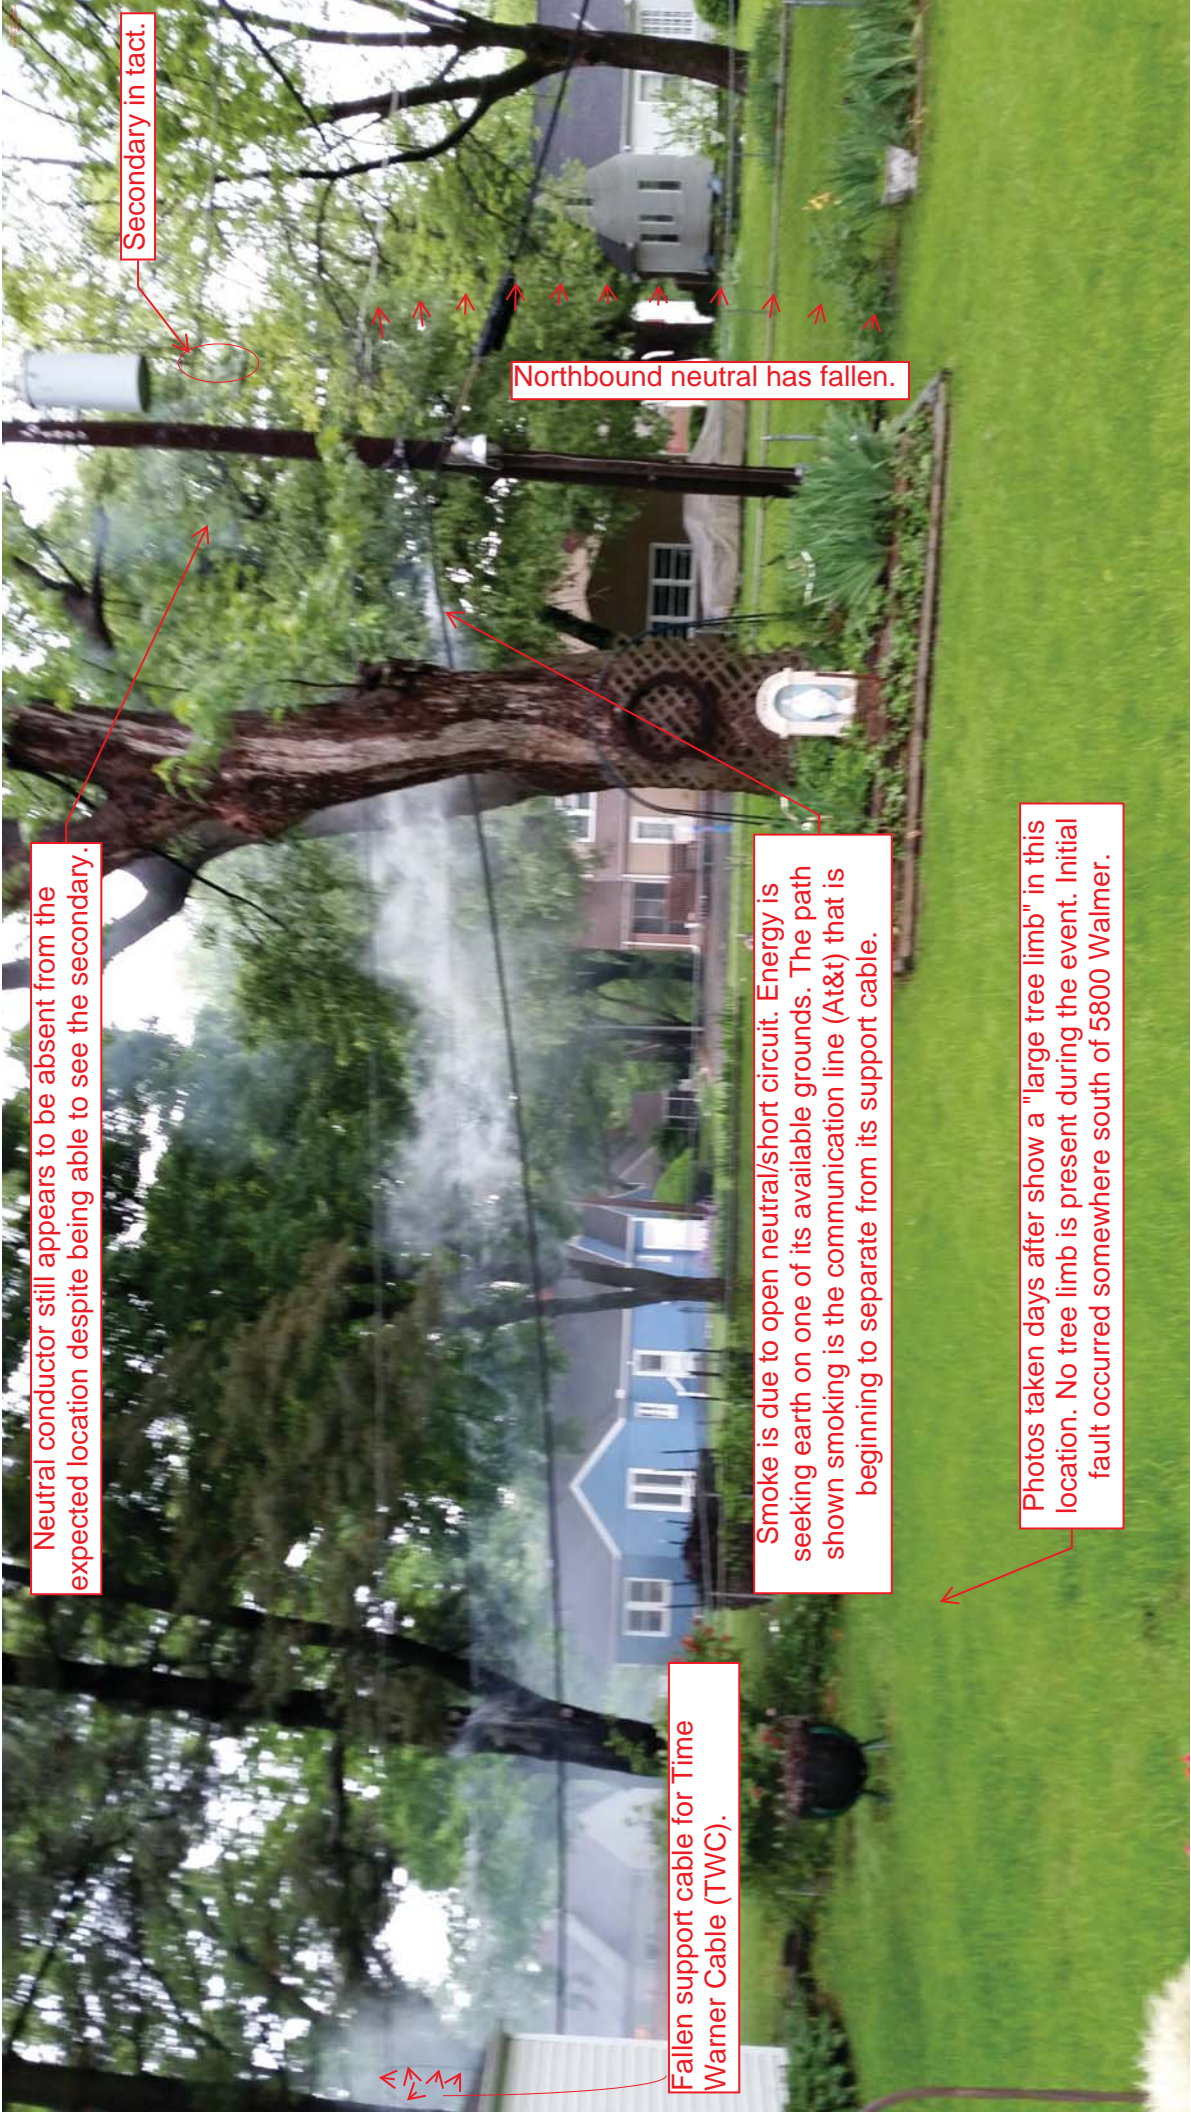
**EXHIBIT C.3: 5800 Walmer Fire Escape Photo #3, time stamped 5/20/15 8:49:52 AM (+3 m 24 s from Ex.B)**

The 5800 Walmer St. homeowner's third photo is the first photo to show the northbound neutral to have fallen. The photo also shows damage occurring on alternative ground paths including Time Warner Cable's (TWC) service and AT&T's service. The southbound neutral is still absent from where it is normally located and you can see both southbound secondaries still intact. The northbound secondary is also shown intact and no evidence of the primary falling is present.

Neutral conductor still appears to be absent from the expected location despite being able to see the secondary.

Secondary in tact.

Northbound neutral has fallen.

Smoke is due to open neutral/short circuit. Energy is seeking earth on one of its available grounds. The path shown smoking is the communication line (At&t) that is beginning to separate from its support cable.

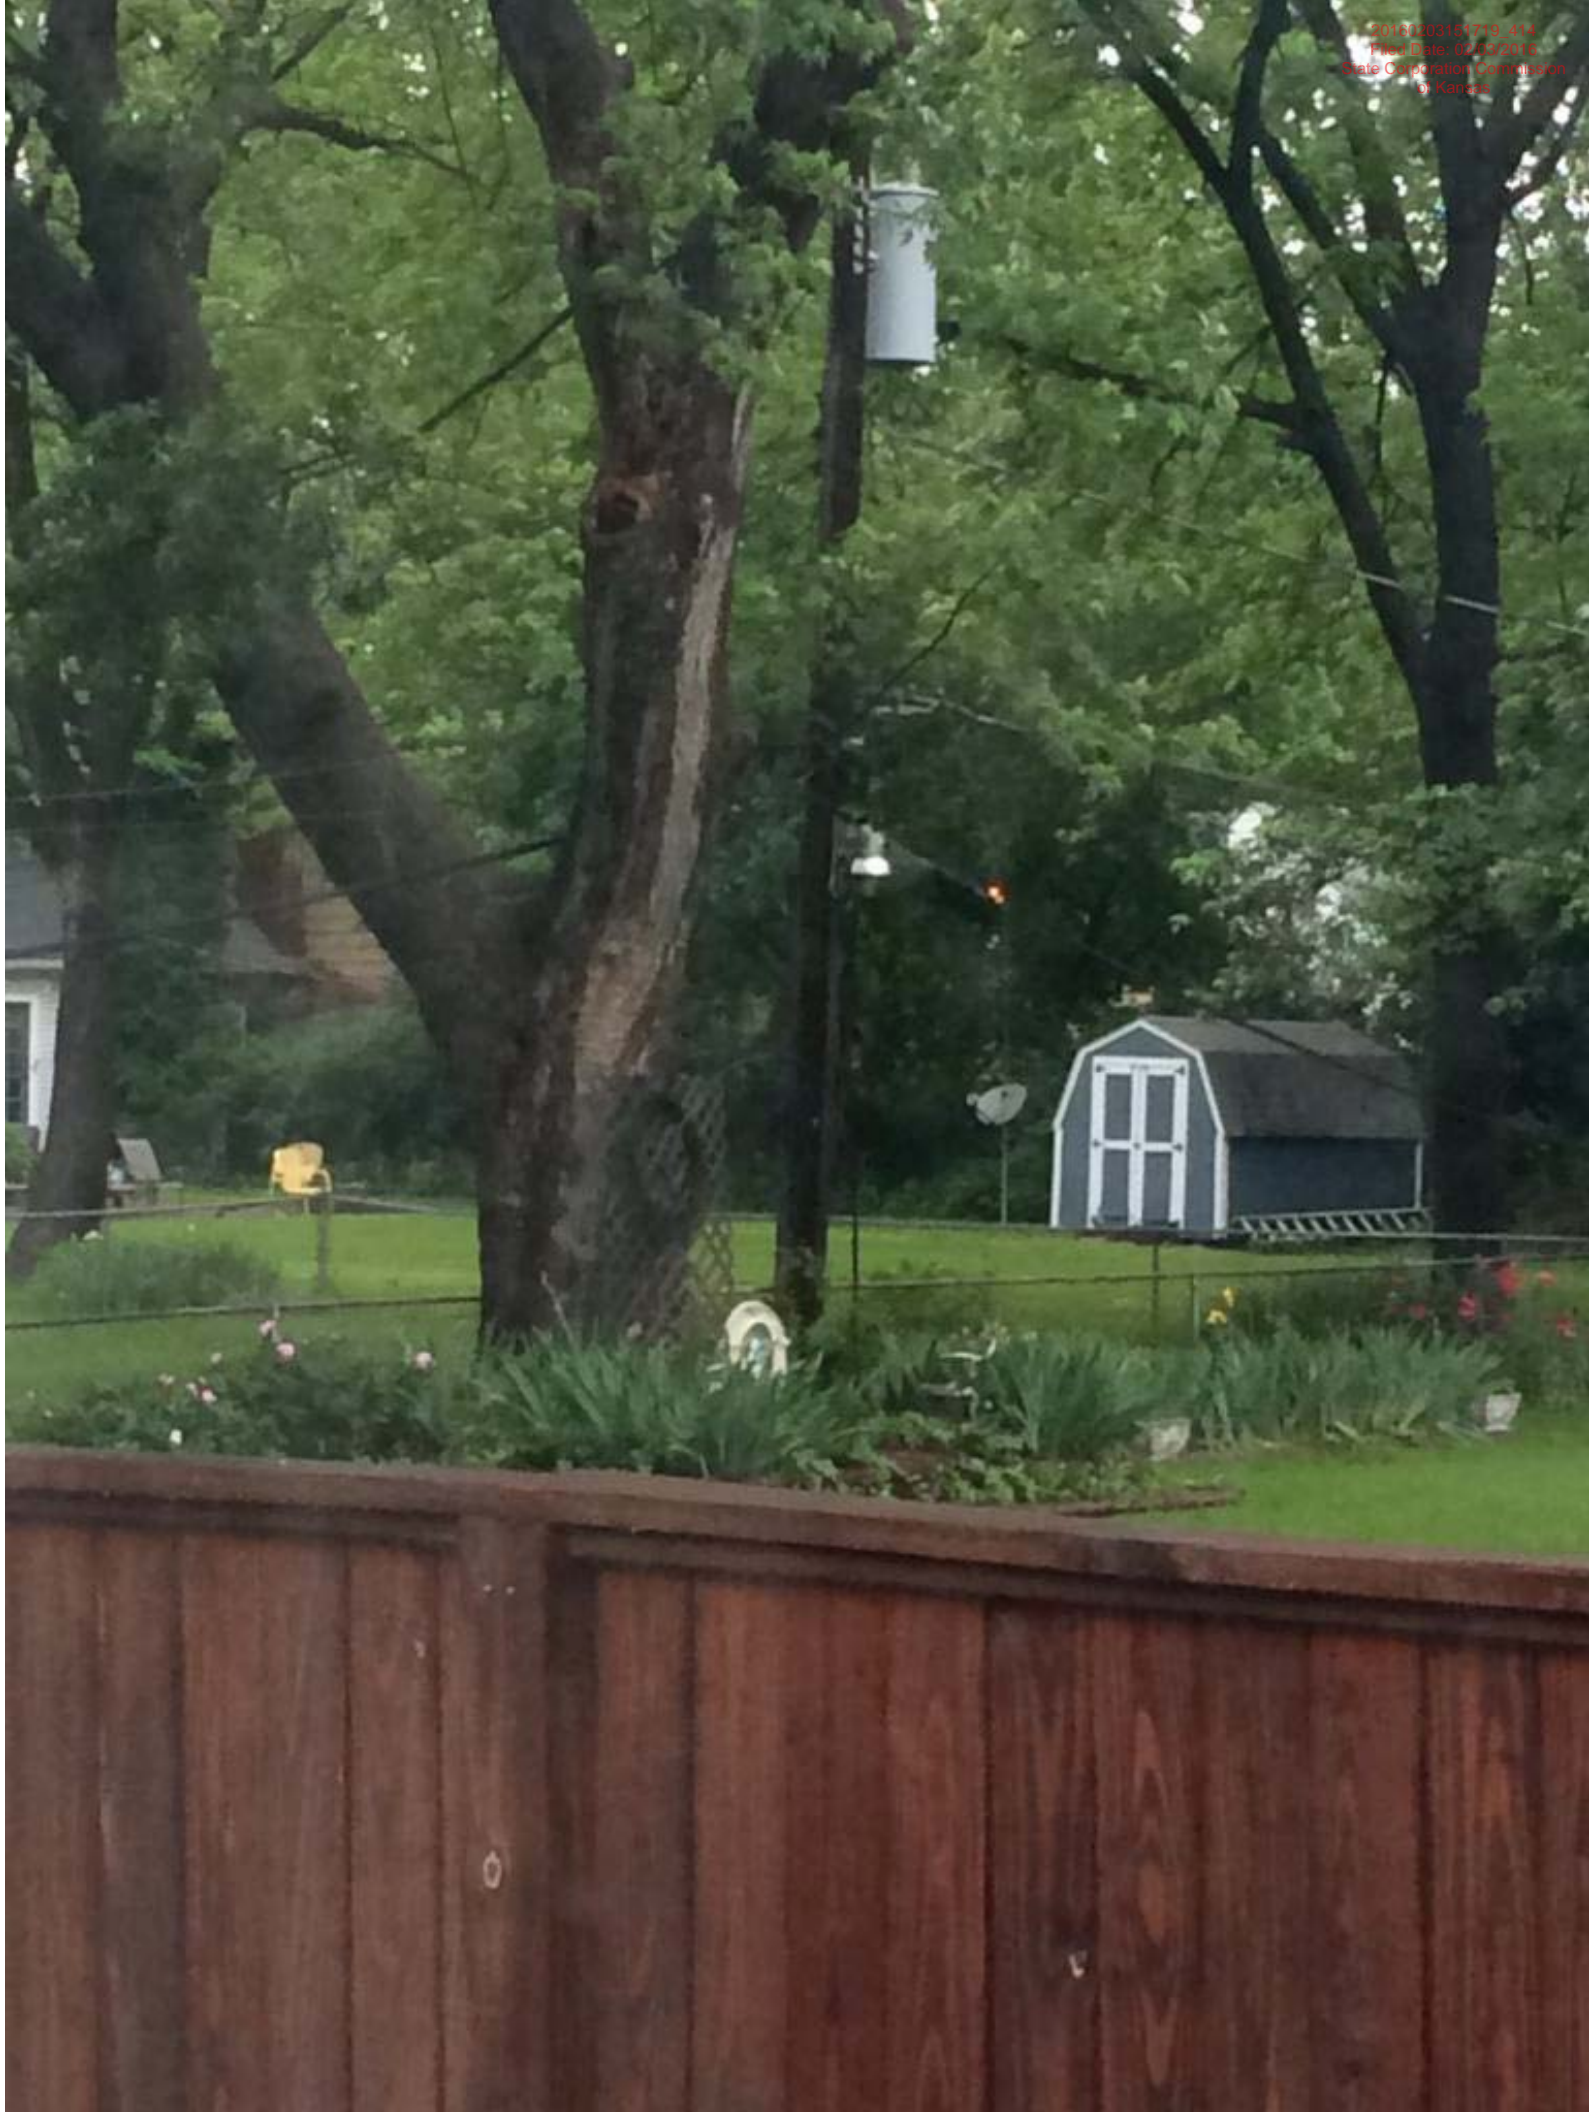
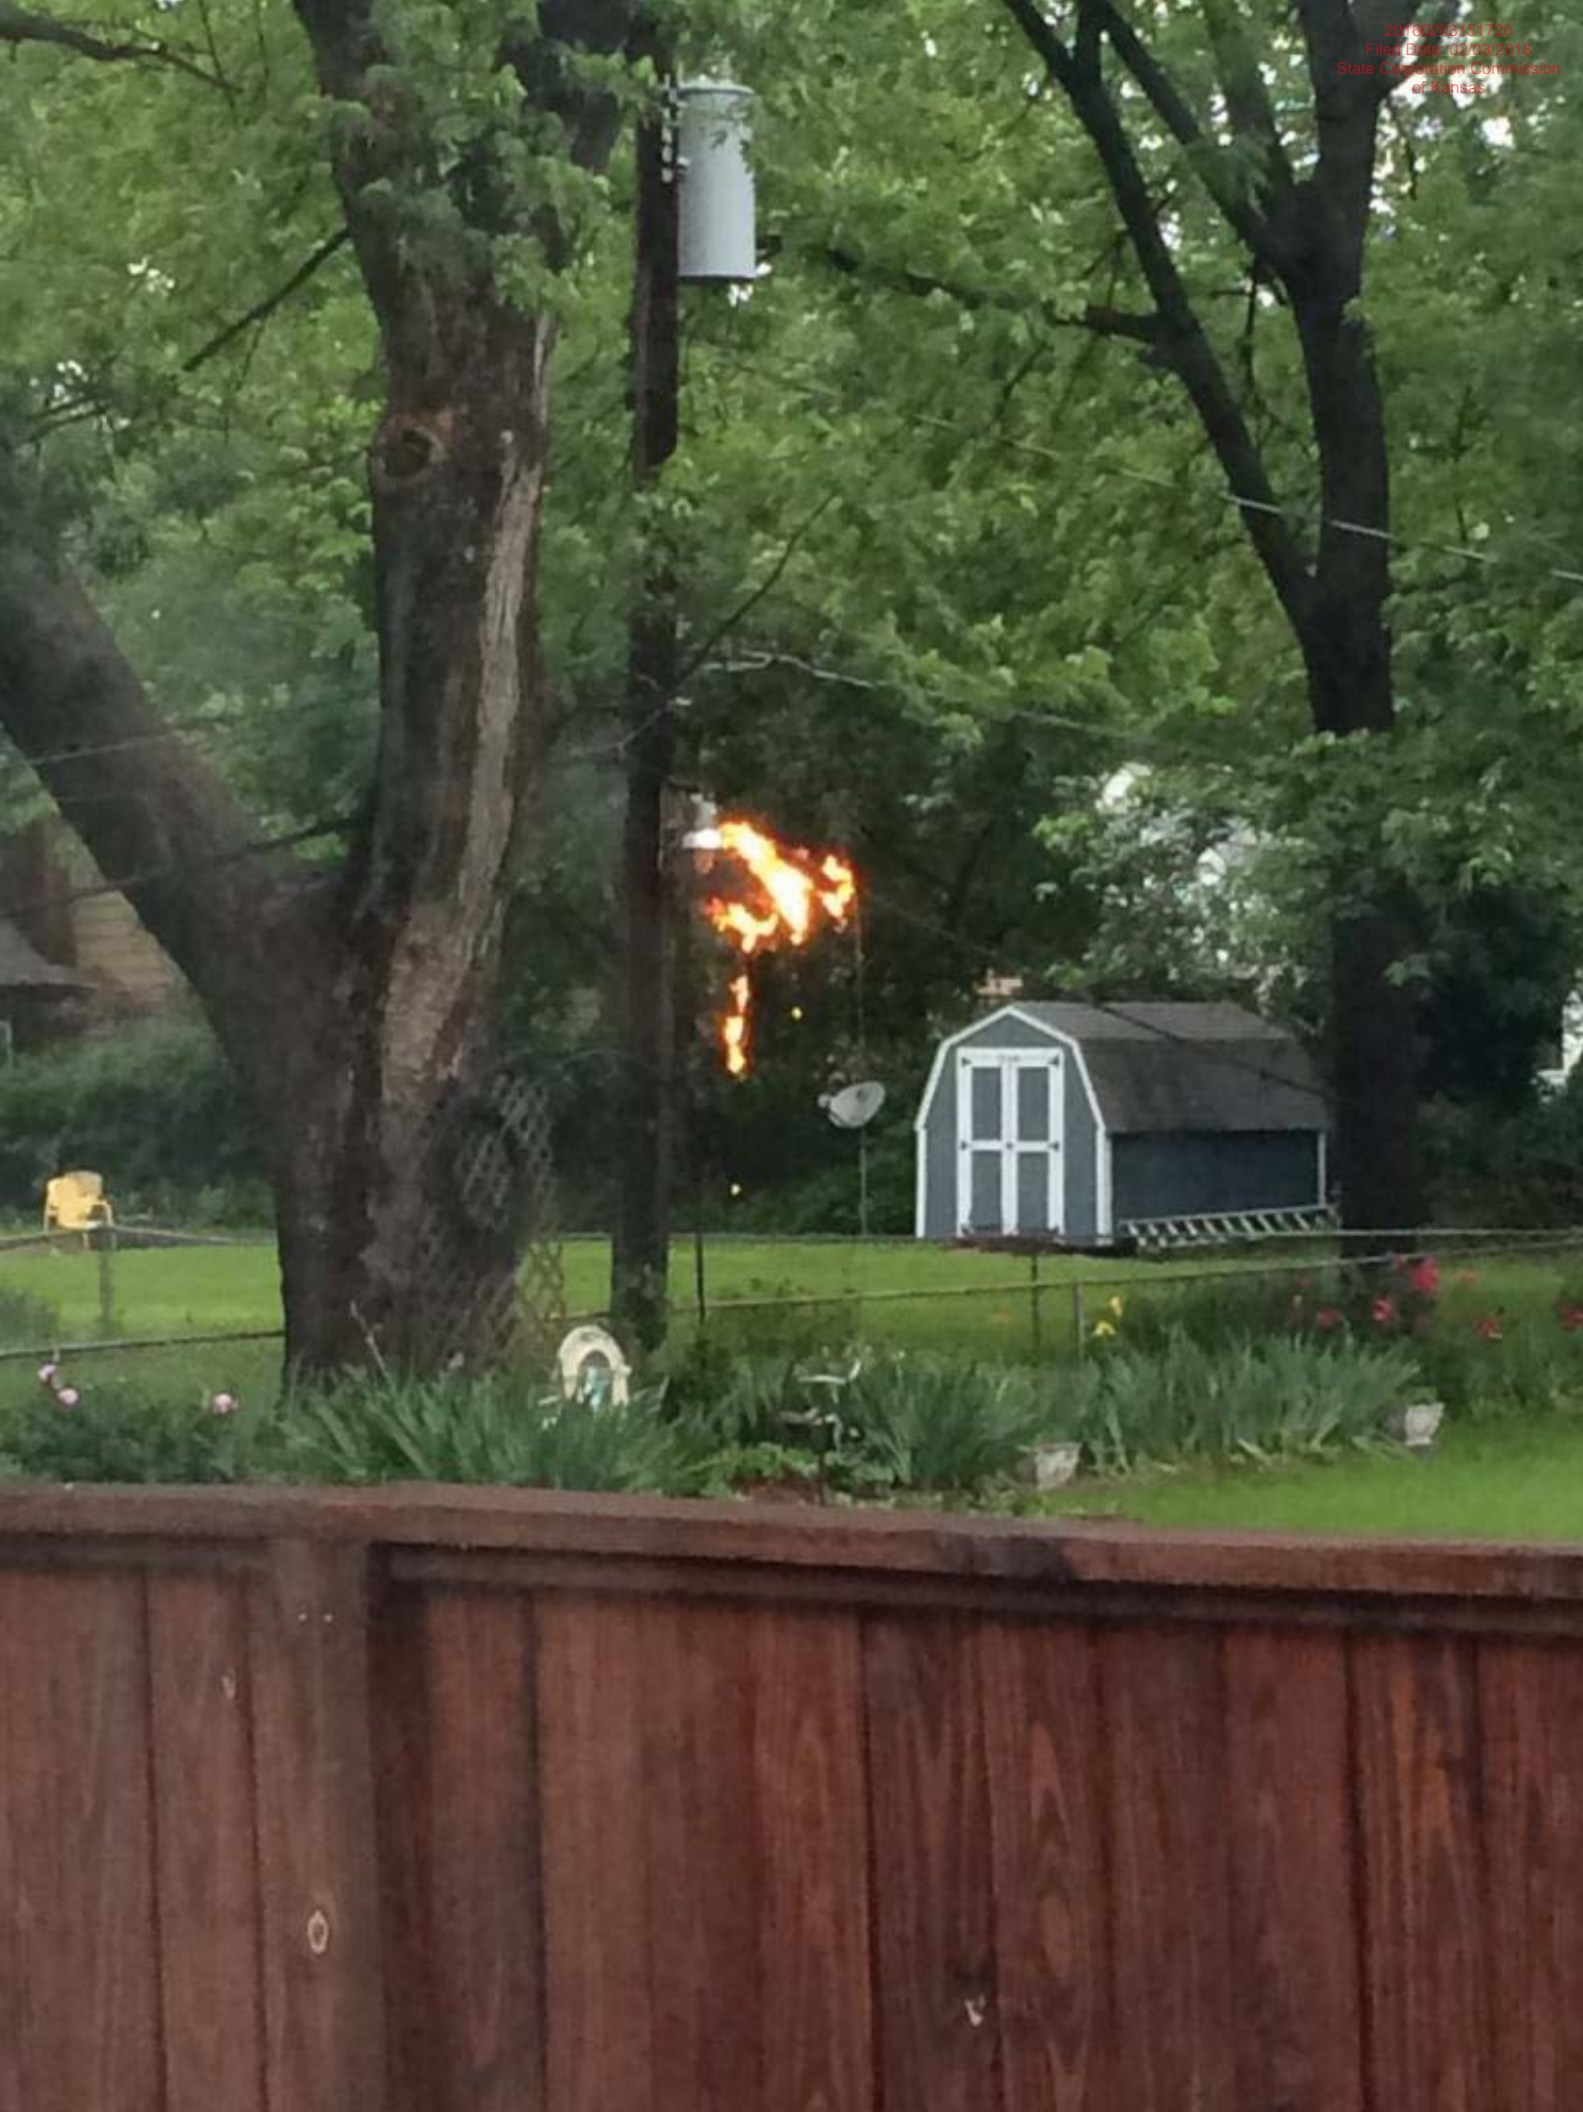
**EXHIBIT D: 5806 Walmer Photos: time stamped 5/20/15 8:58 AM thru 9:02 AM (+15 m from Ex.B)**

At the beginning of this series of photos, the Consolidated Fire Department #2 has been on scene for a little over five minutes based on the fire report. The photos show that over the course of 4 minutes, the communications box on the AT&T line starts to ignite due to the open neutral and short circuit condition in the lateral. The downed northbound neutral is visible in each photo.

The final photo in Exhibit D is the photo provided to KCTV 5 for their 10 o'clock report. The photo is time stamped at 9:02 AM meaning the short circuit fault persisted in causing damage on the secondary for at least 15 minutes.

Start of communication  
box fire on At&t line.
