**THE STATE CORPORATION COMMISSION
OF THE STATE OF KANSAS**

In the matter of the failure of Viva International,) Docket No.: 21-CONS-3295-CPEN
Inc. (Operator) to comply with K.S.A. 55-172)
and K.A.R. 82-3-603(e) at its North Campbell) CONSERVATION DIVISION
Tank Battery in Wilson County, Kansas.)
_____) License No.: 5556

PENALTY ORDER

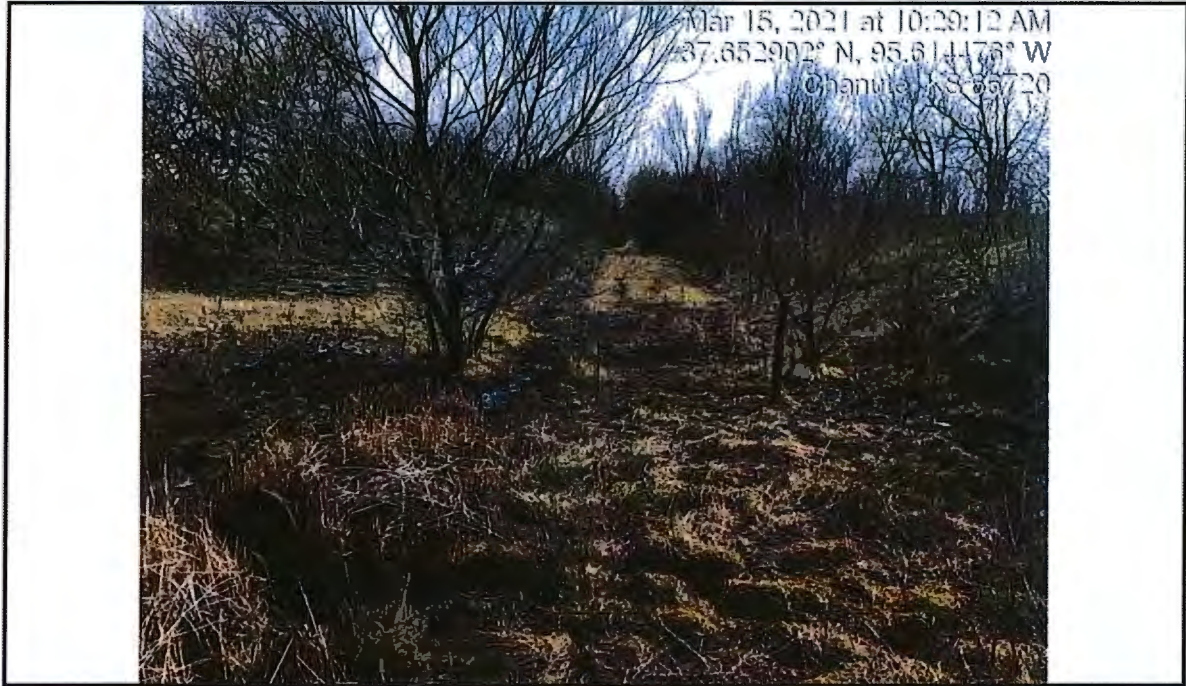
KLN: 5556
Legal: 36-27-16E SW SW NW
PIC ID#: 1
PIC Orientation: East
Latitude: 37.65352
Longitude: -095.61460

Additional Information: This photo shows the area the spill entered after leaving the road ditch. You can see some oil stain around the base of the trees.

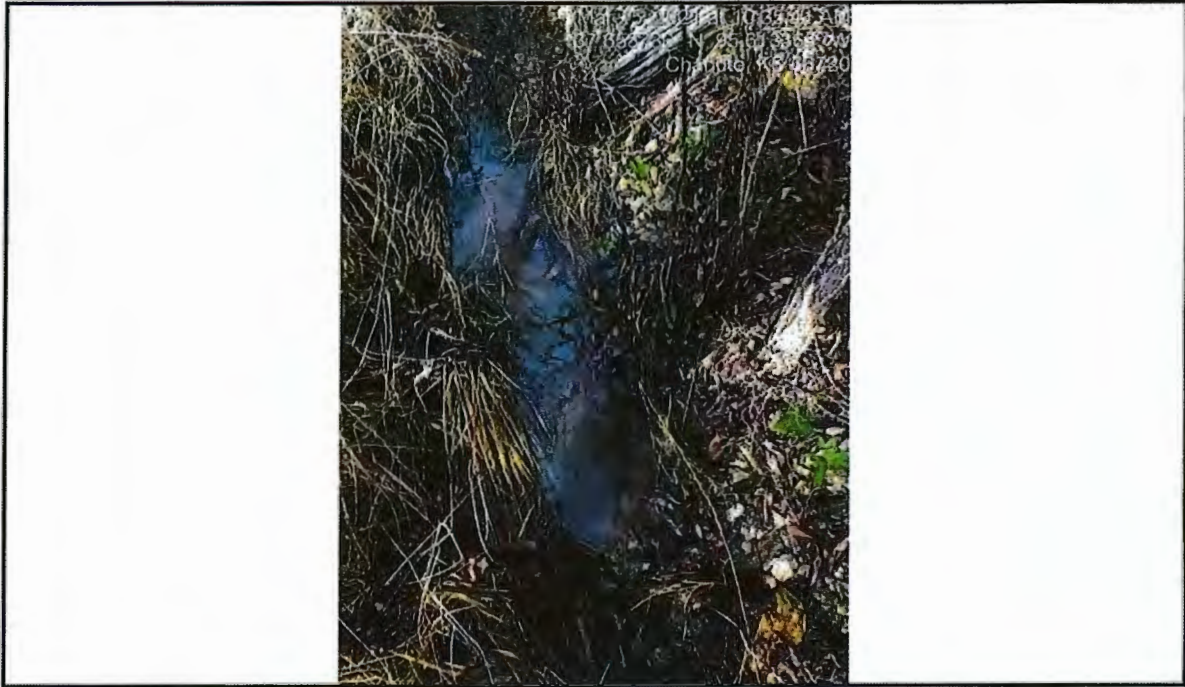
Operator: Viva International, Inc.	KLN: 5556
Lease: North Campbell	Legal: 36-27-16E SW SW NW
County: Wilson	PIC ID#: 4
Subject: Spill	PIC Orientation: Down
FSL: 2932	Latitude: 37.65370
FEL: 4980	Longitude: -095.61342
API#: NA	
Date: 3/15/2021	Time: 10:35 AM
Staff: Dallas Logan

Additional Information: This photo a small amount of oil pooled in fluid and oil stain around the edges of the pool.

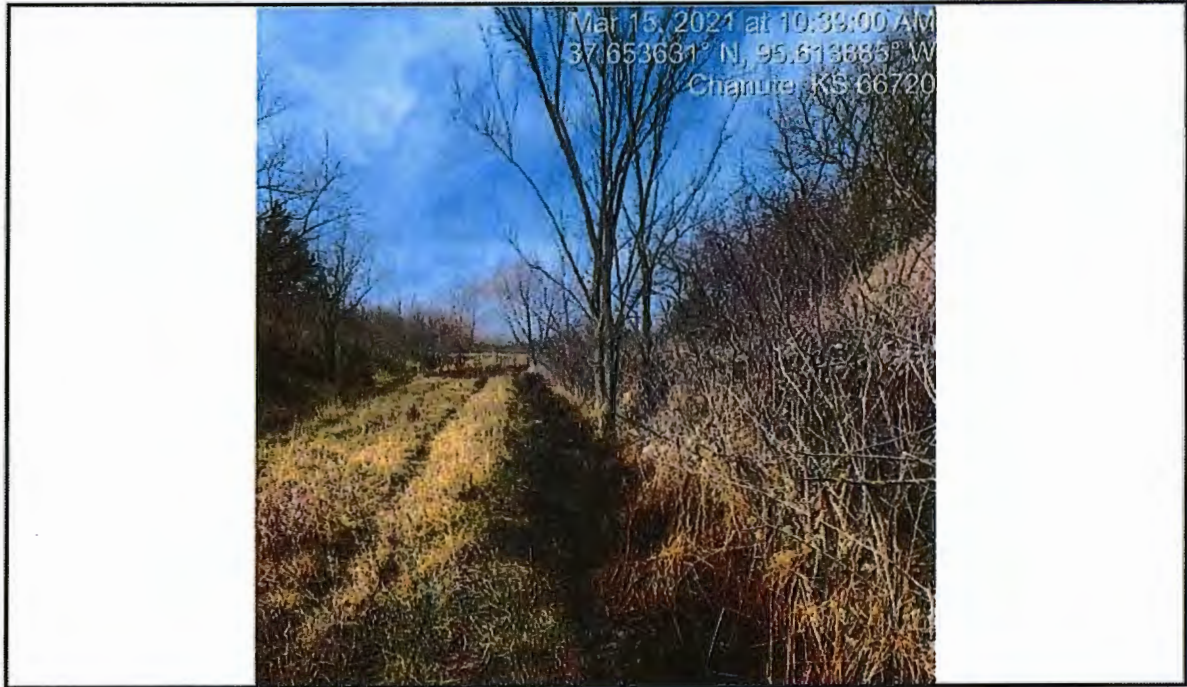
Operator: Viva International, Inc.	KLN: 5556
Lease: North Campbell	Legal: 36-27-16E SW SW NW
County: Wilson	PIC ID#: 7
Subject: Spill	PIC Orientation: West
FSL: 2917	Latitude: 37.65366
FEL: 5119	Longitude: -095.61390
API#: NA	
Date: 3/15/2021	Time: 10:37 AM
Staff: Dallas Logan

Additional Information: This photo shows oil stained grass.

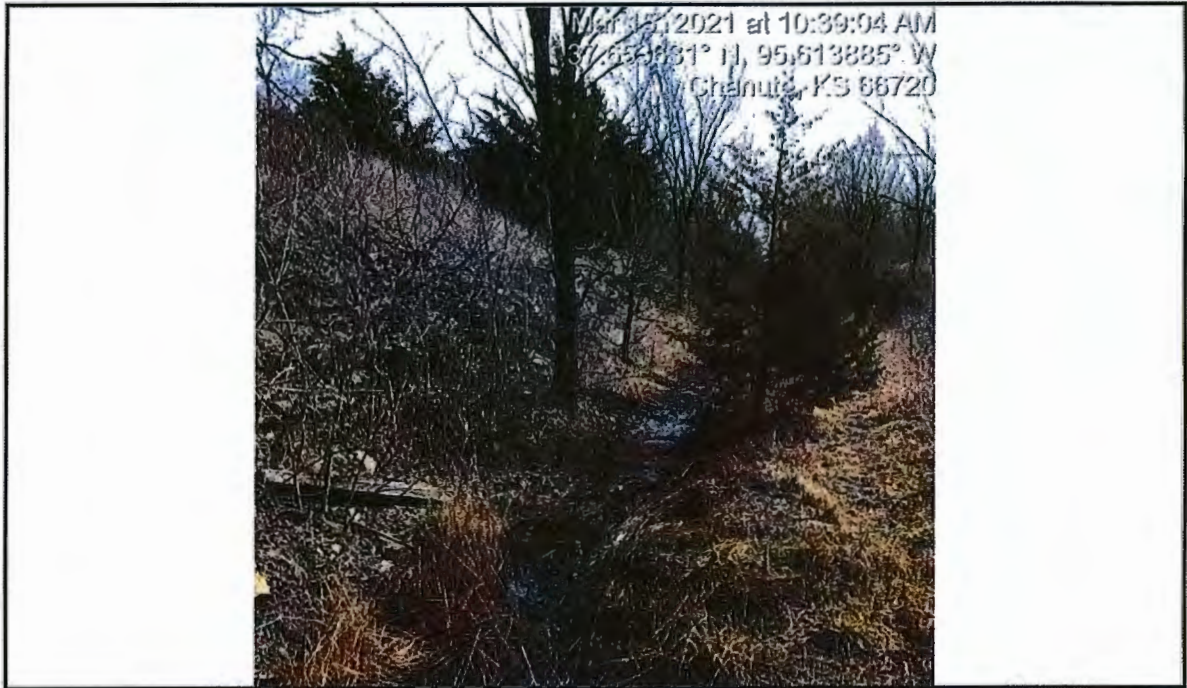
KLN: 5556
Legal: 36-27-16E SW SW NW
PIC ID#: 8
PIC Orientation: East
Latitude: 37.65366
Longitude: -095.61390

Additional Information: This photo shows oil stained grass.

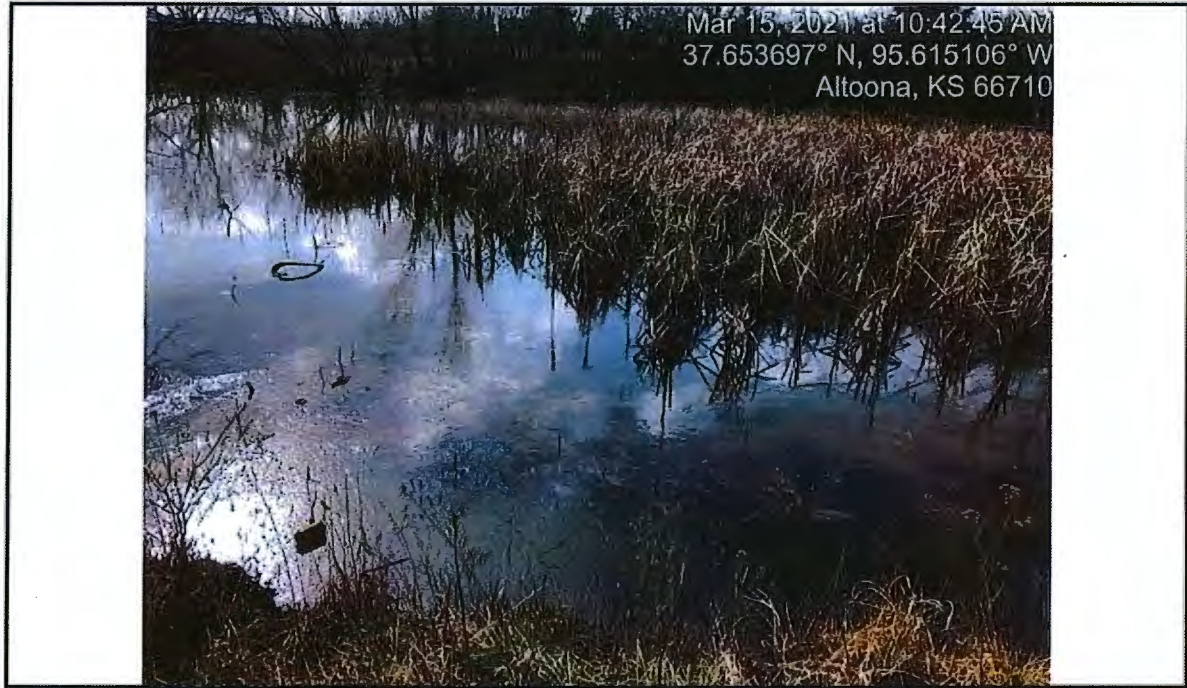
Operator: Viva International, Inc.	KLN: 5556
Lease: North Campbell	Legal: 35-27-16E SE SE NE
County: Wilson	PIC ID#: 10
Subject: Spill	PIC Orientation: South
FSL: 2921	Latitude: 37.65366
FEL: 128	Longitude: -095.61390
API#: NA	
Date: 3/15/2021	Time: 10:42 AM
Staff: Dallas Logan

Additional Information: This photo shows oil pooled on the surface of the pond.

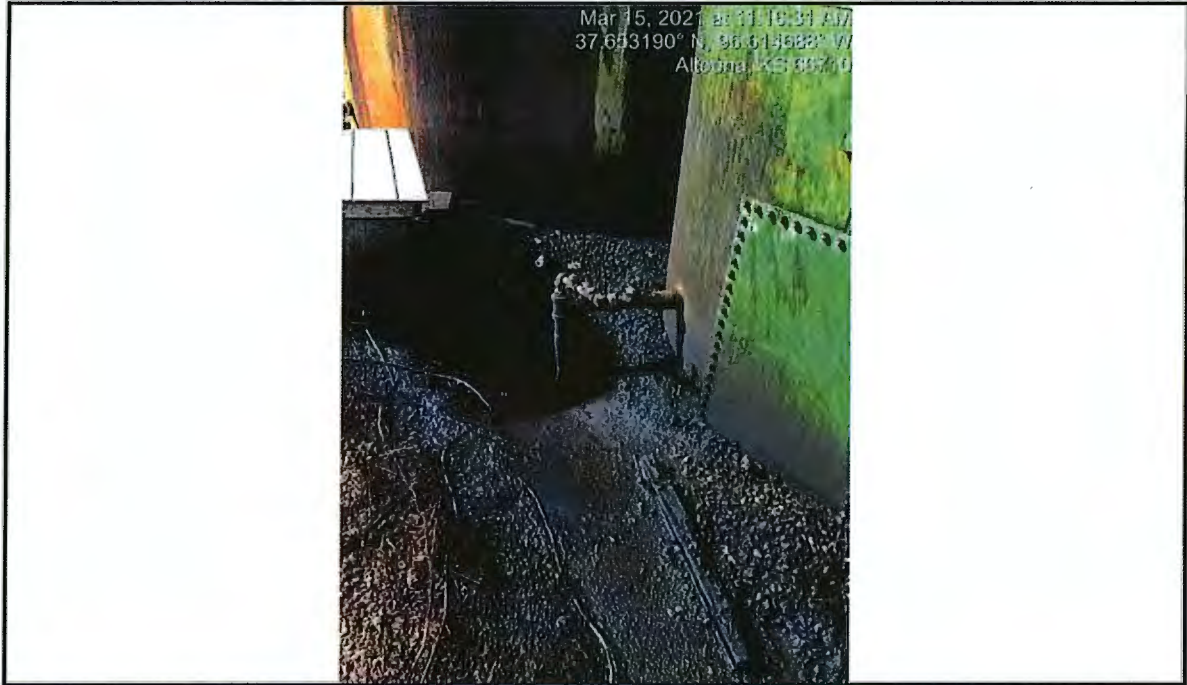
Additional Information: This photo shows free standing fluid inside the berm and is thought to be the possible cause of the spill.

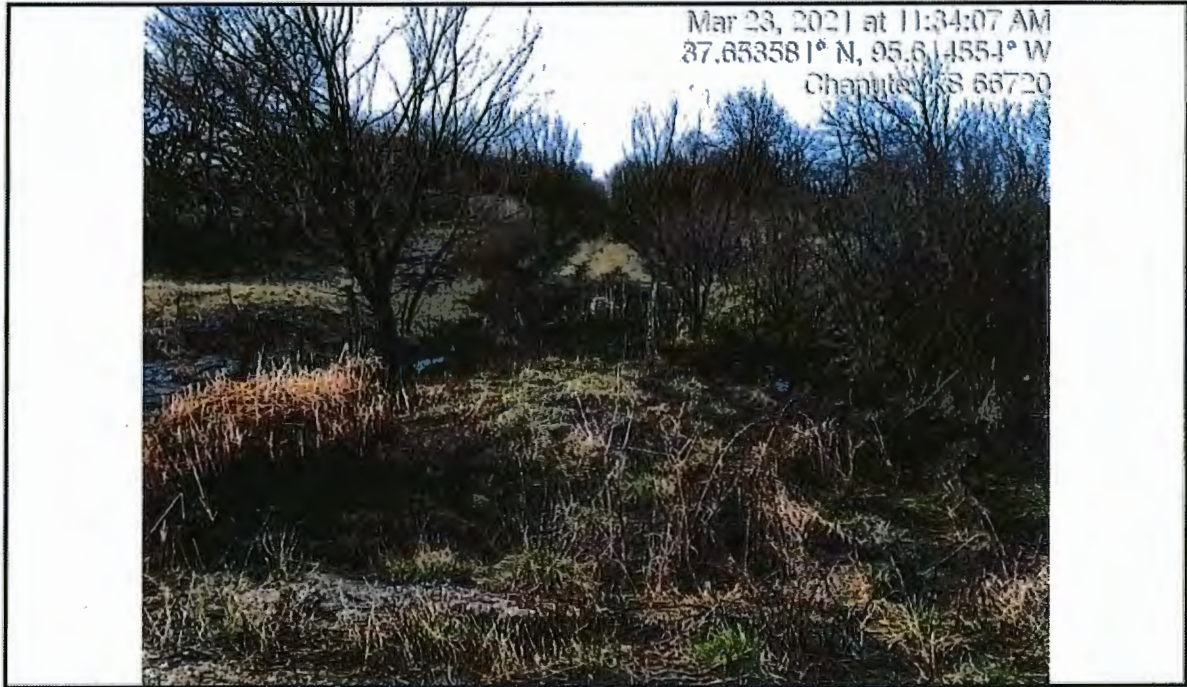
Operator: Viva International, Inc.	KLN: 5556
Lease: North Campbell	Legal: 36-27-16E SW SW NW
County: Wilson	PIC ID#: 3
Subject: Spill	PIC Orientation: East
FSL: 2867	Latitude: 37.65352
FEL: 5321	Longitude: -095.61460
API#: NA	
Date: 3/23/2021	Time: 11:34 AM
Staff: Dallas Logan

Additional Information: This photo shows the area the spill entered after leaving the road ditch. You can see that the operator has not begun cleaning up the spill in this area and recent rains have made the impacted area larger.

I will refer this report to District # 3 Compliance Officer John Almond for review. The operator was sent the attached Notice of Violation Letter after my 3/23/2021 investigation with a deadline of 4/5/2021 to clean the spill up. I will return after the 4/5/2021 deadline to determine if cleanup has been completed.

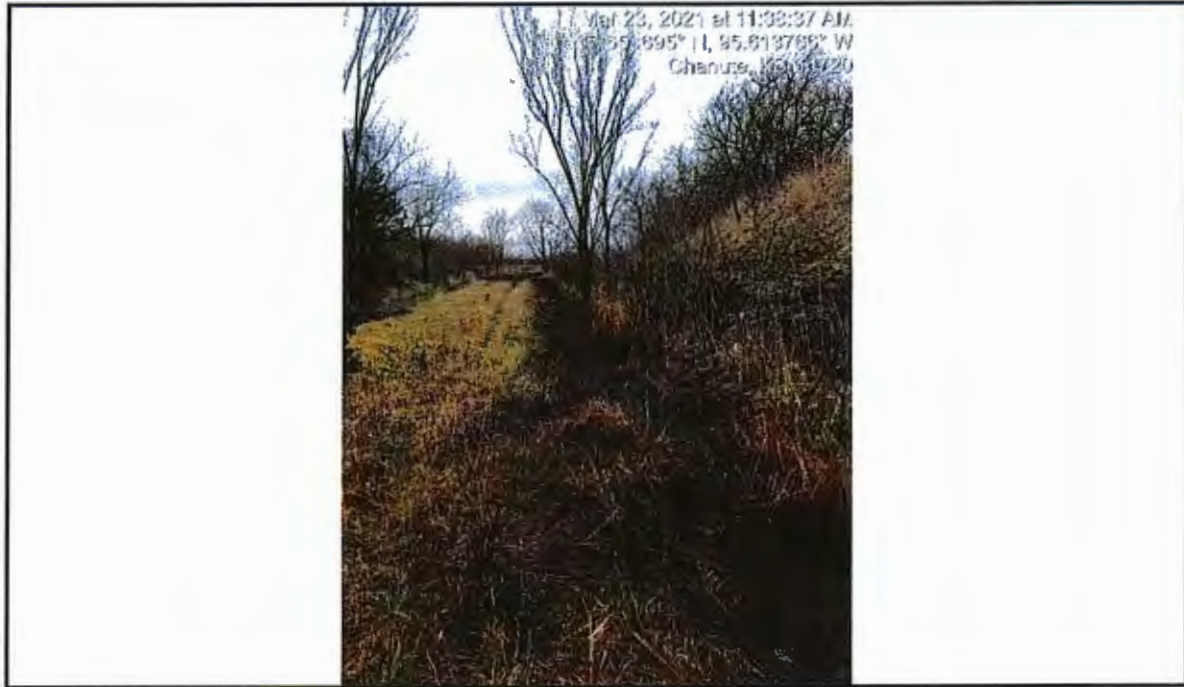
Additional Information: This photo the grass in this area is still stained in oil and no cleanup has been done.

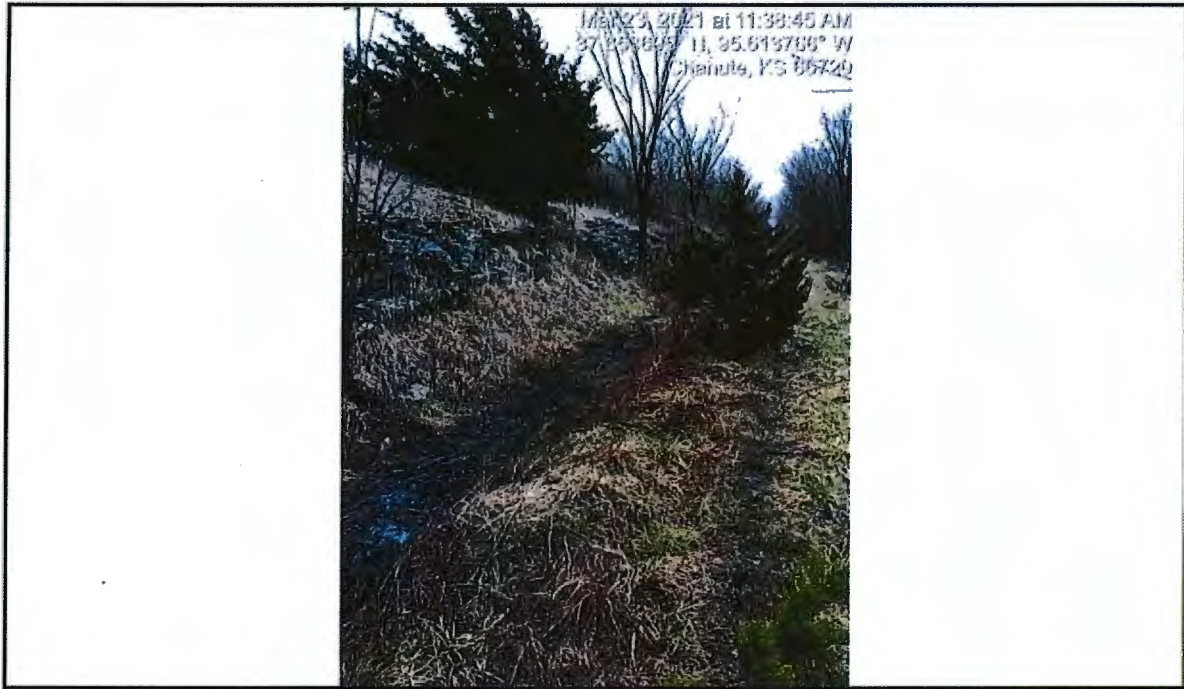
Operator: Viva International, Inc.	KLN: 5556
Lease: North Campbell	Legal: 36-27-16E SW SW NW
County: Wilson	PIC ID#: 5
Subject: Spill	PIC Orientation: East
FSL: 2917	Latitude: 37.65366
FEL: 5119	Longitude: -095.61390
API#: NA	
Date: 3/23/2021	Time: 11:38 AM
Staff: Dallas Logan

Additional Information: This photo the grass in this area is still stained in oil and no cleanup has been done.

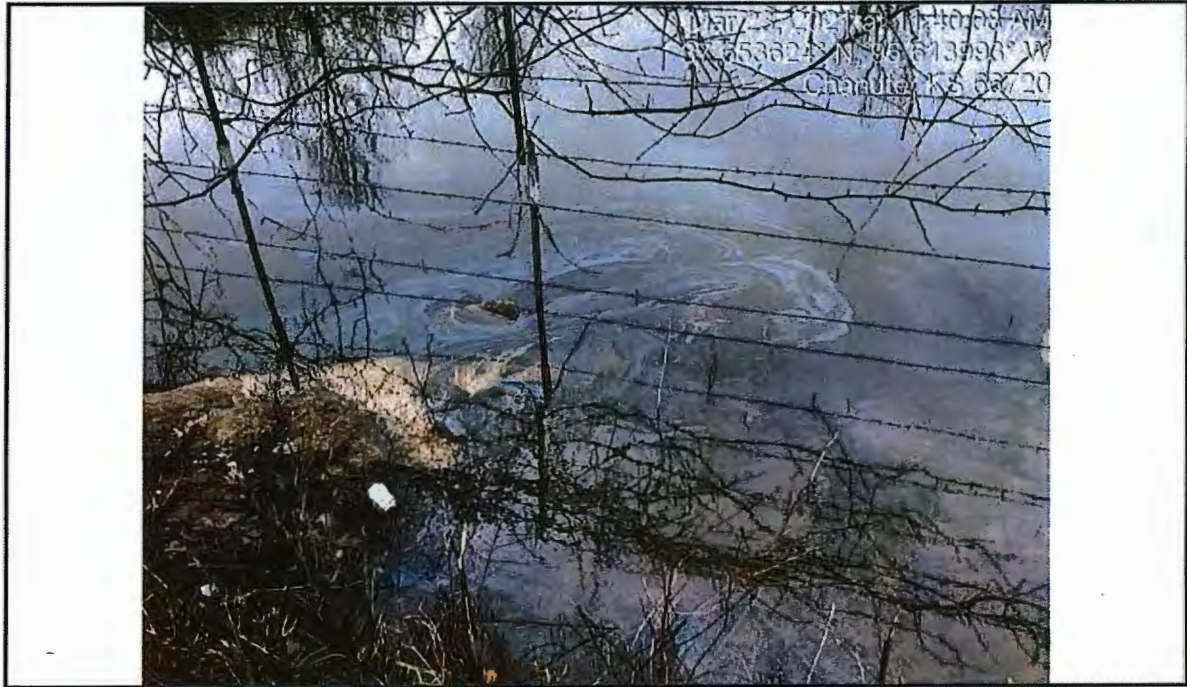
Operator: Viva International, Inc.	KLN: 5556
Lease: North Campbell	Legal: 36-27-16E SW SW NW
County: Wilson	PIC ID#: 6
Subject: Spill	PIC Orientation: West
FSL: 2867	Latitude: 37.65352
FEL: 5321	Longitude: -095.61460
API#: NA	
Date: 3/23/2021	Time: 11:40 AM
Staff: Dallas Logan

Additional Information: This shows a rainbow of oil along the edge of the pond on the west side of the county road.

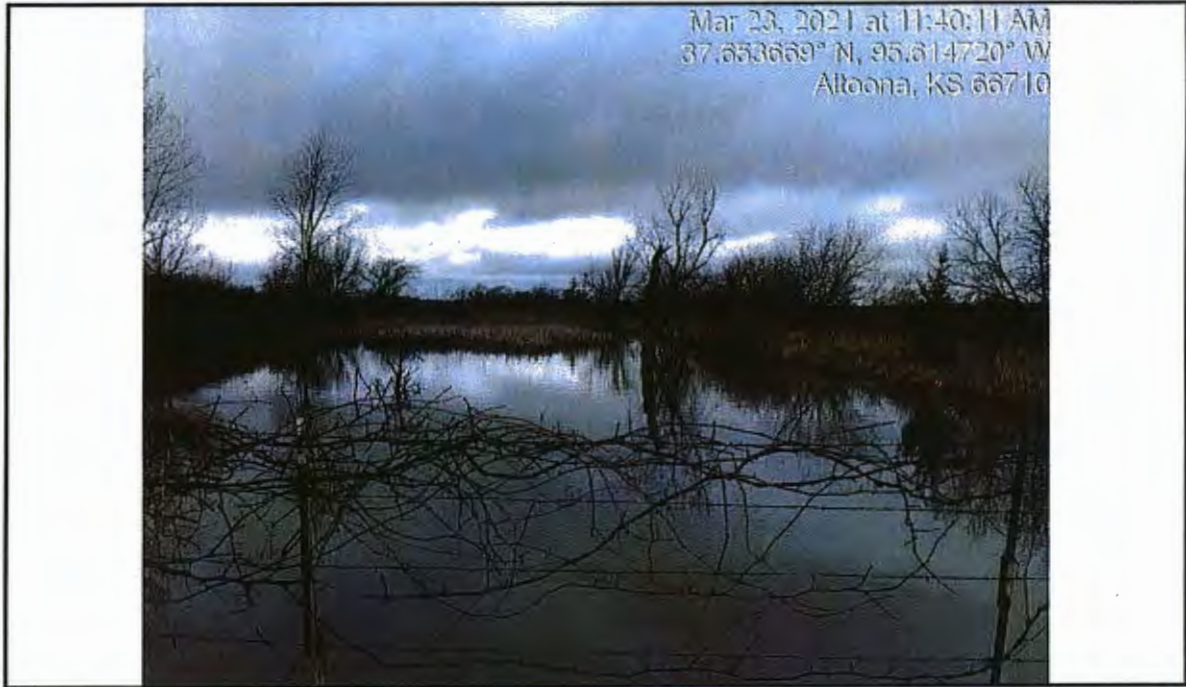
Operator: Viva International, Inc.	KLN: 5556
Lease: North Campbell	Legal: 36-27-16E SW SW NW
County: Wilson	PIC ID#: 7
Subject: Spill	PIC Orientation: West
FSL: 2867	Latitude: 37.65352
FEL: 5321	Longitude: -095.61460
API#: NA	
Date: 3/23/2021	Time: 11:40 AM
Staff: Dallas Logan

Additional Information: This the pond that oil has entered. There is oil stained along the edges of the pond and on the vegetation in the pond.

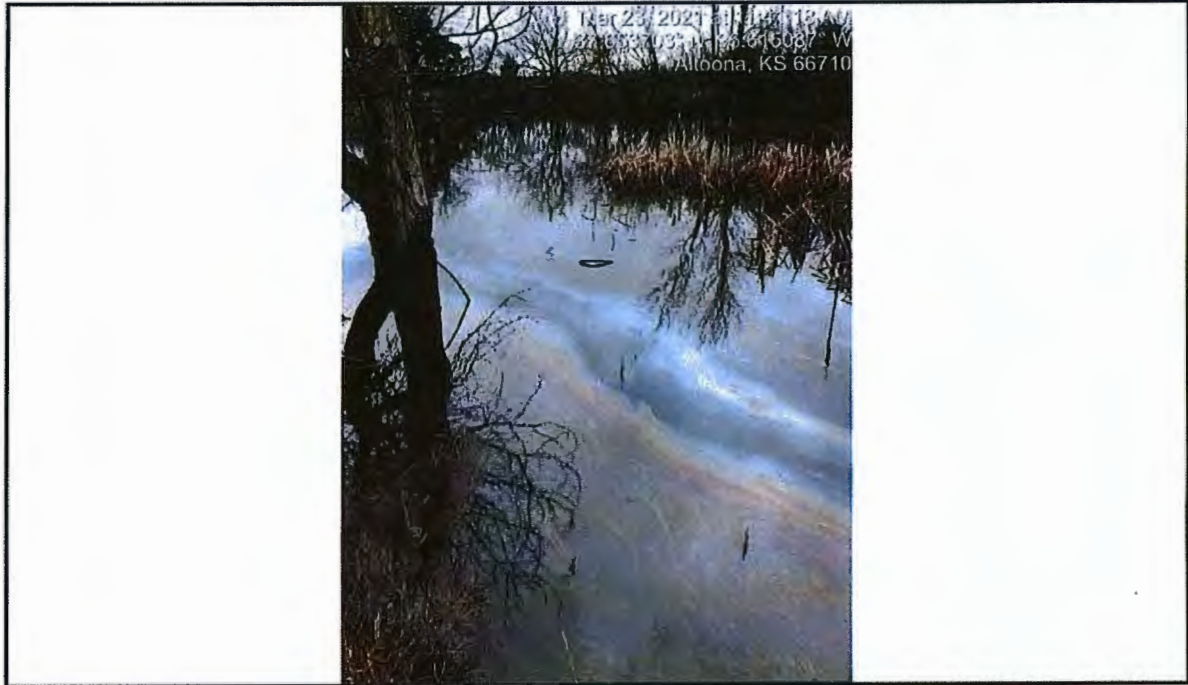
Operator: Viva International, Inc.	KLN: 5556
Lease: North Campbell	Legal: 35-27-16E SE SE NE
County: Wilson	PIC ID#: 9
Subject: Spill	PIC Orientation: Southeast
FSL: 2921	Latitude: 37.65367
FEL: 128	Longitude: -095.61513
API#: NA	
Date: 3/23/2021	Time: 11:41 AM
Staff: Dallas Logan

Additional Information: This photo shows a rainbow of oil on the pond.

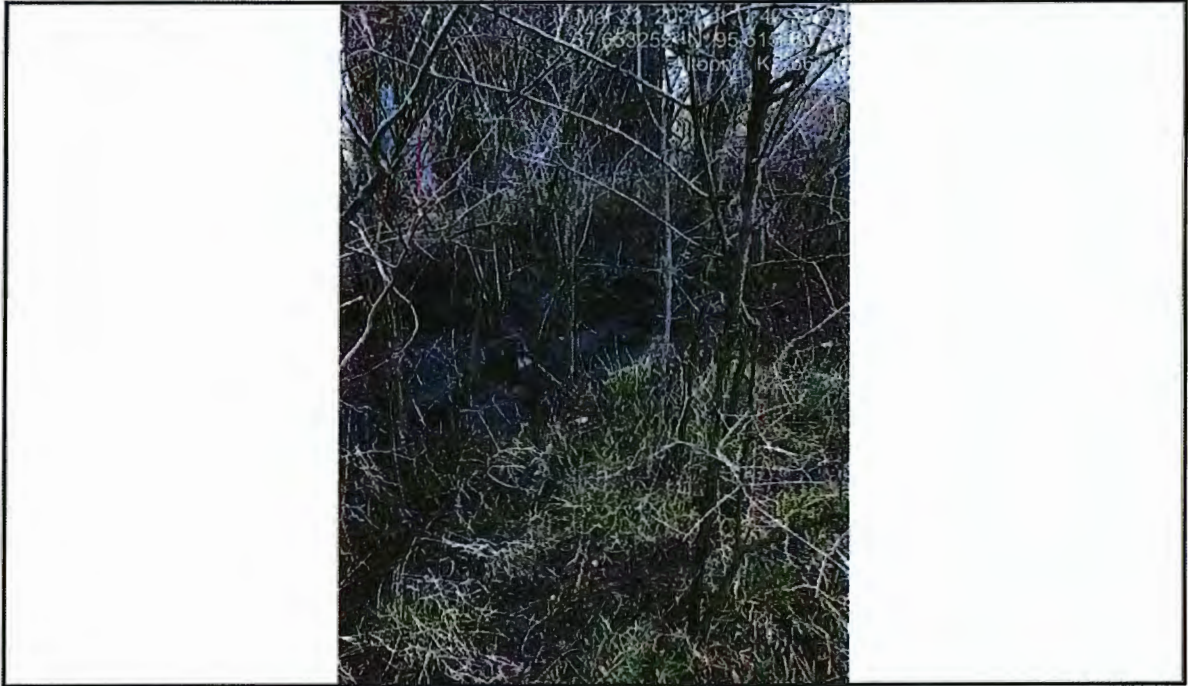
Operator: Viva International, Inc.	KLN: 5556
Lease: North Campbell	Legal: 35-27-16E SE SE NE
County: Wilson	PIC ID#: 12
Subject: Spill	PIC Orientation: Southwest
FSL: NA	Latitude: NA
FEL: NA	Longitude: NA
API#: NA	
Date: 3/23/2021	Time: 11:47 AM
Staff: Dallas Logan

Additional Information: This photo is taken just east of the last photo and shows free standing fluids and oil stain.

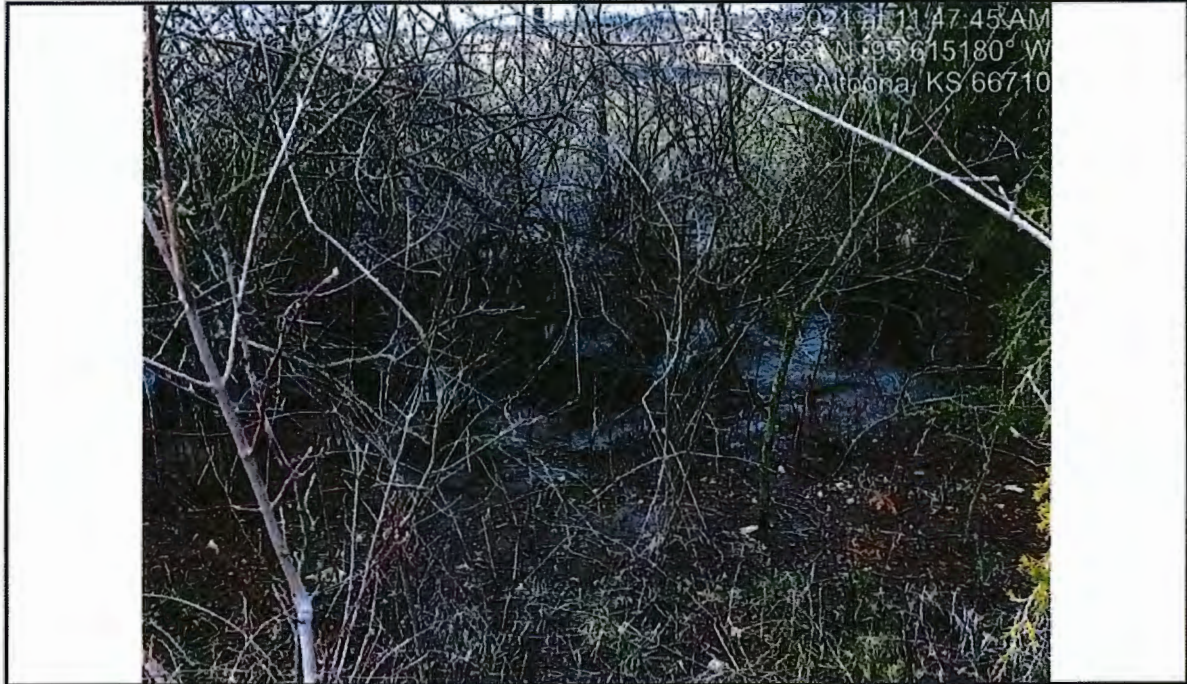
Operator: Viva International, Inc.	KLN: 5556
Lease: North Campbell	Legal: 35-27-16E SE SE NE
County: Wilson	PIC ID#: 13
Subject: Spill	PIC Orientation: South
FSL: NA	Latitude: NA
FEL: NA	Longitude: NA
API#: NA	
Date: 3/23/2021	Time: 11:47 AM
Staff: Dallas Logan

Additional Information: This photo is taken just east of the last photo and shows free standing fluids and oil stain.

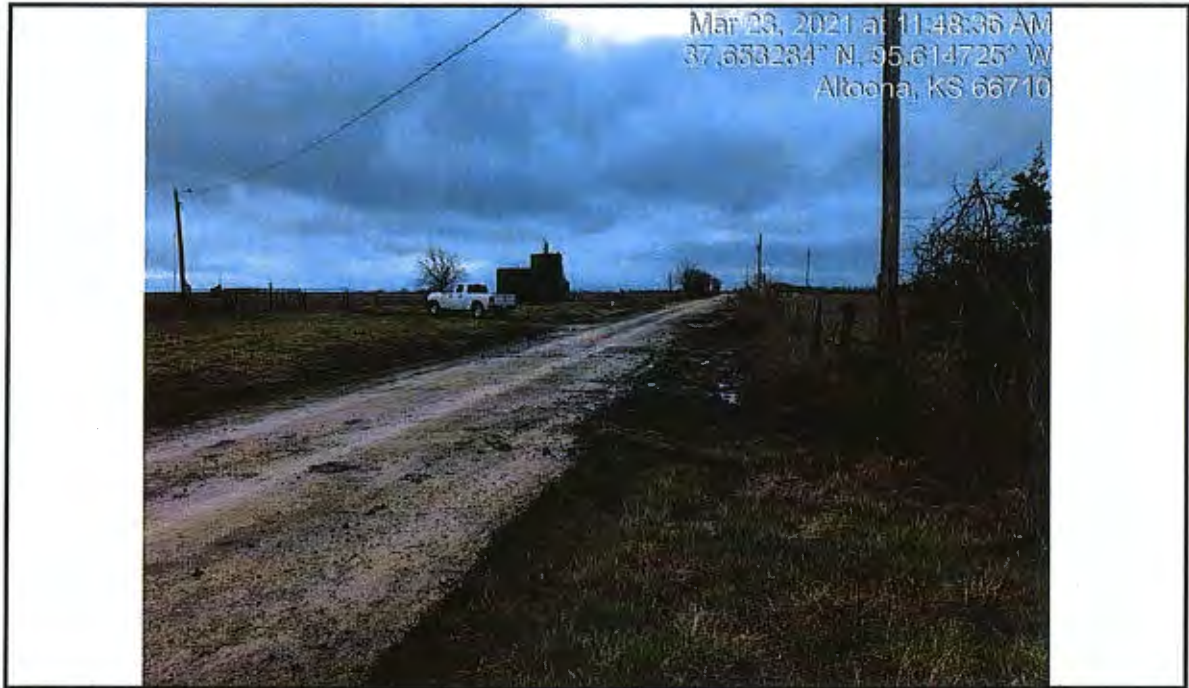
Operator: Viva International, Inc.	KLN: 5556
Lease: North Campbell	Legal: 35-27-16E SE SE NE
County: Wilson	PIC ID#: 14
Subject: Spill	PIC Orientation: South
FSL: 2750	Latitude: 37.65320
FEL: 4	Longitude: -095.61470
API#: NA	
Date: 3/23/2021	Time: 11:48 AM
Staff: Dallas Logan

Additional Information: This photo shows the road ditches.

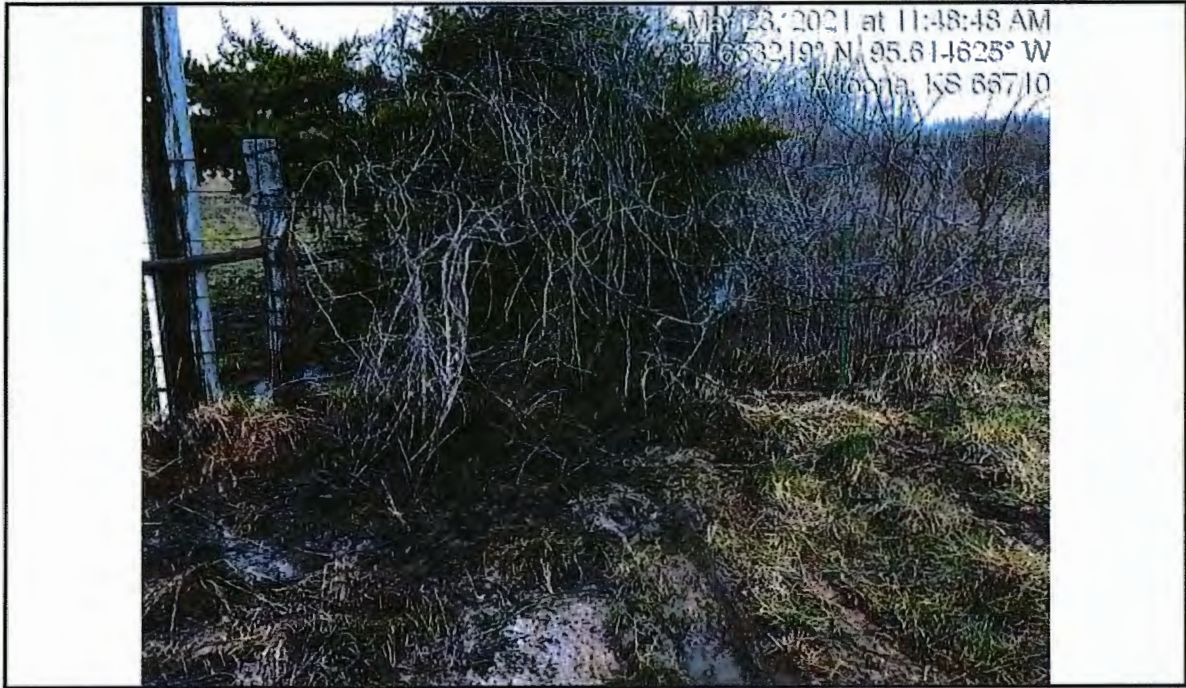
Additional Information: This photo shows where the spill left the ditch and entered the new area where the spill was found.

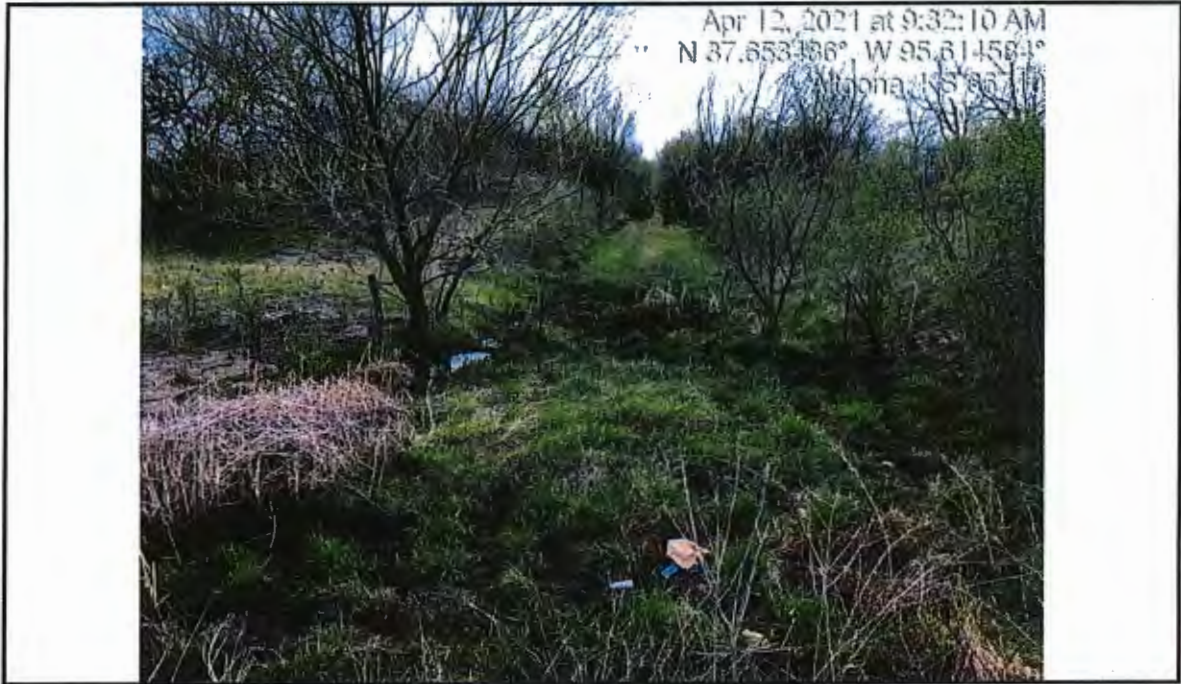
Operator: Viva International, Inc.	KLN: 5556
Lease: North Campbell	Legal: 36-27-16E SW SW NW
County: Wilson	PIC ID#: 3
Subject: Spill	PIC Orientation: East
FSL: 2867	Latitude: 37.65352
FEL: 5321	Longitude: -095.61460
API#: NA	
Date: 4/12/2021	Time: 9:32 AM
Staff: Dallas Logan

Additional Information: You can see there is oil stain in the grass over this area.

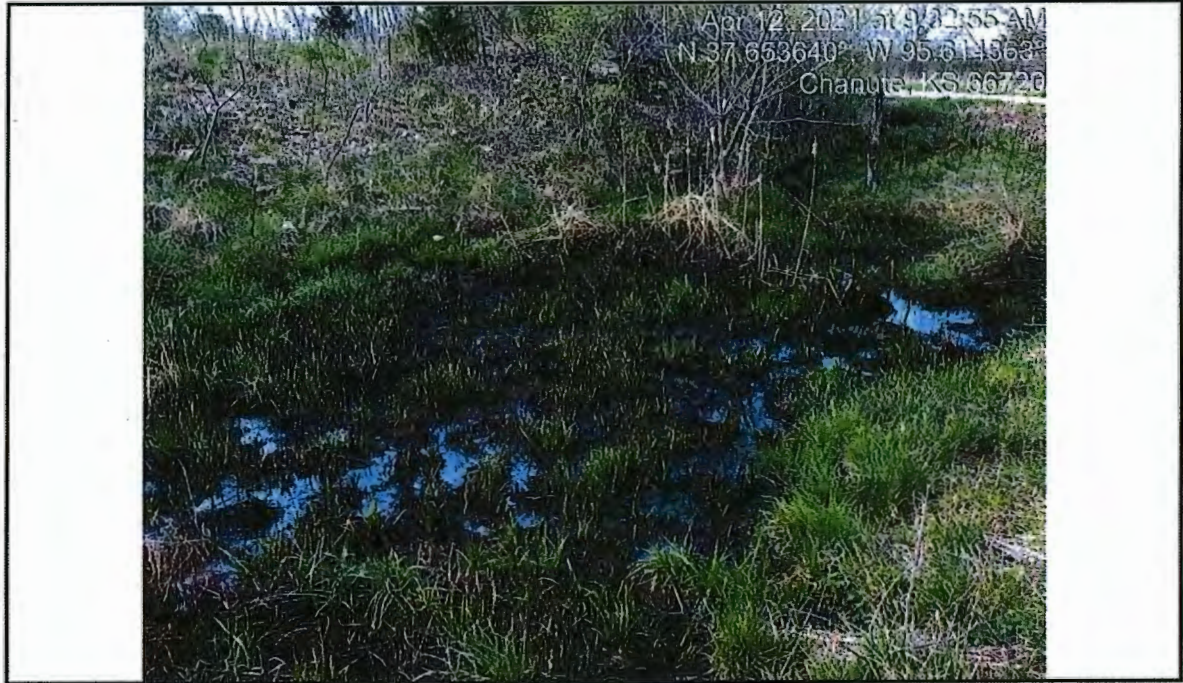
Operator: Viva International, Inc.	KLN: 5556
Lease: North Campbell	Legal: 36-27-16E SW SW NW
County: Wilson	PIC ID#: 4
Subject: Spill	PIC Orientation: West
FSL: 2867	Latitude: 37.65352
FEL: 5321	Longitude: -095.61460
API#: NA	
Date: 4/12/2021	Time: 9:32 AM
Staff: Dallas Logan

Additional Information: This photo better shows oil stained in the grass when standing fluids covering the area. This oil stain has not been addressed and the fluids that travel over it are capable of allowing the oil to travel.

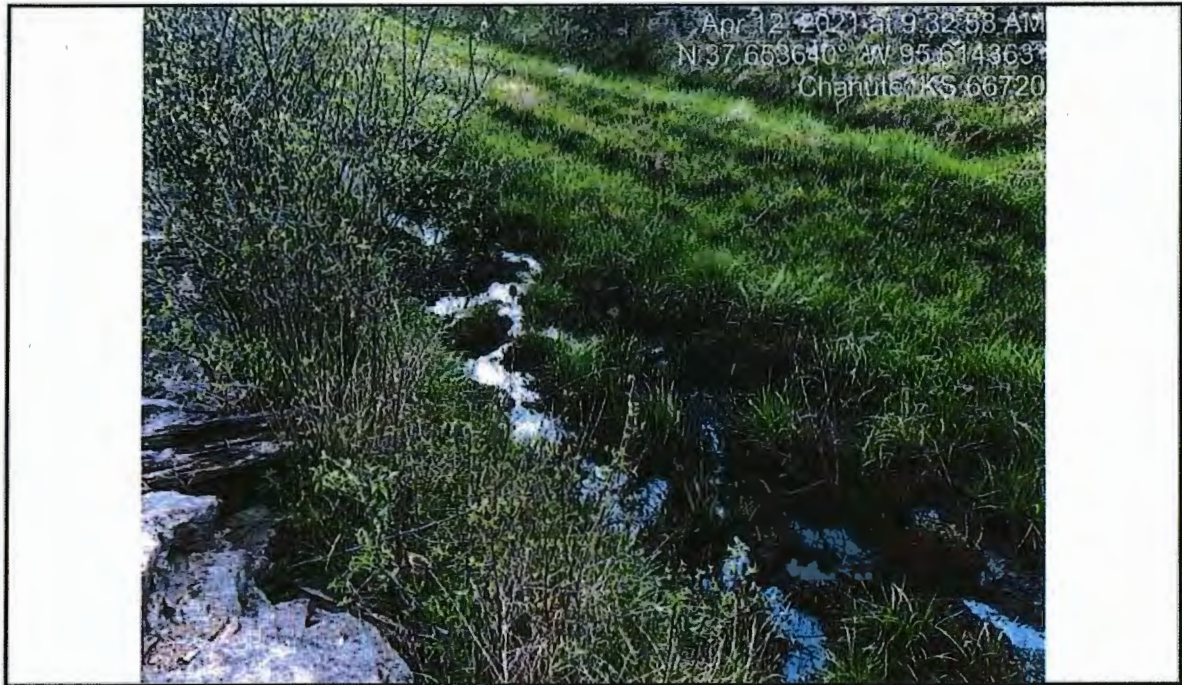
Operator: Viva International, Inc.	KLN: 5556
Lease: North Campbell	Legal: 36-27-16E SW SW NW
County: Wilson	PIC ID#: 5
Subject: Spill	PIC Orientation: Southeast
FSL: 2867	Latitude: 37.65352
FEL: 5321	Longitude: -095.61460
API#: NA	
Date: 4/12/2021	Time: 9:32 AM
Staff: Dallas Logan

Additional Information: This shows were the spill area narrows down traveling east. You can still see oil stain with fluids traveling over the spill area. The grass just south of the free standing fluids also has oil stain amongst the grass from being carried by rain.

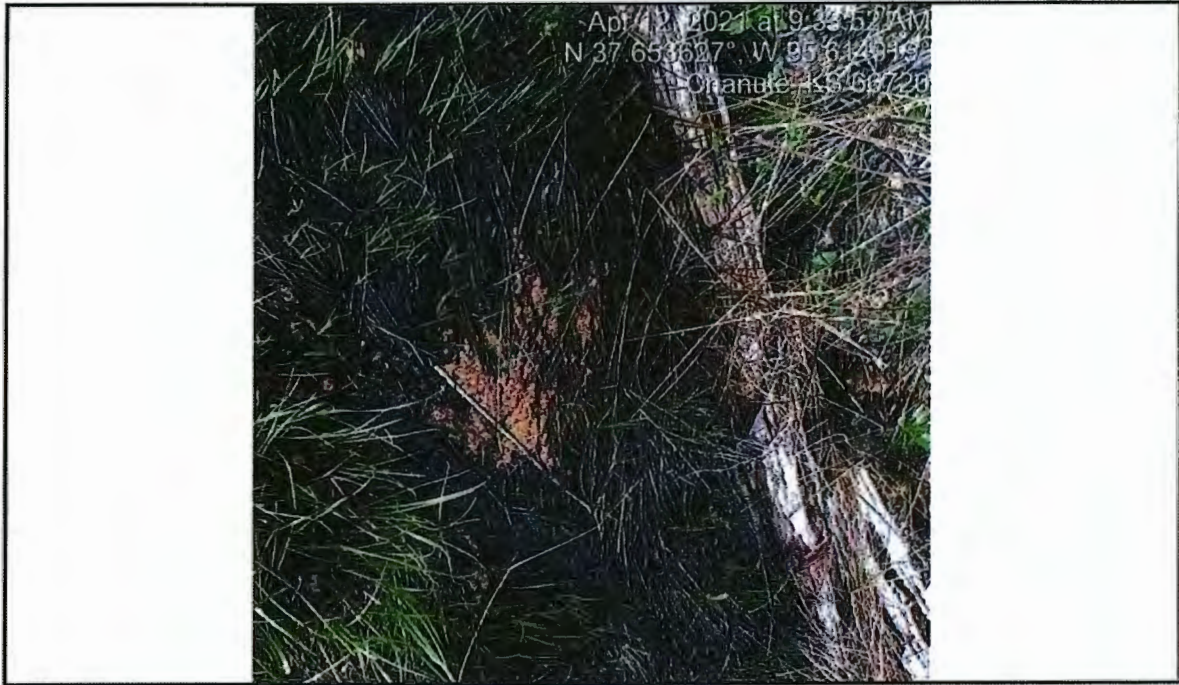
Operator: Viva International, Inc.	KLN: 5556
Lease: North Campbell	Legal: 36-27-16E SW SW NW
County: Wilson	PIC ID#: 6
Subject: Spill	PIC Orientation: Down
FSL: NA	Latitude: NA
FEL: NA	Longitude: NA
API#: NA	
Date: 4/12/2021	Time: 9:33 AM
Staff: Dallas Logan

Additional Information: This photo shows that there is spag sorb present however it is not incorporated in the oil it is just laying on top of the oil.

I will refer this report to District # 3 Compliance Officer John Almond for review. It is my recommendation that the operator be considered for fine recommendations for failure to cleanup spill # 28425. While the operator has performed some cleanup on spill # 28425 cleanup has not yet been completed.

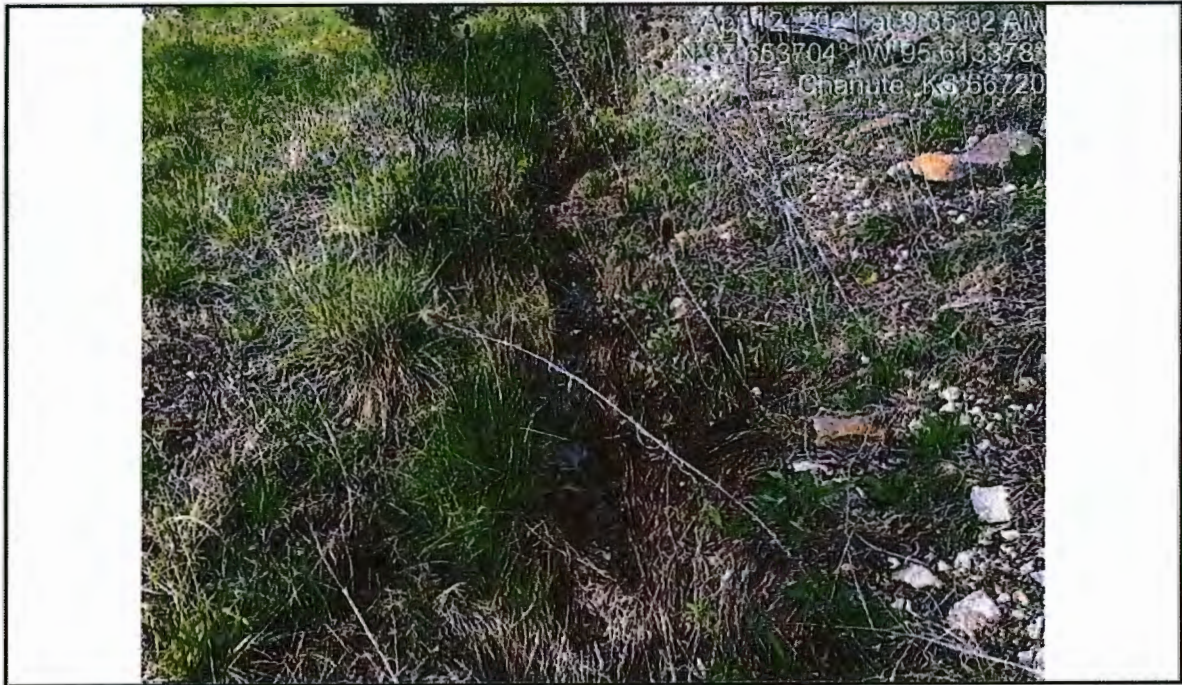
Operator: Viva International, Inc.	KLN: 5556
Lease: North Campbell	Legal: 36-27-16E SW SW NW
County: Wilson	PIC ID#: 7
Subject: Spill	PIC Orientation: West
FSL: NA	Latitude: NA
FEL: NA	Longitude: NA
API#: NA	
Date: 4/12/2021	Time: 9:35 AM
Staff: Dallas Logan

Additional Information: This photo shows oil stain in a narrow path.

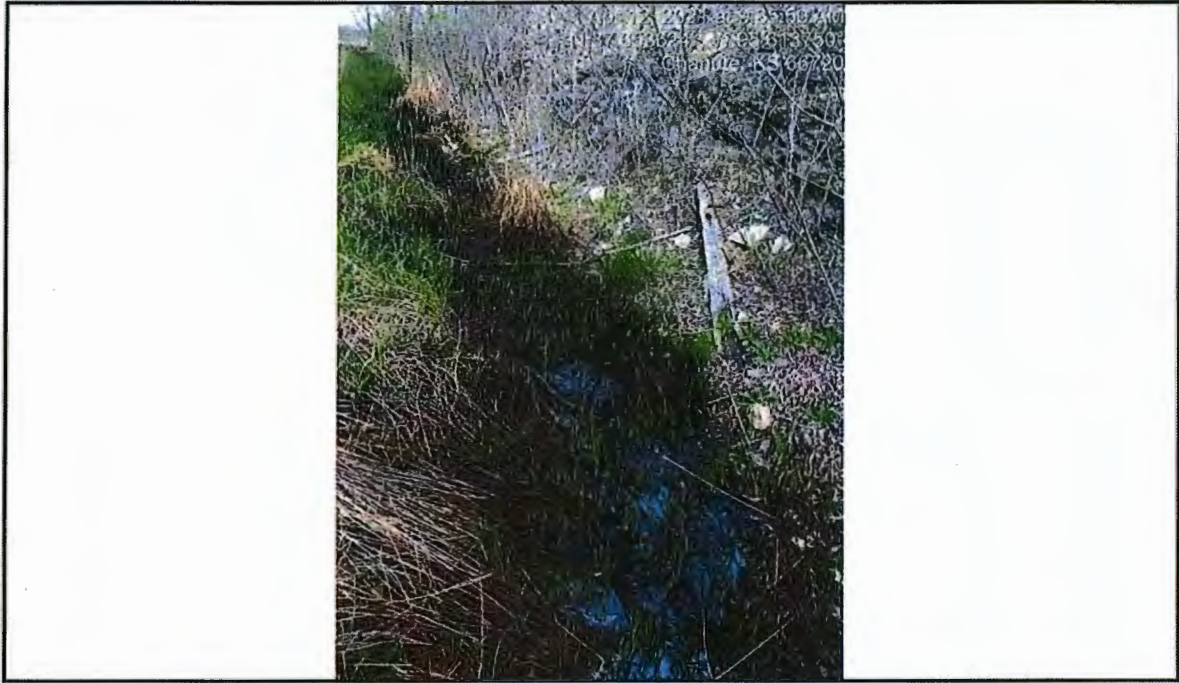
Additional Information: This photo shows oil stain with free standing fluids covering it.

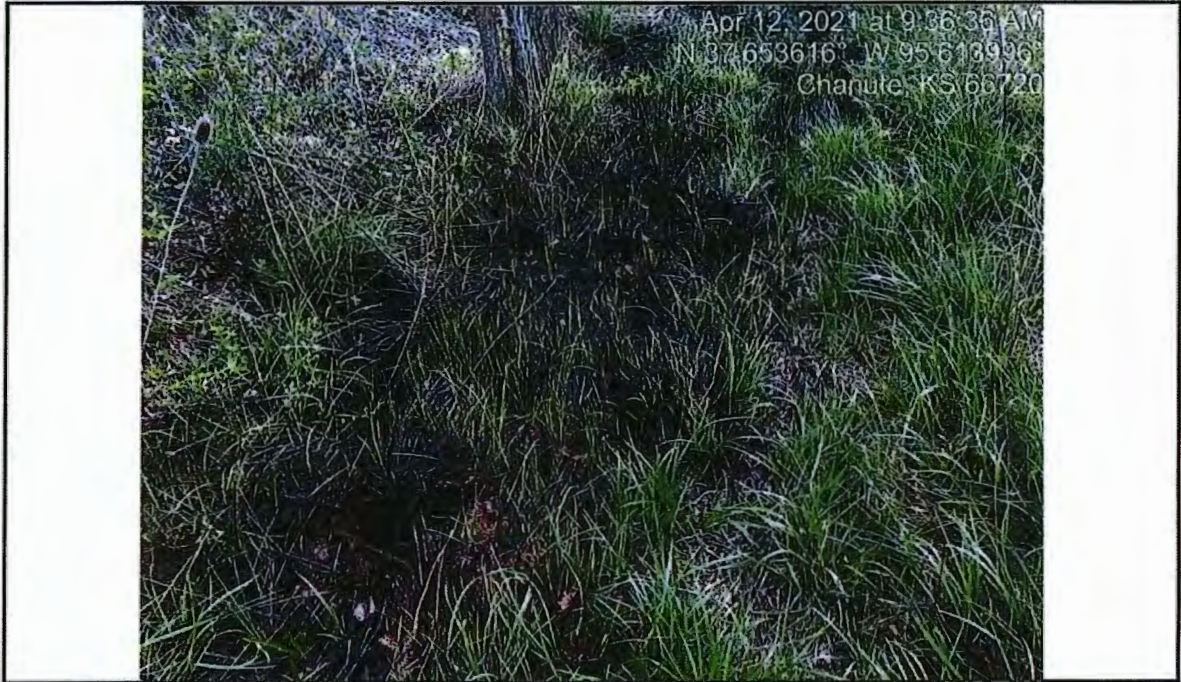
Additional Information: This photo shows oil stained grass with a small amount of spag sorb spread over the area.

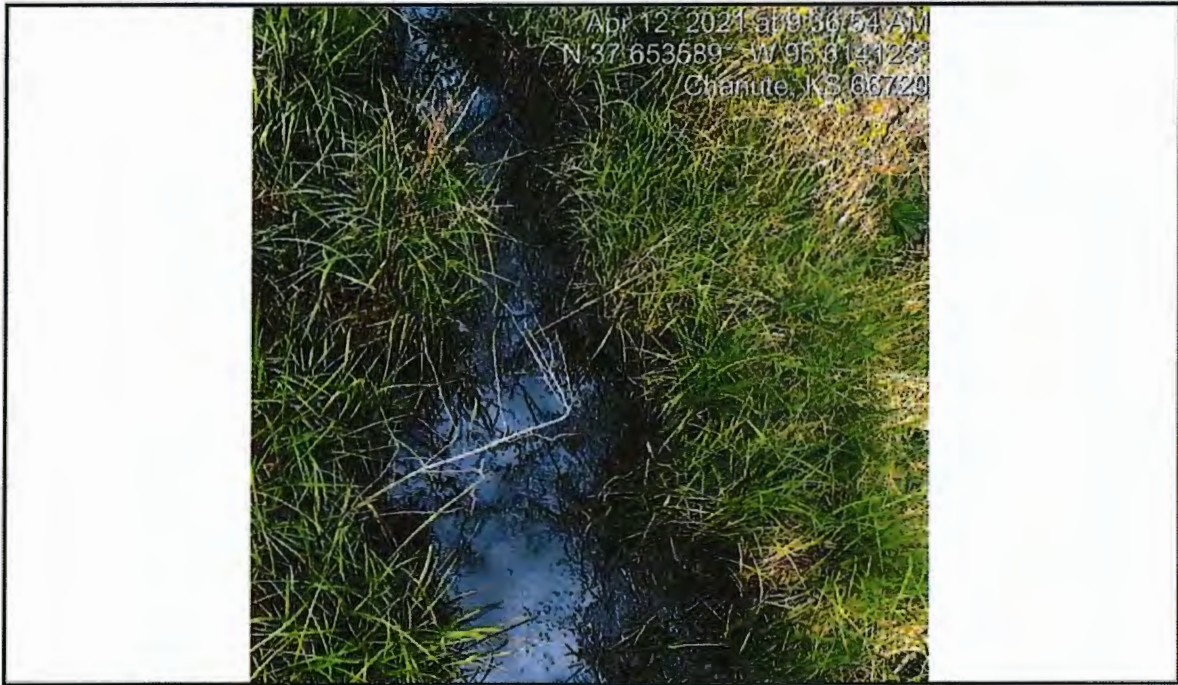
Operator: Viva International, Inc.	KLN: 5556
Lease: North Campbell	Legal: 36-27-16E SW SW NW
County: Wilson	PIC ID#: 10
Subject: Spill	PIC Orientation: East
FSL: NA	Latitude: NA
FEL: NA	Longitude: NA
API#: NA	
Date: 4/12/2021	Time: 9:36 AM
Staff: Dallas Logan

Additional Information: This photo shows oil present on the ground with free standing fluid covering it.

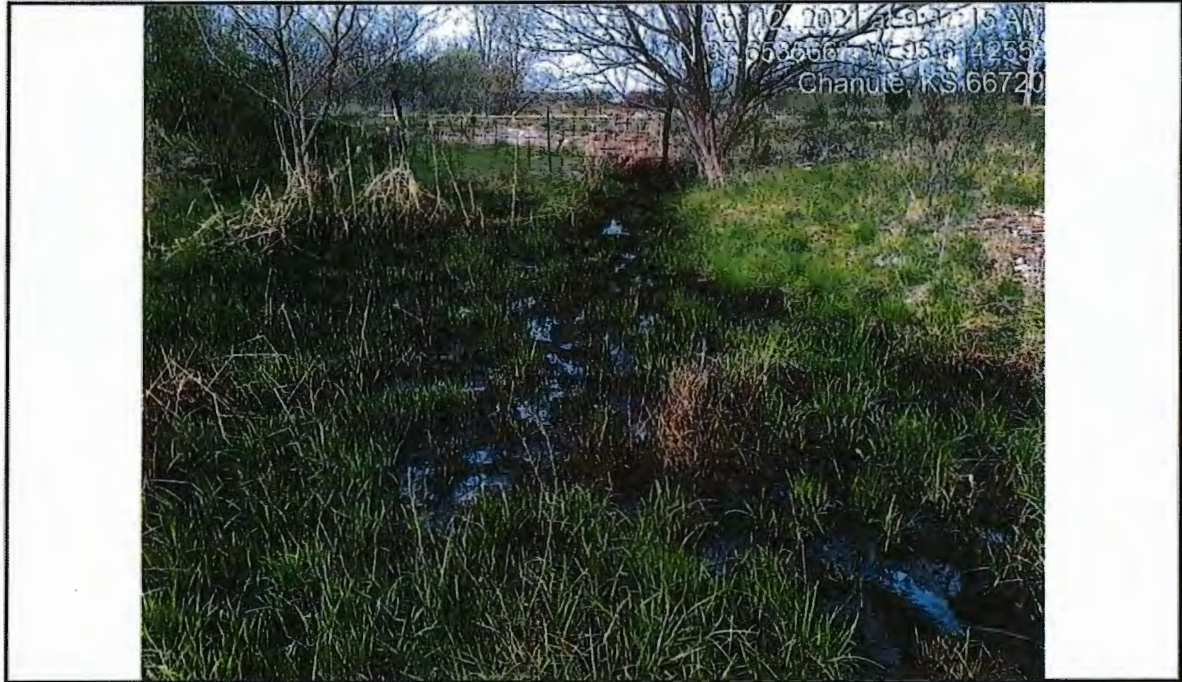
Operator: Viva International, Inc.	KLN: 5556
Lease: North Campbell	Legal: 36-27-16E SW SW NW
County: Wilson	PIC ID#: 11
Subject: Spill	PIC Orientation: West
FSL: NA	Latitude: NA
FEL: NA	Longitude: NA
API#: NA	
Date: 4/12/2021	Time: 9:37 AM
Staff: Dallas Logan

Additional Information: This is another photo of directly after the spill turned east after leaving the road ditch. You can see that there is still oil present. You can also see nothing has been done to keep fluid from continuing to spread the oil.
