**THE STATE CORPORATION COMMISSION
OF THE STATE OF KANSAS**

In the matter of the failure of Viva International,) Docket No.: 21-CONS-3295-CPEN
Inc. (Operator) to comply with K.S.A. 55-172)
and K.A.R. 82-3-603(e) at its North Campbell) CONSERVATION DIVISION
Tank Battery in Wilson County, Kansas.)
_____) License No.: 5556

PENALTY ORDER

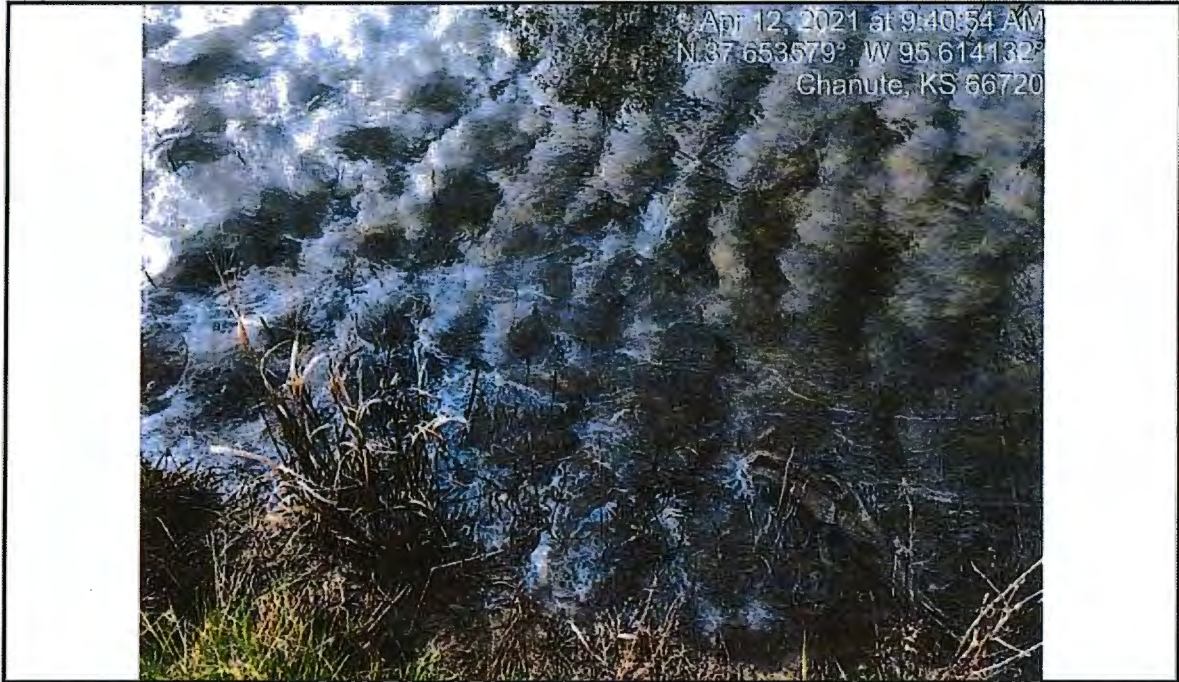
Operator: Viva International, Inc.	KLN: 5556
Lease: North Campbell	Legal: 35-27-16E SE SE NE
County: Wilson	PIC ID#: 12
Subject: Spill	PIC Orientation: South
FSL: 2921	Latitude: 37.65367
FEL: 128	Longitude: -095.61513
API#: NA	
Date: 4/12/2021	Time: 9:40 AM
Staff: Dallas Logan

Additional Information: This photo shows a small oil sheen or rainbow of oil along the pond edge. You can also see that the oil has stained the vegetation along the bank.

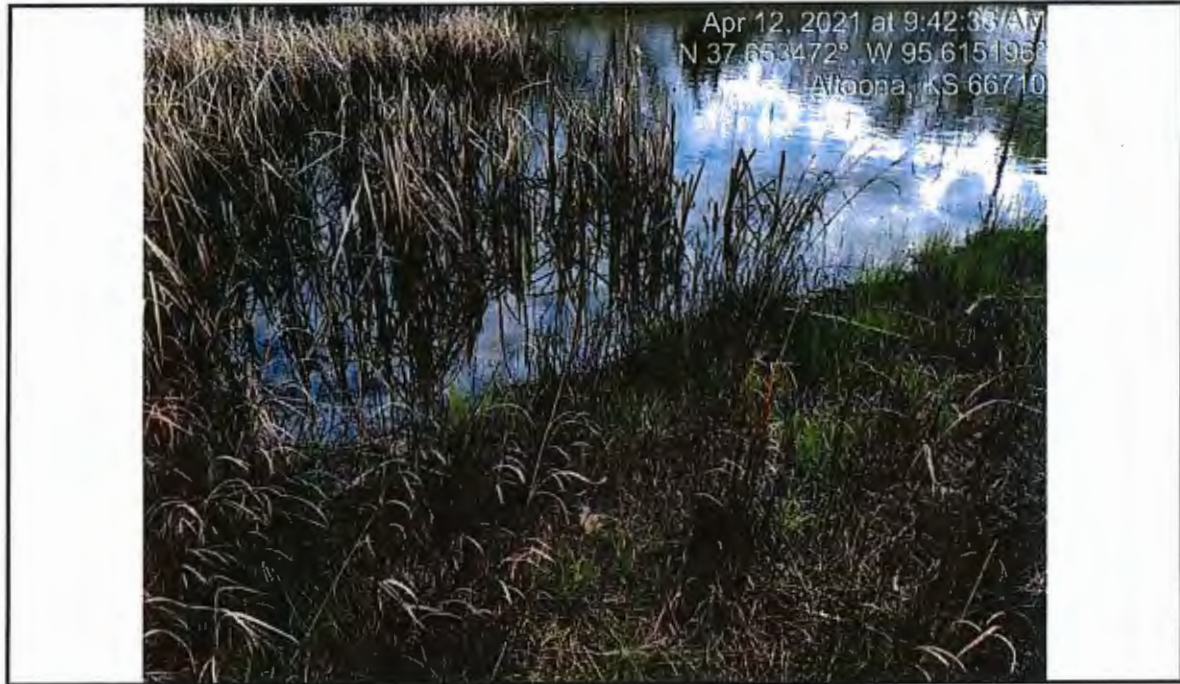
Operator: Viva International, Inc.	KLN: 5556
Lease: North Campbell	Legal: 35-27-16E SE SE NE
County: Wilson	PIC ID#: 13
Subject: Spill	PIC Orientation: North
FSL: NA	Latitude: NA
FEL: NA	Longitude: NA
API#: NA	
Date: 4/12/2021	Time: 9:42 AM
Staff: Dallas Logan

Additional Information: This photo shows a small oil sheen or rainbow of oil along the pond edge. You can also see that the oil has stained the vegetation along the bank, and in the pond.
