NOTICE OF PENALTY ASSESSMENT

20-CONS-3182-CPEN

KCC DISTRICT III OFFICE FIELD REPORT PHOTO ID FORM

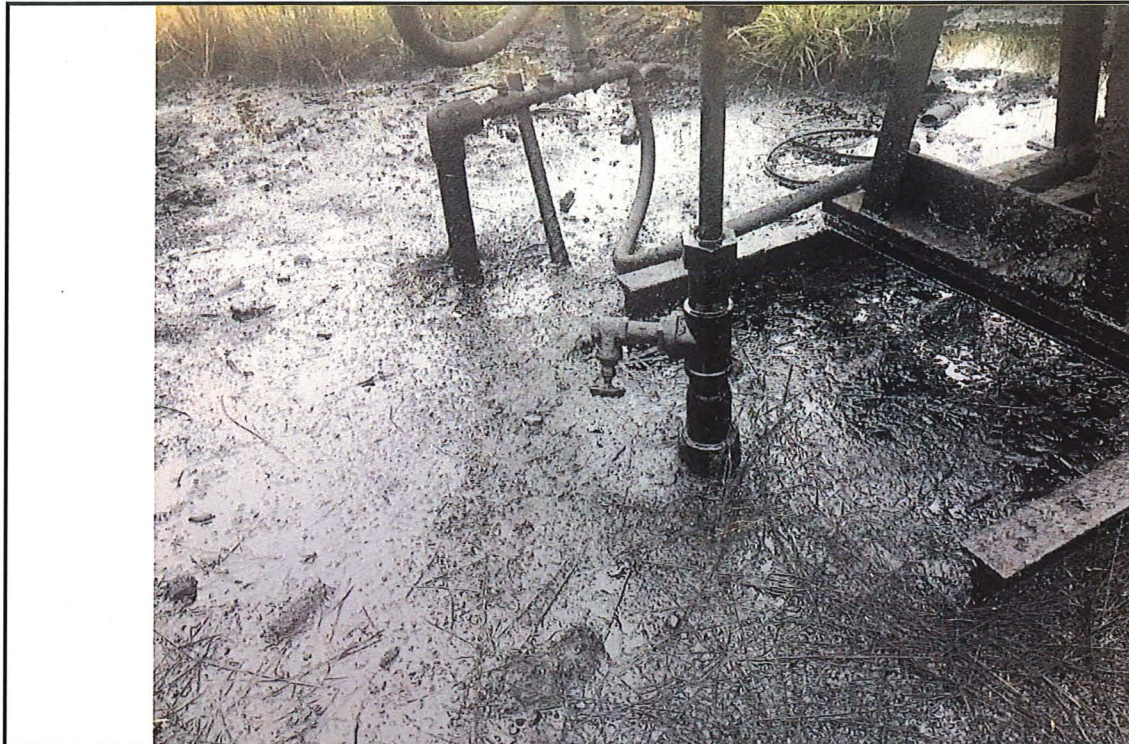
Oil is leaking around the stuffing box approximately 2 barrels spilled.

Additional Information: This is a picture taken at well location #4-87. The well is leaking up through the stuffing box and spilling on the ground. The spill area location has been outlined using GPS waypoints.

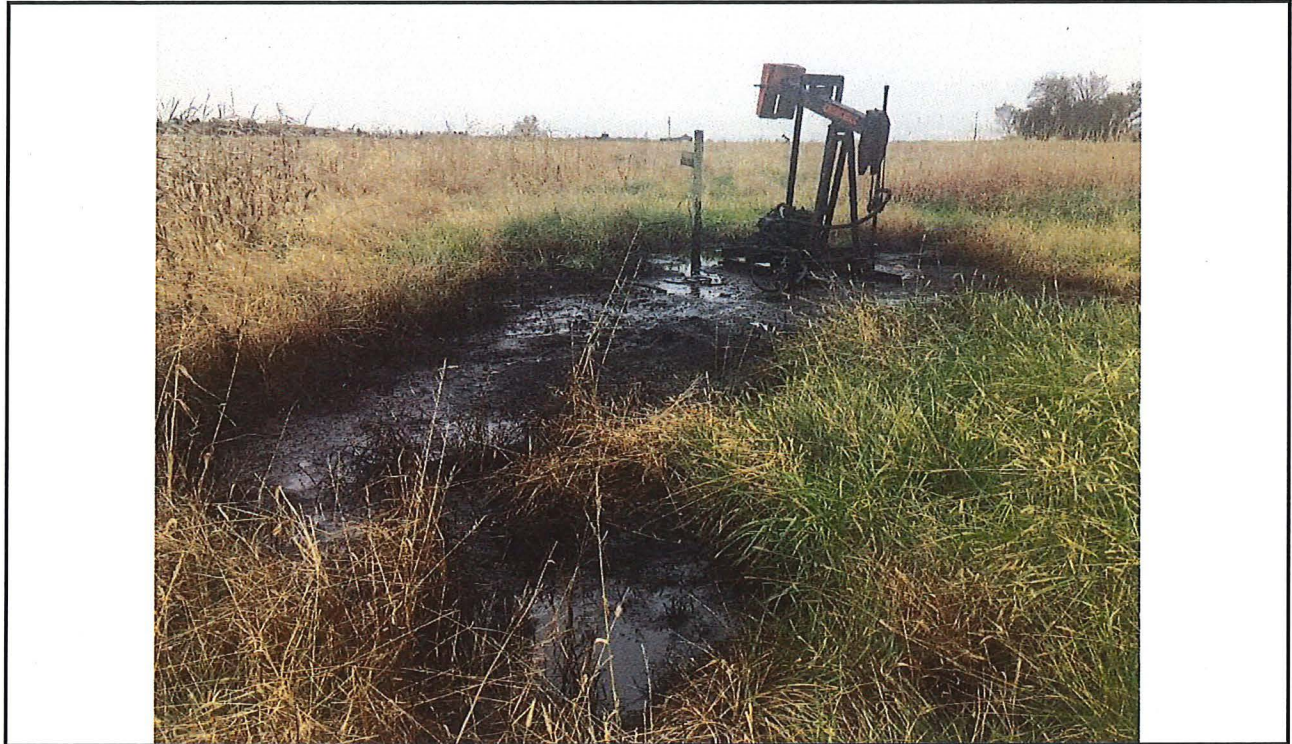
Operator: Viva International, Inc	KLN: 5556
Lease: Wright	Legal: 18-22-22E
County: Linn	PIC ID#: 4-87 Pic 2
Subject: Spill at well number #4-87	PIC Orientation:
FSL: 593	Latitude: 38.12637
FEL: 2444	Longitude: -095.03374
API#: 15-107-22844-00-00	
Date: 10/28/2019	Time: 2:20 PM
Staff: Keith Carswell

Additional Information: This is a picture taken at well location #4-87. The well is leaking up through the stuffing box and spilling on the ground. The spill area location has been outlined using GPS waypoints.

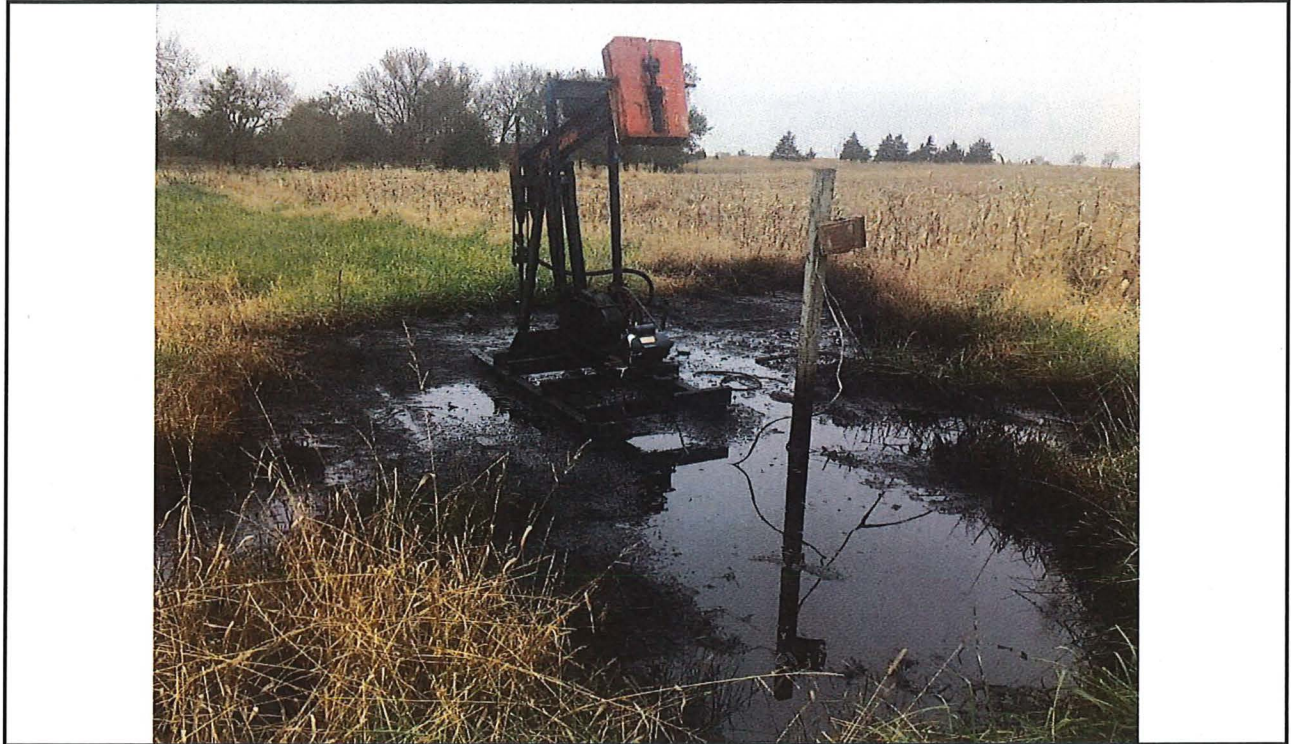
Operator: Viva International, Inc	KLN: 5556
Lease: Wright	Legal: 18-22-22E
County: Linn	PIC ID#: 4-87 Pic 3
Subject: Spill at well number #4-87	PIC Orientation:
FSL: 593	Latitude: 38.12637
FEL: 2444	Longitude: -095.03374
API#: 15-107-22844-00-00	
Date: 10/28/2019	Time: 2:20 PM
Staff: Keith Carswell

Additional Information: This is a picture taken at well location #4-87. The well is leaking up through the stuffing box and spilling on the ground. The spill area location has been outlined using GPS waypoints.

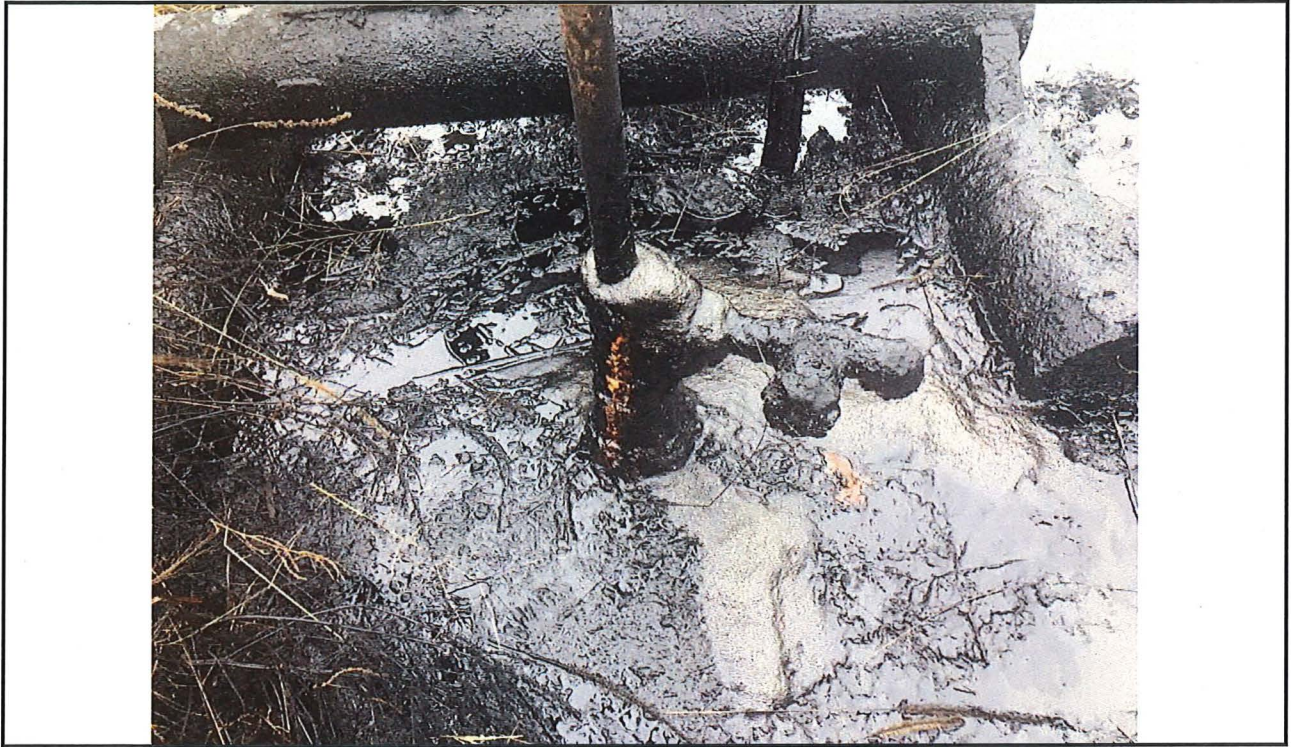
Operator: Viva International, Inc	KLN: 5556
Lease: Wright	Legal: 18-22-22E
County: Linn	PIC ID#: 7-87 Pic 1
Subject: Spill at well number #7-87	PIC Orientation:
FSL: 1482	Latitude: 38.12881
FEL: 2409	Longitude: -095.03369
API#: 15-107-22867-00-00	
Date: 10/28/2019	Time: 2:33 PM
Staff: Keith Carswell

The well does not have a stuffing box, oil is leaking between the 1" pipe and the casing. About 2 barrels of oil spilled.

Additional Information: This is a picture taken at well location #7-87. The well is not equipped with a stuffing box. The well is leaking crude and spilling on the ground. The spill area location has been outlined using GPS waypoints.

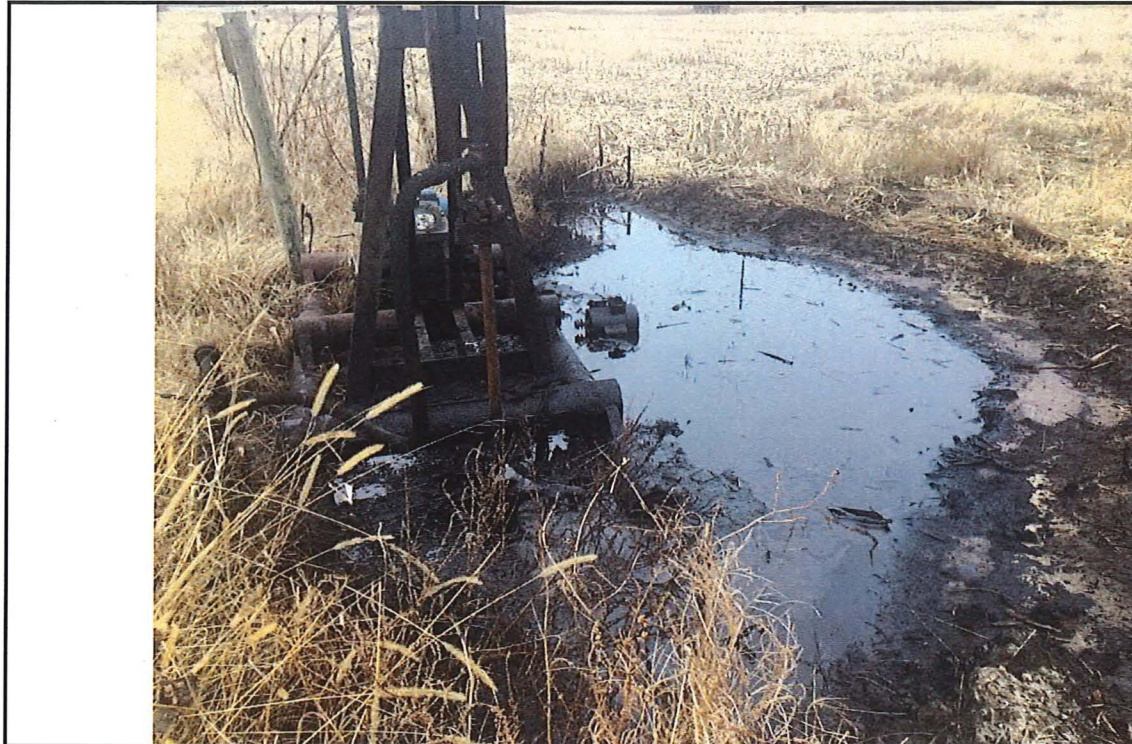
Additional Information: This is a picture taken at well location #7-87. The well is not equipped with a stuffing box. The well is leaking crude and spilling on the ground. The spill area location has been outlined using GPS waypoints.

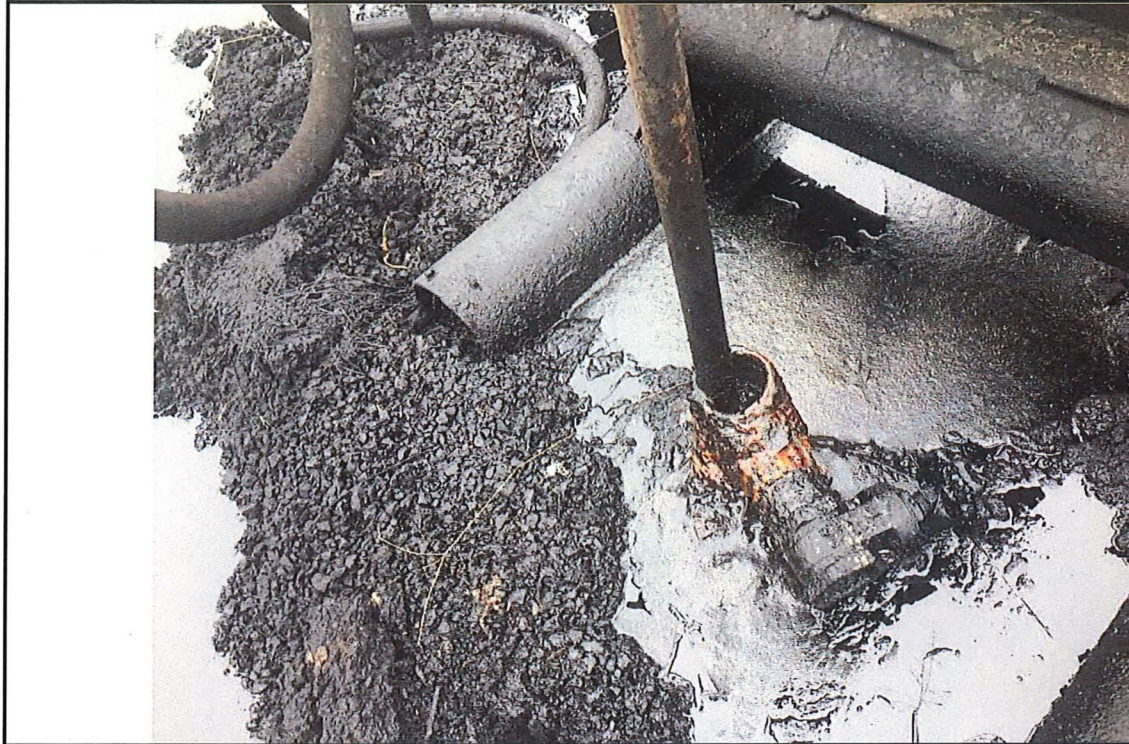
Well #9-87 does not have a stuffing box, oil is leaking between the 1" pipe and the casing. About 2 barrels of oil spilled.

Additional Information: This is a picture taken at well location #9-87. The well is not equipped with a stuffing box. The well is bubbling and leaking crude and spilling on the ground. The spill area location has been outlined using GPS waypoints. The landowner had tried to dam up the area around the well to keep the spill from spreading but it was leaching out through the dam.

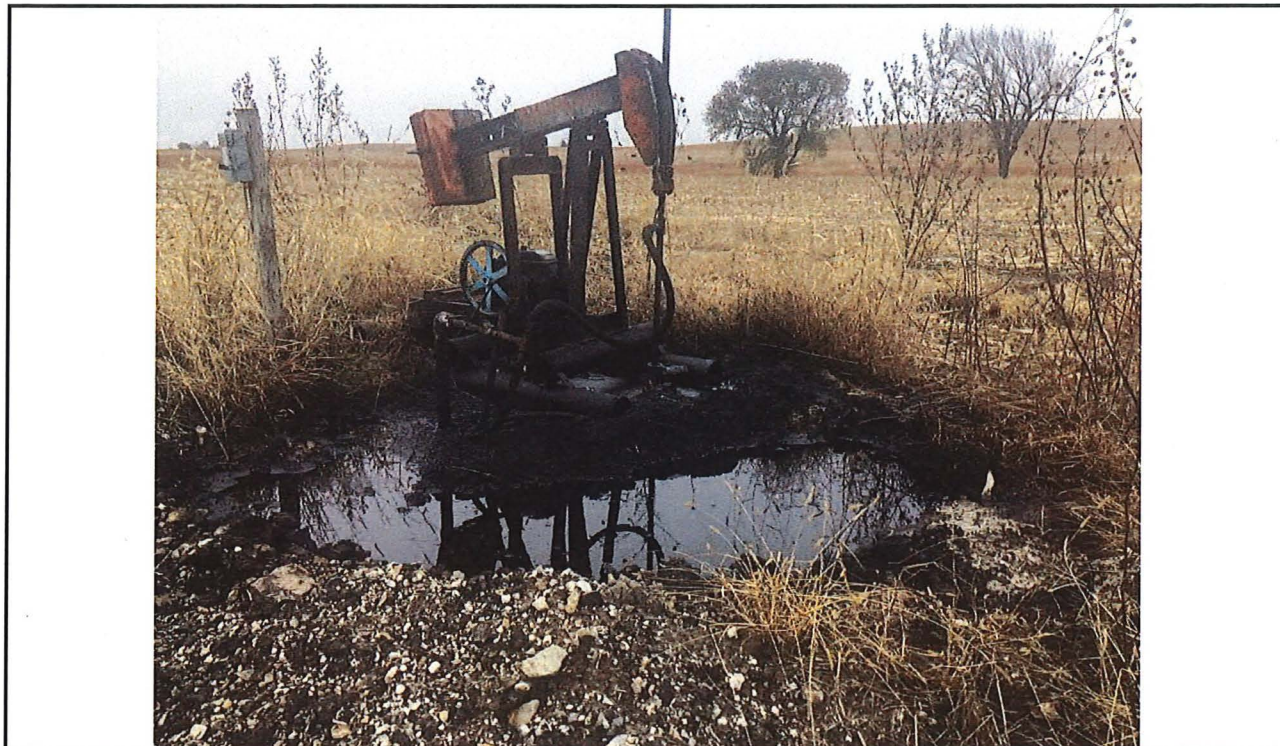
Additional Information: This is a picture taken at well location #9-87. The well is not equipped with a stuffing box. The well is bubbling and leaking crude and spilling on the ground. The spill area location has been outlined using GPS waypoints. The landowner had tried to dam up the area around the well to keep the spill from spreading but it was leaching out through the dam.

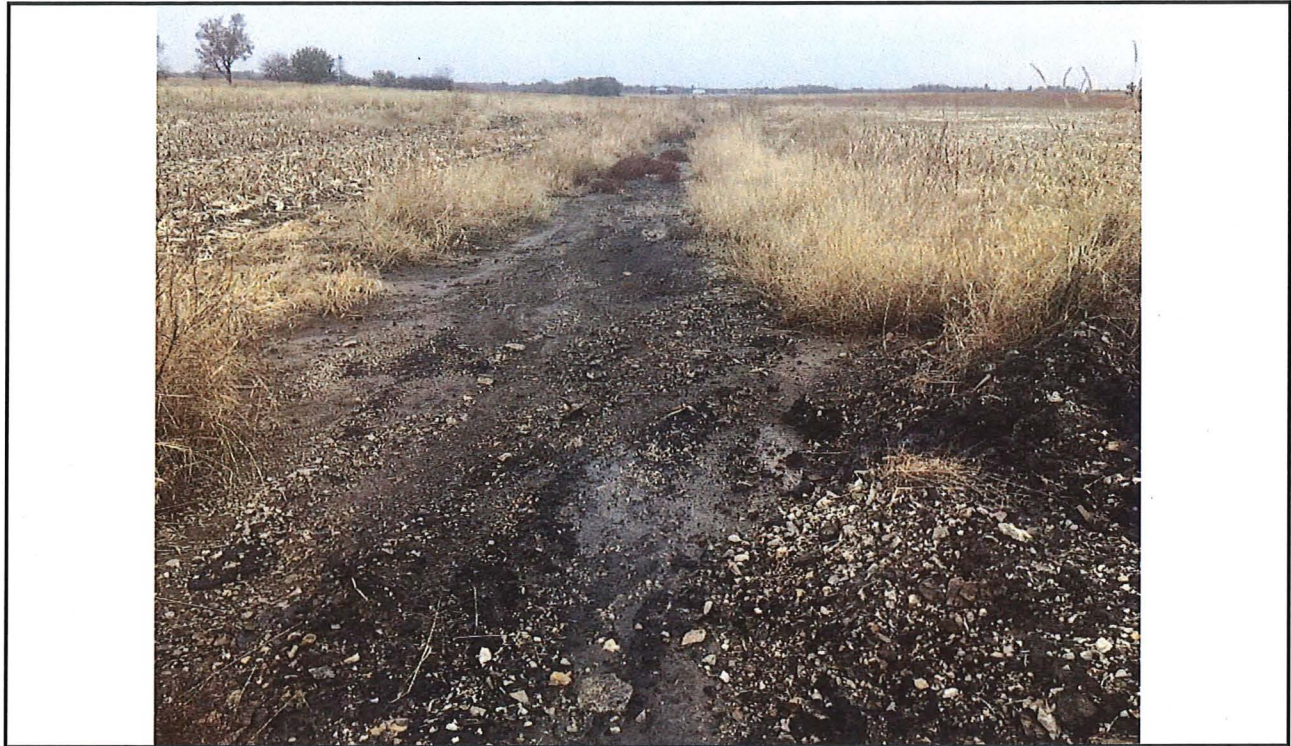
Operator: Viva International, Inc	KLN: 5556
Lease: Wright	Legal: 18-22-22E
County: Linn	PIC ID#: 9-87 Pic 3
Subject: Spill at well number #9-87	PIC Orientation:
FSL: 1923	Latitude: 38.13002
FEL: 2406	Longitude: -095.03364
API#: 15-107-22866-00-00	
Date: 10/28/2019	Time: 2:44 PM
Staff: Keith Carswell

Additional Information: This is a picture taken at well location #9-87. The well is not equipped with a stuffing box. The well is bubbling and leaking crude and spilling on the ground. The spill area location has been outlined using GPS waypoints. The landowner had tried to dam up the area around the well to keep the spill from spreading but it was leaching out through the dam.

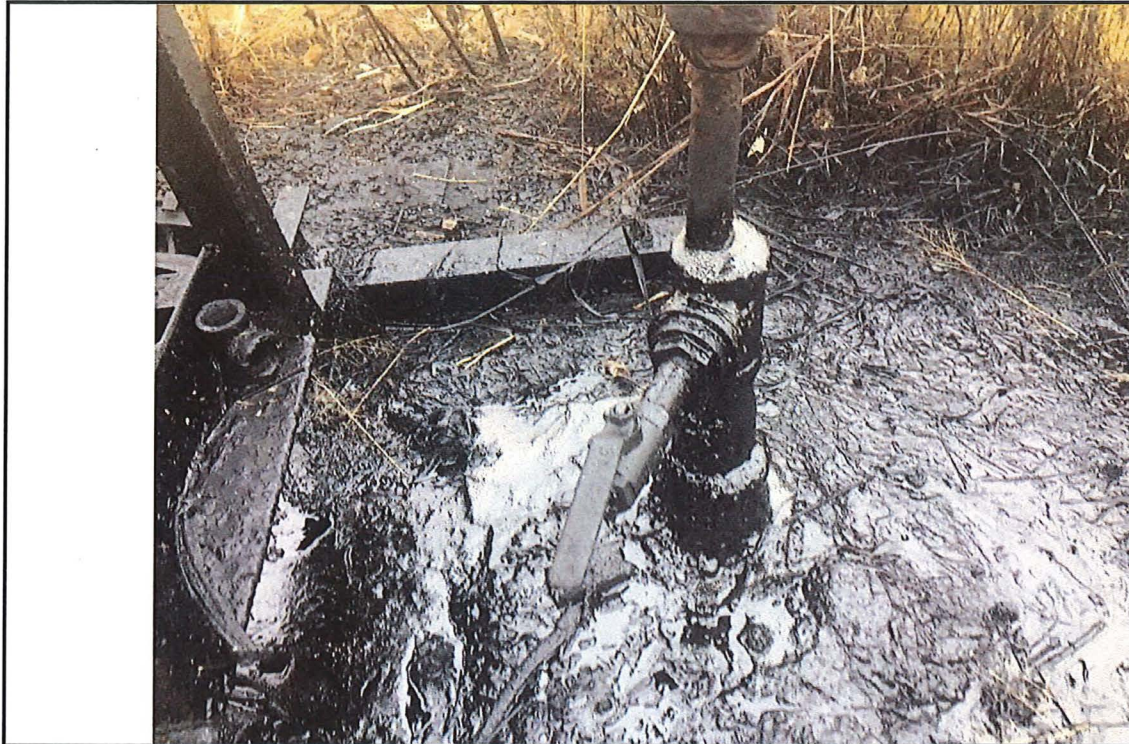
Well #12-87 does not have a stuffing box to shut in the well, oil is leaking between the 1" pipe and the casing, about 2 barrel oil spilled from the well.

Additional Information: This is a picture taken at well location #12-87. The well is not equipped with a stuffing box. The well is bubbling and leaking crude and spilling on the ground. The spill area location has been outlined using GPS waypoints.

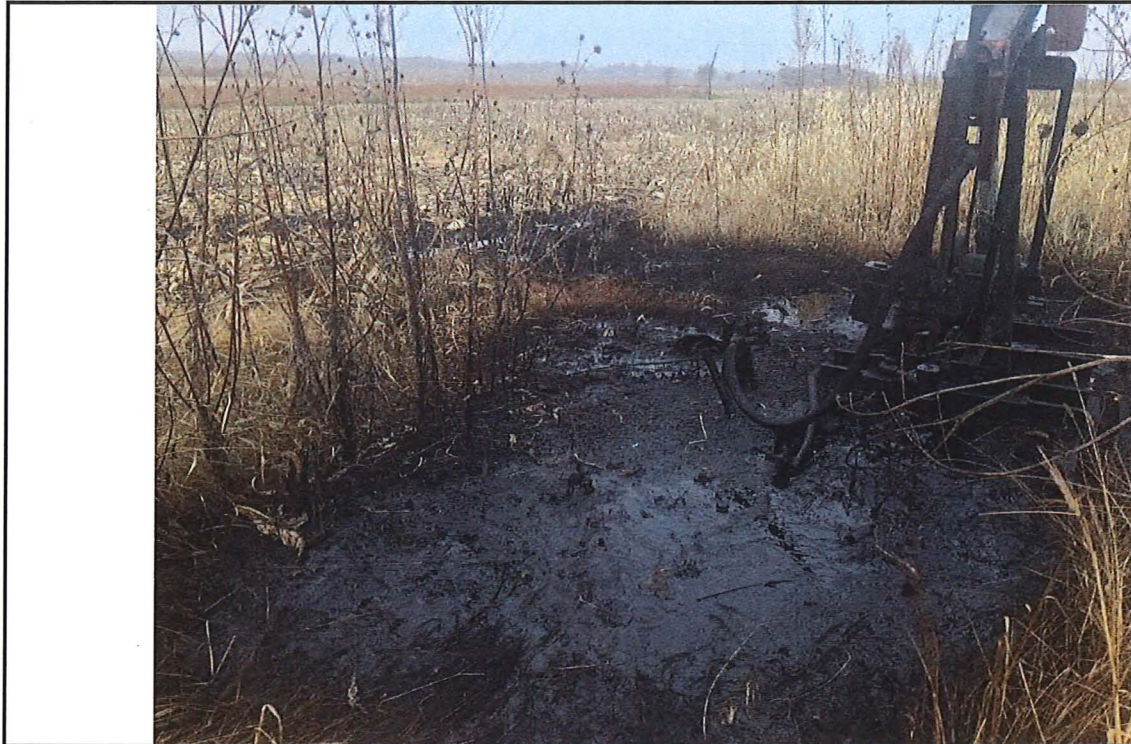
Additional Information: This is a picture taken at well location #12-87. The well is not equipped with a stuffing box. The well is bubbling and leaking crude and spilling on the ground. The spill area location has been outlined using GPS waypoints.

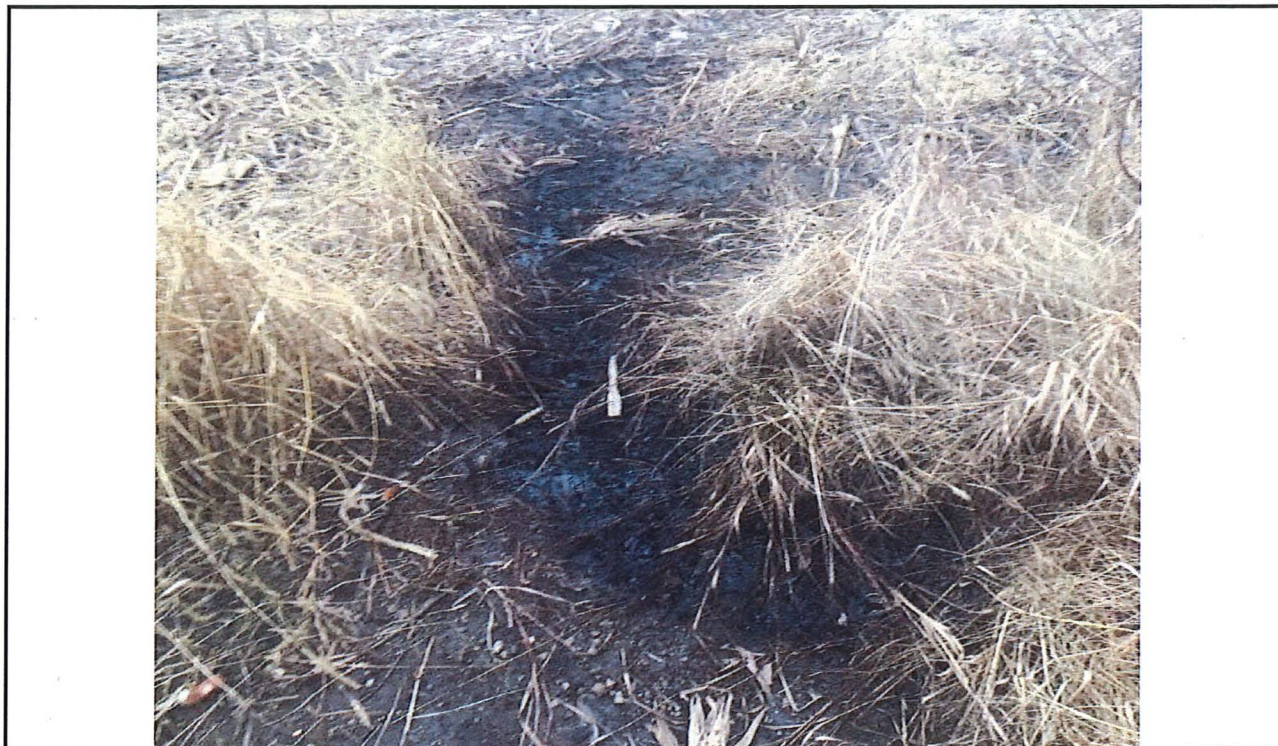
Additional Information: This is a picture taken at well location #12-87. The well is not equipped with a stuffing box. The well is bubbling and leaking crude and spilling on the ground. The spill area location has been outlined using GPS waypoints.

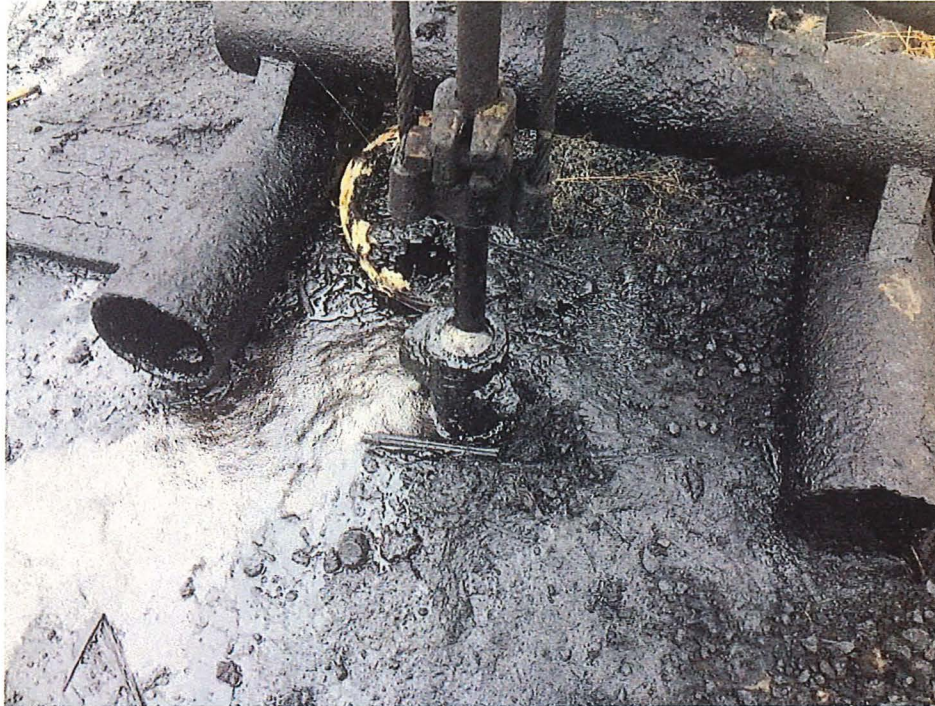
Additional Information: This is a picture taken at well location #20-89. The well is not equipped with a stuffing box. The well is bubbling and leaking crude and spilling on the ground. The spill area location has been outlined using GPS waypoints. The landowner had tried to dam up the area around the well to keep the spill from spreading but it was leaching out through the dam.

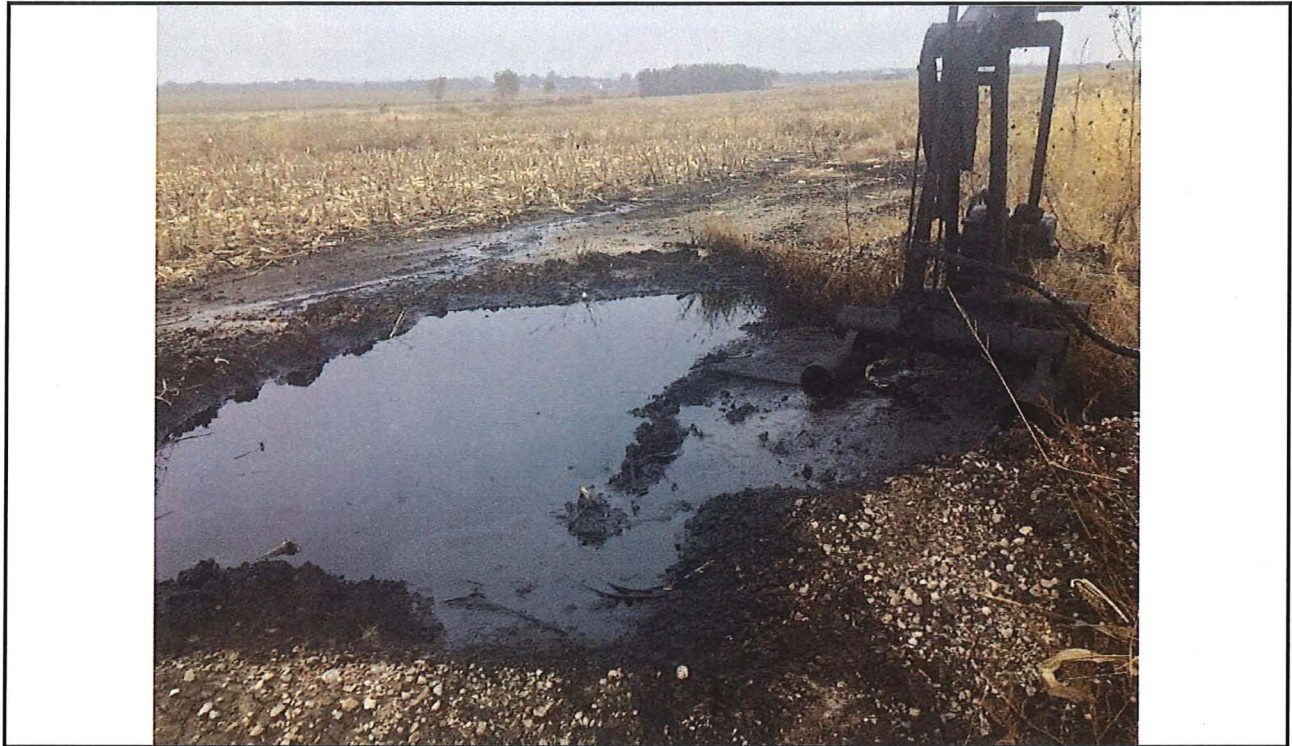
Additional Information: This is a picture taken at well location #20-89. The well is not equipped with a stuffing box. The well is bubbling and leaking crude and spilling on the ground. The spill area location has been outlined using GPS waypoints. The landowner had tried to dam up the area around the well to keep the spill from spreading but it was leaching out through the dam.

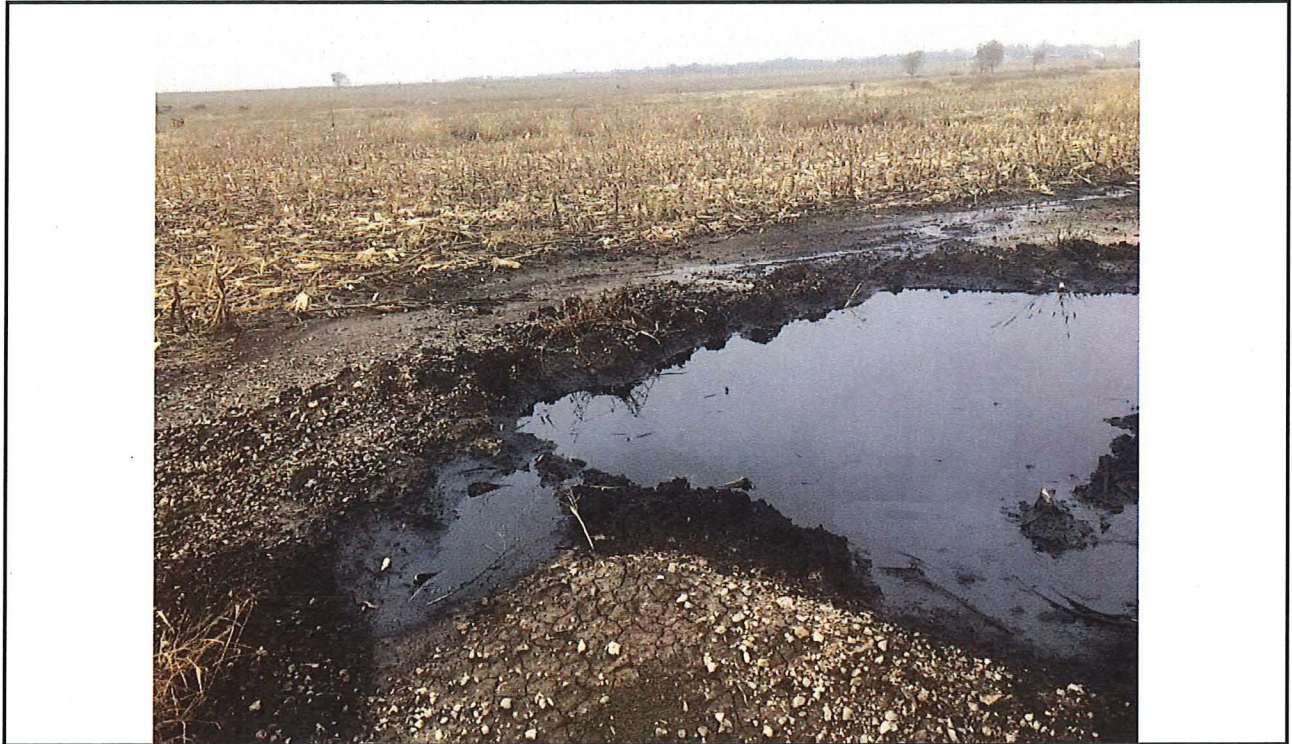
Additional Information: This is a picture taken at well location #20-89. The well is not equipped with a stuffing box. The well is bubbling and leaking crude and spilling on the ground. The spill area location has been outlined using GPS waypoints. The landowner had tried to dam up the area around the well to keep the spill from spreading but it was leaching out through the dam.

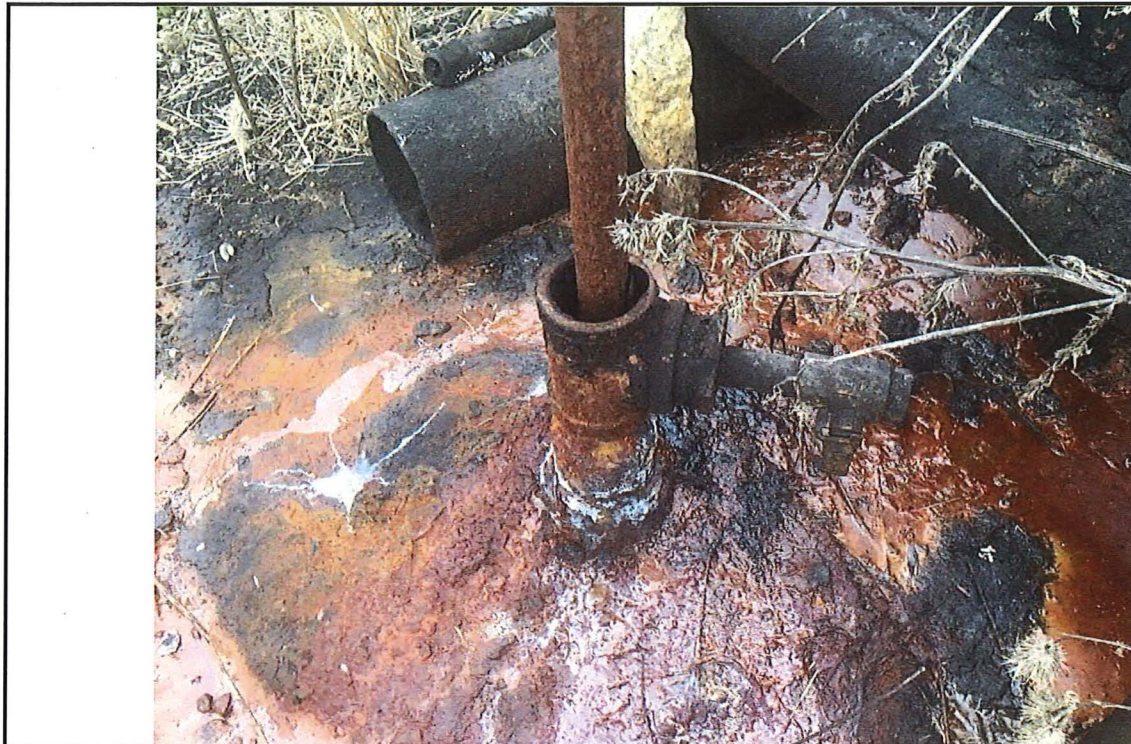
Additional Information: This is a picture taken at well location #28-89. The well is not equipped with a stuffing box. This well wasn't currently leaking at time of inspection but shows signs of leaking in the past with the discoloration of the ground and the kill area outlined with GPS waypoints.

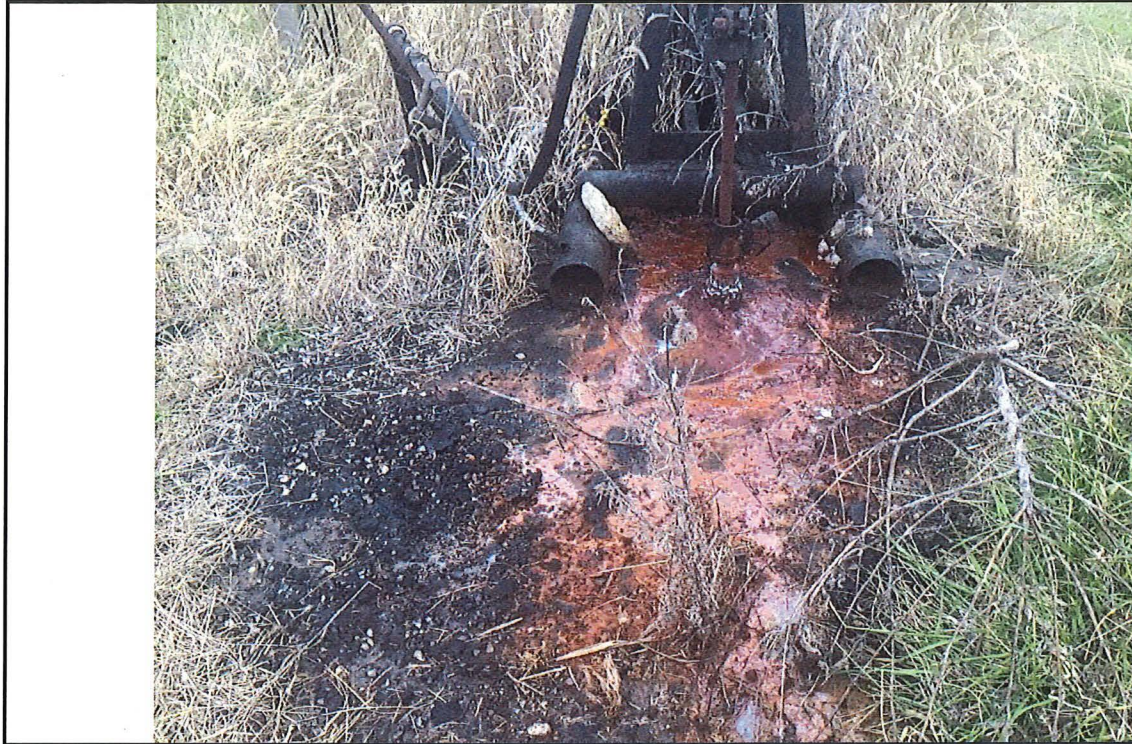
Additional Information: This is a picture taken at well location #28-89. The well is not equipped with a stuffing box. This well wasn't currently leaking at time of inspection but shows signs of leaking in the past with the discoloration of the ground and the kill area outlined with GPS waypoints.

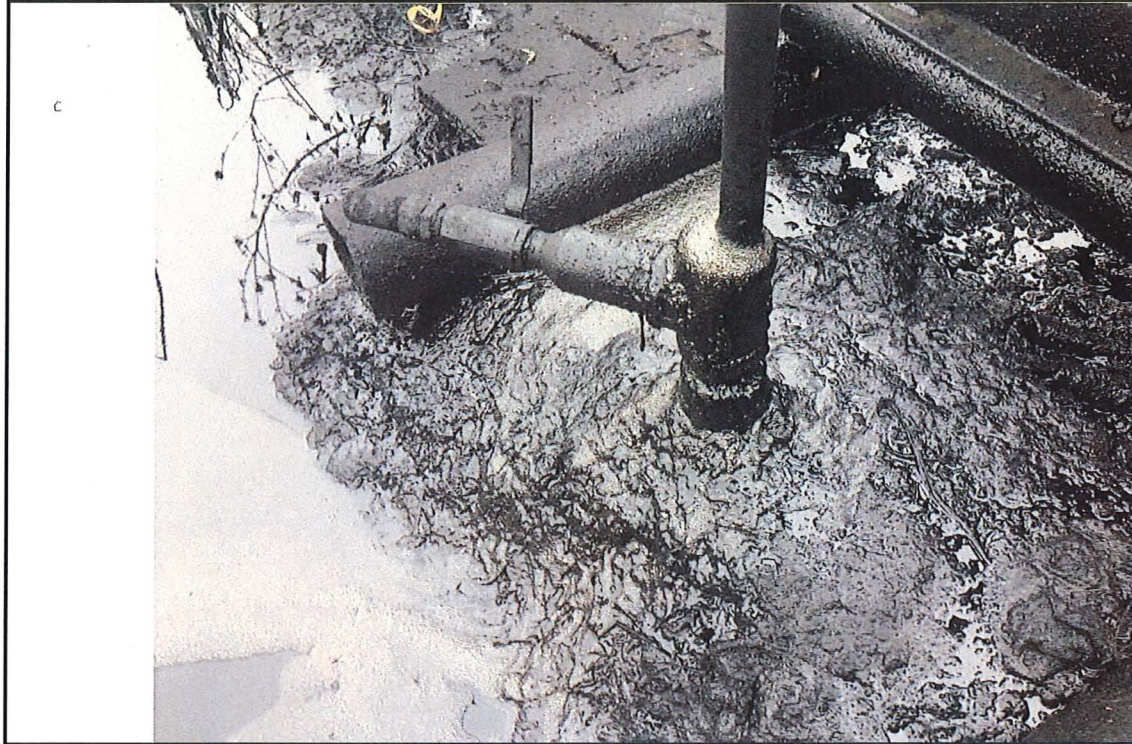
Well #29-89 does not have a stuffing box and is leaking oil between the 1" and the casing, about 2 barrel oil spilled on ground.

Additional Information: This is a picture taken at well location #29-89. Well is not equipped with a stuffing box. The well is bubbling and leaking crude and spilling on the ground. The spill area location has been outlined using GPS waypoints. The landowner had tried to dam up the area around the well to keep the spill from spreading but it was leaching out through the dam and has ran over the dam in the past.

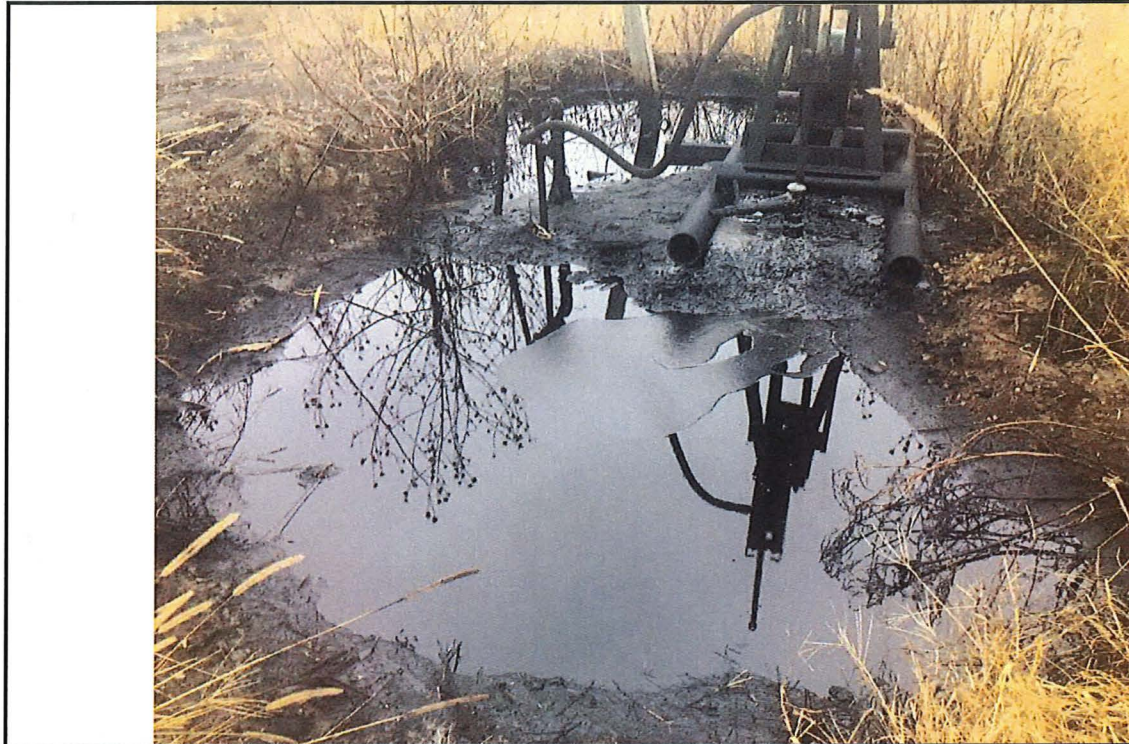
Additional Information: This is a picture taken at well location #29-89. Well is not equipped with a stuffing box. The well is bubbling and leaking crude and spilling on the ground. The spill area location has been outlined using GPS waypoints. The landowner had tried to dam up the area around the well to keep the spill from spreading but it was leaching out through the dam and has ran over the dam in the past.

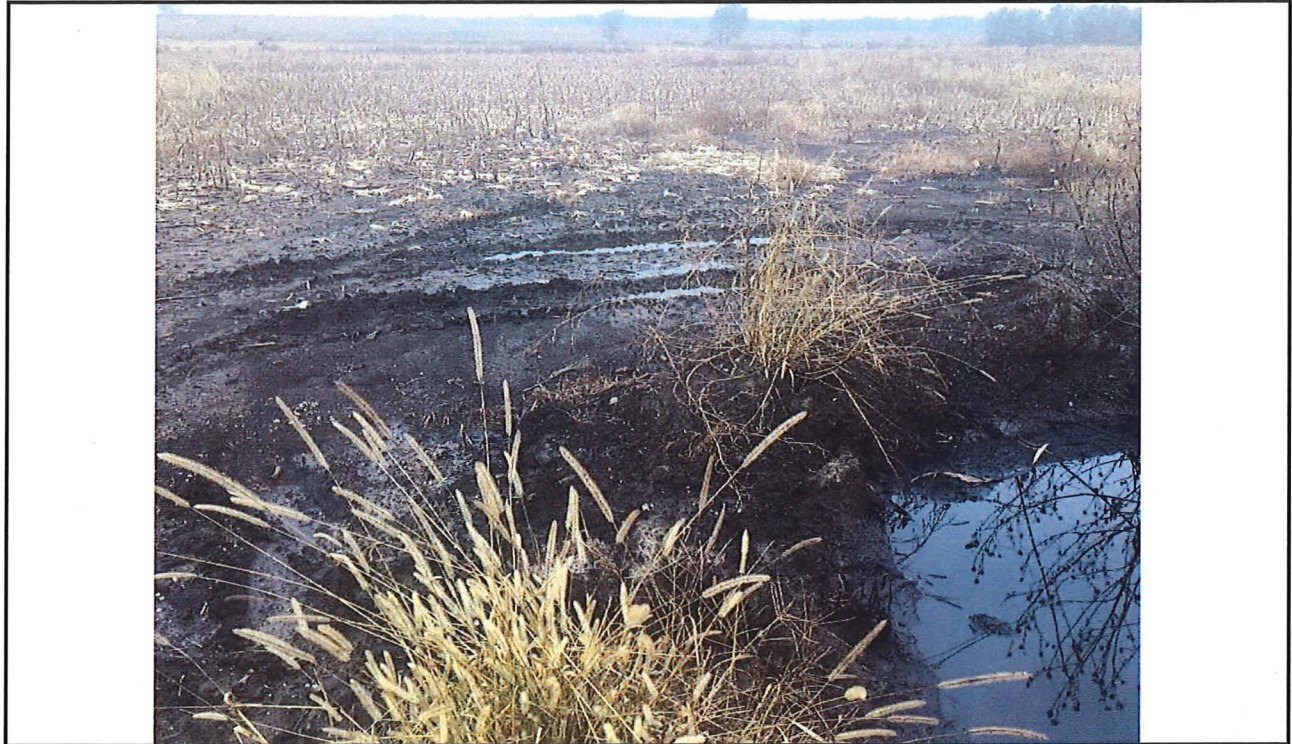
Additional Information: This is a picture taken at well location #29-89. Well is not equipped with a stuffing box. The well is bubbling and leaking crude and spilling on the ground. The spill area location has been outlined using GPS waypoints. The landowner had tried to dam up the area around the well to keep the spill from spreading but it was leaching out through the dam and has ran over the dam in the past.

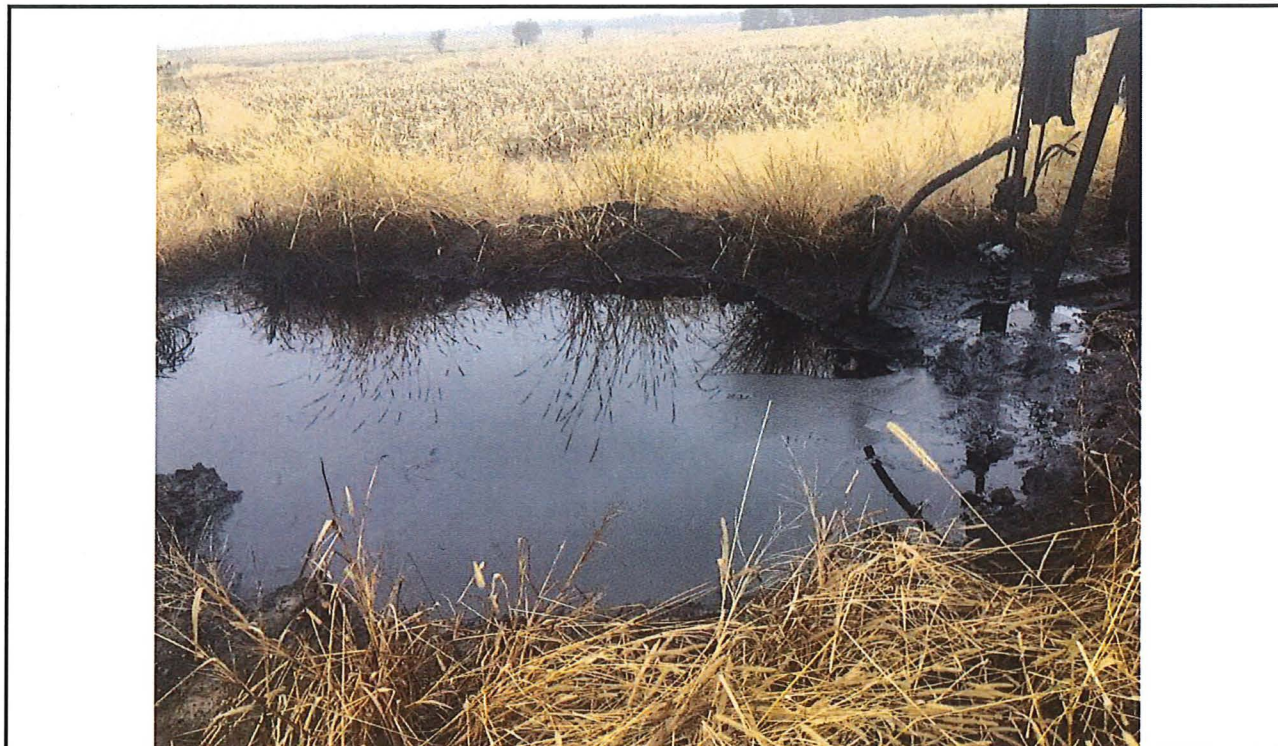
Additional Information: This is a picture taken at well location #40-90. Well is not equipped with a stuffing box. The well is bubbling and leaking crude and spilling on the ground. The spill area location has been outlined using GPS waypoints. The landowner had tried to dam up the area around the well to keep the spill from spreading but it is currently running over the dam.

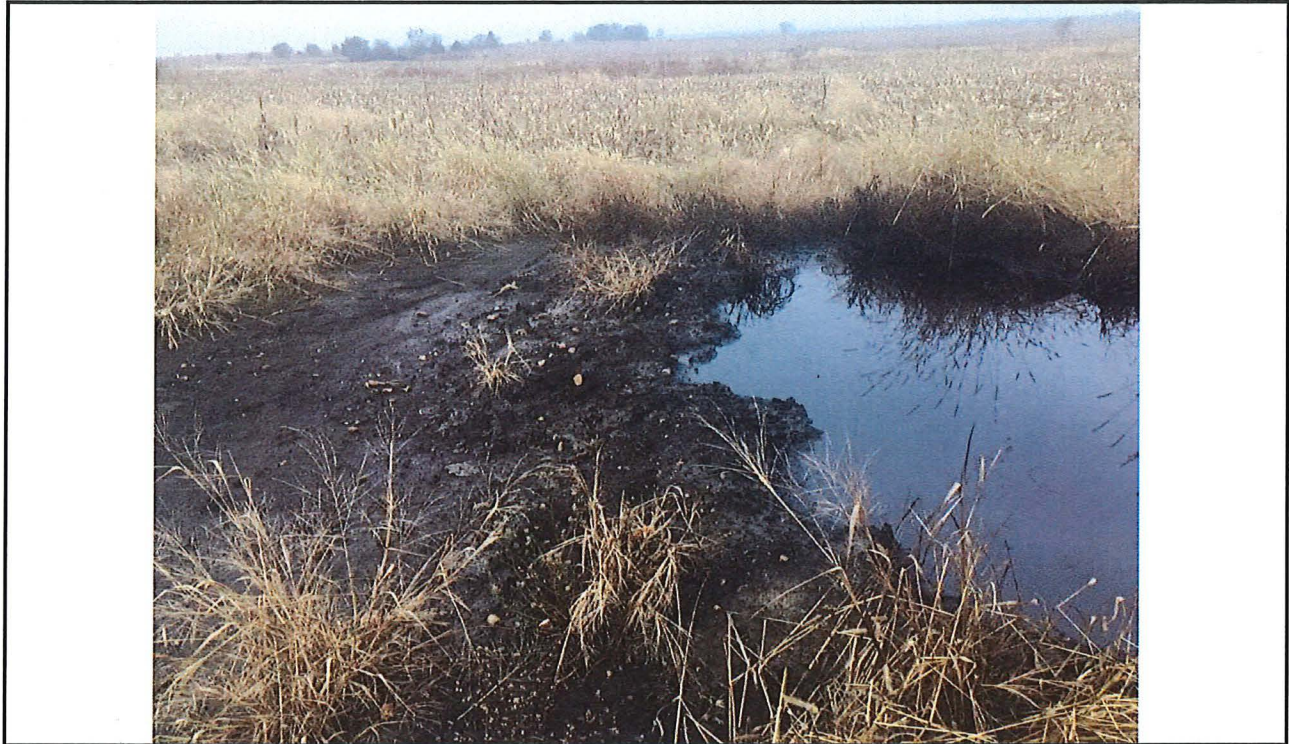
Additional Information: This is a picture taken at well location #40-90. Well is not equipped with a stuffing box. The well is bubbling and leaking crude and spilling on the ground. The spill area location has been outlined using GPS waypoints. The landowner had tried to dam up the area around the well to keep the spill from spreading but it is currently running over the dam.

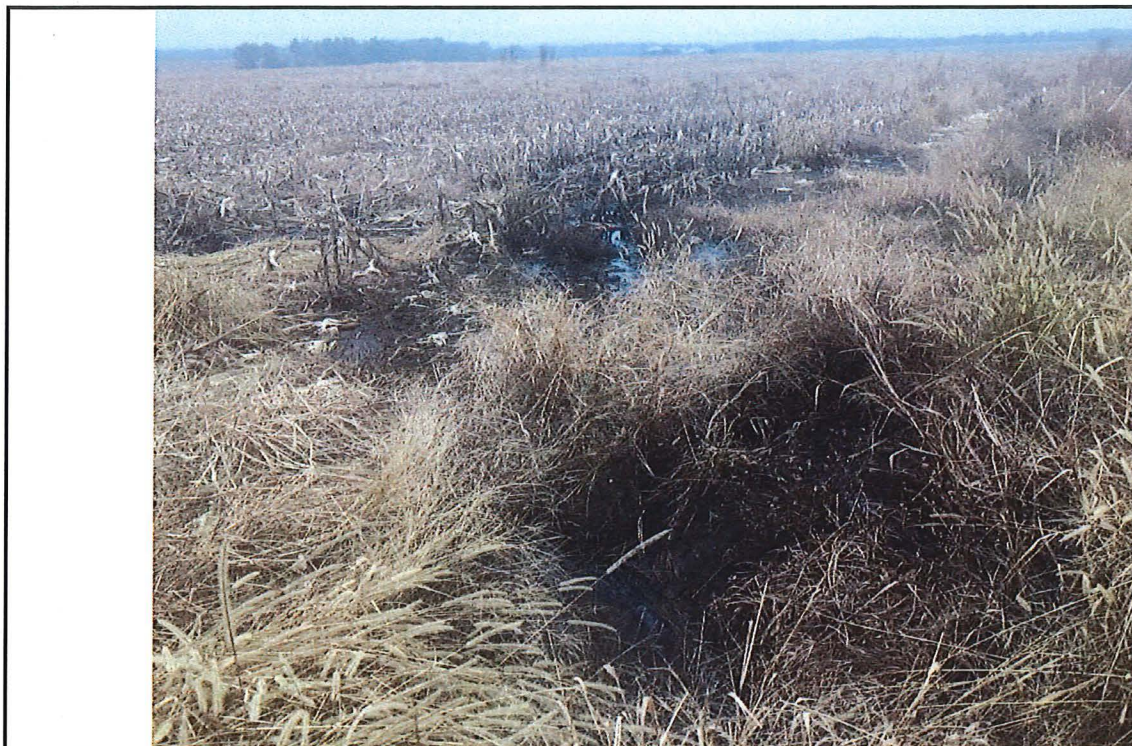
Additional Information: This is a picture taken at well location #40-90. Well is not equipped with a stuffing box. The well is bubbling and leaking crude and spilling on the ground. The spill area location has been outlined using GPS waypoints. The landowner had tried to dam up the area around the well to keep the spill from spreading but it is currently running over the dam.

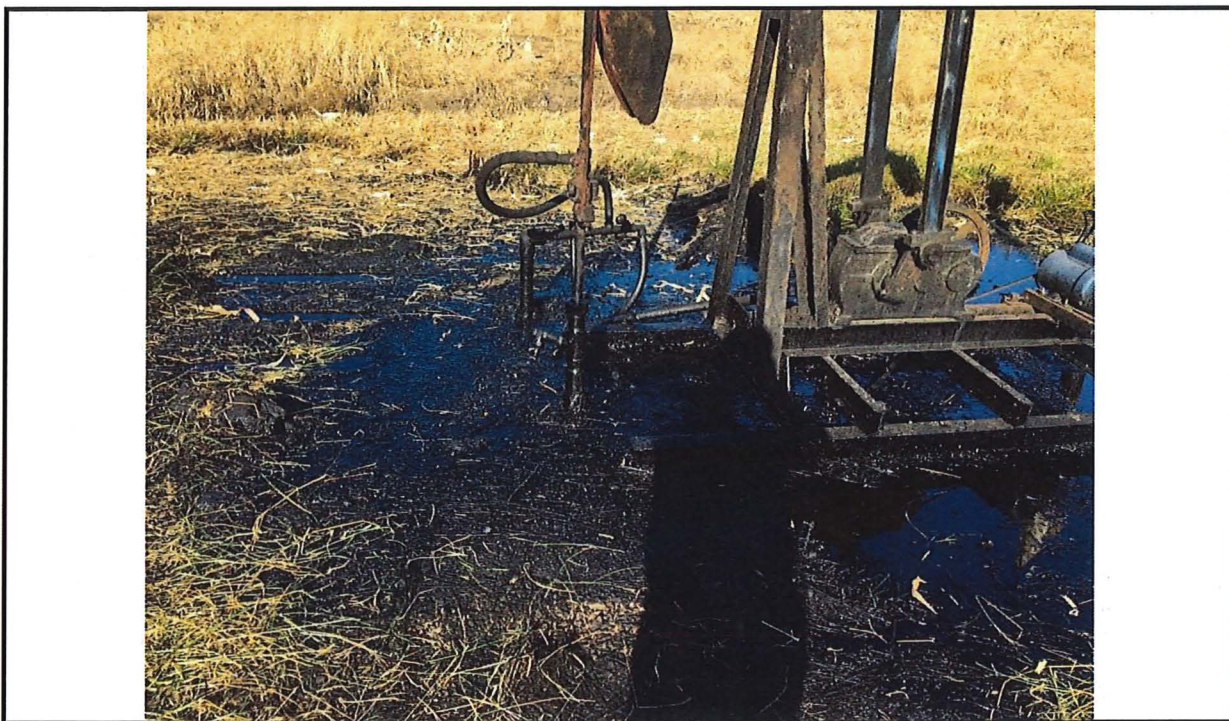
Operator: Viva International, Inc	KLN: 5556
Lease: Wright	Legal: 18-22-22E
County: Linn	PIC ID#: 4-87
Subject: Spill at well number #4-87	PIC Orientation:
FSL: 593	Latitude: 38.12637
FEL: 2444	Longitude: -095.03374
API#: 15-107-22844-00-00	
Date: 11/07/2019	Time: 2:40 PM
Staff: Keith Carswell

Additional Information: This is a picture taken at well location #4-87. The well is leaking up through the stuffing box and spilling on the ground. The spill area location has been outlined using GPS waypoints.
