NOTICE OF PENALTY ASSESSMENT

20-CONS-3182-CPEN

KCC DISTRICT III OFFICE FIELD REPORT PHOTO ID FORM

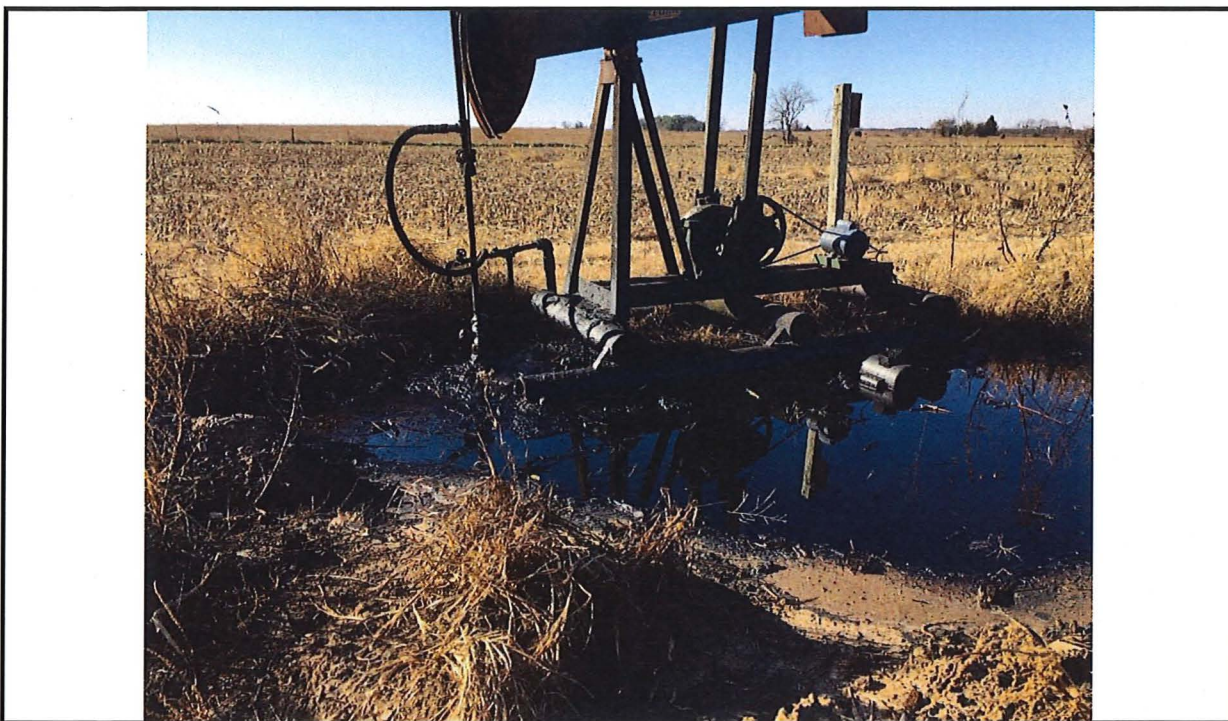
Operator: Viva International, Inc	KLN: 5556
Lease: Wright	Legal: 18-22-22E
County: Linn	PIC ID#: 7-87
Subject: Spill at well number #7-87	PIC Orientation:
FSL: 1482	Latitude: 38.12881
FEL: 2409	Longitude: -095.03369
API#: 15-107-22867-00-00	
Date: 11/07/2019	Time: 2:46 PM
Staff: Keith Carswell

Additional Information: This is a picture taken at well location #7-87. The well is not equipped with a stuffing box. The well is leaking crude and spilling on the ground. The spill area location has been outlined using GPS waypoints.

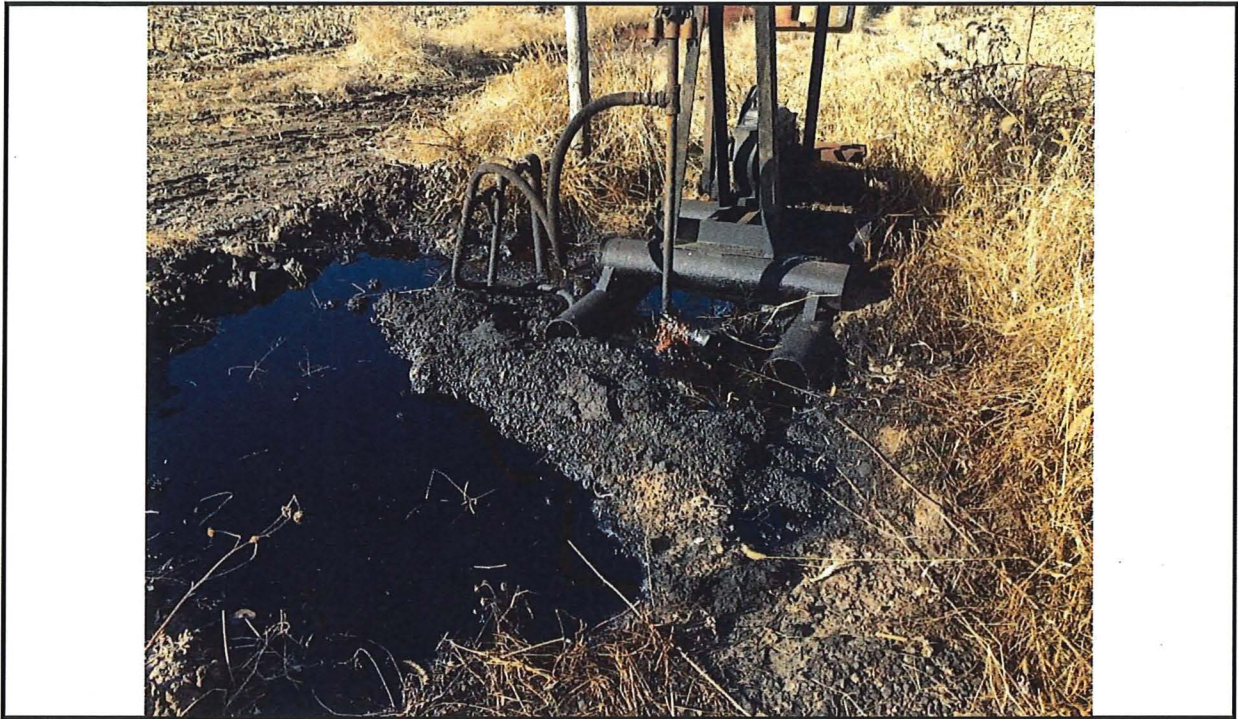
Operator: Viva International, Inc	KLN: 5556
Lease: Wright	Legal: 18-22-22E
County: Linn	PIC ID#: 9-87
Subject: Spill at well number #9-87	PIC Orientation:
FSL: 1923	Latitude: 38.13002
FEL: 2406	Longitude: -095.03364
API#: 15-107-22866-00-00	
Date: 11/07/2019	Time: 2:49 PM
Staff: Keith Carswell

Additional Information: This is a picture taken at well location #9-87. The well is not equipped with a stuffing box. The well is bubbling and leaking crude and spilling on the ground. The spill area location has been outlined using GPS waypoints. The landowner had tried to dam up the area around the well to keep the spill from spreading but it was leaching out through the dam.

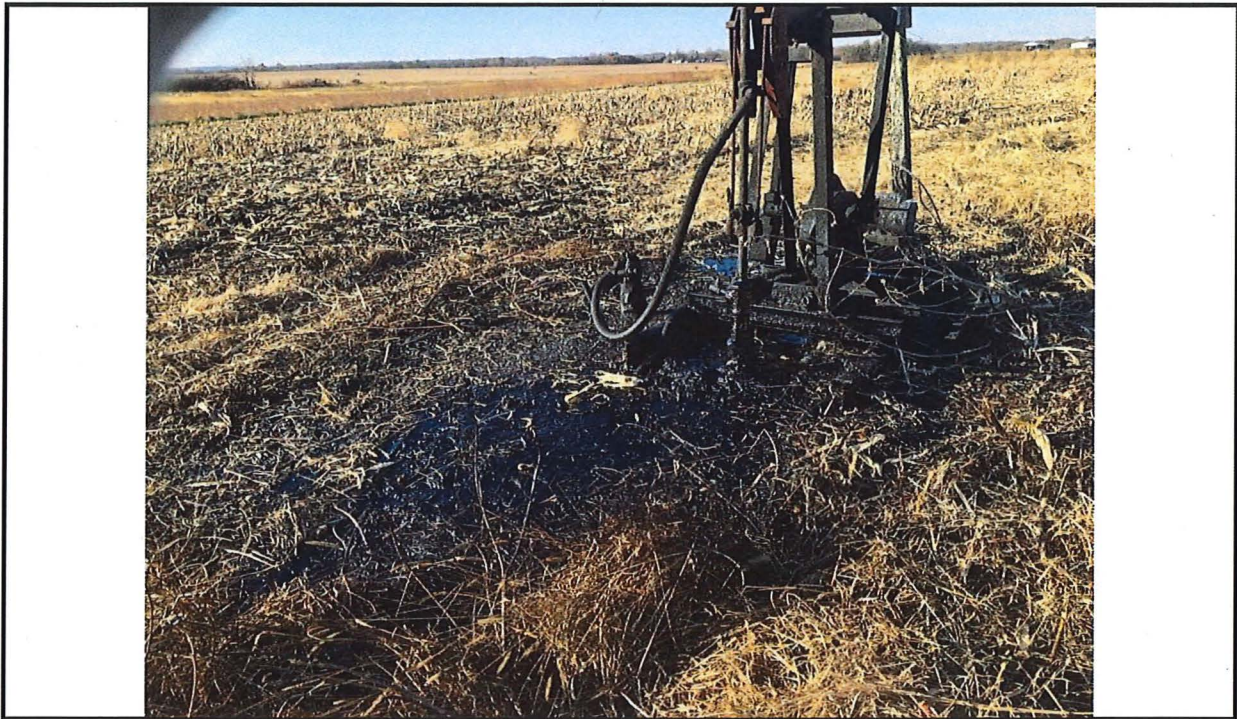
KCC DISTRICT III OFFICE FIELD REPORT PHOTO ID FORM

Operator: Viva International, Inc	KLN: 5556
Lease: Wright	Legal: 18-22-22E
County: Linn	PIC ID#: 12-87
Subject: Spill at well number #12-87	PIC Orientation:
FSL: 2375	Latitude: 38.13125
FEL: 1984	Longitude: -095.03218
API#: 15-107-22905-00-00	
Date: 11/07/2019	Time: 3:17 PM
Staff: Keith Carswell

Additional Information: This is a picture taken at well location #12-87. The well is not equipped with a stuffing box. The well is bubbling and leaking crude and spilling on the ground. The spill area location has been outlined using GPS waypoints.

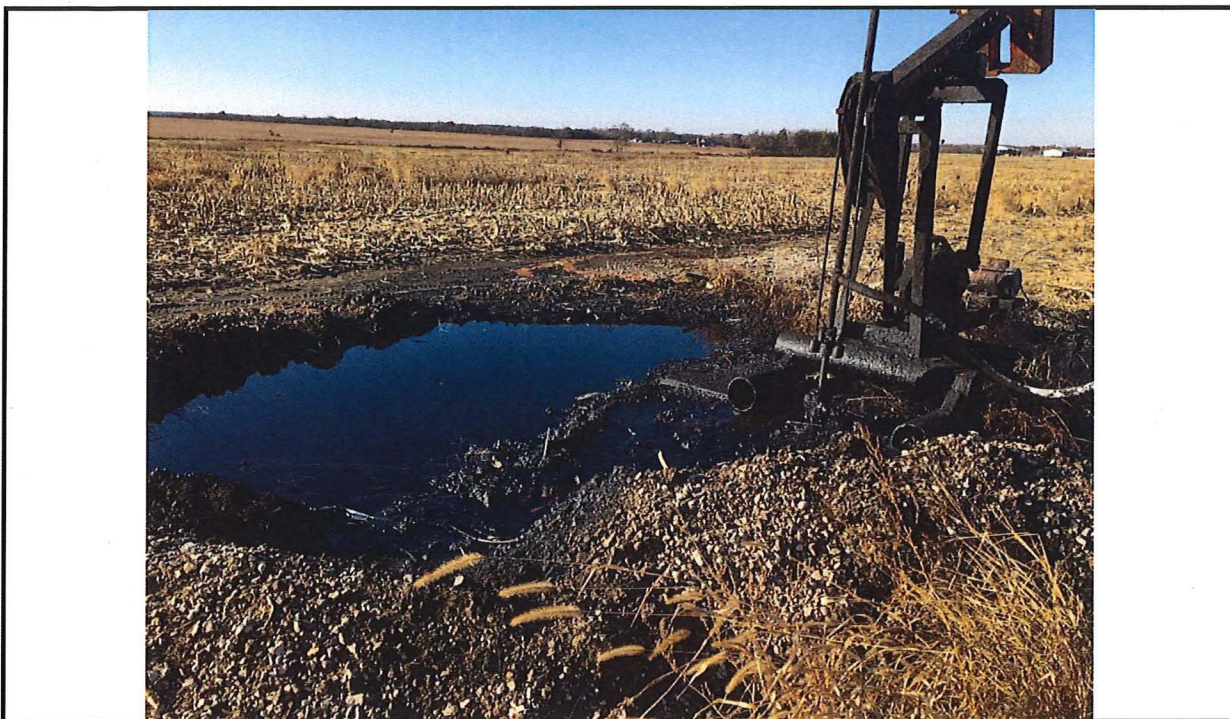
KCC DISTRICT III OFFICE FIELD REPORT PHOTO ID FORM

Time: 3:19 PM	KLN: 5556
Lease: Wright	Legal: 18-22-22E
County: Linn	PIC ID#: 20-89
Subject: Spill at well number #20-89	PIC Orientation:
FSL: 2808	Latitude: 38.13244
FEL: 1986	Longitude: -095.03220
API#: 15-107-23055-00-00	
Date: 11/07/2019	
Staff: Keith Carswell

Additional Information: This is a picture taken at well location #20-89. The well is not equipped with a stuffing box. The well is bubbling and leaking crude and spilling on the ground. The spill area location has been outlined using GPS waypoints. The landowner had tried to dam up the area around the well to keep the spill from spreading but it was leaching out through the dam.

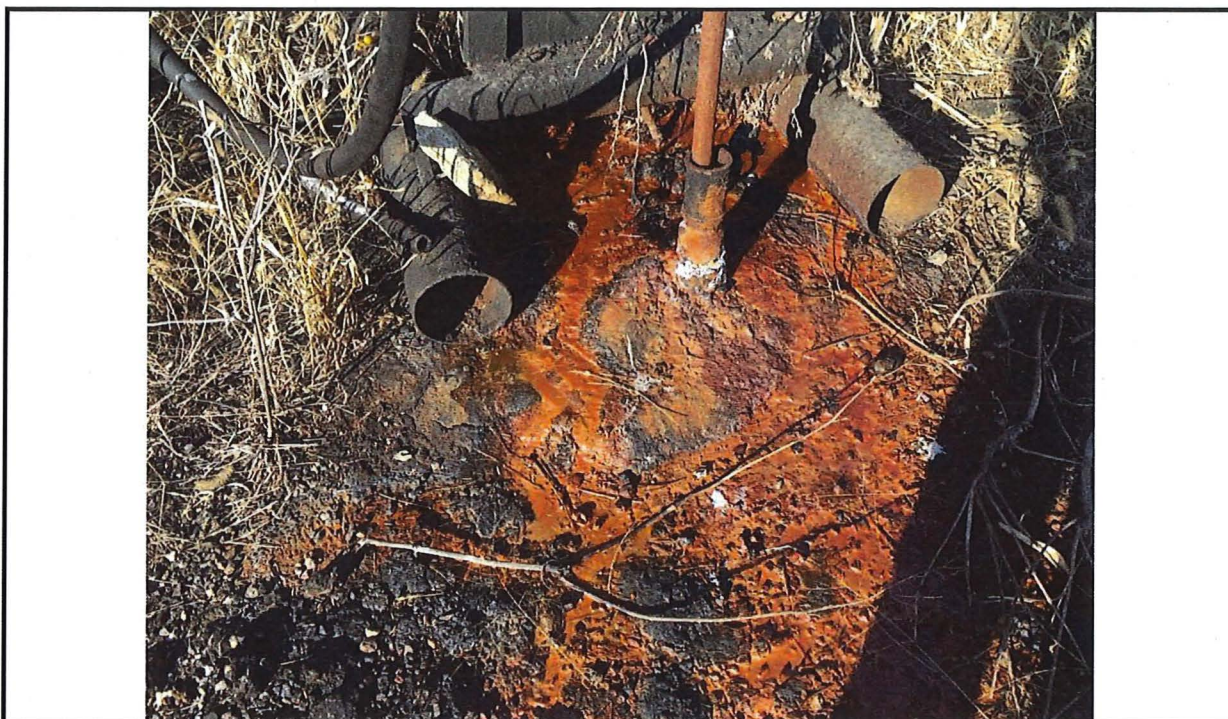
KCC DISTRICT III OFFICE FIELD REPORT PHOTO ID FORM

Operator: Viva International, Inc	KLN: 5556
Lease: Wright	Legal: 18-22-22E
County: Linn	PIC ID#: 28-89
Subject: Spill at well number #28-89	PIC Orientation:
FSL: 3244	Latitude: 38.13365
FEL: 2441	Longitude: -095.03379
API#: 15-107-23096-00-00	
Date: 11/07/2019	Time: 3:11 PM
Staff: Keith Carswell

Additional Information: This is a picture taken at well location #28-89. The well is not equipped with a stuffing box. This well wasn't currently leaking at time of inspection but shows signs of leaking in the past with the discoloration of the ground and the kill area outlined with GPS waypoints.

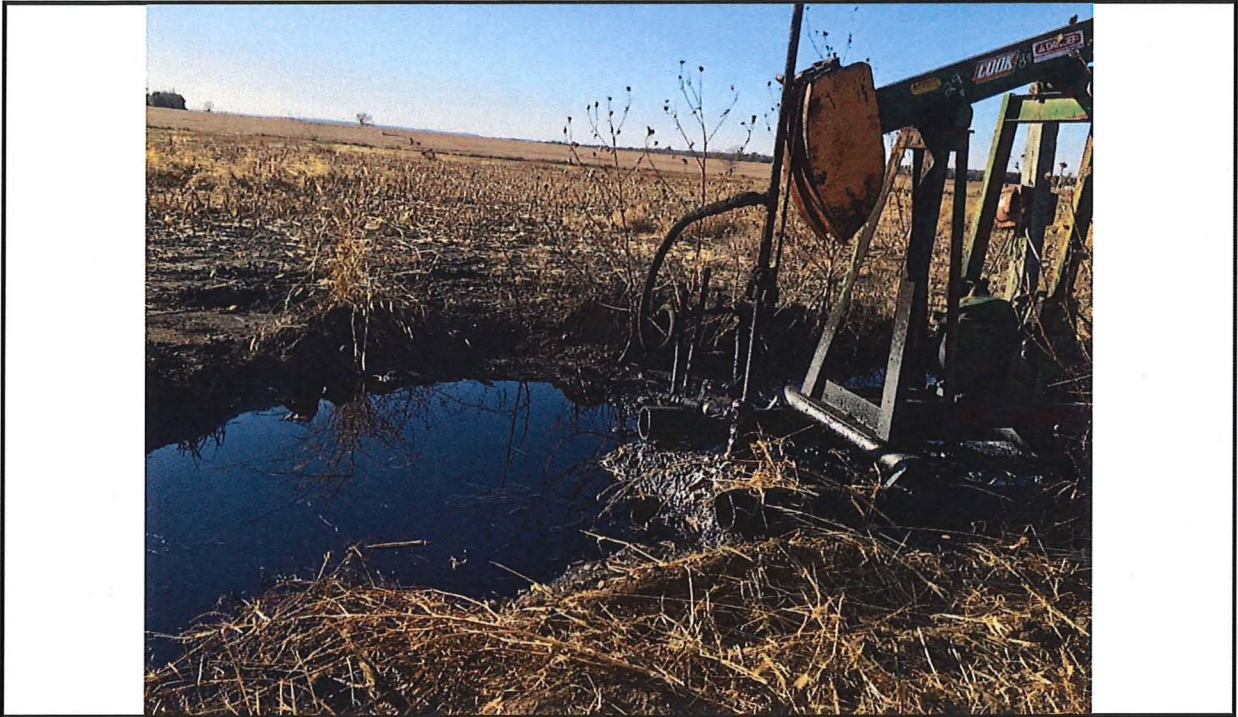
KCC DISTRICT III OFFICE FIELD REPORT PHOTO ID FORM

Operator: Viva International, Inc	KLN: 5556
Lease: Wright	Legal: 18-22-22E
County: Linn	PIC ID#: 29-89
Subject: Spill at well number #29-89	PIC Orientation:
FSL: 3205	Latitude: 38.13353
FEL: 1984	Longitude: -095.03220
API#: 15-107-23097-00-00	
Date: 11/07/2019	Time: 3:21 PM
Staff: Keith Carswell

Additional Information: This is a picture taken at well location #29-89. Well is not equipped with a stuffing box. The well is bubbling and leaking crude and spilling on the ground. The spill area location has been outlined using GPS waypoints. The landowner had tried to dam up the area around the well to keep the spill from spreading but it was leaching out through the dam and has ran over the dam in the past.

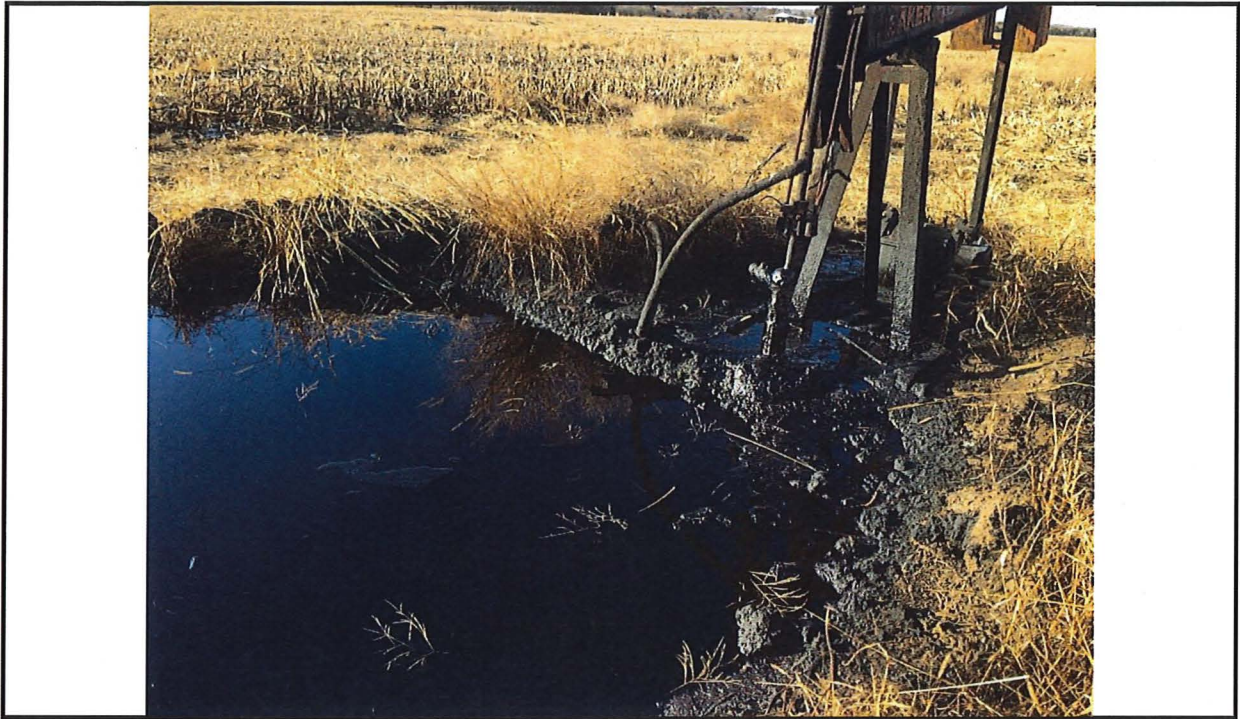
KCC DISTRICT III OFFICE FIELD REPORT PHOTO ID FORM

Operator: Viva International, Inc	KLN: 5556
Lease: Wright	Legal: 18-22-22E
County: Linn	PIC ID#: 40-90
Subject: Spill at well number #40-90	PIC Orientation:
FSL: 3191	Latitude: 38.13348
FEL: 1552	Longitude: -095.03070
API#: 15-107-23179-00-00	
Date: 11/07/2019	Time: 3:30 PM
Staff: Keith Carswell

Additional Information: This is a picture taken at well location #40-90. Well is not equipped with a stuffing box. The well is bubbling and leaking crude and spilling on the ground. The spill area location has been outlined using GPS waypoints. The landowner had tried to dam up the area around the well to keep the spill from spreading but it is currently running over the dam.
