**BEFORE THE STATE CORPORATION COMMISSION  
OF THE STATE OF KANSAS**

In the matter of the failure of Ace Energy, ) **Docket No. 23-CONS-3195-CPEN**  
LLC (Operator) to comply with K.A.R. )  
82-3-407 at the Grundy B #5 SWD well in ) **CONSERVATION DIVISION**  
Greenwood County, Kansas. )  
\_\_\_\_\_ ) **License No. 34998**

**PRE-FILED TESTIMONY OF**

**JONATHAN FREIDEN**

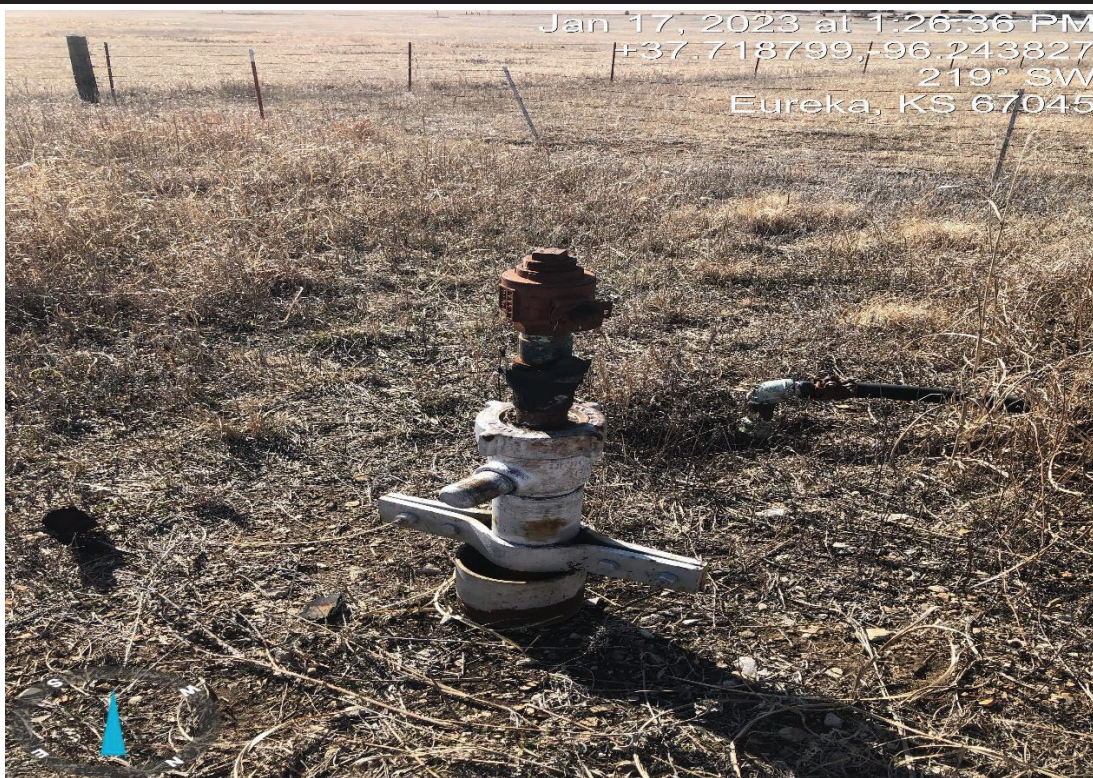
PIC ID#: 12

Additional Information: Grundy B # (RA) 1SWD is an authorized disposal well, permit #D-20506 constructed with 8" surface, 5.5" casing, and 2" tubing that is inactive. This well passed a Mechanical Integrity Test (MIT) on 9/18/2022. This well has no surface control, No Temporary Abandonment (TA) application has been filed. See attached photo numbered (12).

Grundy B # (RA) 1SWD API # 15-073-22073-00-00, Sec 7 - T27S - R11E, 4021 FSL, 2715 FEL, Lat. 37.71882, Long. -96.24387, SE NE NW, Grundy B # (RA) 1SWD is an authorized SWD well, permit #D-20506, that is constructed with 8" surface, 5.5" casing, and 2" tubing that is inactive with no surface control. This well passed a Mechanical Integrity Test (MIT) on 9/18/2022. No Temporary Abandonment (TA) application has been filed and well would need to be properly shut-in before application could be approved.. See attached photo numbered (12).

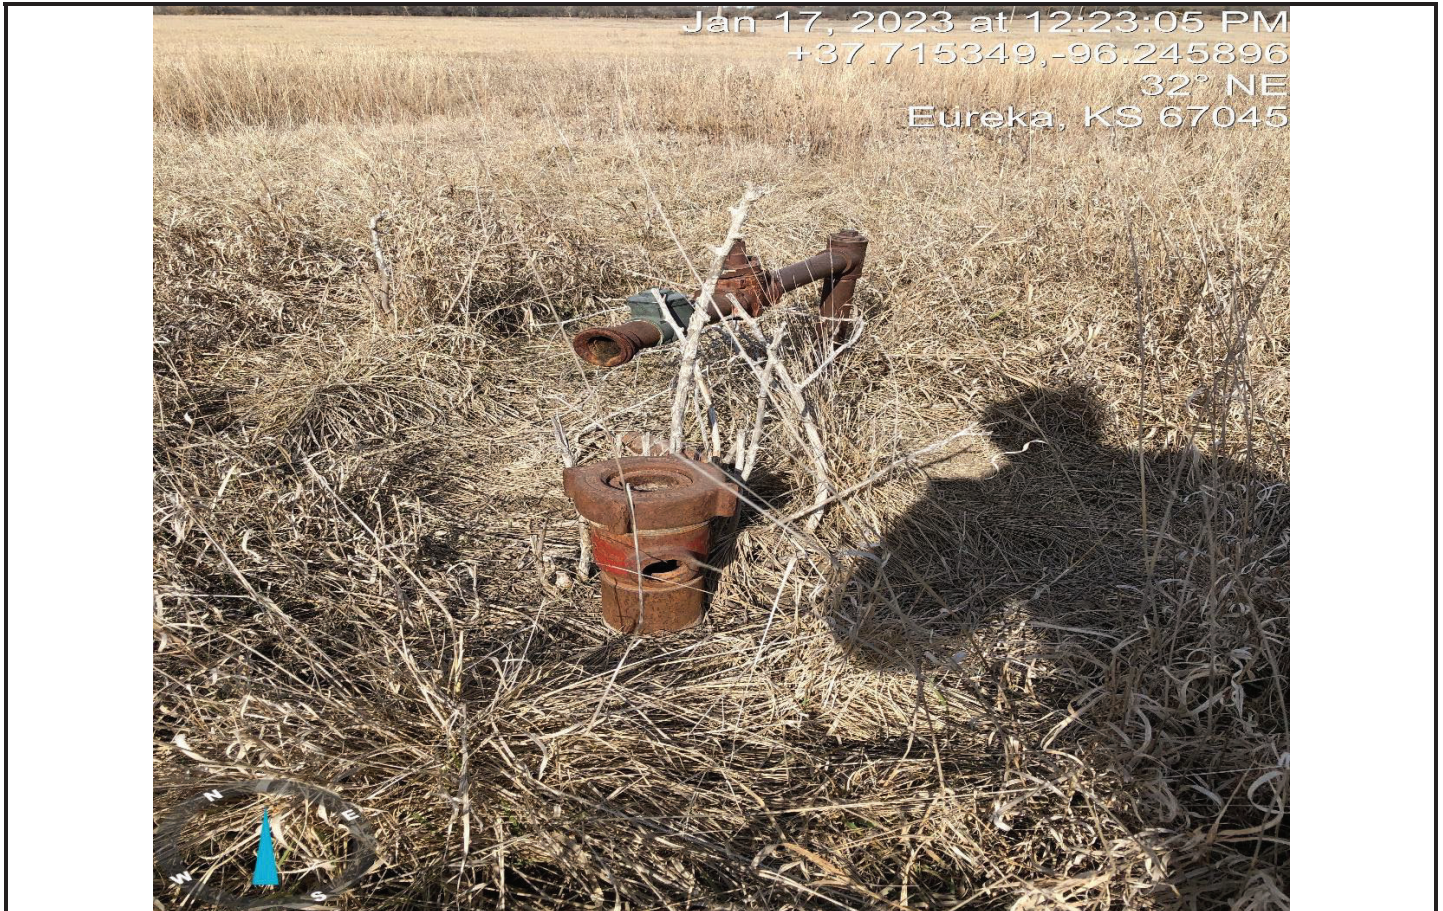
PIC ID#: 2

Additional Information: Grundy B #1 is an inactive oil well constructed with 4.5" casing only. This well has no surface control, An Approved Temporary Abandonment (TA) application has been filed on 2/9/2022. See attached photo numbered (2).

Grundy B #1 API # 15-073-21853-00-00, Sec 7 - T27S - R11E, 2737 FSL, 3293 FEL, Lat. 37.71529, Long. - 96.24584, SW SE NW, Grundy B #1 is an inactive oil well constructed with 4.5" casing that is open with no surface control. Operator filed a Temporary Abandonment (TA) application and the application was approved on 9/2/2022. This well is not properly shut in with a swedge and valve and the TA needs to be revoked. See attached photo numbered (2).

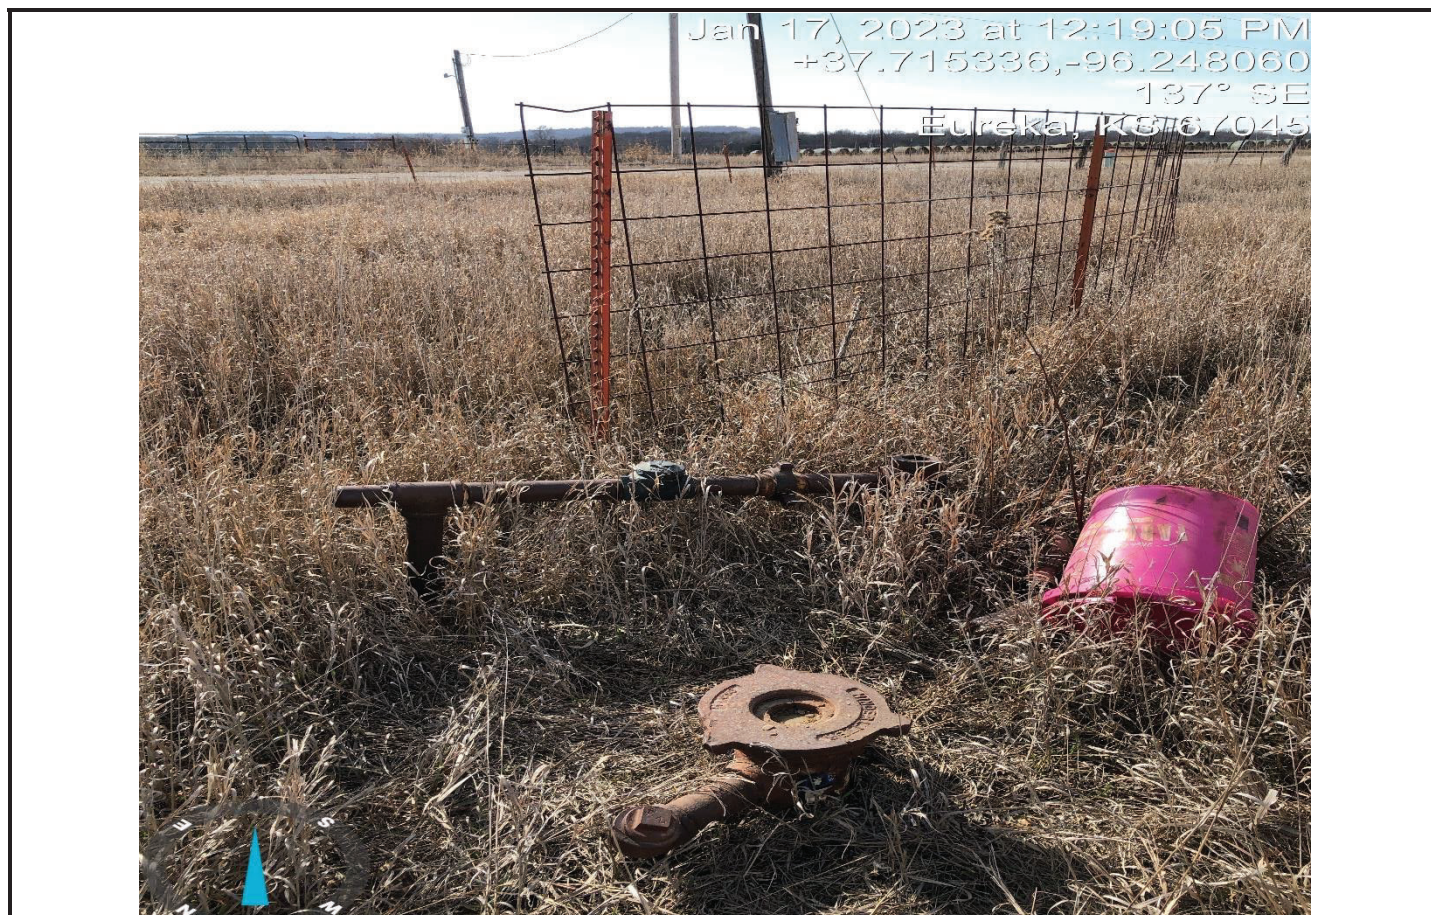
Operator: Ace Energy	KLN: 34998
Lease: Grundy B	Legal: Sec 7 T27S R 11E SE SW NW
County: GW	PIC ID#: 2
Subject: # 2	PIC Orientation: pic taken towards the South
FSL: 2738'	Latitude: 37.71529
FEL: 3965'	Longitude: -96.24816
API#: 15-073-21854-00-00	
Date: 01/17/2023	Time: 12:19
Staff: Triboulet

Additional Information: Grundy B #2 is an inactive oil well constructed with 4.5" casing only. This well has no surface control, An Approved Temporary Abandonment (TA) application has been filed on 9/2/2022. See attached photo numbered (1).

Grundy B #2 API # 15-073-21854-00-00, Sec 7 - T27S - R11E, 2738 FSL, 3265 FEL, Lat. 37.71529, Long. - 96.24816, SE SW NW, Grundy B #2 is an inactive oil well constructed with 4.5" casing that is open with no surface control. Operator filed a Temporary Abandonment (TA) application and the application was approved on 9/2/2022. This well is not properly shut in with a swedge and valve and the TA needs to be revoked. See attached photo numbered (1).

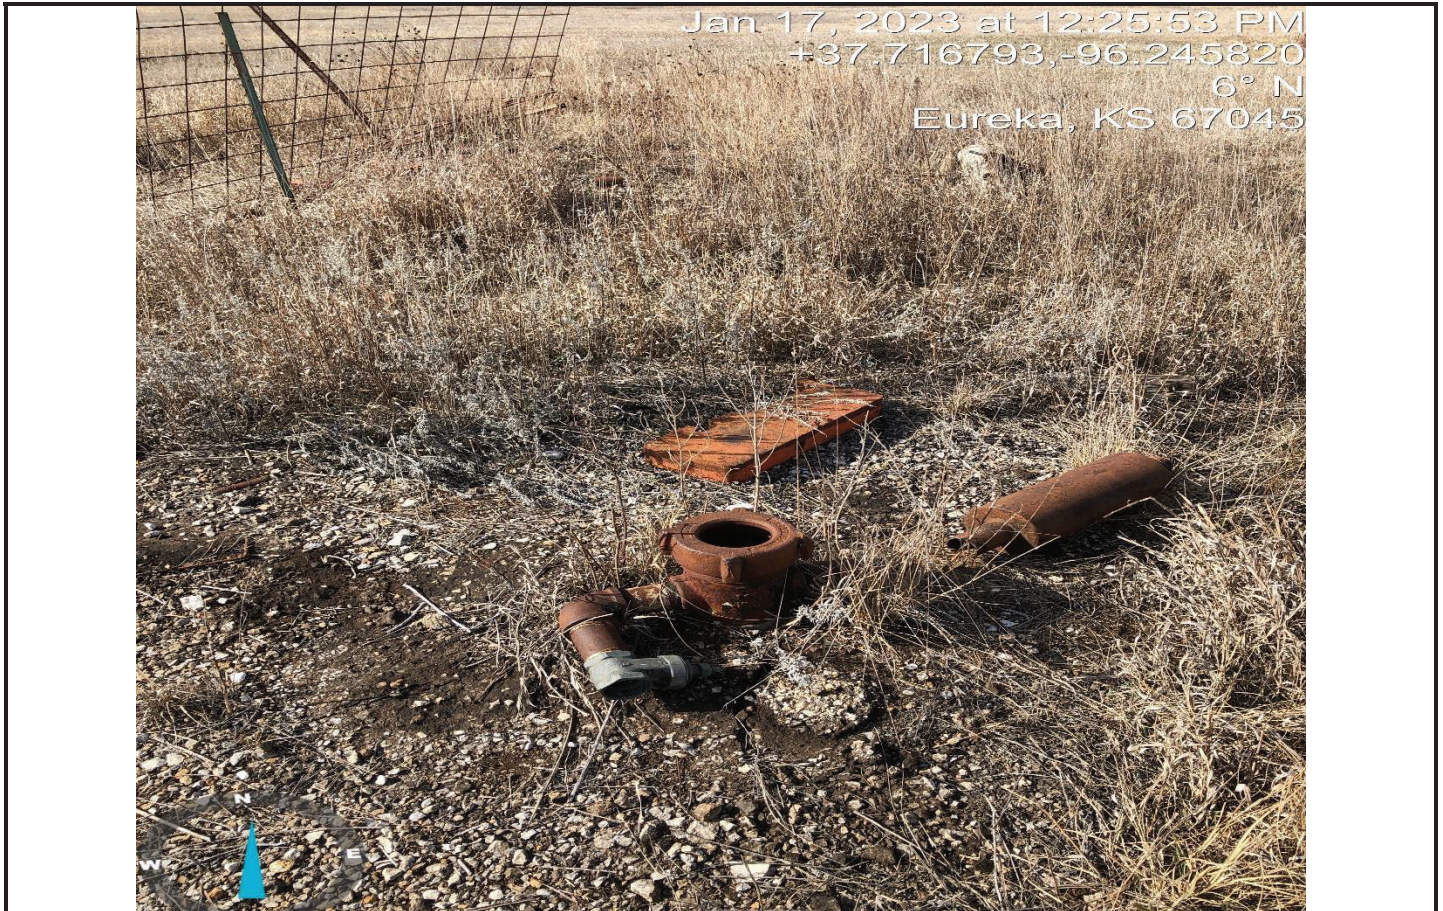
Additional Information: Grundy B #3 is an inactive oil well constructed with 4.5" casing only. This well has no surface control, No Temporary Abandonment (TA) application has been filed. See attached photo numbered (3).

Grundy B #3 API # 15-073-21859-00-00, Sec 7 - T27S - R11E, 3283 FSL, 3290 FEL, Lat. 37.71679, Long. - 96.24584, SW SE NW, Grundy B #2 is an inactive oil well constructed with 4.5" casing that is open with no surface control. Operator filed a Temporary Abandonment (TA) application and the application was approved on 9/2/2022. This well is not properly shut in with a swedge and valve and the TA needs to be revoked. See attached photo numbered (3).

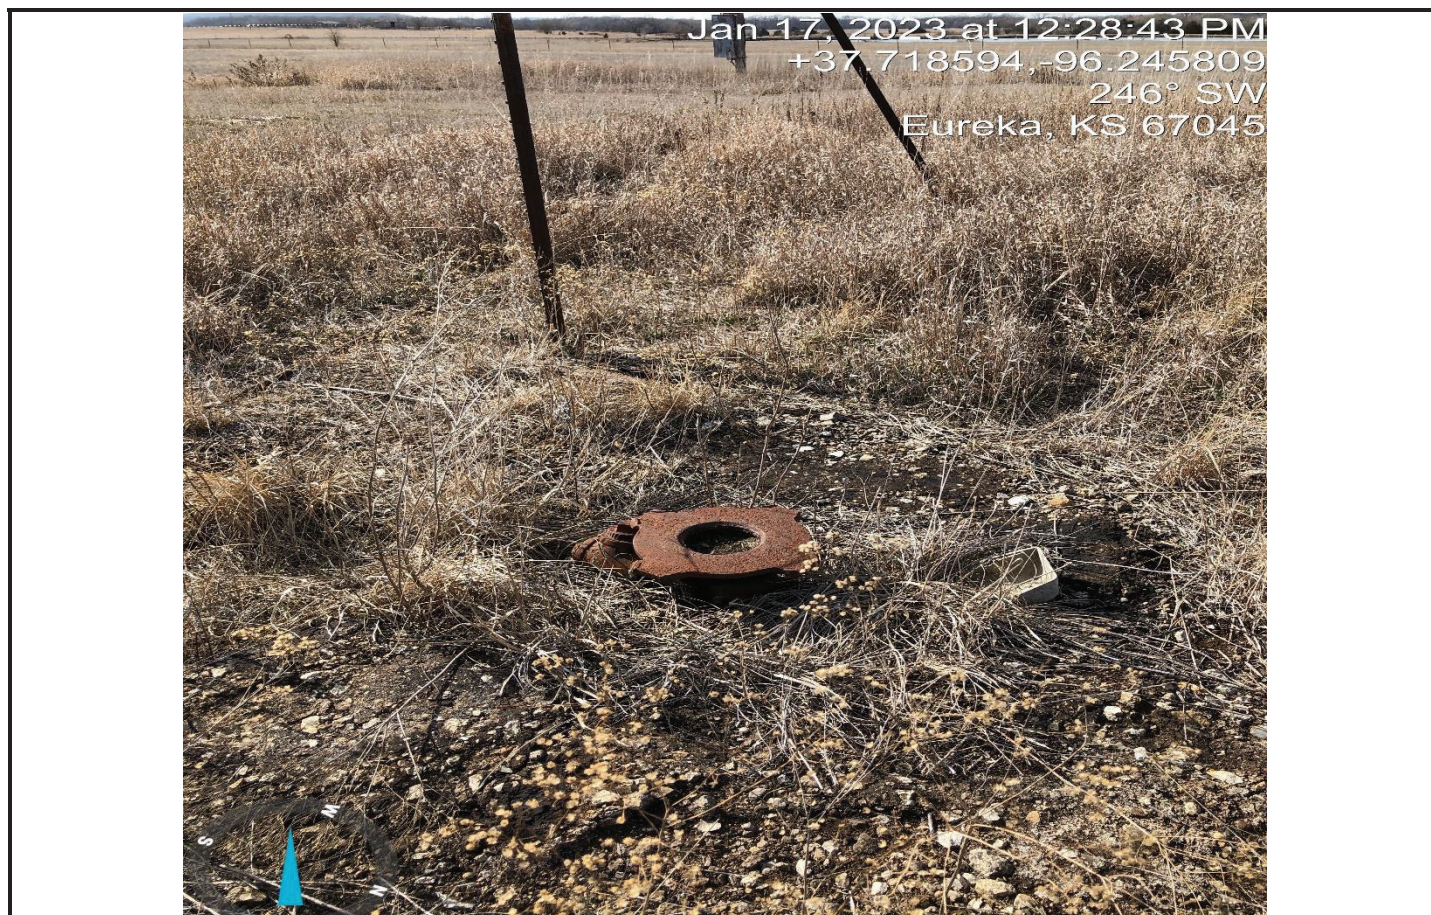
Additional Information: Grundy B #4 is an inactive oil well constructed with 4.5" casing only. This well has no surface control, An Temporary Abandonment (TA) application has been filed on 9/2/2022. See attached photo numbered (4).

Grundy B #4 API # 15-073-21860-00-00, Sec 7 - T27S - R11E, 3939 FSL, 3306 FEL, Lat. 37.71859, Long. - 96.24591, NW SE NW, Grundy B #4 is an inactive oil well constructed with 4.5" casing that is open with no surface control. Operator filed a Temporary Abandonment (TA) application and the application was approved on 9/2/2022. This well is not properly shut in with a swedge and valve and the TA needs to be revoked. See attached photo numbered (4).

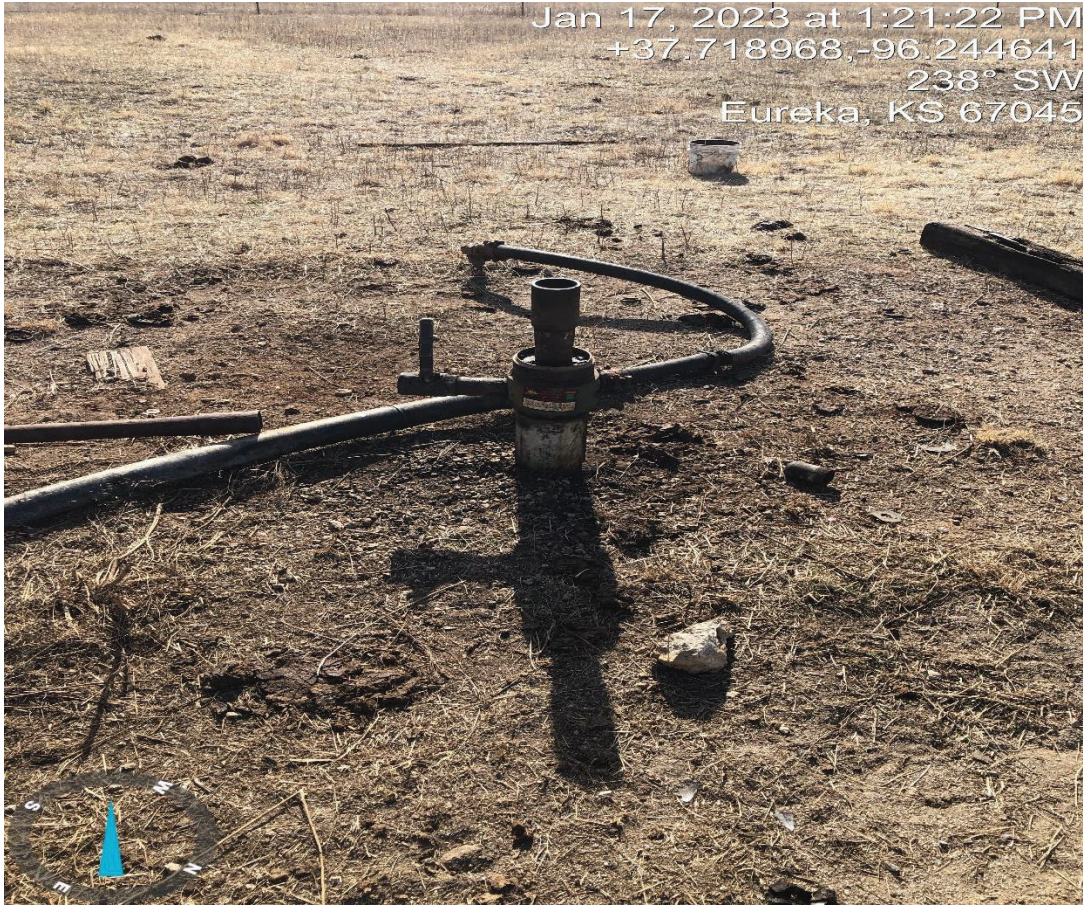
Additional Information: Grundy B # 5 SWD is an unauthorized disposal well, permit #D-24701 constructed with 5.5" casing, and 2.5" tubing that is inactive. This well failed a Mechanical Integrity Test (MIT) on 9/18/2022. This well has no surface control, No Temporary Abandonment (TA) application has been filed. See attached photo numbered (11).

Grundy B # 5 SWD API # 15-073-22198-00-00, Sec 7 - T27S - R11E, 4062 FSL, 2955 FEL, Lat. 37.71893, Long. -96.24470, SE NE NW, Grundy B # 5 SWD is an authorized disposal well, permit #D-24701, that is constructed with 5.5" casing and 2.5" tubing that is inactive with no surface control. This well failed a Mechanical Integrity Test (MIT) on 9/18/2022 and remains out of compliance. Operator need to repair the well and pass a witnessed MIT or well needs to be plugged. See attached photo numbered (11).

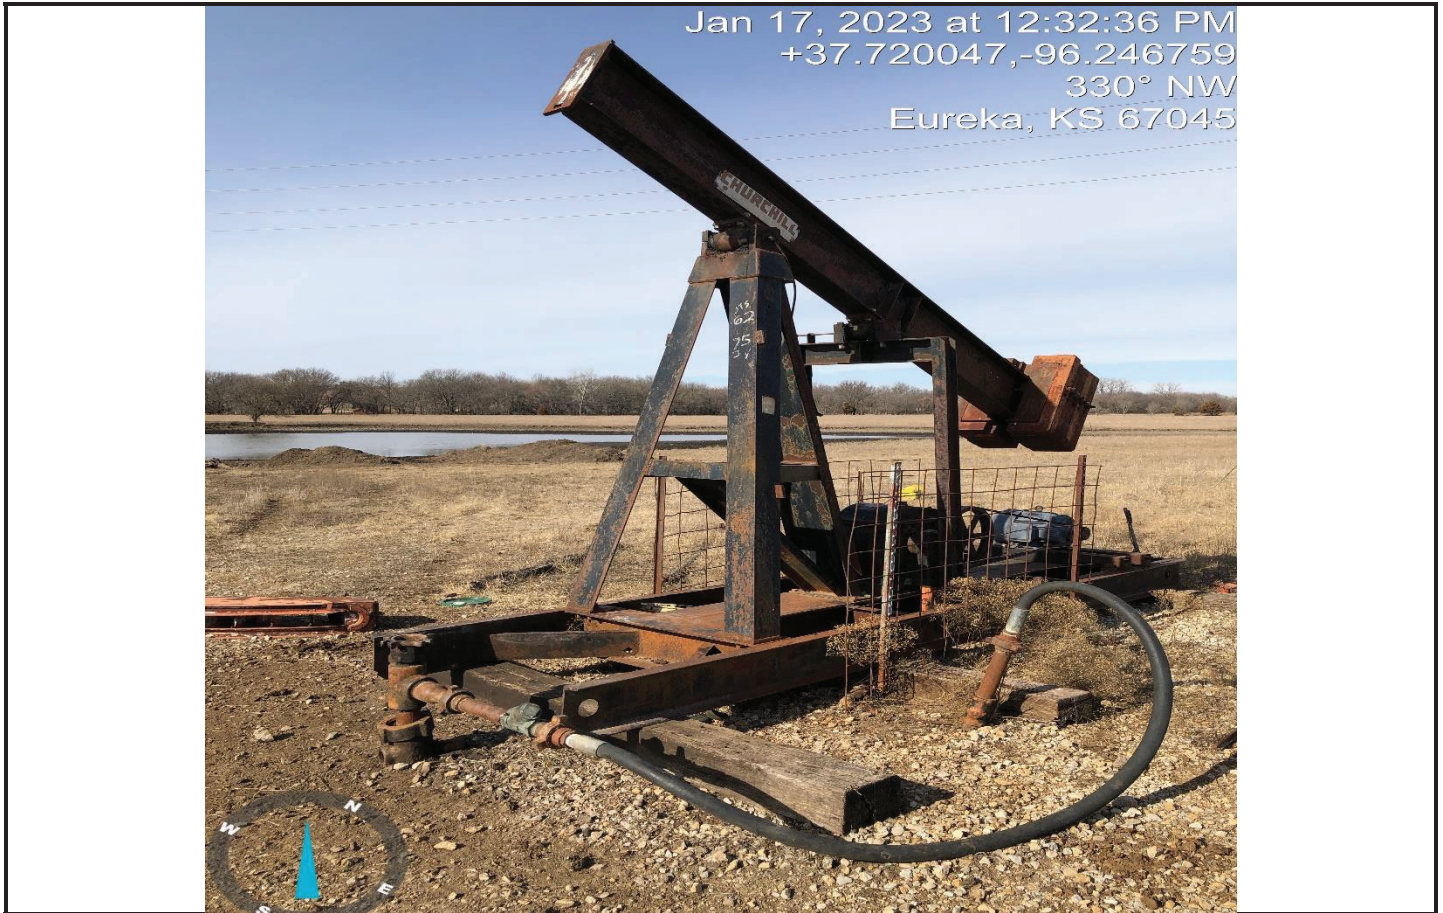
Operator: Ace Energy	KLN: 34998
Lease: Grundy B	Legal: Sec 7 T27S R 11E SW NE NW
County: GW	PIC ID#: 5
Subject: # 5	PIC Orientation: pic taken towards the West
FSL: 4329'	Latitude: 37.71966
FEL: 3624'	Longitude: -96.24702
API#: 15-073-23276-00-00	
Date: 01/17/2023	Time: 12:32
Staff: Triboulet

Additional Information: Grundy B #5 is an inactive oil well constructed with 4.5" casing, 2.5" tubing, pump jack, electric motor with no belt, and no sucker rods. This well has no surface control, No Temporary Abandonment (TA) application has been filed. See attached photo numbered (5).

Grundy B #5 API # 15-073-23276-00-00, Sec 7 - T27S - R11E, 4329 FSL, 3624 FEL, Lat. 37.71966, Long. - 96.24702, SW NE NW, Grundy B #5 is an inactive oil well constructed with 4.5" casing, 2.5" tubing and pump jack. The pump jack is equipped with an electric motor but is not equipped with a belt. Well does not have rods inside the tubing and has no surface control. No Temporary Abandonment (TA) application has been filed and well would need to be properly shut-in before application could be approved. See attached photo numbered (5).

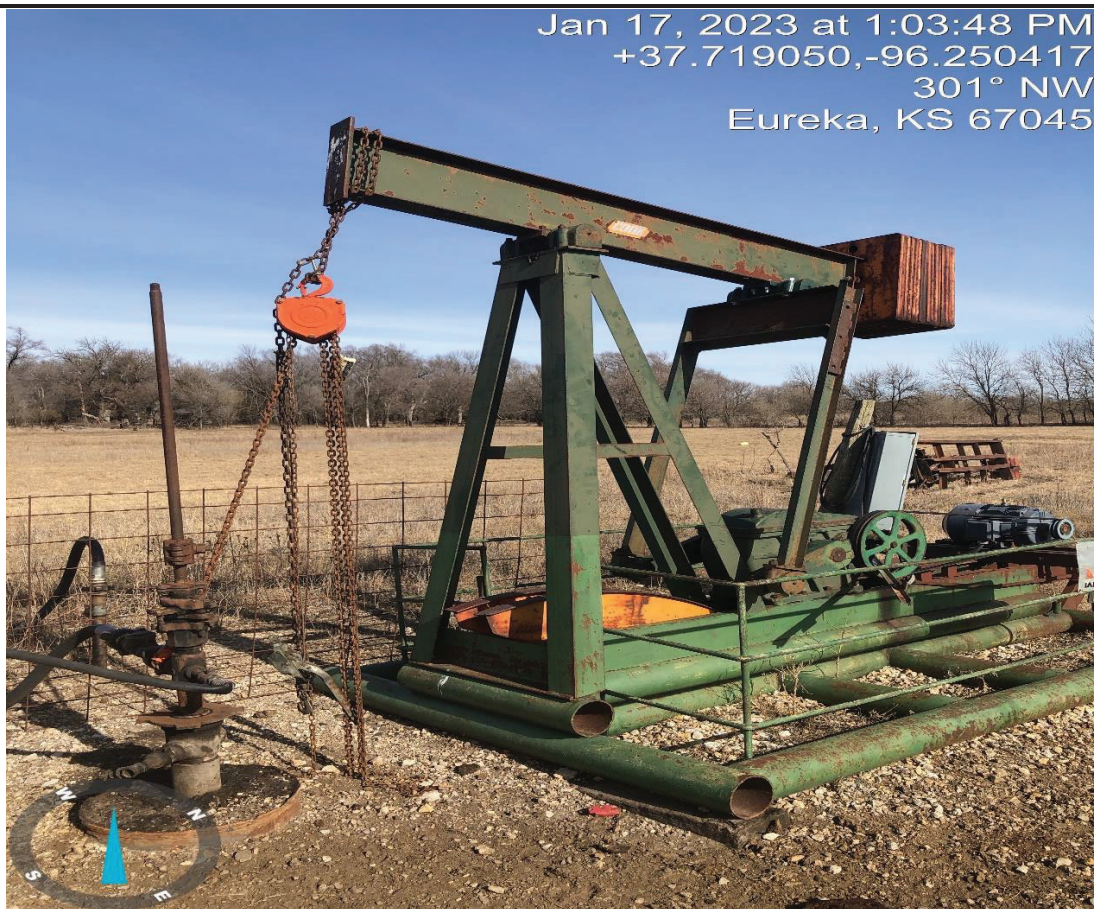
Additional Information: Grundy B #6 is an inactive oil well constructed with 4.5" casing, 2" tubing, rods, pumpjack, electric motor with belt, no bridal or horse head. This well has no surface control, No Temporary Abandonment (TA) application has been filed. See attached photo numbered (9).

Grundy B #6 API # 15-073-23359-00-00, Sec 7 - T27S - R11E, 4995 FSL, 2960 FEL, Lat. 37.72149, Long. - 96.24474, NE NE NW, Grundy B #6 is an inactive oil well constructed with 4.5" casing, 2" tubing, rods and a pump jack. The pump jack is equipped with an electric motor but is not equipped with a belt, bridal cable, horse head nor has no surface control. No Temporary Abandonment (TA) application has been filed and well would need to be properly shut-in before application could be approved. See attached photo numbered (9).

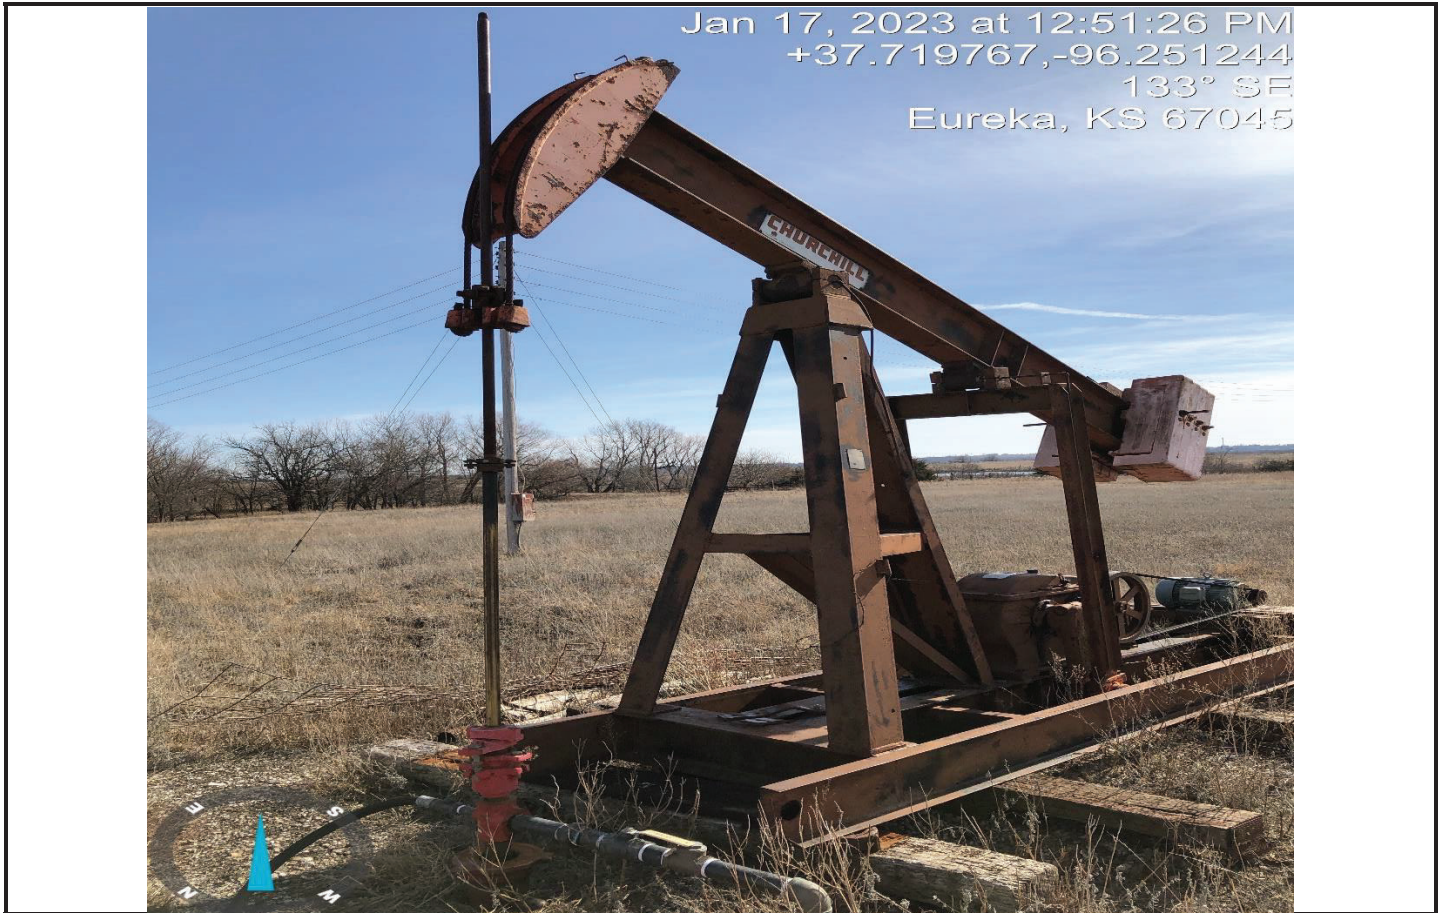
Additional Information: Grundy B #8 is an inactive oil well constructed with 4.5" casing, 2" tubing, rods, pumpjack, electric motor with belt, all hooked up electric box shut off. No surface control, No Temporary Abandonment (TA) application has been filed. See attached photo numbered (8).

Grundy B #8 API # 15-073-23385-00-00, Sec 7 - T27S - R11E, 4365 FSL, 4816 FEL, Lat. 37.71975, Long. - 96.25114, SW NW NW, Grundy B #8 is an inactive oil well constructed with 4.5" casing, 2" tubing, rods and a pump jack. Well is totally equipped for production. This well does not have surface control. No Temporary Abandonment (TA) application has been filed and well would need to be properly shut-in before application could be approved. See attached photo numbered (8).

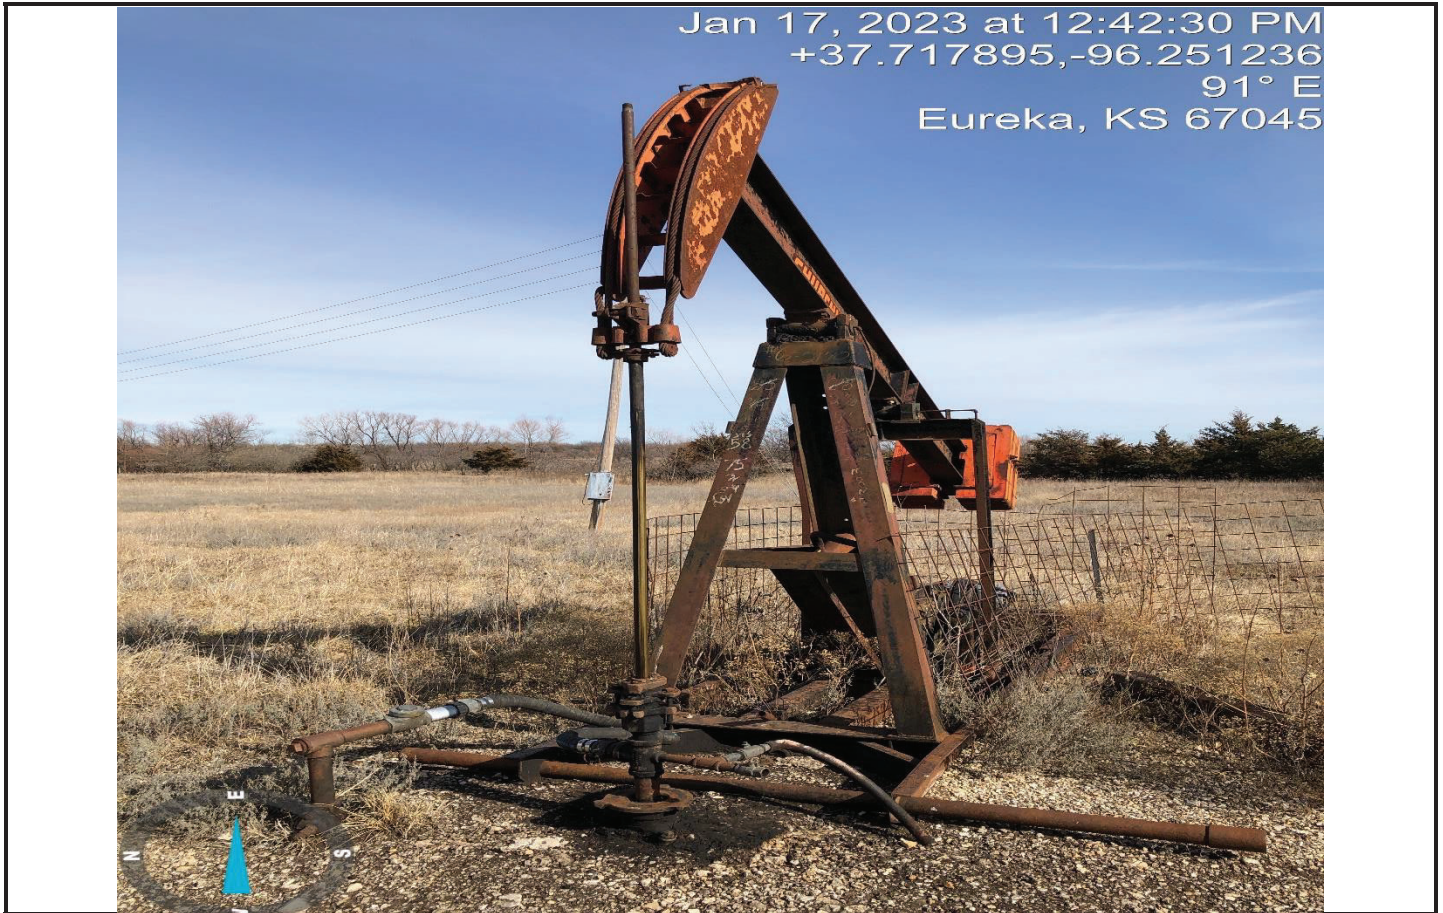
Operator: Ace Energy	KLN: 34998
Lease: Grundy B	Legal: Sec 7 T27S R 11E NW SW NW
County: GW	PIC ID#: 7
Subject: # 9	PIC Orientation: pic taken towards the East
FSL: 3691'	Latitude: 37.71790
FEL: 4815'	Longitude: -96.25112
API#: 15-073-23411-00-00	
Date: 01/17/2023	Time: 12:42
Staff: Triboulet

Additional Information: Grundy B #9 is an inactive oil well constructed with 4.5" casing, 2" tubing, rods, pumpjack, electric motor with belt, all hooked up electric box shut off. No surface control. No Temporary Abandonment (TA) application has been filed. See attached photo numbered (7).

Grundy B #9 API # 15-073-23411-00-00, Sec 7 - T27S - R11E, 3691 FSL, 4815 FEL, Lat. 37.71790, Long. - 96.25112, SW NW NW, Grundy B #9 is an inactive oil well constructed with 4.5" casing, 2" tubing, rods and a pumpjack. Well is totally equipped for production. This well does not have surface control. No Temporary Abandonment (TA) application has been filed and well would need to be properly shut-in before application could be approved. See attached photo numbered (7).

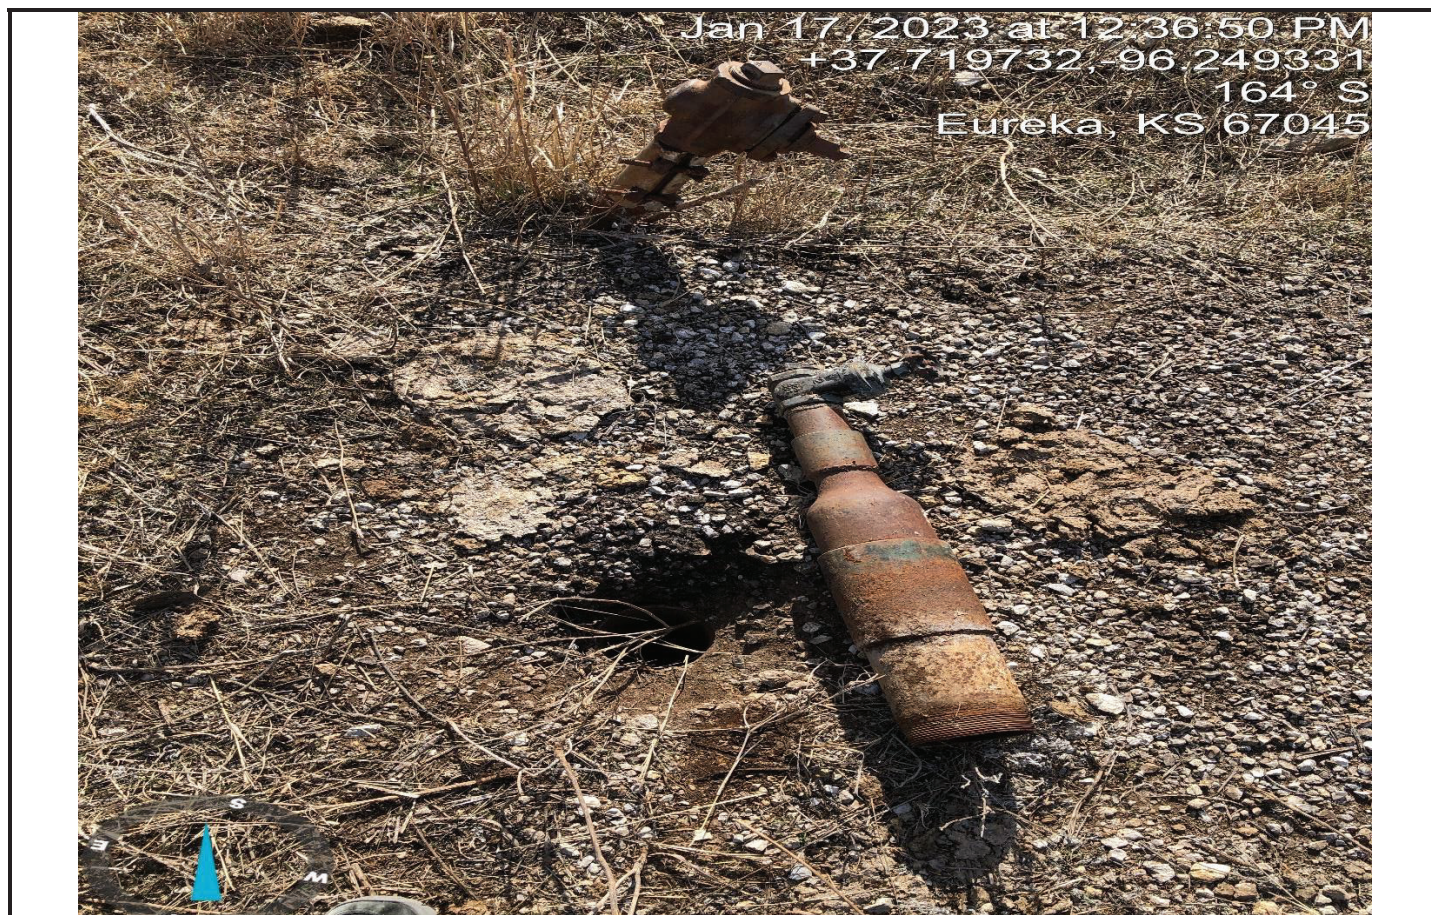
Operator: Ace Energy	KLN: 34998
Lease: Grundy B	Legal: Sec 7 T27S R 11E SE NW NW
County: GW	PIC ID#: 6
Subject: # 10	PIC Orientation: pic taken towards the South
FSL: 4345'	Latitude: 37.7197
FEL: 4278'	Longitude: -96.24928
API#: 15-073-23435-00-00	
Date: 01/17/2023	Time: 12:36
Staff: Triboulet

Additional Information: Grundy B #10 is an inactive oil well constructed with 4.5" casing only. This well has no surface control, No Temporary Abandonment (TA) application has been filed. See attached photo numbered (6).

Grundy B #10 API # 15-073-23435-00-00, Sec 7 - T27S - R11E, 4345 FSL, 4278 FEL, Lat. 37.71970, Long. - 96.24928, SE NW NW, Grundy B #10 is an inactive oil well constructed with 4.5" casing that is open with no surface control. No Temporary Abandonment (TA) application has been filed and well would need to be properly shut-in before application could be approved. See attached photo numbered (6).

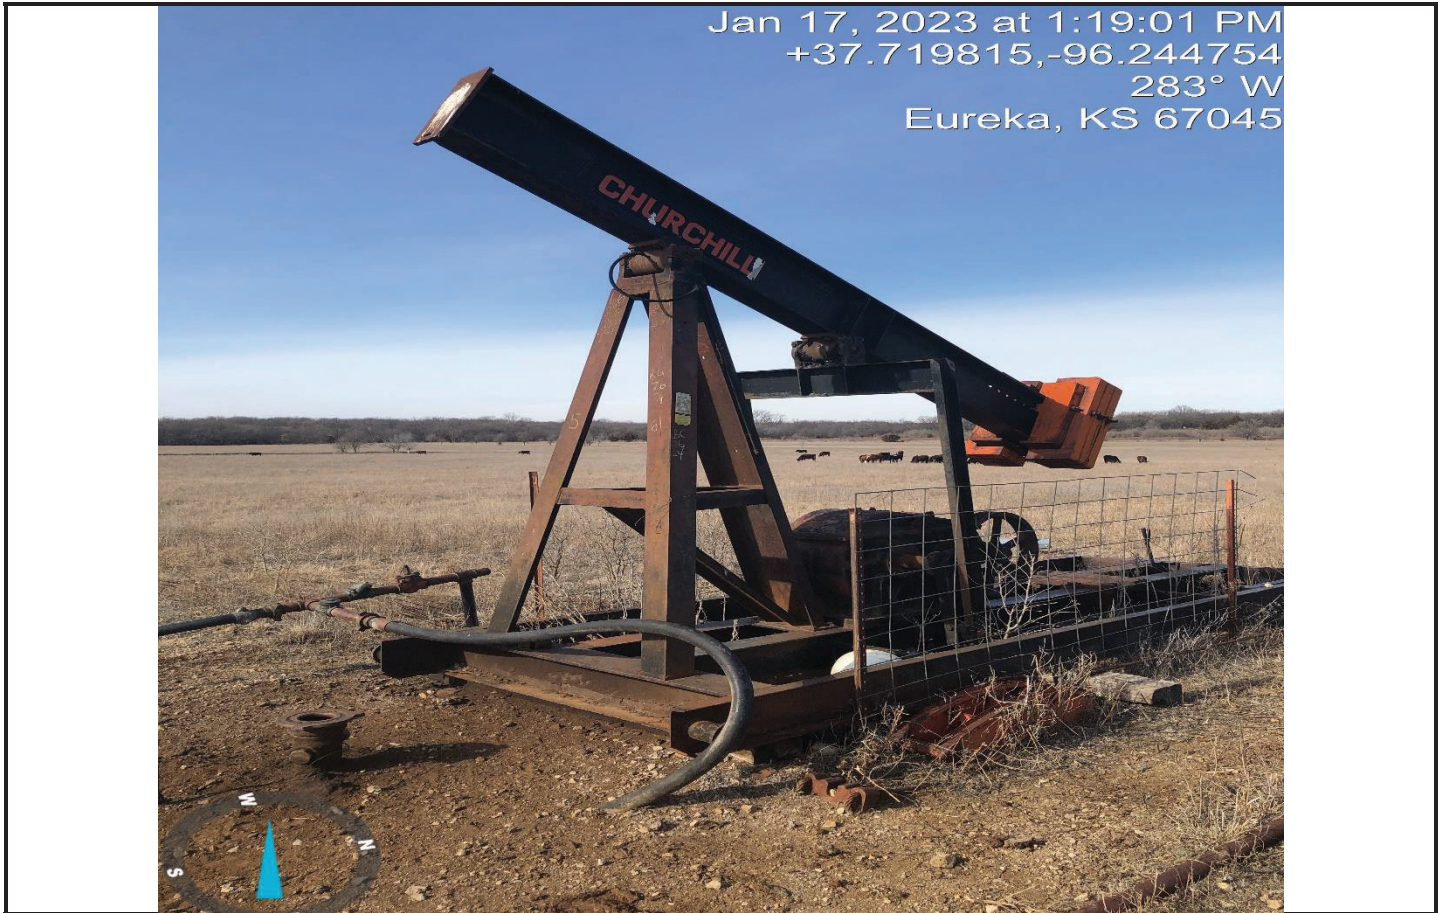
Operator: Ace Energy	KLN: 34998
Lease: Grundy B	Legal: Sec 7 T27S R 11E SE NE NW
County: GW	PIC ID#: 10
Subject: RAS # 5	PIC Orientation: pic taken towards the West
FSL: 4342'	Latitude: 37.719700
FEL: 2947'	Longitude: -96.244680
API#: 15-073-22866-00-00	
Date: 01/17/2023	Time: 1:19
Staff: Triboulet

Additional Information: Grundy RAS #5 is an inactive oil well constructed with 4.5" casing only. This well is not on operator's well inventory. This is a permitted well on RBDMS and shows a drilling intent on KGS. This well has no surface control, No Temporary Abandonment (TA) application has been filed. See attached photo numbered (6).

Grundy RAS #5 API # 15-073-22866-00-00, Sec 7 - T27S - R11E, 4342 FSL, 2947 FEL, Lat. 37.71970, Long. - 96.244680 SE NW NW, Grundy RAS #5 is an inactive oil well constructed with 4.5" casing that is open with no surface control. This well is listed as a permitted well (PW) on RBDMS and Kansas Geological Survey (KGS) shows a drilling intent. This well is not listed on the operators well inventory, however, this well falls within a quarter mile Area of Review (AOR) of Grundy B #(RA) 1 SWD and Grundy B #5 SWD salt water disposal (SWD) wells. Operator will need to transfer this well to their well inventory and bring the well into

compliance or the Commission should revoke the authorization permits for both SWD wells. See attached photo numbered (10).
