**BEFORE THE STATE CORPORATION COMMISSION  
OF THE STATE OF KANSAS**

In the matter of the failure of Tailwater, Inc.	)	Docket No. 21-CONS-3032-CPEN
(Operator) to comply with K.A.R. 82-3-603 at	)	
the South Kempnich Lease in Anderson County,	)	CONSERVATION DIVISION
Kansas.	)	
_____	)	License No. 32461

**PRE-FILED DIRECT TESTIMONY**

**TAYLOR HERMAN**

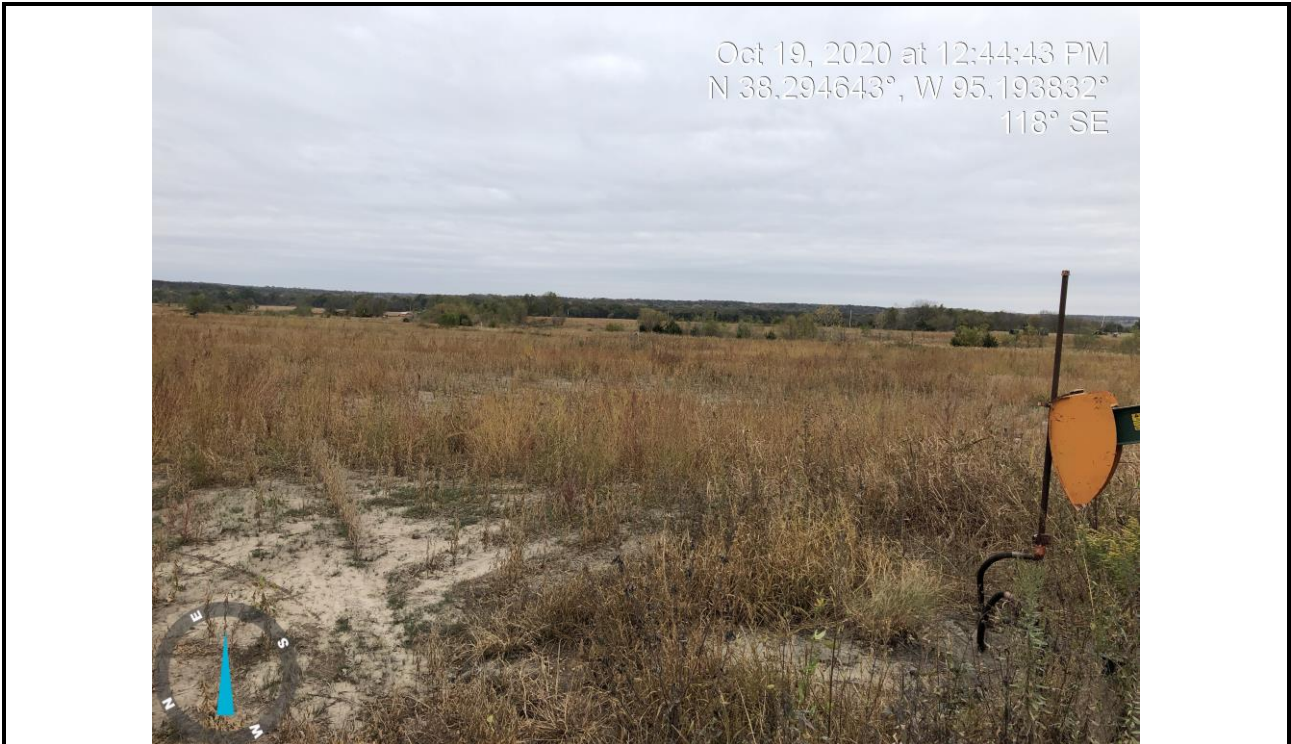
Operator: Tailwater, Inc.	KLN: 32461
Lease: Kempnich	Legal: 22-20-20E
County: Anderson	PIC ID#: IMG_0355
Subject: Remediation Site at 1-T	PIC Orientation: Facing East
FSL: 3914	Latitude: 38.298866
FEL: 5136	Longitude: -95.19375
API#: 15-003-24507	
Date: 10-19-2020	Time: 12:44 PM
Staff: Taylor Herman

Additional Information: Bine impacted soils evident from stunted or non-existent crop growth.

- 1.) Till impacted area to a depth of 12' or bedrock.
- 2.) Even application of pelletized gypsum. (amount of gypsum varied by acreage impacted)
- 3.) Incorporate soil amendments through tillage.
- 4.) Implement erosion controls over entire impacted area (i.e., Native hay mulch etc.).

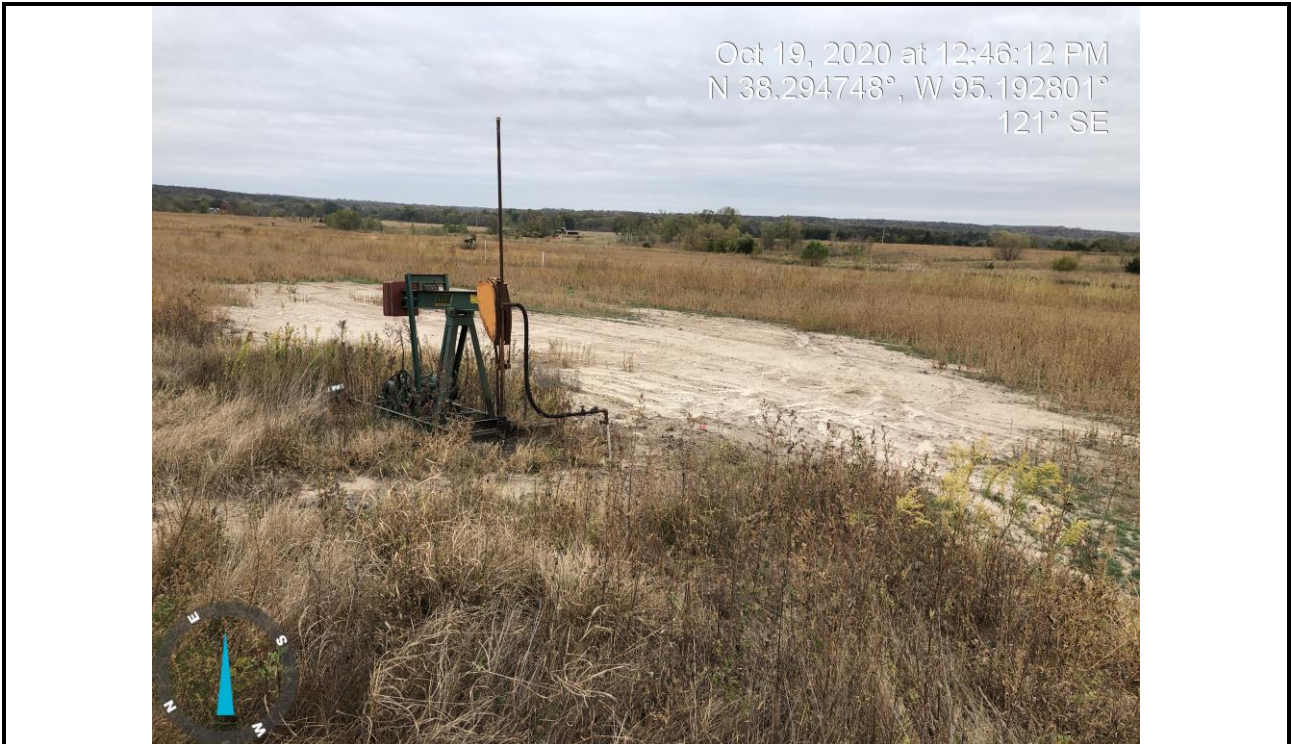
Operator: Tailwater, Inc.	KLN: 32461
Lease: Kempnich	Legal: 22-20-20E
County: Anderson	PIC ID#: IMG_0356
Subject: Remediation Site at 2-T	PIC Orientation: Facing East
FSL: 2335	Latitude: 38.29452
FEL: 4830	Longitude: -95.19267
API#: 15-003-24646	
Date: 10-10-2020	Time: 12:46 PM
Staff: Taylor Herman

Additional Information: Brine impacted soils evident from stunted or non-existent crop growth.

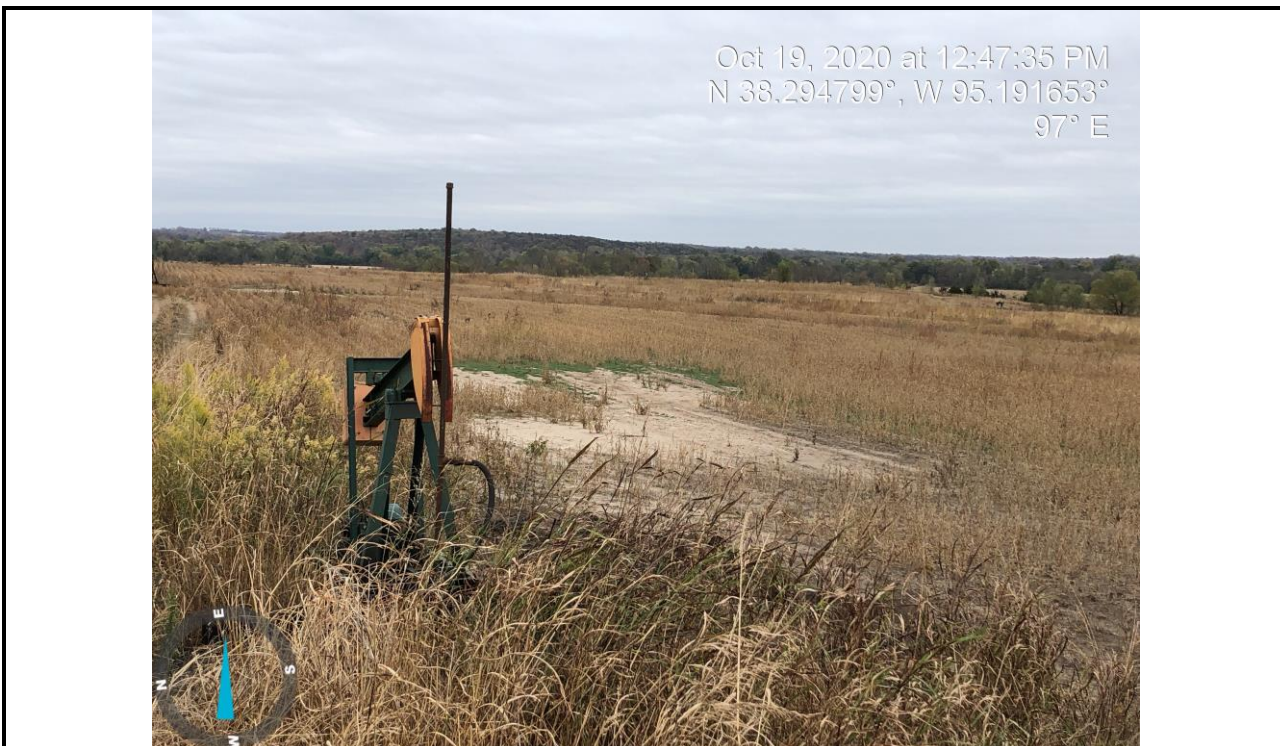
Operator: Tailwater, Inc.	KLN: 32461
Lease: Kempnich	Legal: 22-20-20E
County: Anderson	PIC ID#: IMG_0357
Subject: Remediation Site at 3-T	PIC Orientation: Facing East
FSL: 2462	Latitude: 38.29486
FEL: 4483	Longitude: -95.19146
API#: 15-003-24647	
Date: 10-19-2020	Time: 12:47 PM
Staff: Taylor Herman

Additional Information: Brine impacted soils evident from stunted or non-existent crop growth.

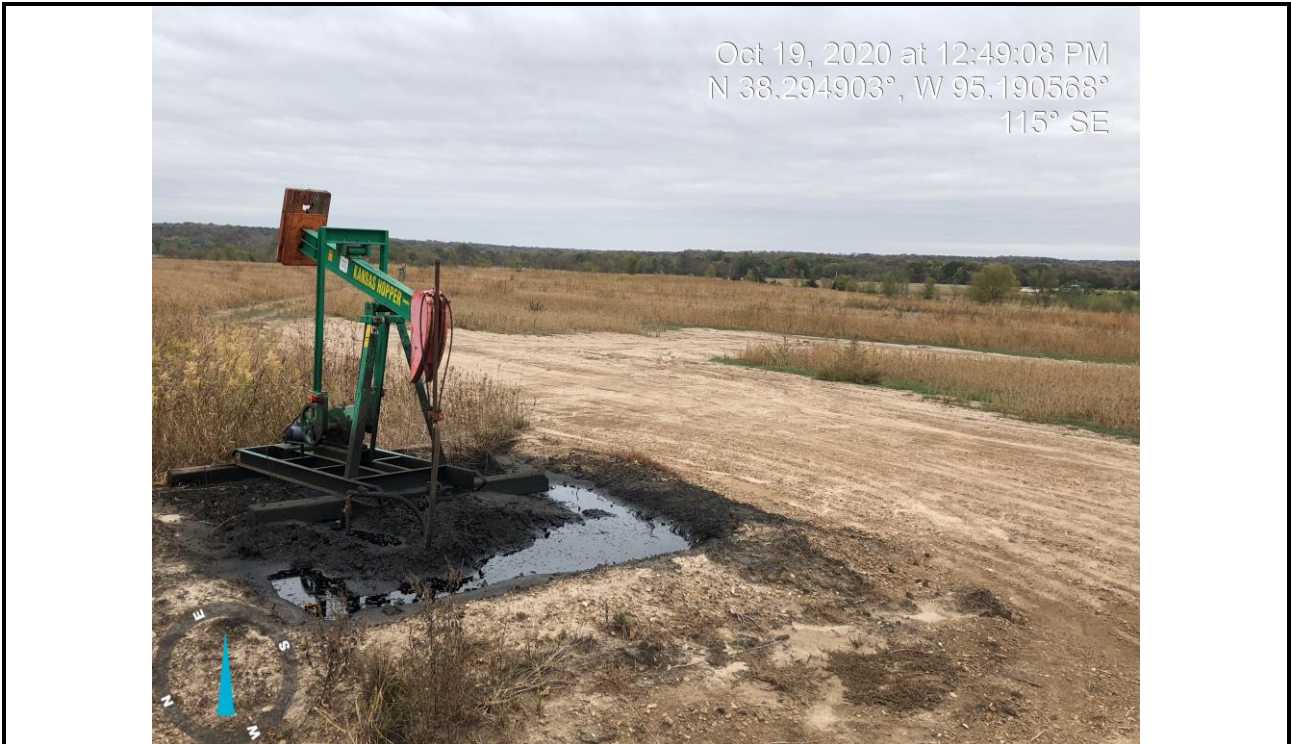
Operator: Tailwater, Inc.	KLN: 32461
Lease: Kempnich	Legal: 22-20-20E
County: Anderson	PIC ID#: IMG_0358
Subject: Remediation Site at 4-T	PIC Orientation: Facing East
FSL: 2462	Latitude: 38.29485
FEL: 4173	Longitude: -95.19038
API#: 15-003-24648	
Date: 10-19-2020	Time: 12:49 PM
Staff: Taylor Herman

Additional Information: Brine impacted soils evident from stunted or non-existent crop growth.

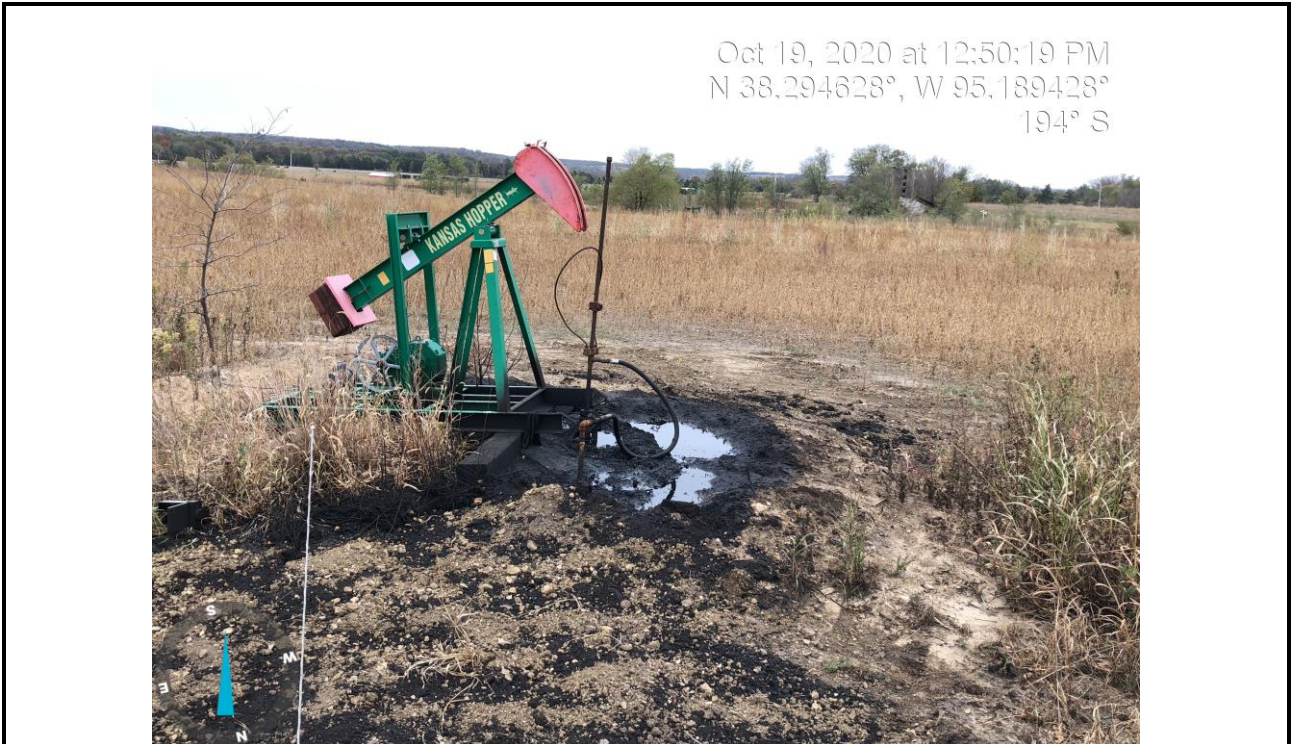
Operator: Tailwater, Inc.	KLN: 32461
Lease: Kempnich	Legal: 22-20-20E
County: Anderson	PIC ID#: IMG_0359
Subject: Remediation Site at 5-T	PIC Orientation: Facing South
FSL: 2346	Latitude: 38.29452
FEL: 3829	Longitude: -95.18918
API#: 15-003-24649	
Date: 10-19-2020	Time: 12:50 PM
Staff: Taylor Herman

Additional Information: Brine impacted soils evident from stunted or non-existent crop growth.

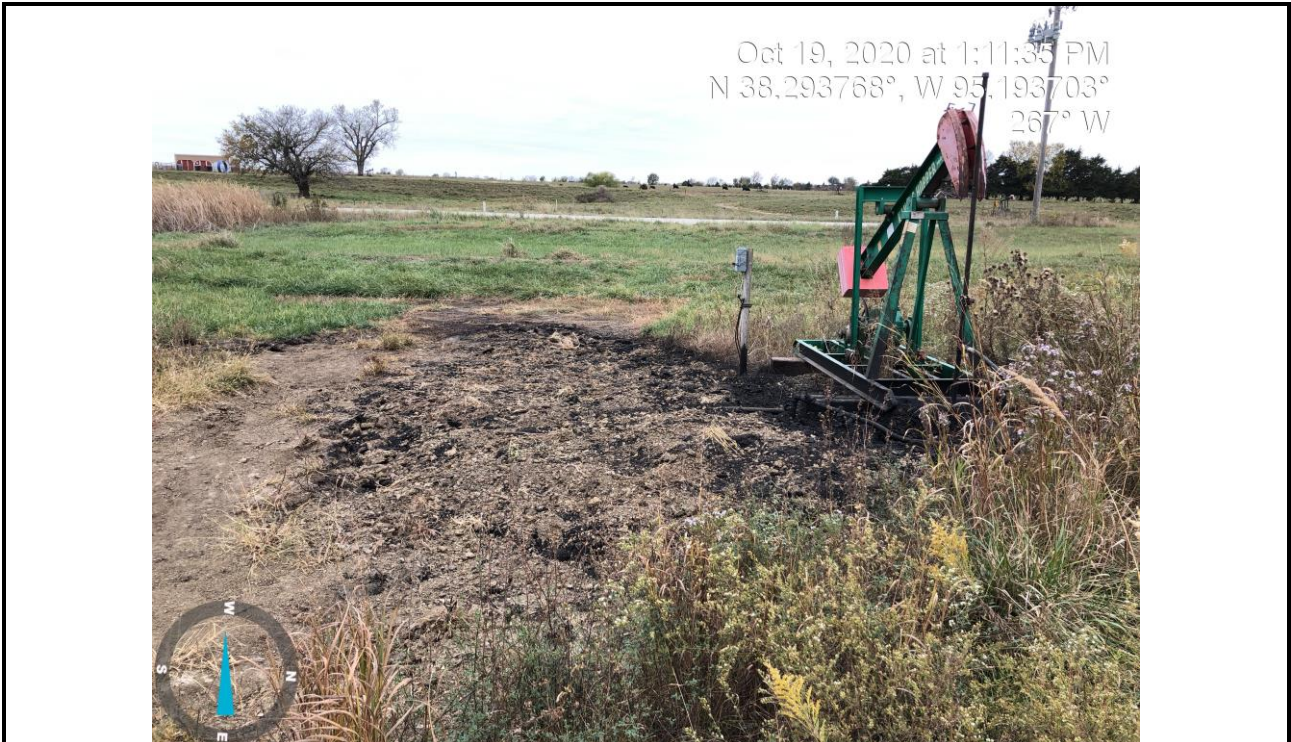
Operator: Tailwater, Inc.	KLN: 32461
Lease: Kempnich	Legal: 22-20-20E
County: Anderson	PIC ID#: IMG_0370
Subject: Remediation Site at 7-T	PIC Orientation: Facing West
FSL: 2041	Latitude: 38.293726
FEL: 5167	Longitude: -95.193840
API#: 15-003-24651	
Date: 10-19-2020	Time: 1:11 PM
Staff: Taylor Herman

Additional Information: Produced fluids leak from well head. Brine impacted soils evident from stunted or non-existent vegetation.

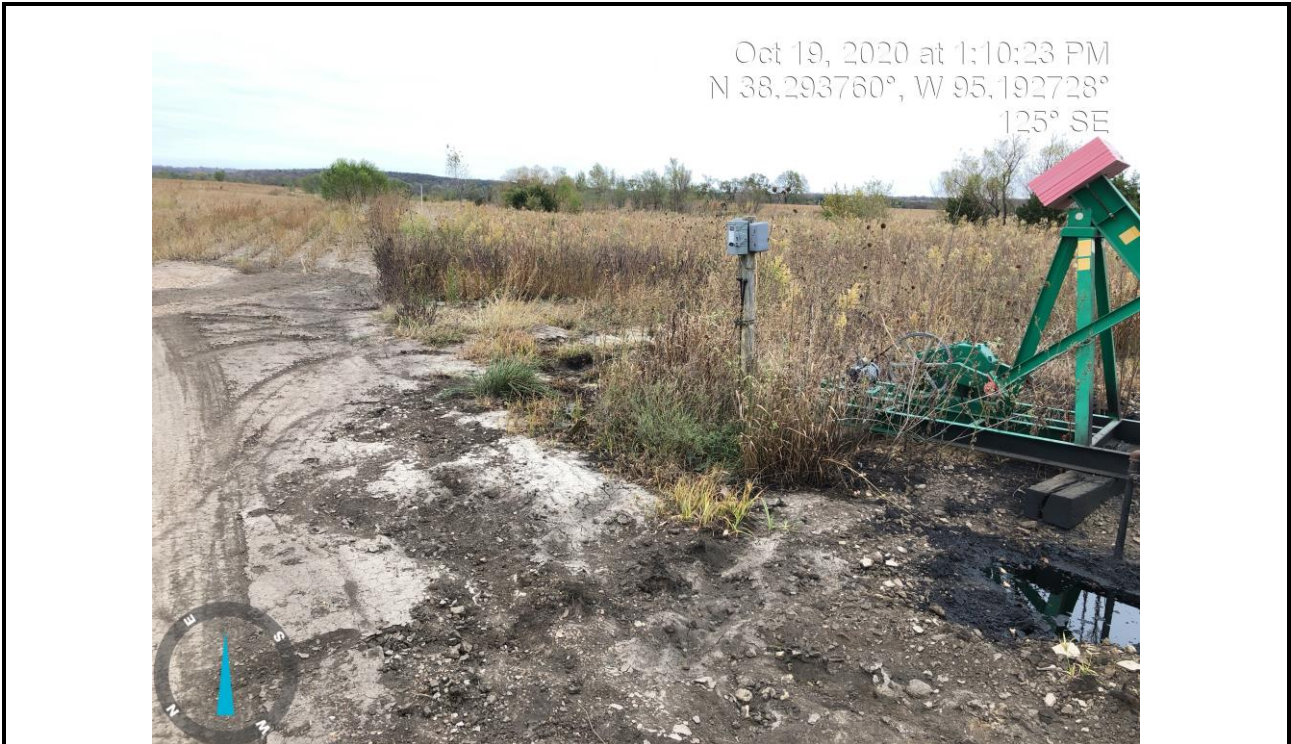
Operator: Tailwater, Inc.	KLN: 32461
Lease: Kempnich	Legal: 22-20-20E
County: Anderson	PIC ID#: IMG_0369
Subject: Remediation Site at 8-T	PIC Orientation: Facing East
FSL: 2056	Latitude: 38.293754
FEL: 4804	Longitude: -95.192574
API#: 15-003-24652	
Date: 10-19-2020	Time: 1:10 PM
Staff: Taylor Herman

Additional Information: Brine impacted soils evident from stunted or non-existent crop growth.

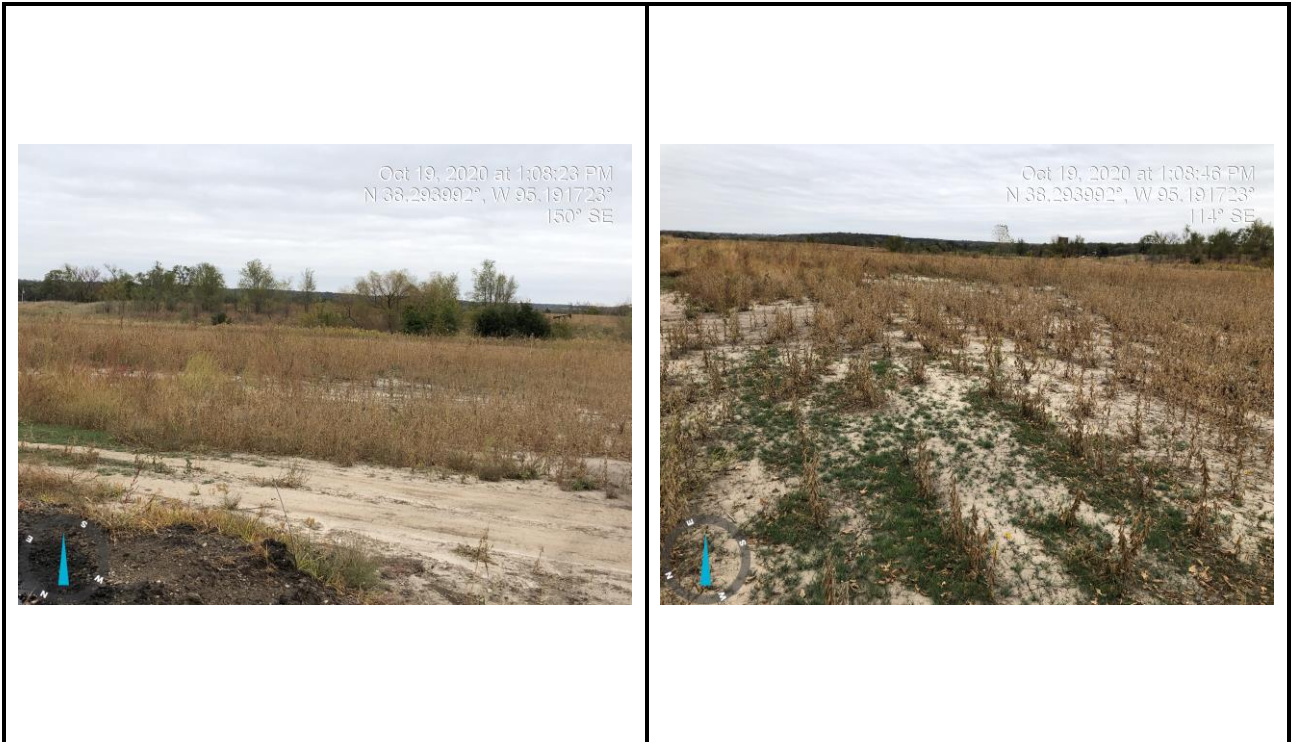
Additional Information: Brine impacted soils evident from stunted or non-existent crop growth.

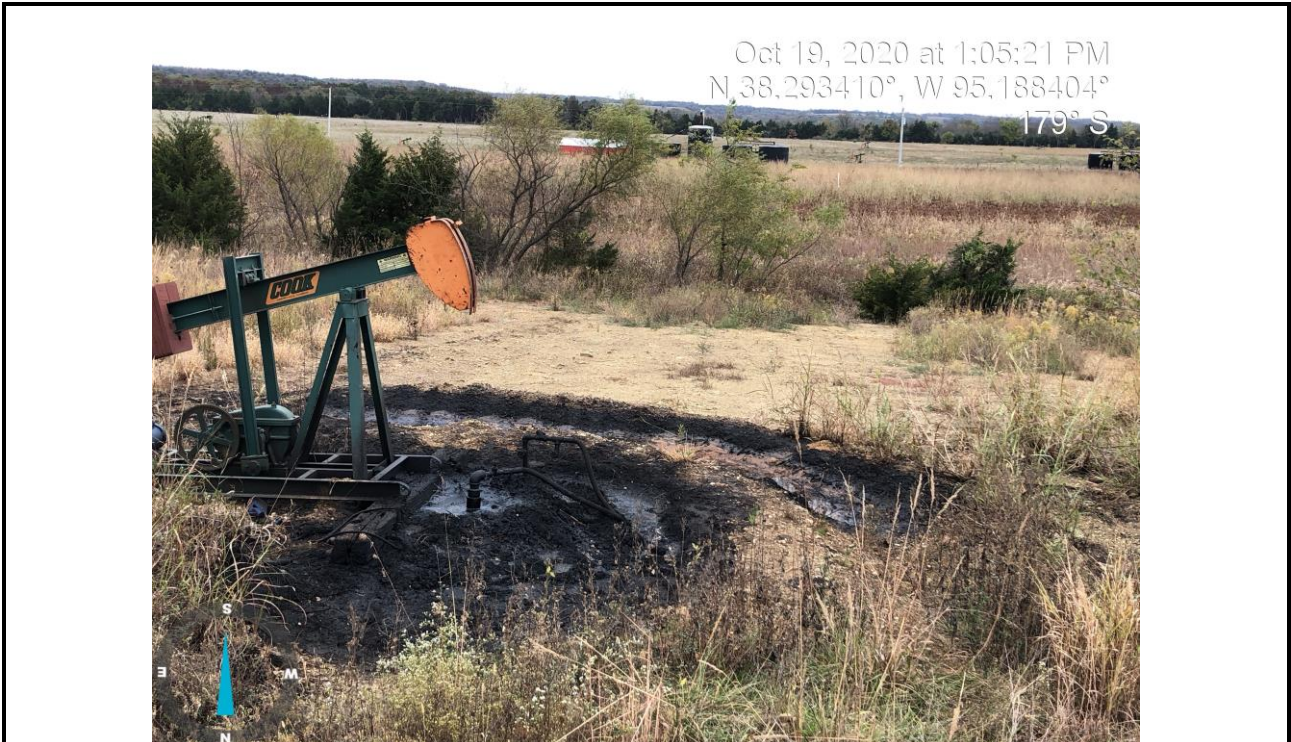
Additional Information: Produced fluids leak from well head. Brine impacted soils evident from stunted or non-existent vegetation growth.

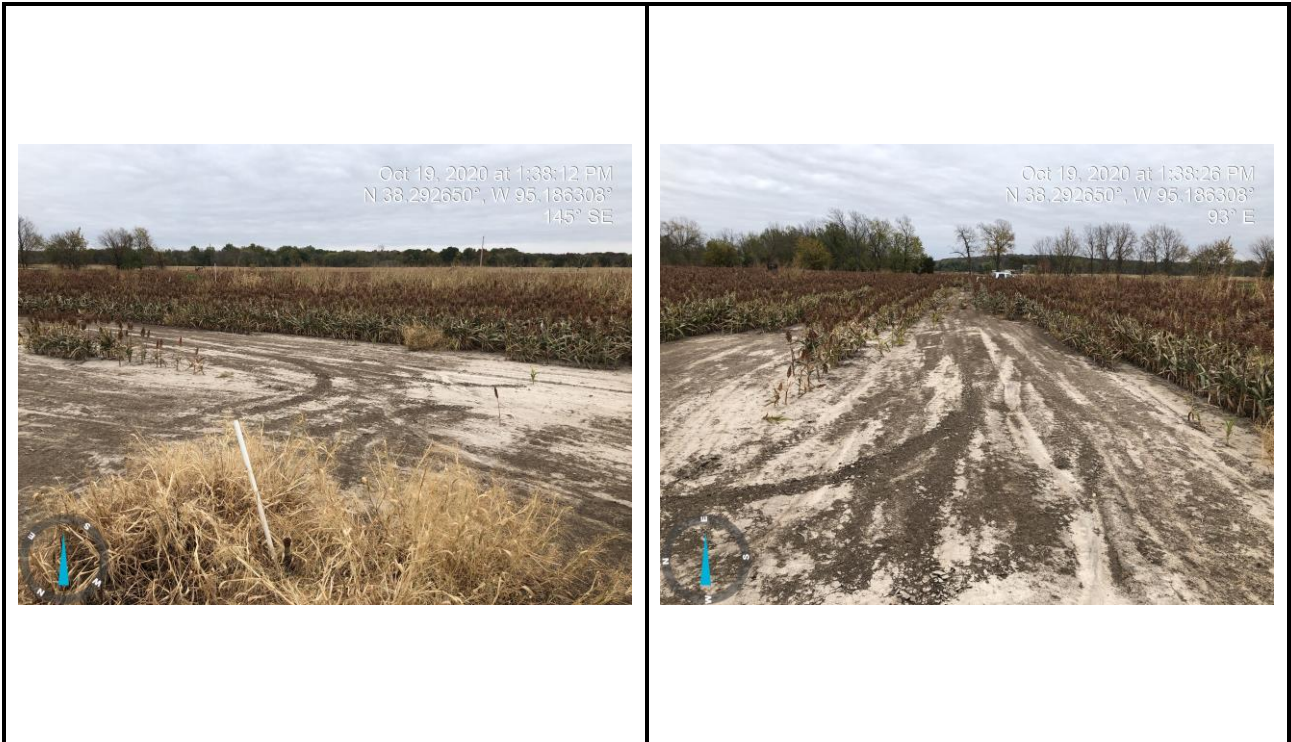
Additional Information: Brine impacted soils evident from stunted or non-existent crop growth.

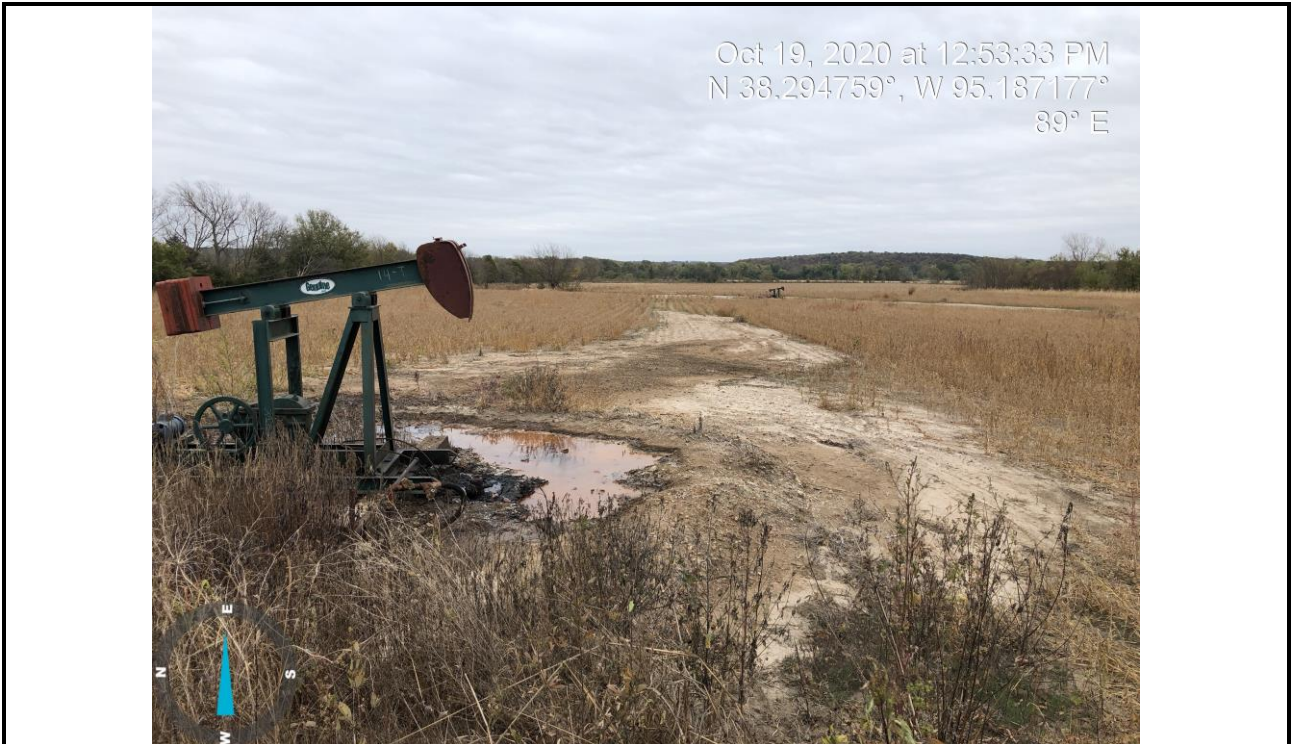
Operator: Tailwater, Inc.	KLN: 32461
Lease: Kempnich	Legal: 22-20-20E
County: Anderson	PIC ID#: IMG_0360
Subject: Remediation Site at 14-T	PIC Orientation: Facing East
FSL: 2334	Latitude: 38.29474
FEL: 3188	Longitude: -95.18695
API#: 15-003-25017	
Date: 10-19-2020	Time: 12:53 PM
Staff: Taylor Herman

Additional Information: Brine impacted soils evident from stunted or non-existent crop growth.

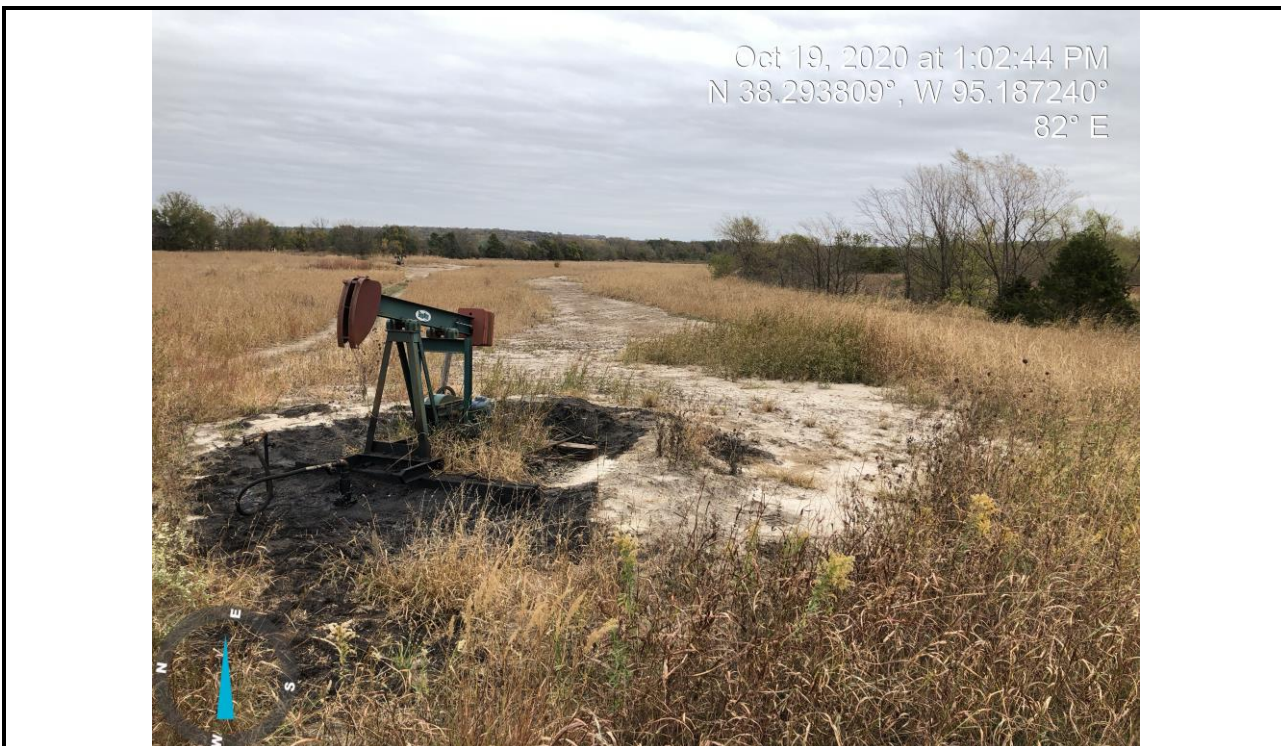
Operator: Tailwater, Inc.	KLN: 32461
Lease: Kempnich	Legal: 22-20-20E
County: Anderson	PIC ID#: IMG_0365
Subject: Remediation Site at 15-T	PIC Orientation: Facing East
FSL: 2110	Latitude: 38.29474
FEL: 3256	Longitude: -95.18695
API#: 15-003-25018	
Date: 10-19-2020	Time: 1:02 PM
Staff: Taylor Herman

Additional Information: Brine impacted soils evident from stunted or non-existent crop growth. Composite soil sample electrical conductivity 9.20 mS/cm.

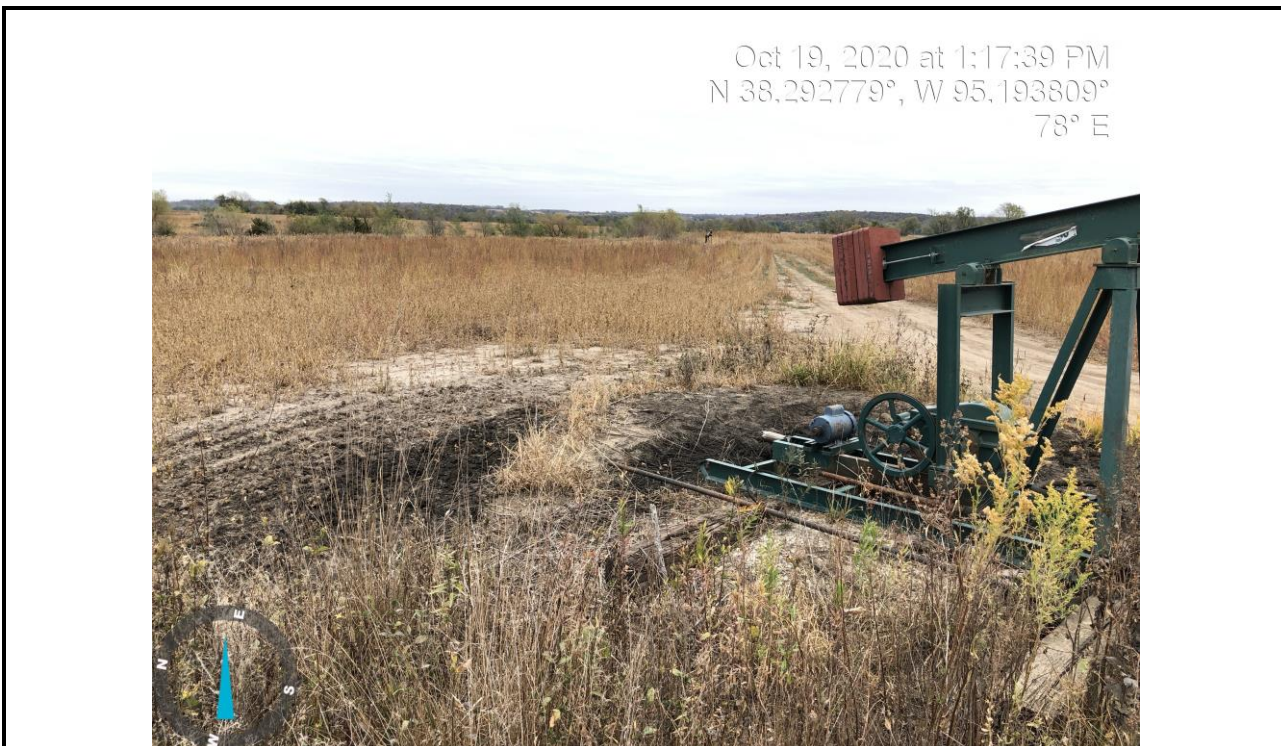
Additional Information: Produced fluids leak from well head. Brine impacted soils evident from stunted or non-existent crop growth.

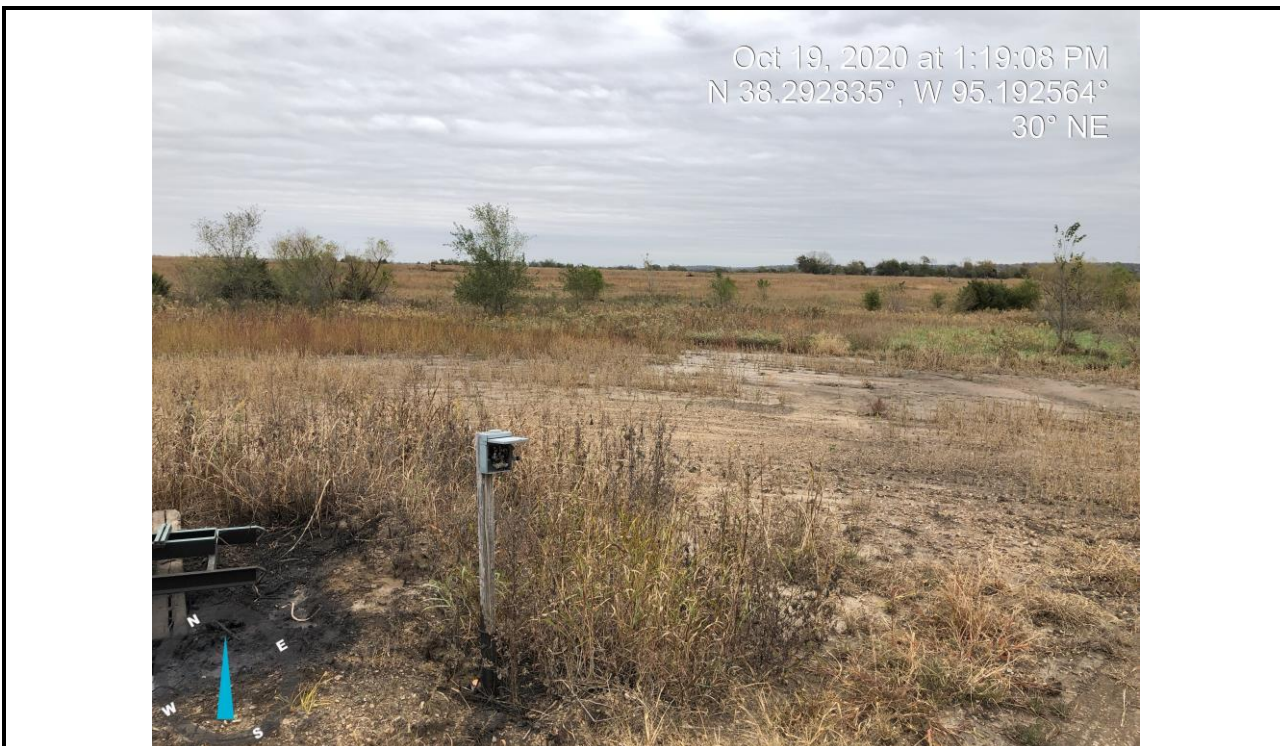
Additional Information: Brine impacted soils evident from stunted or non-existent crop growth.

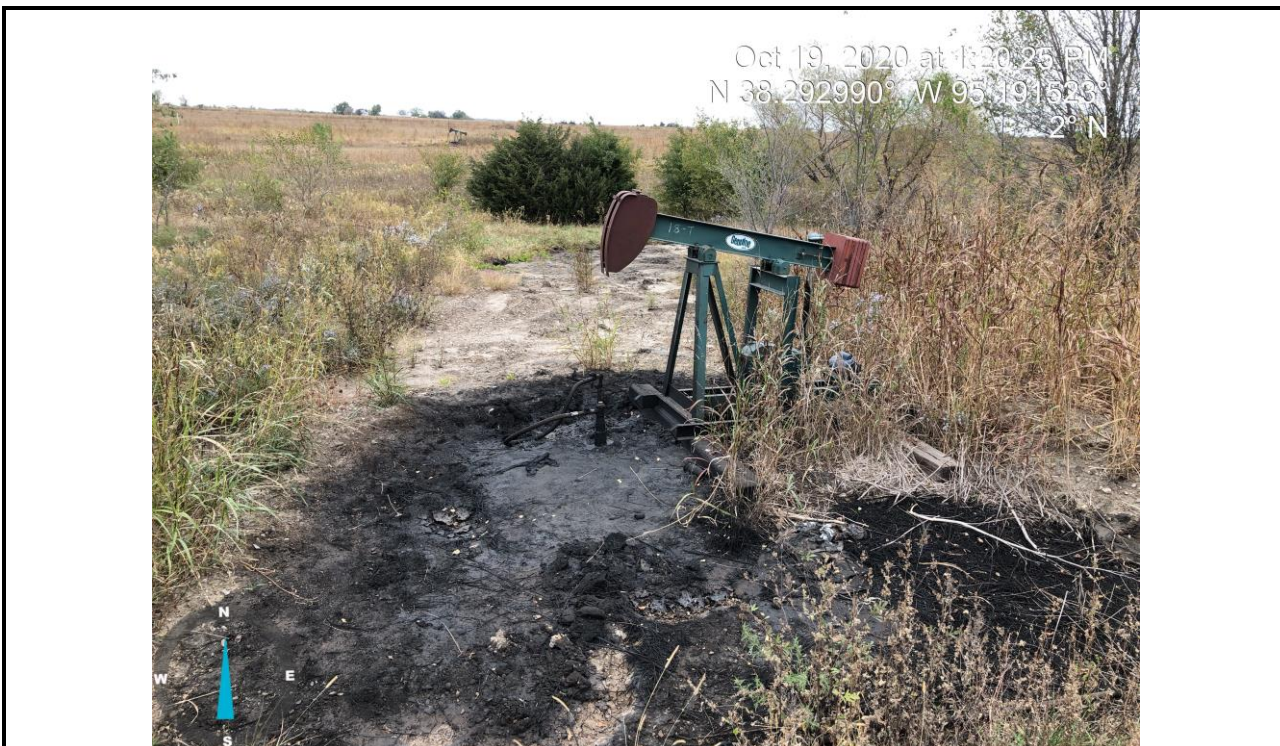
Additional Information: Produced fluids leak from well head. Brine impacted soils evident from stunted or non-existent vegetation growth.

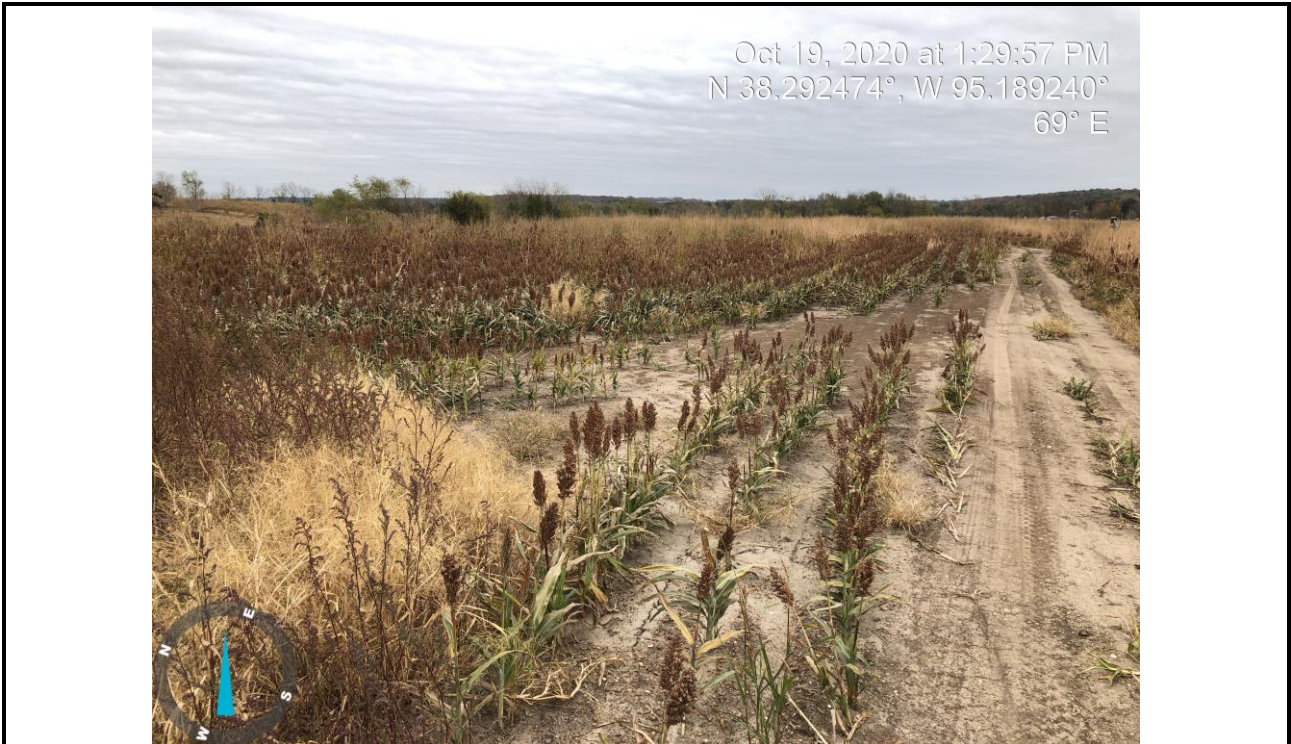
Additional Information: Brine impacted soils evident from stunted or non-existent crop growth.

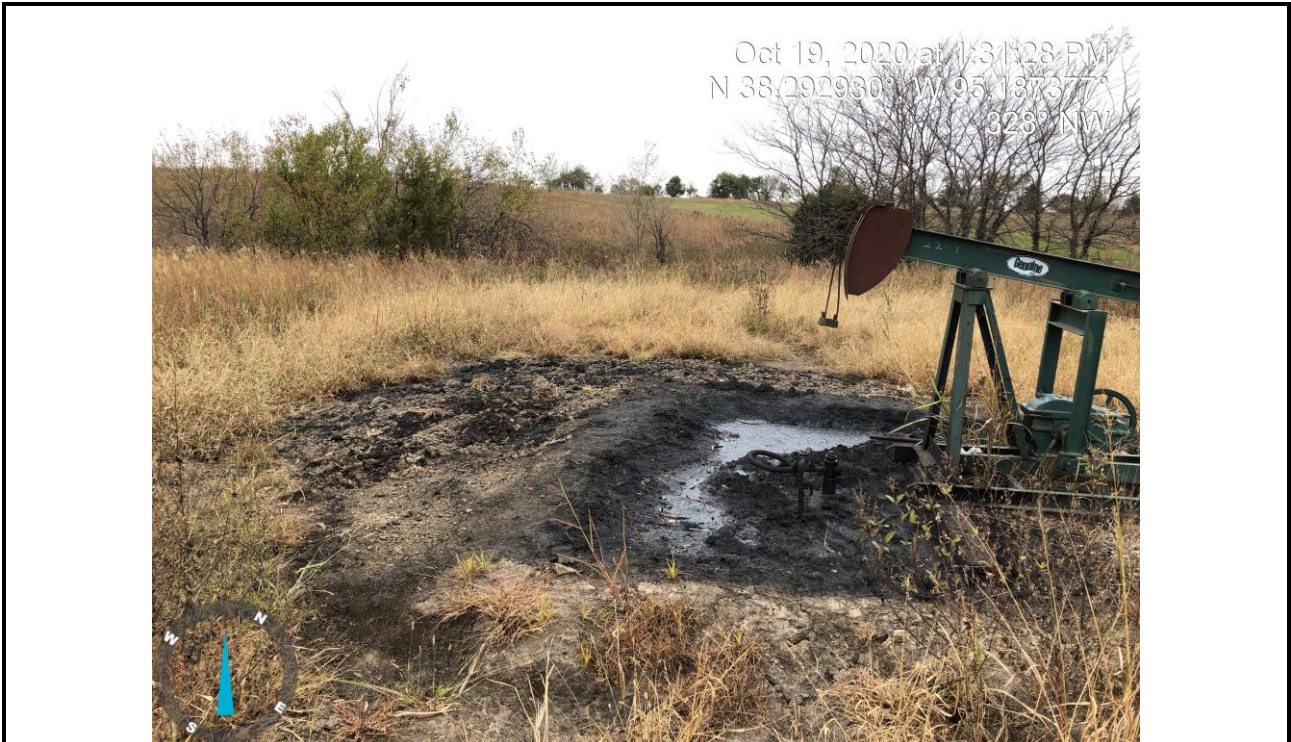
Additional Information: Produced fluids leak from well head. Brine impacted soils evident from stunted or non-existent crop growth.

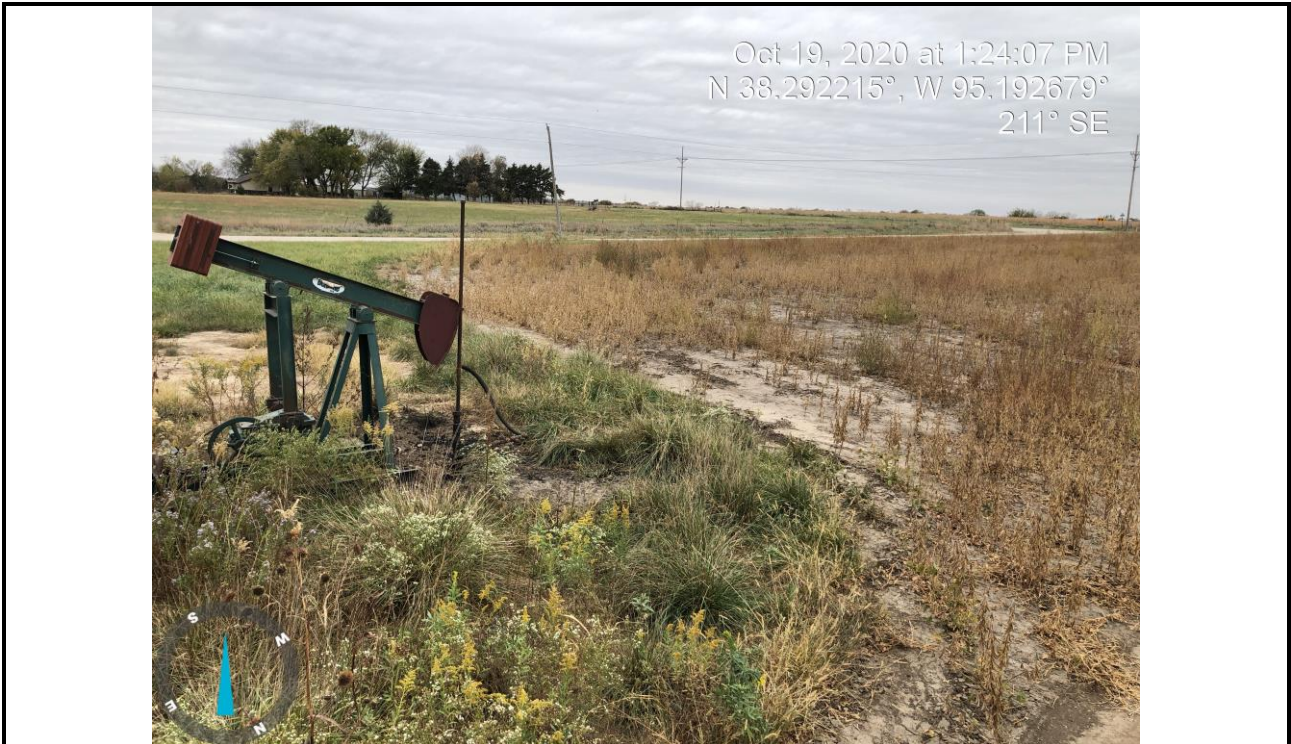
Additional Information: Brine impacted soils evident from stunted or non-existent crop growth.

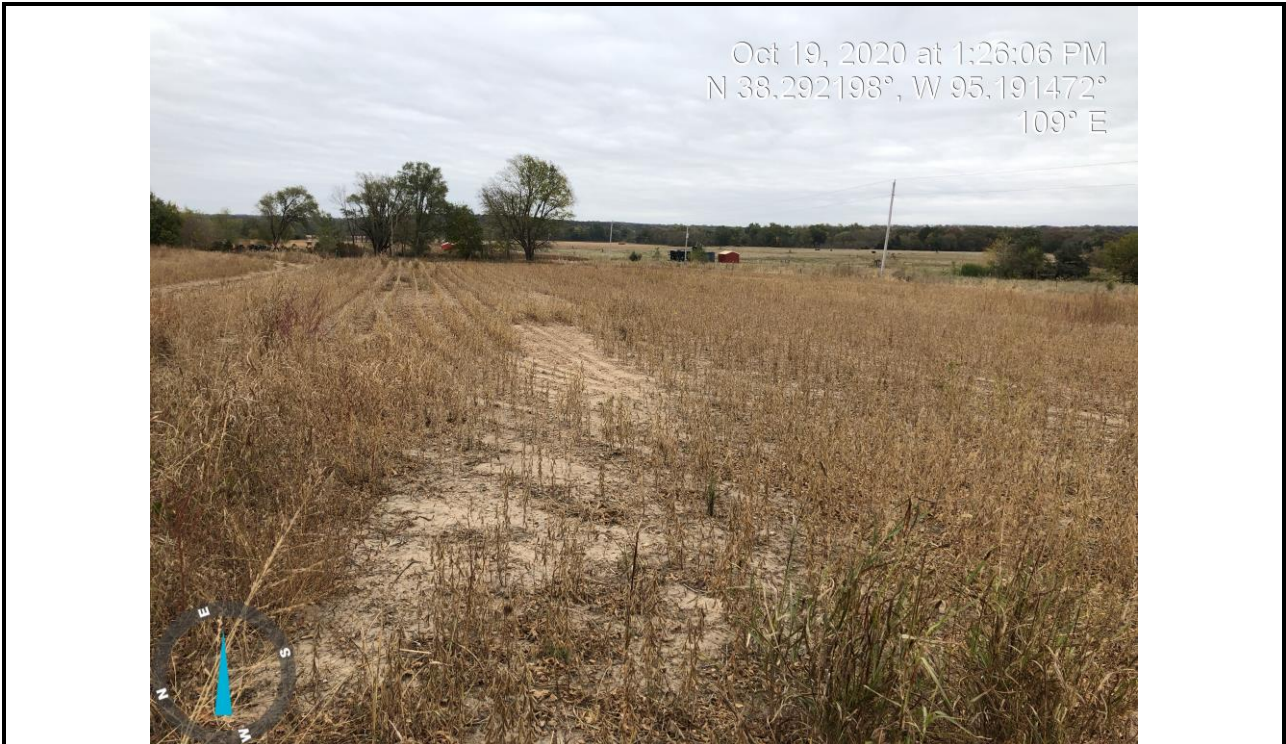
Additional Information: Brine impacted soils evident from stunted or non-existent crop growth.

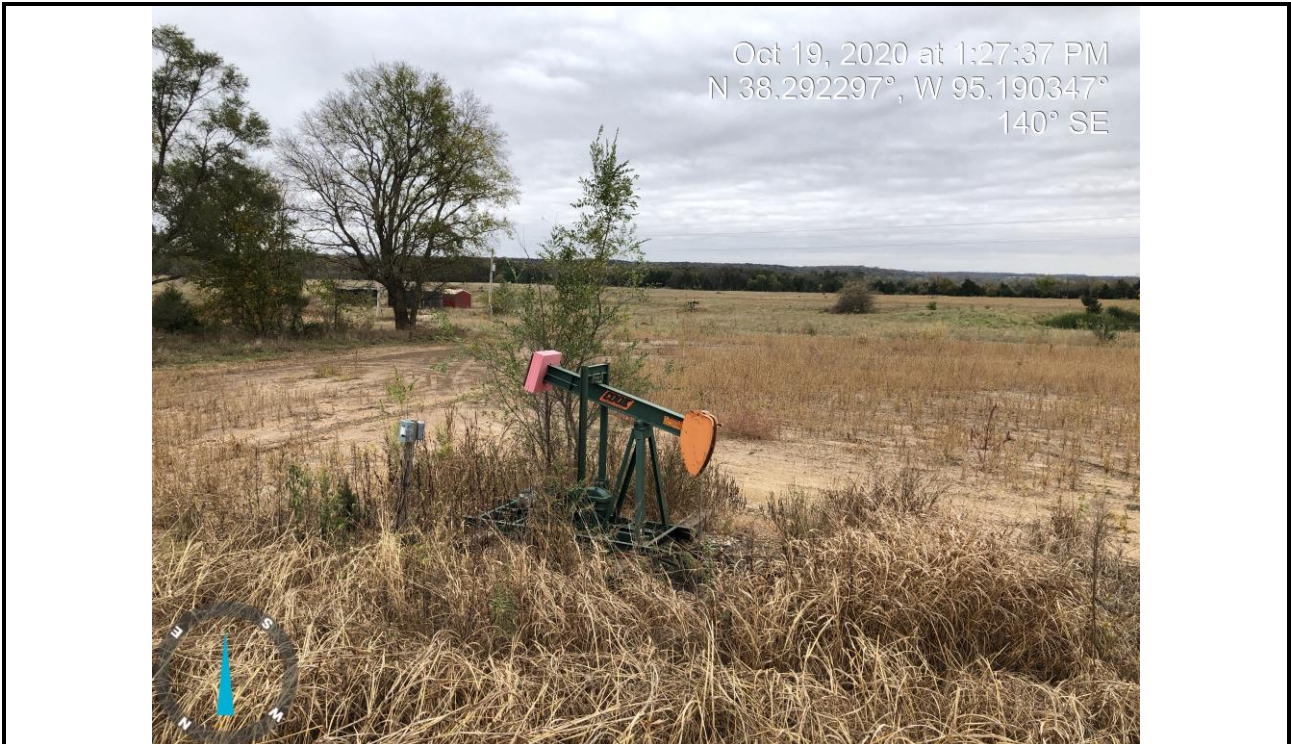
Additional Information: Brine impacted soils evident from stunted or non-existent crop growth.

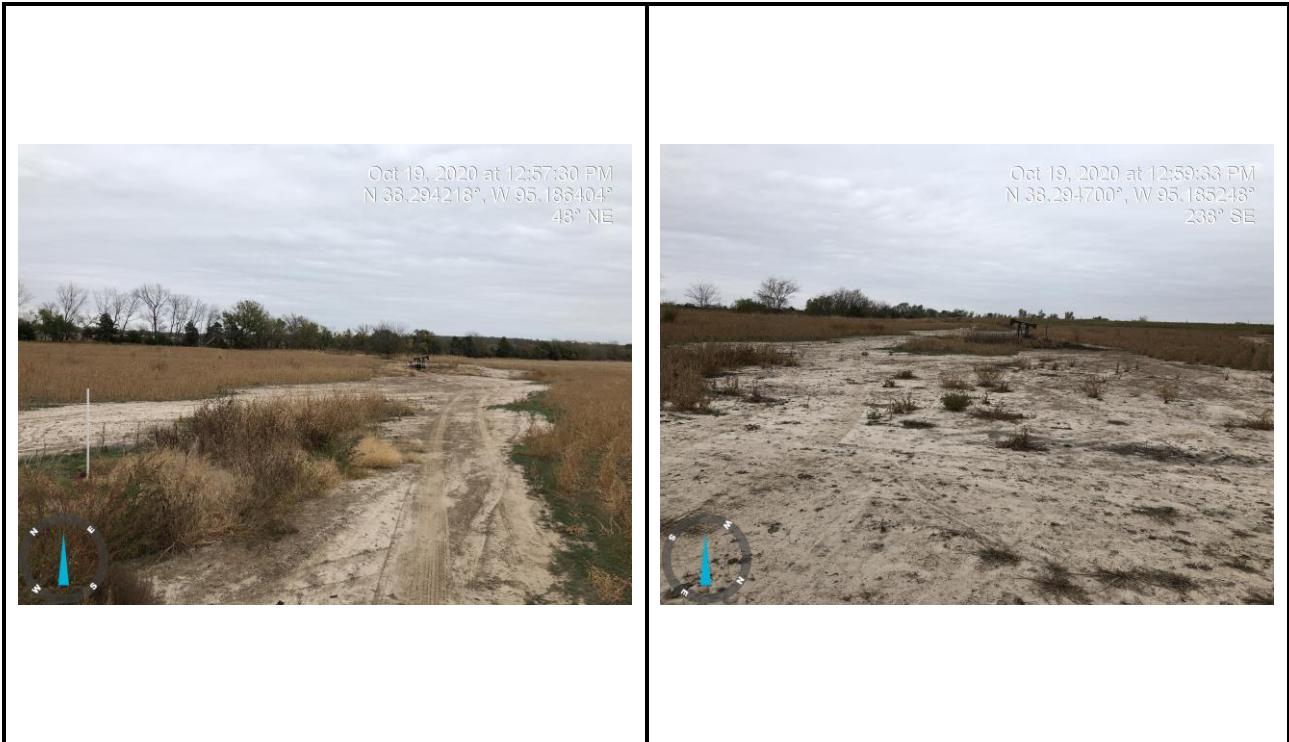
Additional Information: Brine impacted soils evident from stunted or non-existent crop growth.

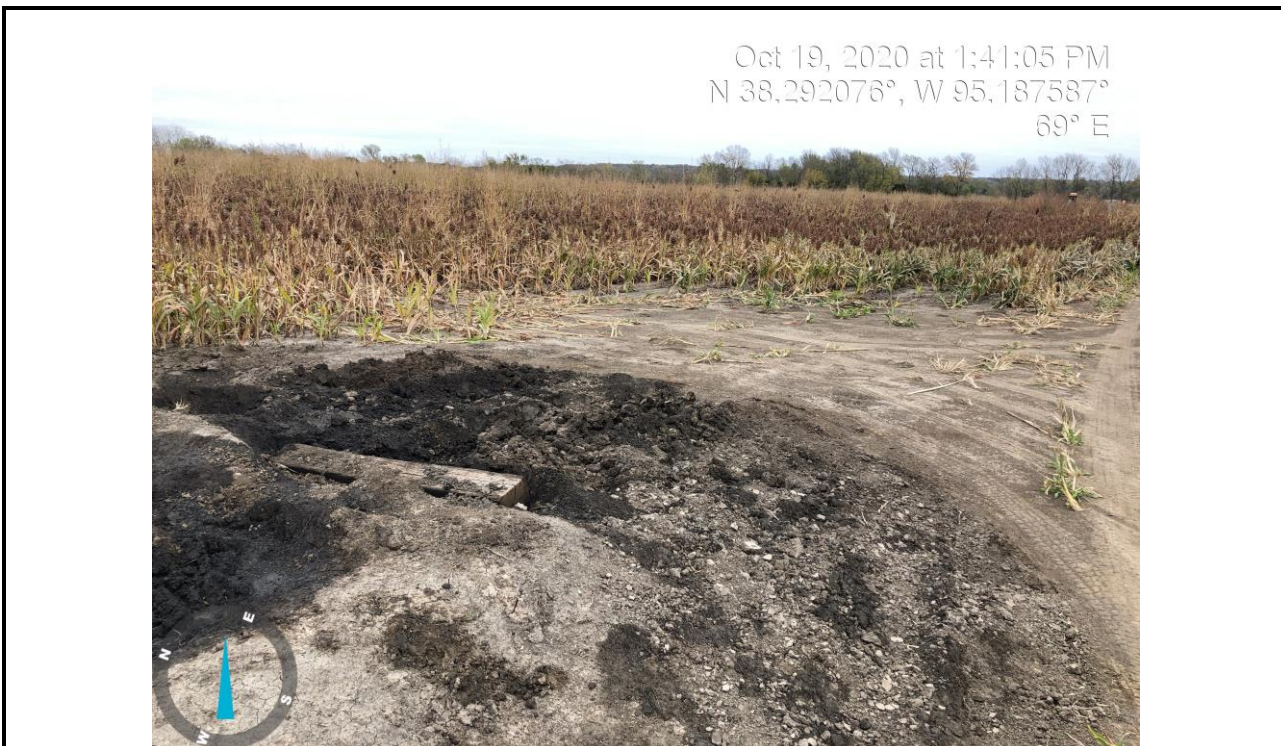
Additional Information: Produced fluids leak from well head. Brine impacted soils evident from stunted or non-existent crop growth.
