**BEFORE THE STATE CORPORATION COMMISSION  
OF THE STATE OF KANSAS**

In the matter of the failure of Tailwater, Inc.	)	Docket No. 21-CONS-3032-CPEN
(Operator) to comply with K.A.R. 82-3-603 at	)	
the South Kempnich Lease in Anderson County,	)	CONSERVATION DIVISION
Kansas.	)	
_____	)	License No. 32461

**PRE-FILED DIRECT TESTIMONY**

**TAYLOR HERMAN**

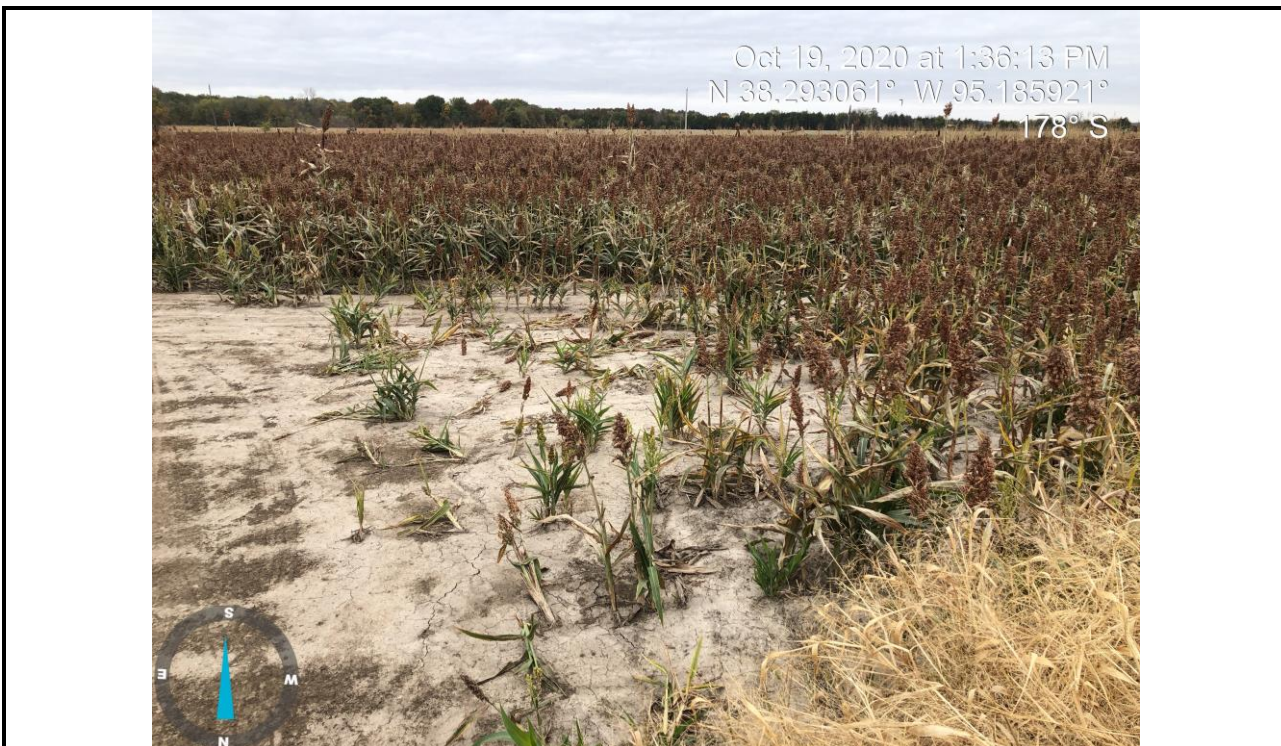
Additional Information: Brine impacted soils evident from stunted or non-existent crop growth.

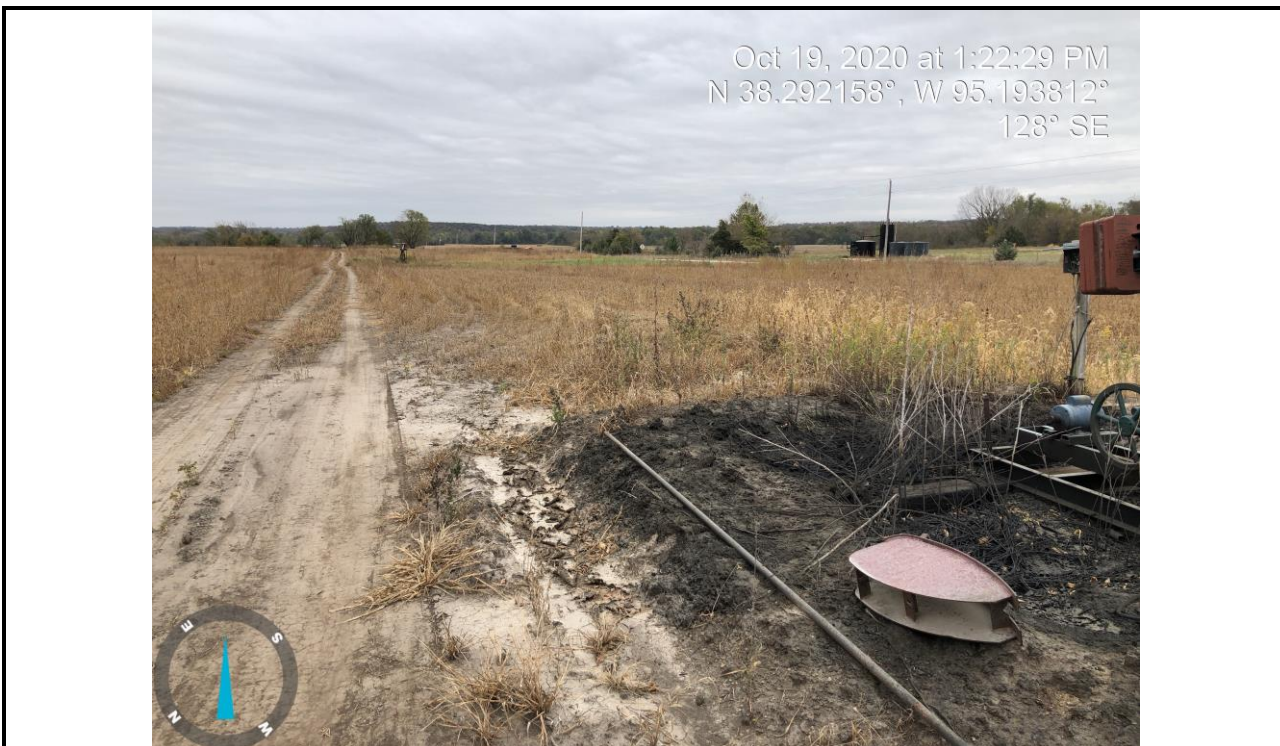
Additional Information: Produced fluids leak from well head. Brine impacted soils evident from stunted or non-existent crop growth.

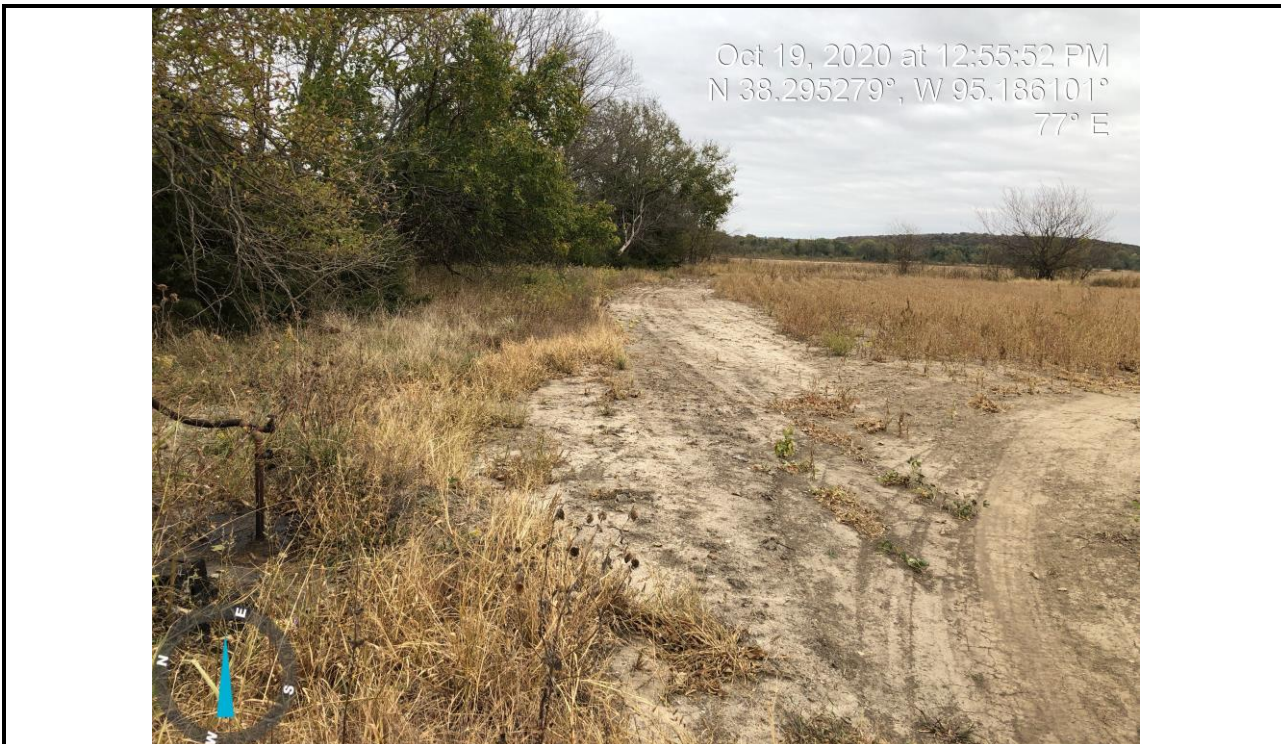
Operator: Tailwater, Inc.	KLN: 32461
Lease: Kempnich	Legal: 22-20-20E
County: Anderson	PIC ID#: IMG_0361
Subject: Remediation Site at 29-T	PIC Orientation: Facing East
FSL: 2625	Latitude: 38.29525
FEL: 2711	Longitude: -95.18529
API#: 15-003-25164	
Date: 10-19-2020	Time: 12:55 PM
Staff: Taylor Herman

Additional Information: Brine impacted soils evident from stunted or non-existent crop growth.

The last date of remediation performed by the operator was on 12-11-2019 when 800 pounds of gypsum were applied at spill site 29-T. The operator spread the gypsum on to the soil but did not incorporate it through tillage.

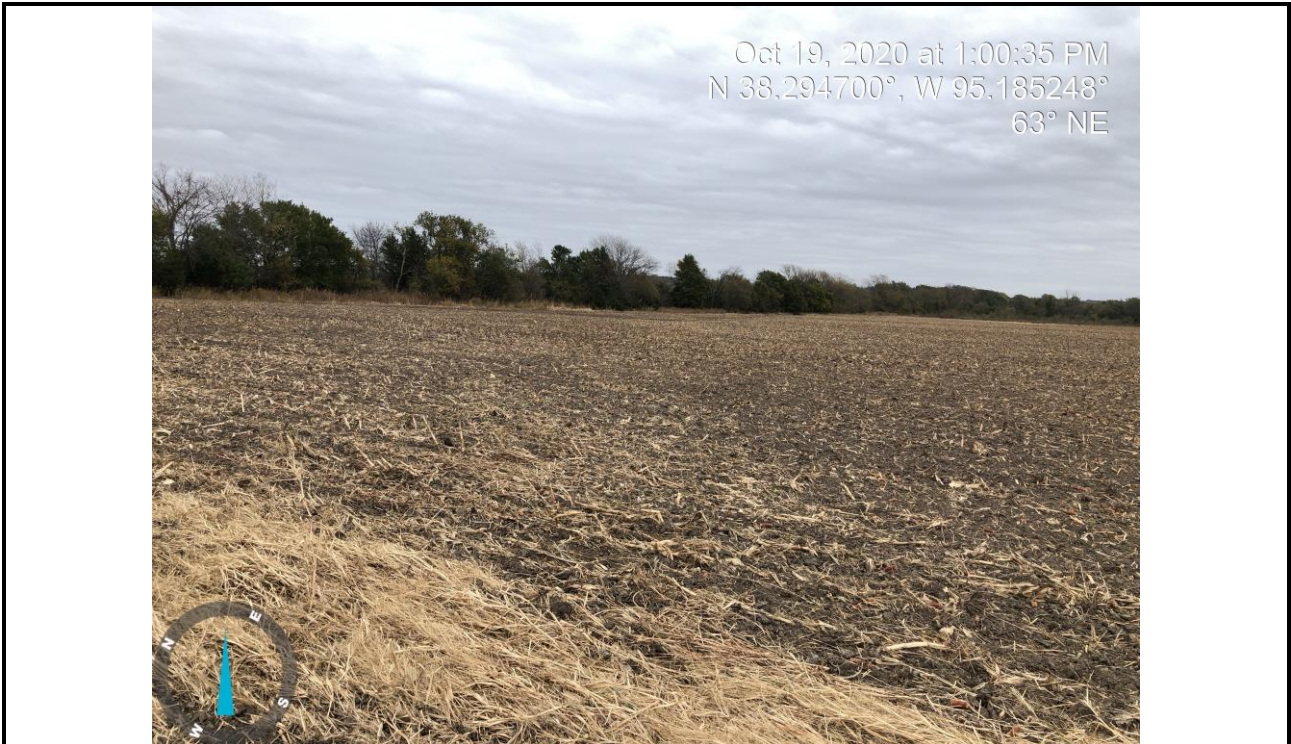
Additional Information: Corn cut along previous spill area.

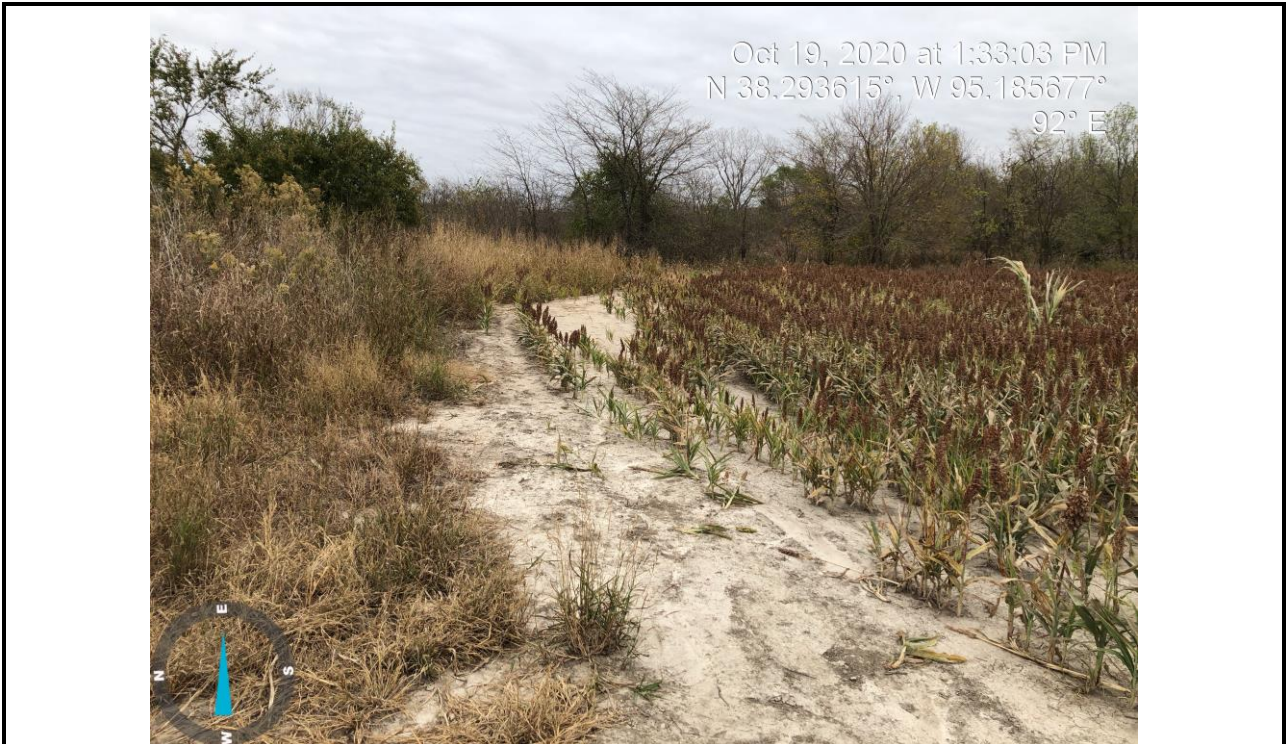
Additional Information: Brine impacted soils evident from stunted or non-existent crop growth.

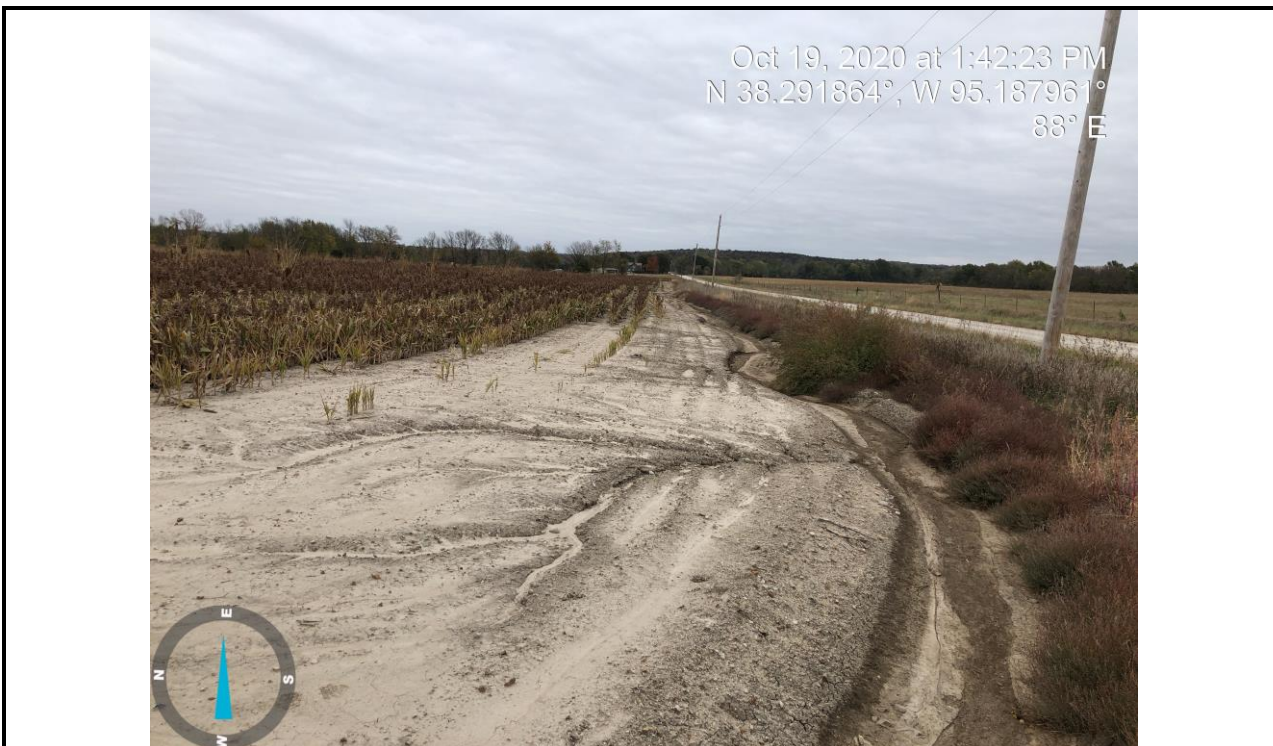
Additional Information: Brine impacted soils evident from stunted or non-existent crop growth.
