**BEFORE THE STATE CORPORATION COMMISSION
OF THE STATE OF KANSAS**

PRE-FILED REBUTTAL TESTIMONY OF

TROY RUSSELL

KCC DISTRICT III OFFICE FIELD REPORT PHOTO ID FORM

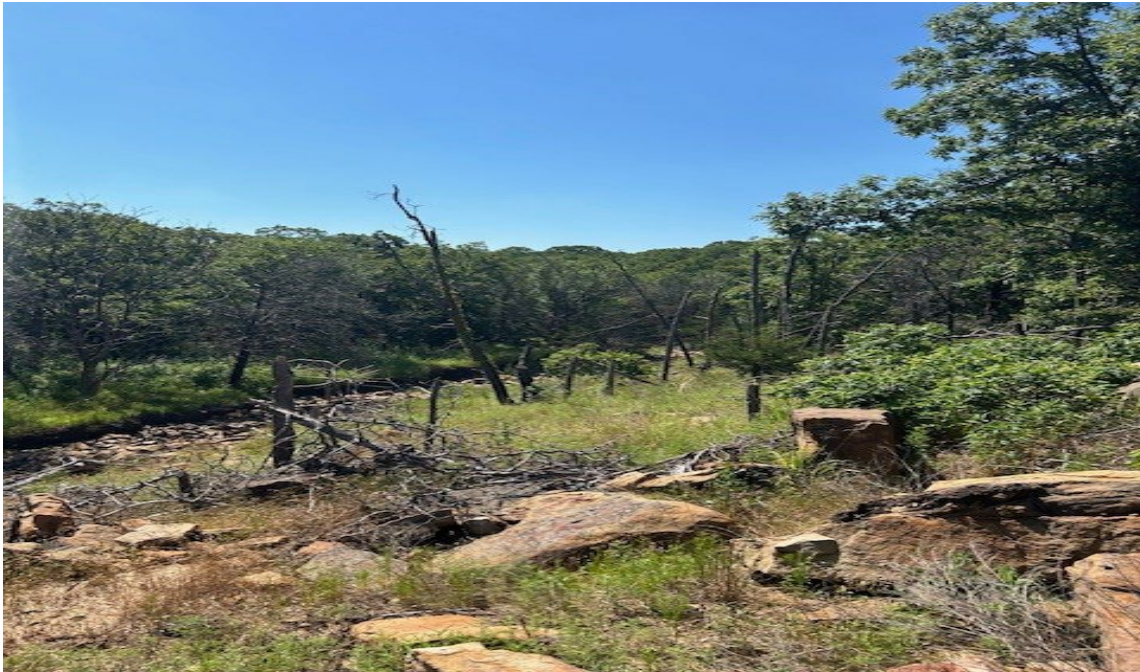
Picture taken to show the spill path that runs east of the Sears #33.
