**BEFORE THE STATE CORPORATION COMMISSION  
OF THE STATE OF KANSAS**

In the Matter of the Complaint Against                     )  
KCP&L by Stephen and Karen                     )     Docket No. 15-KCPE-544-COM  
Gradwohl.                     )

**NOTICE OF FILING OF STAFF REPORT & RECOMMENDATION**

**SUBJECT:** 15-KCPE-544-COM: In the Matter of the Complaint Against Kansas City Power & Light by In the Matter of the Complaint by Stephen and Karen Gradwohl

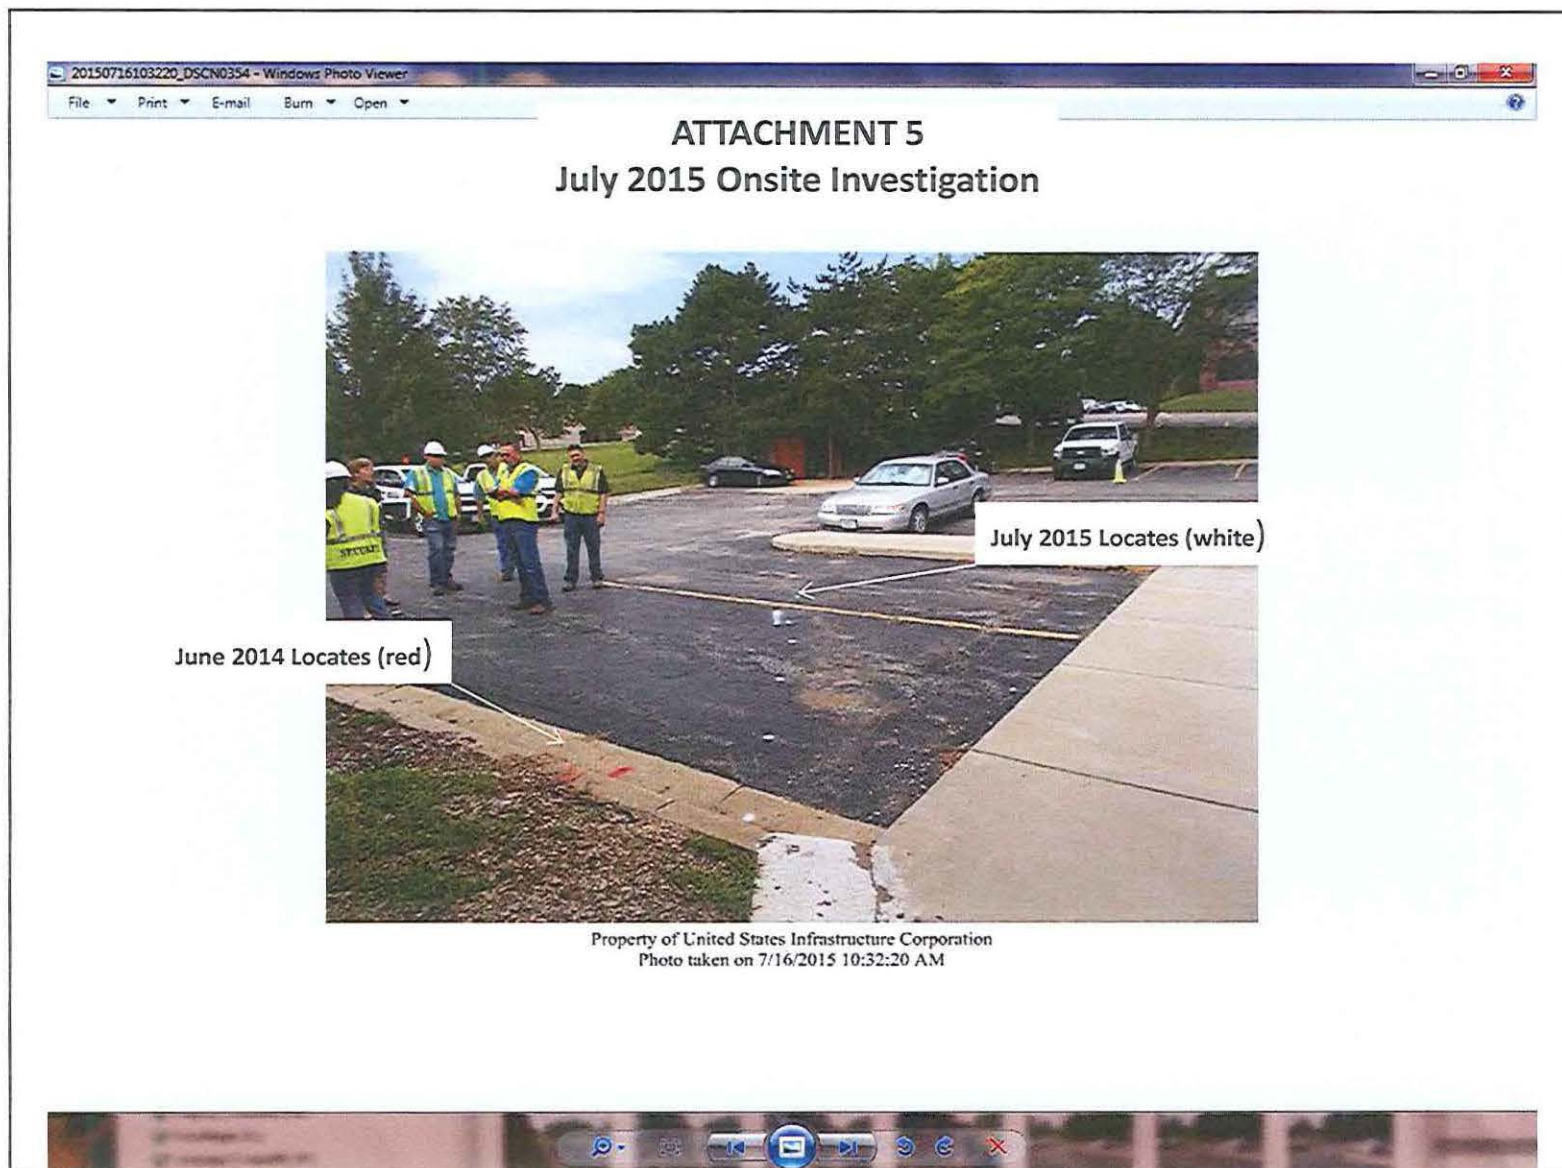
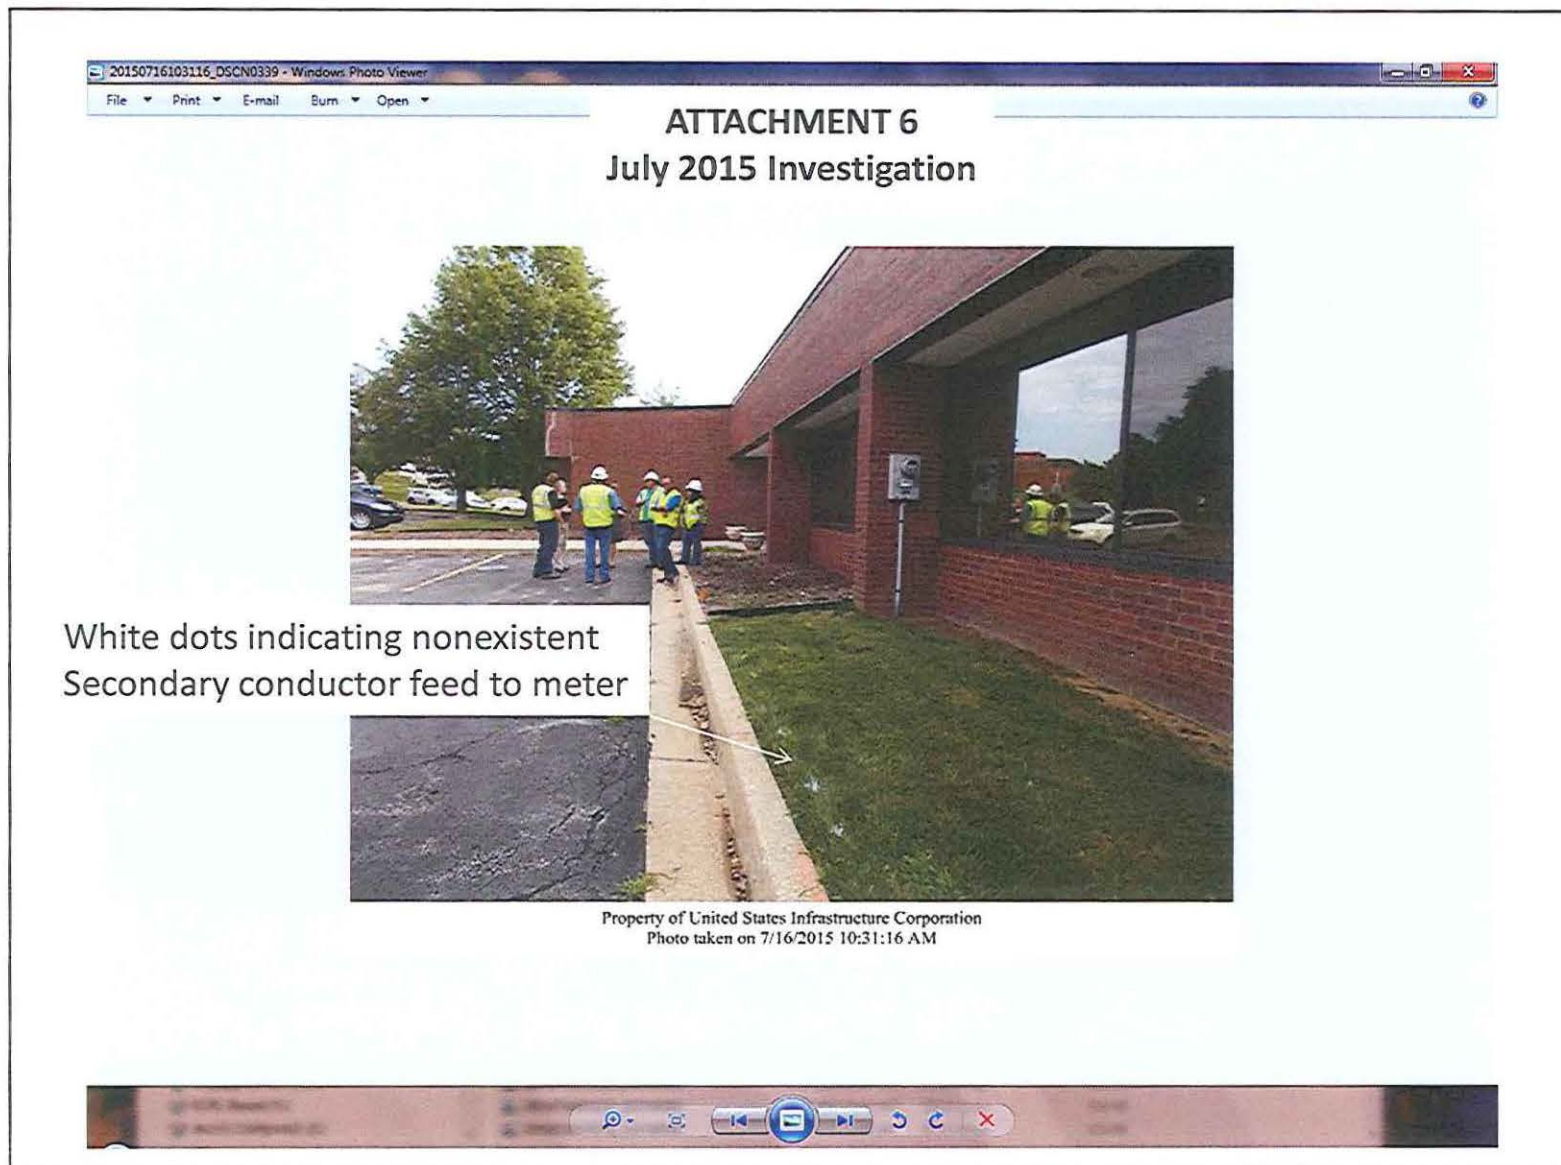
Property of United States Infrastructure Corporation  
Photo taken on 6/8/2014 8:26:50 AM

Date/ Time	Description
June 4, 2014	Duarte Irrigation requested locates to install a lawn sprinkler system with the excavation scheduled start date set at June 7, 2014.
June 8, 2014	USIC, contract locator for KCPL, provided locates of electric conductors up to the building. The locates were performed one day past the required due date. Photos of the locates done at that time incorrectly show two service drops serving the customer. <sup>1</sup>
June 14, 2014/ approx. 11:00am	Duarte damaged the secondary electric conductor serving 11791 West 112 <sup>th</sup> Street.
June 14, 2014/ 12:05 pm	KCPL is alerted to a loss of service at 11791 West 112 <sup>th</sup> Street indicating two customers had lost service.
June 14, 2014/ 5:31 pm	Duarte called for emergency locates indicating an electric power line had been damaged.
June 14, 2014/ 8:27 pm	Contract locator employed by KCPL arrived on site to provide additional locates of buried utilities. The locator did not re-mark anything but noted that the facilities in question appeared to be private and not KCPL facilities. The locator also noted there was not a dig in or damaged cable at the time of their investigation; however, photo taken by locator corresponds to other photos of damaged conduit.
