THE STATE CORPORATION COMMISSION OF THE STATE OF KANSAS

In the matter of the failure of Benjamin M. Giles ("Operator") to comply with K.A.R. 82-3-104 and K.A.R. 82-3-111 at the Flying J Geer #2 OWWO well in Butler County, Kansas.	Docket No.: 17-CONS-3684-CPEN CONSERVATION DIVISION License No.: 5446
In the matter of the failure of Benjamin M. Giles ("Operator") to comply with K.A.R. 82-3-111 at the Paulsen #1 in Butler County, Kansas.	Docket No.: 18-CONS-3057-CPEN CONSERVATION DIVISION License No.: 5446
In the matter of the failure of Benjamin M. Giles ("Operator") to comply with K.A.R. 82-3-604 at the Ralston Lease Tank Battery in Butler County, Kansas.	Docket No.: 18-CONS-3160-CPEN CONSERVATION DIVISION License No.: 5446
In the matter of the failure of Benjamin M. Giles ("Operator") to comply with K.A.R. 82-3-104 and K.A.R. 82-3-111 at the Wright #1 OWWO well in Butler County, Kansas.	Docket No.: 18-CONS-3167-CPEN CONSERVATION DIVISION License No.: 5446

PRE-FILED TESTIMONY OF JONATHAN HILL

APRIL 23, 2018

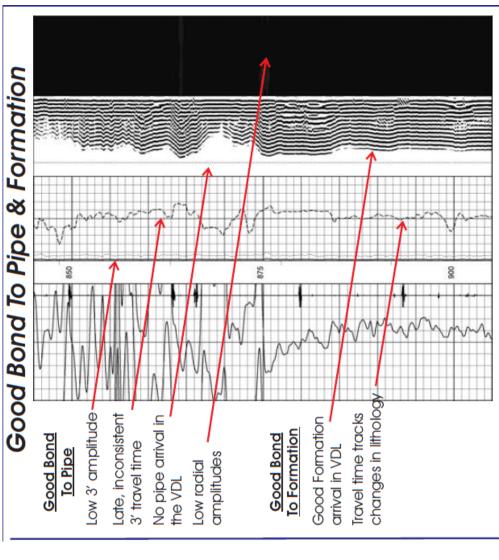
Cement Bond Log Quick Reference

Good Bond To Pipe & Formation - Good bond to pipe is characterized by a low 3' amplitude, transit times of something other than pipe arrivals (which are consistent), lack of pipe arrival in the VDL and low 2' radial amplitudes (if RBL). Good bond to formation can be assumed if the VDL exhibits strong formation arrival suggesting good acoustic coupling between cement and the surrounding formation. Travel time will also track lithology.

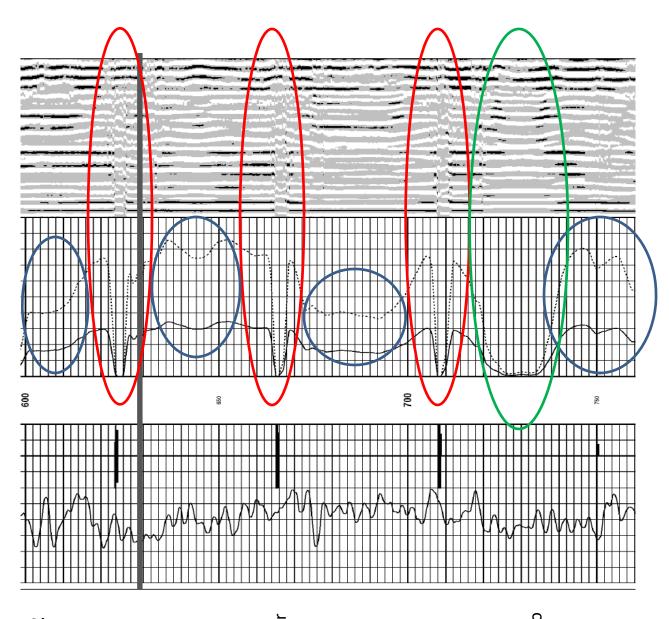
Benjamin Giles – Flying J Geer #2 Cement Bond Log (600'-760')

- Strong collar effects are observed (red ovals) in both the amplitude and VDL. This is an indication of free pipe/poor bond due to the lack of cement behind the casing.
- There is no consistent, low amplitude signal present (blue ovals indicate higher amplitudes). This is an indication free pipe/poor bond due the lack of cement behind the casing.
 - displays low amplitude, but no arrivals on the VDL indicating a lack of acoustic coupling with the casing at this depth, possibly due to an air pocket/turbulent region (green oval).
- 750' is the last depth a collar on the CCL curve is record. There is no explanation for this present in the log.

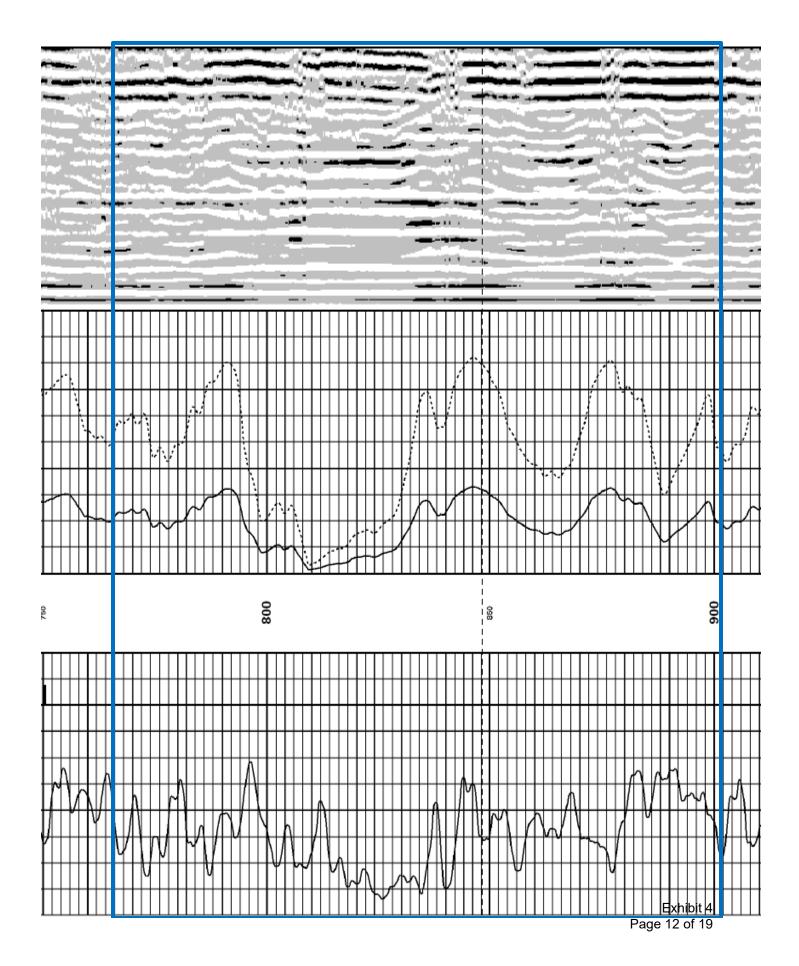
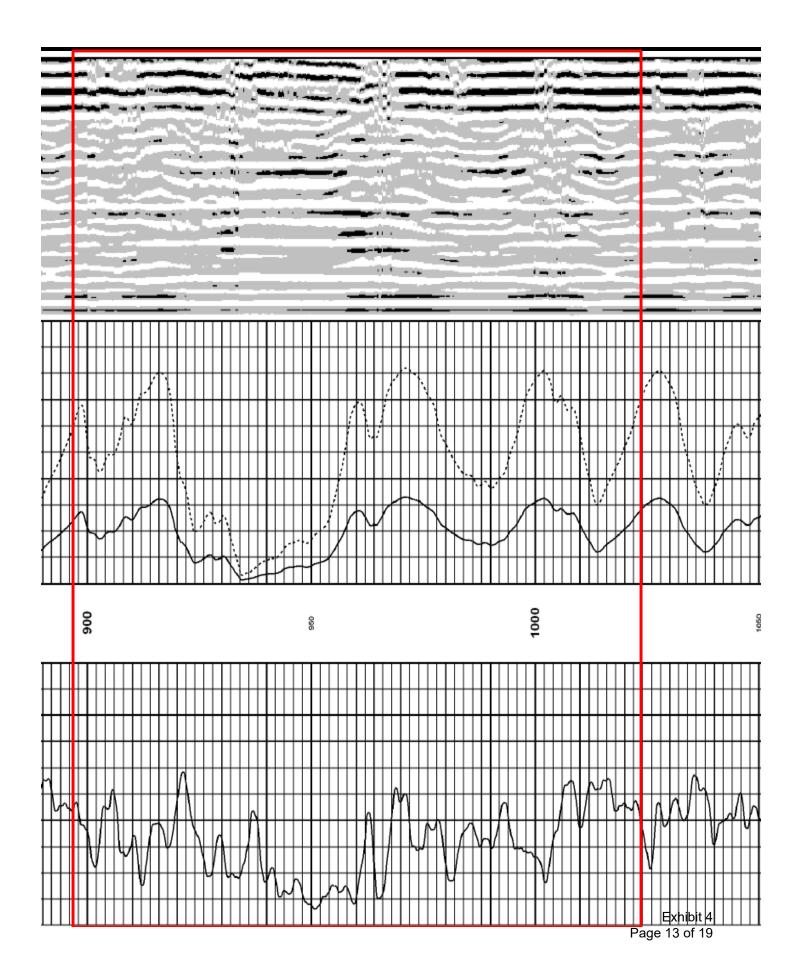
Benjamin Giles – Flying J Geer #2 Cement Bond Log (750'-910')

- There are 2 123' consecutive and identical sections of all curves in this log between the depths of 776' to 899' (Blue), and 899' to 1022' (Red).
- The only known ways for this to occur is for the log to be manipulated by either 'splicing', a computer simulated run, or the raw data was altered at the completion of the logging run.
- There are no explanations or comments about this in the log, or by the operator, as to why this -- and for what purpose-- has occurred.
- Altering the data presented in the log, with no explanations, also results the questioning the validity of the entire log.
- The next sides display the identical sections in greater detail
