NOTICE OF PENALTY ASSESSMENT
21-CONS-3032-CPEN

August 27, 2020

Re: Unreported Spills and Failure to Cleanup Spills on the South Kempnich lease located in Section 22, Township 20 South, Range 20 East, Anderson County, Kansas.

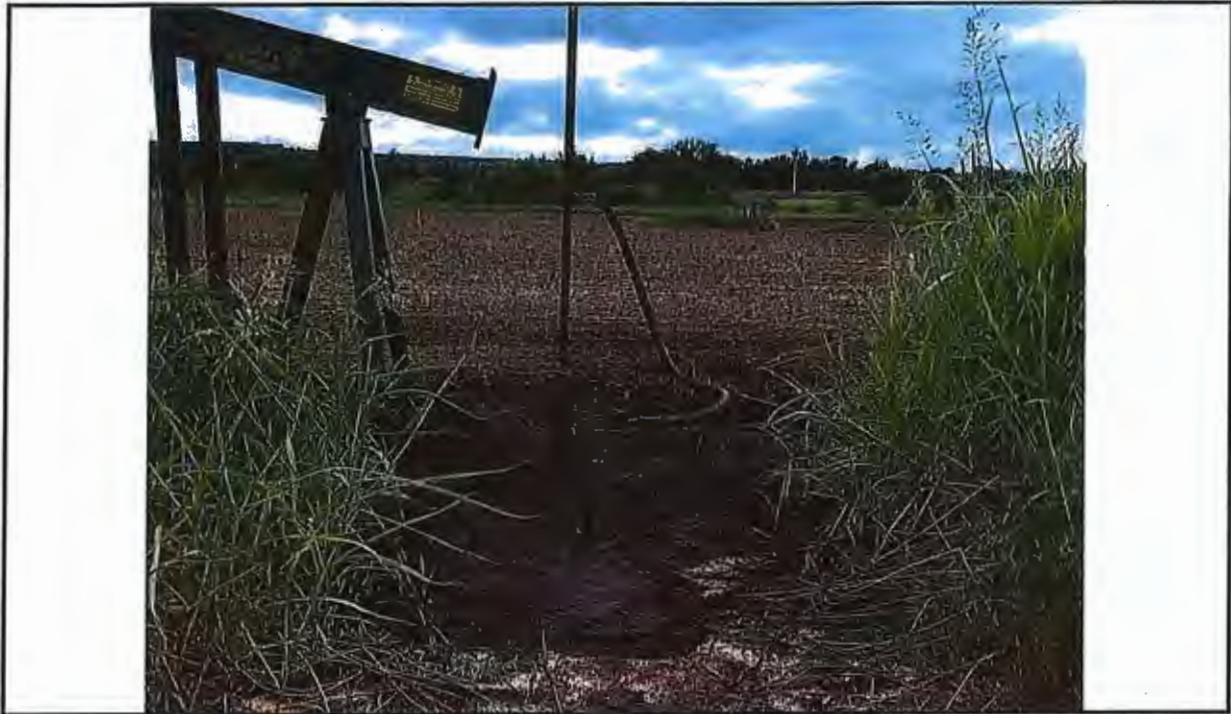
KLN: 32461
Legal: 22-20-20E
PIC ID#: 3-T
PIC Orientation:
Latitude: 38.294933
Longitude: -95.191616

Additional Information: This picture is of well location 3-T. This location has a 10' by 15' new spill. The well is leaking up the production string and is not equipped with a stuffing box. At the time of inspection well was not equipped for production. The pump jack did not have a head.

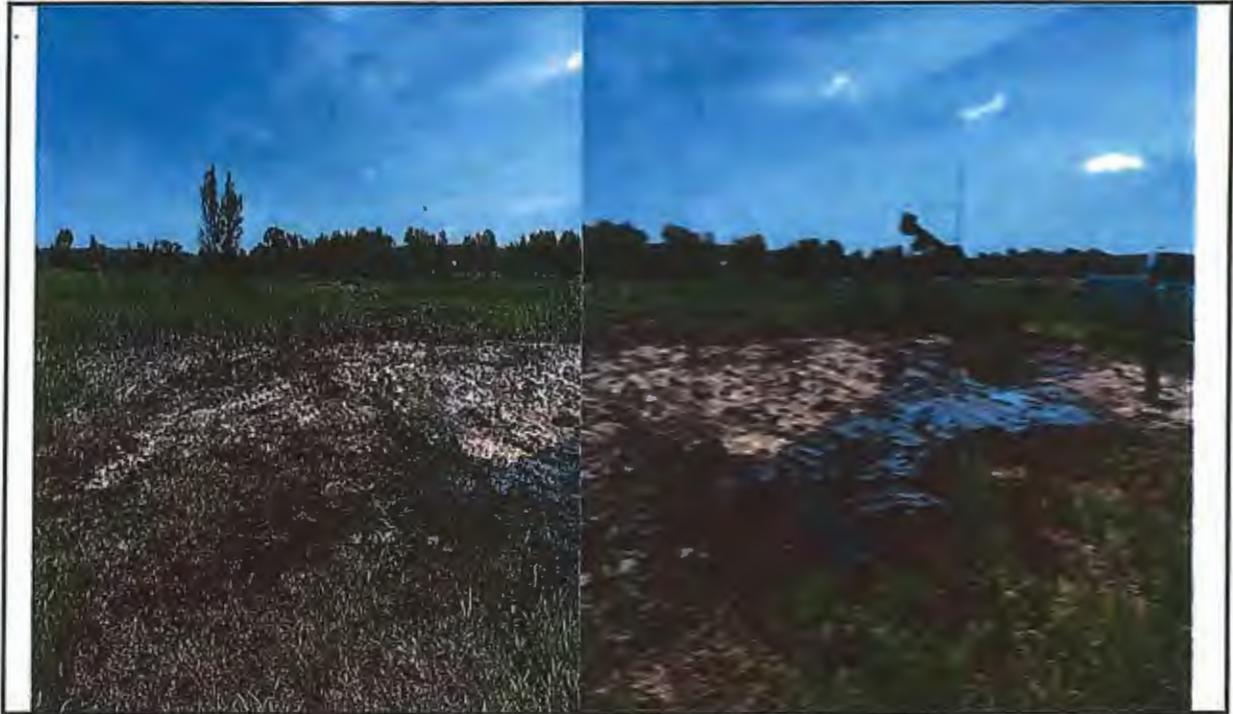
KLN: 32461
Legal: 22-20-20E
PIC ID#: 22-T PIC 1 AND 2
PIC Orientation:
Latitude: 38.292983
Longitude: -95.187395

Additional Information: This picture is of well location 22-T. This location has a 15' by 20' new spill and 60' by 60' old spill. The well is leaking up the production string and is not equipped with a stuffing box. The well is equipped for production but was not producing at the time of the lease inspection.

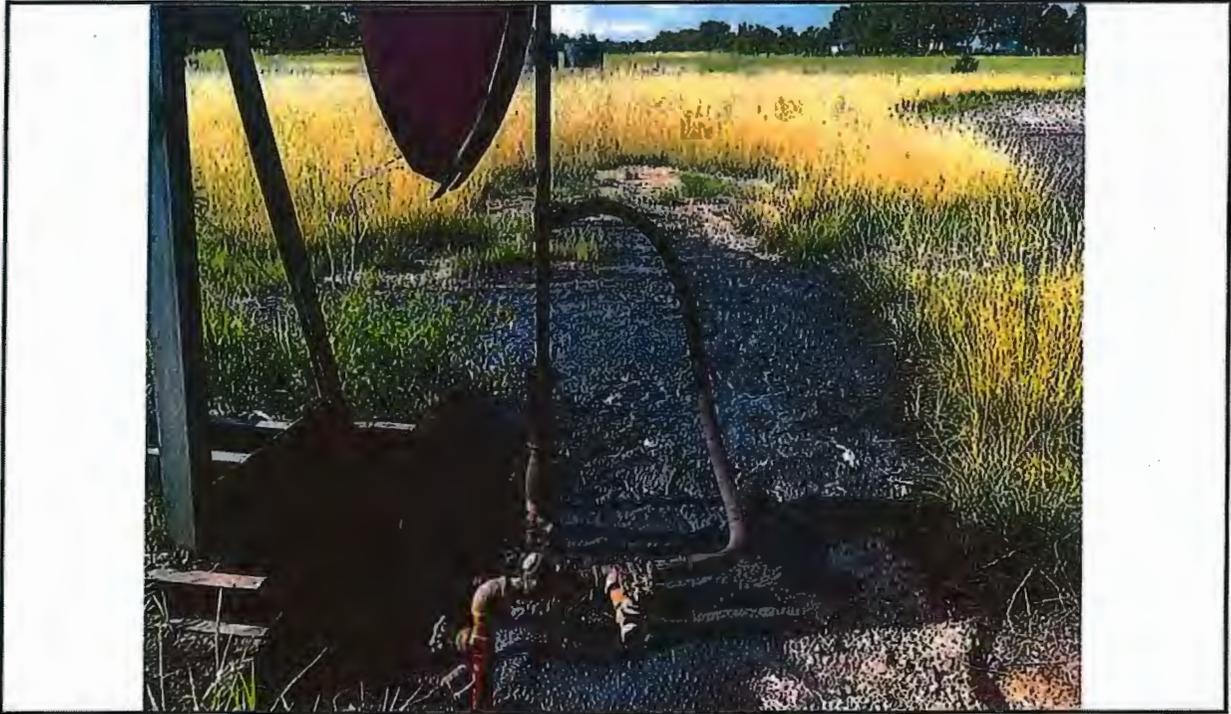
KLN: 32461
Legal: 22-20-20E
PIC ID#: 23-T
PIC Orientation:
Latitude: 38.292160
Longitude: -95.192661

Additional Information: This picture is of well location 23-T. This location has a 10' by 30' spill. The well is leaking up the production string and is not equipped with a stuffing box. The well is equipped for production but was not producing at the time of the lease inspection.

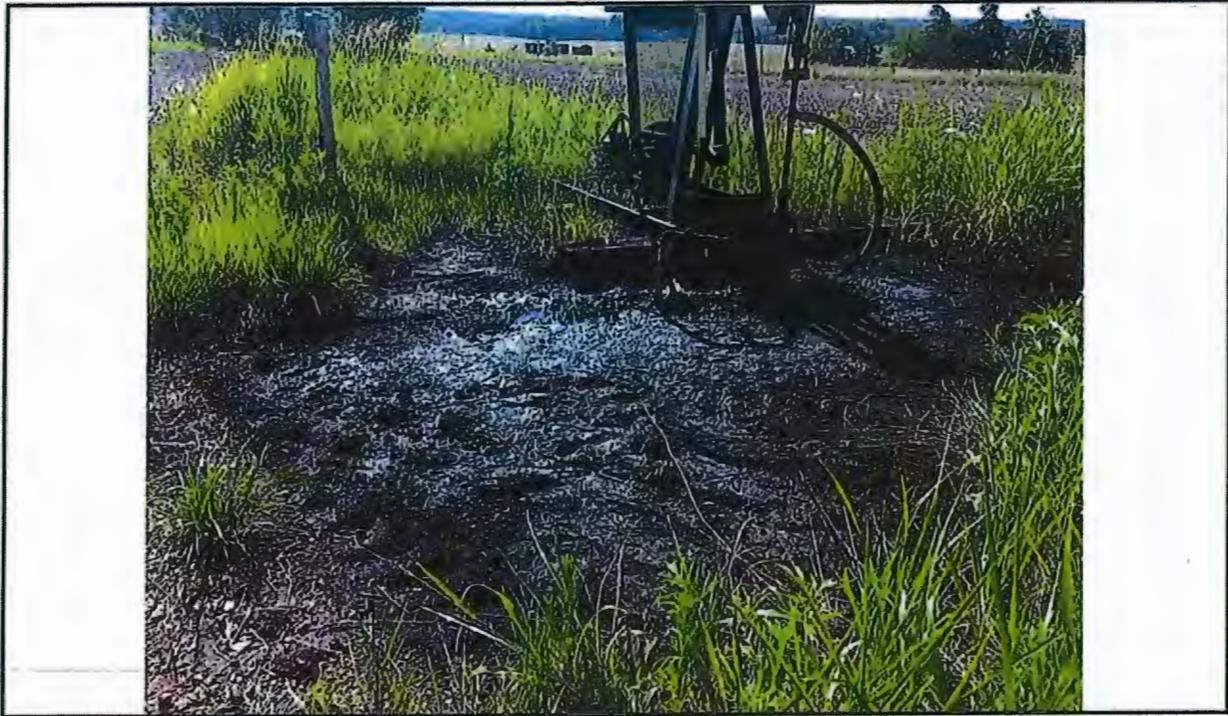
Additional Information: This picture is of well location 24-T. This location has a 15' by 15' spill. The well is leaking up the production string and is not equipped with a stuffing box. The well is equipped for production but was not producing at the time of the lease inspection.

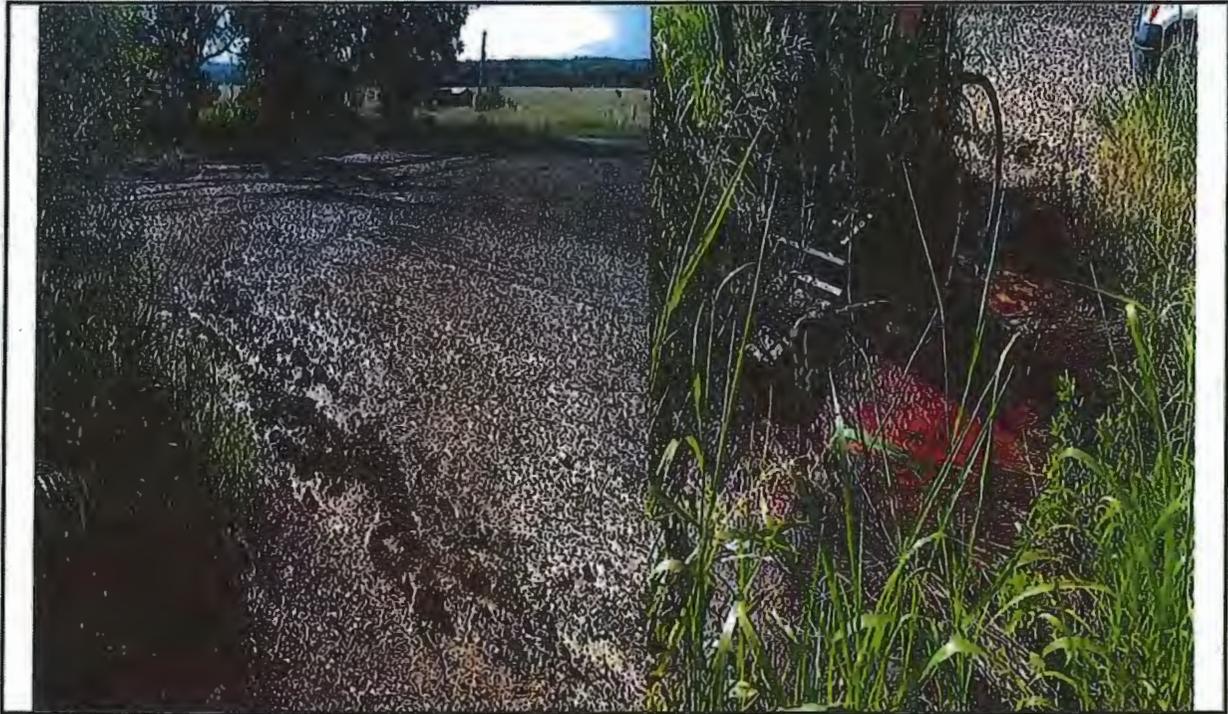
KLN: 32461
Legal: 22-20-20E
PIC ID#: 25-T
PIC Orientation:
Latitude: 38.292224
Longitude: -95.190282

Additional Information: This picture is of well location 25-T. This location has a 10' by 100' spill. The well is leaking up the production string and is not equipped with a stuffing box. The well is equipped for production but was not producing at the time of the lease inspection.

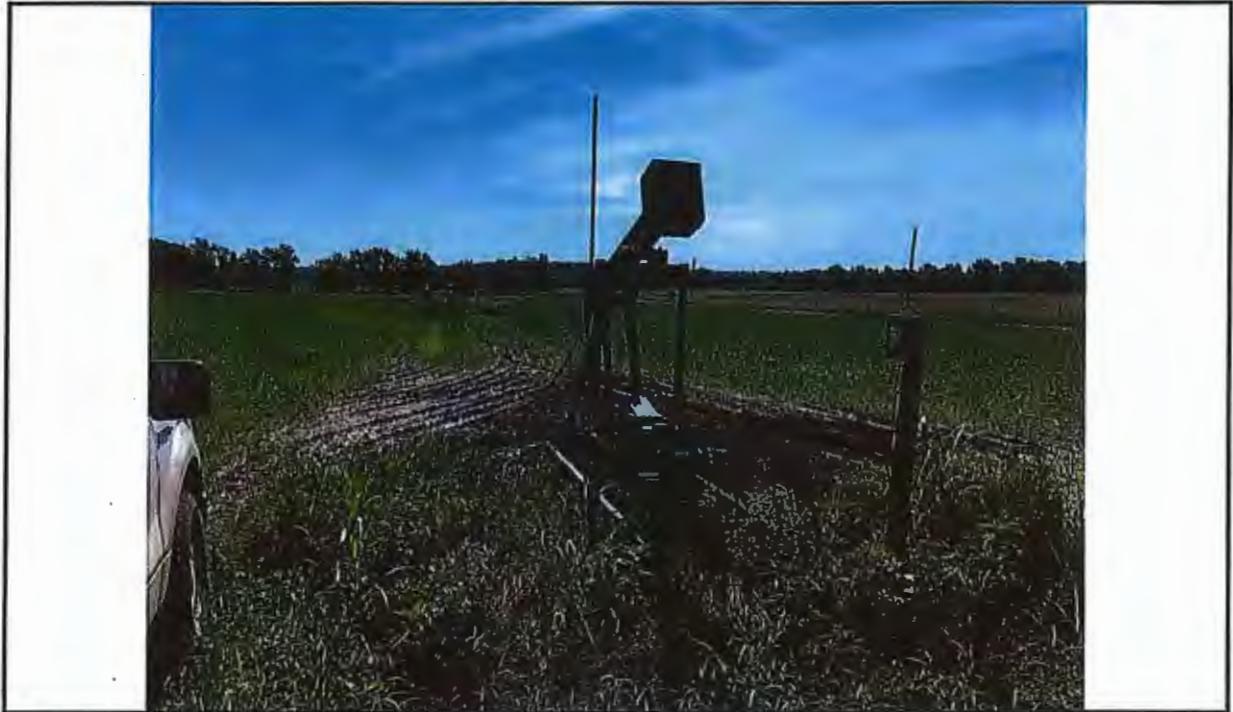
Additional Information: This picture is of well location 26-T. This location has a 20' by 30' new spill. The well is leaking up the production string and is not equipped with a stuffing box. At the time of inspection well was not equipped for production. The pump jack did not have a belt.

Produced fluids were released in 2019 from the well head of producer well 26-T. Brine escaped from the well head and flowed to the East on the ground surface. The brine impacted an area approximately 0.05 of an acre in size (See Map). The following recommendations for the ***initial treatment of this area should be completed by 5 pm on December 11, 2019*** for the remediation of this spill:

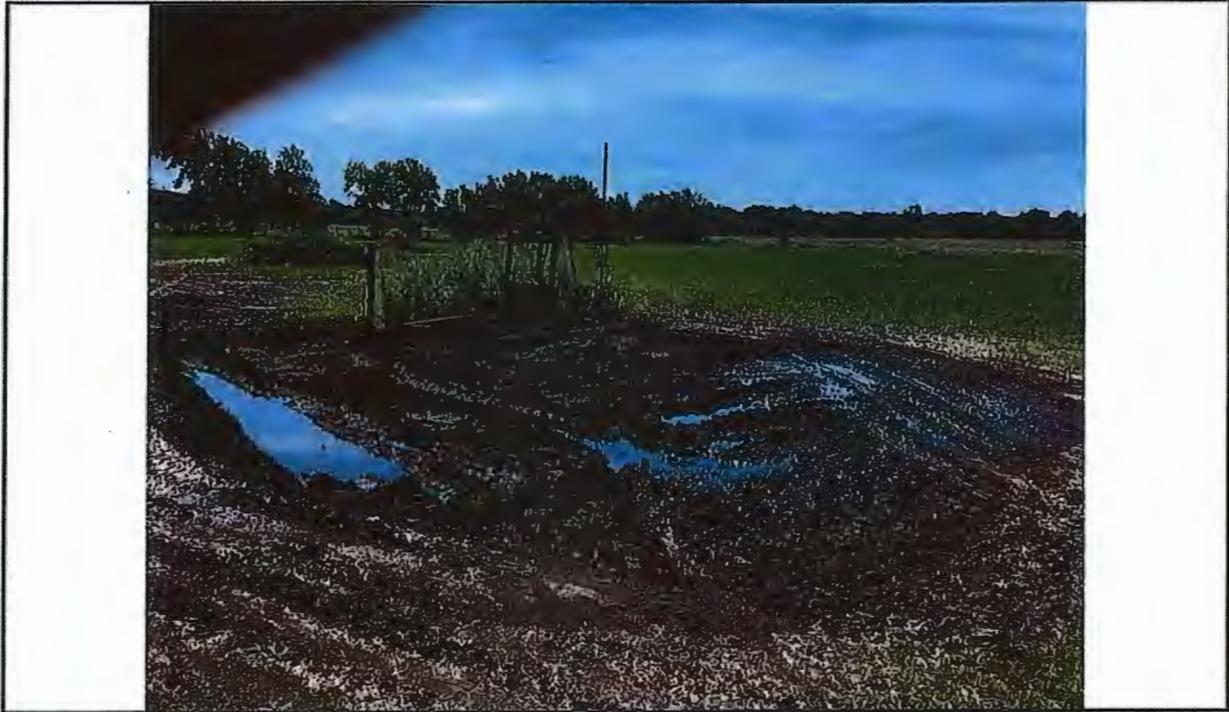
Additional Information: This picture is of well location 27-T. This location has a 30' by 30' spill. The well is leaking up the production string and is not equipped with a stuffing box. The well is equipped for production but was not producing at the time of the lease inspection.

Produced fluids were released in 2019 from the well head of producer well 27-T. The fluids flowed to the South and East on the ground surface. The brine impacted an area approximately .25 of an acre in size (See Map). The following recommendations for the *initial treatment of this area should be completed by 5 pm on December 11, 2019* for the remediation of this spill.

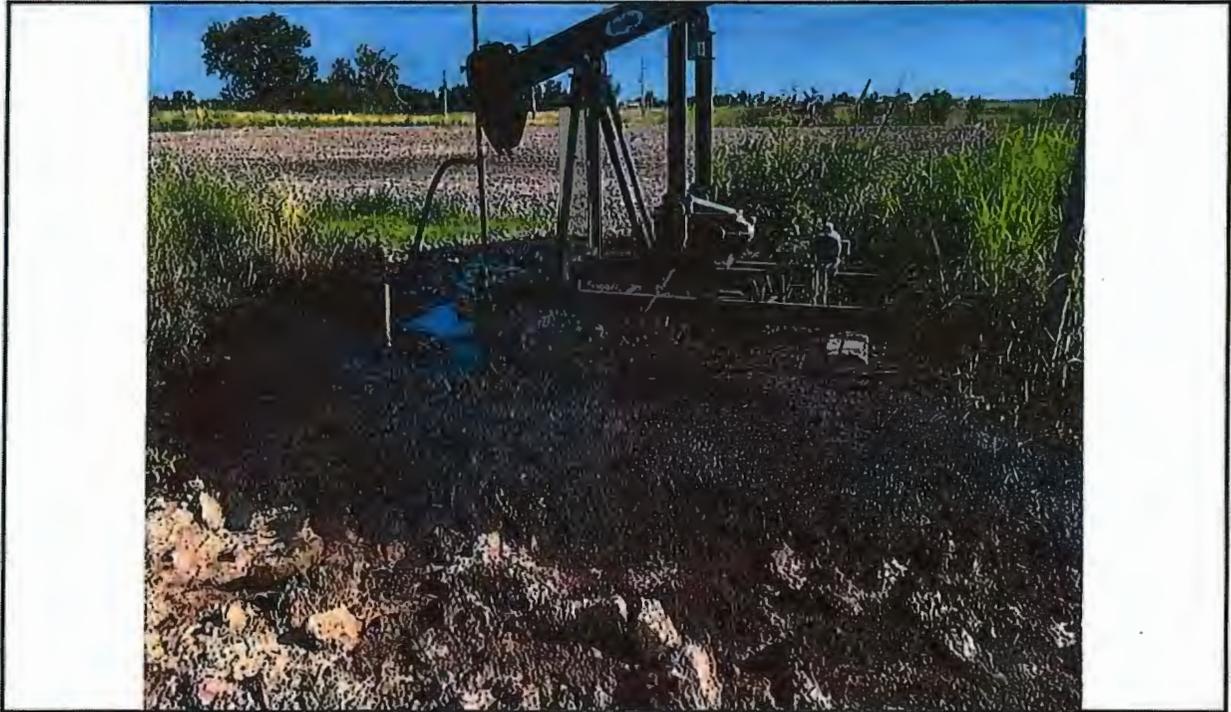
KLN: 32461
Legal: 22-20-20E
PIC ID#: 28-T
PIC Orientation:
Latitude: 38.292164
Longitude: -95.193730

Additional Information: This picture is of well location 28-T. This location has a 20' by 20' spill. The well is leaking up the production string and is not equipped with a stuffing box. The well is equipped for production but was not producing at the time of the lease inspection.

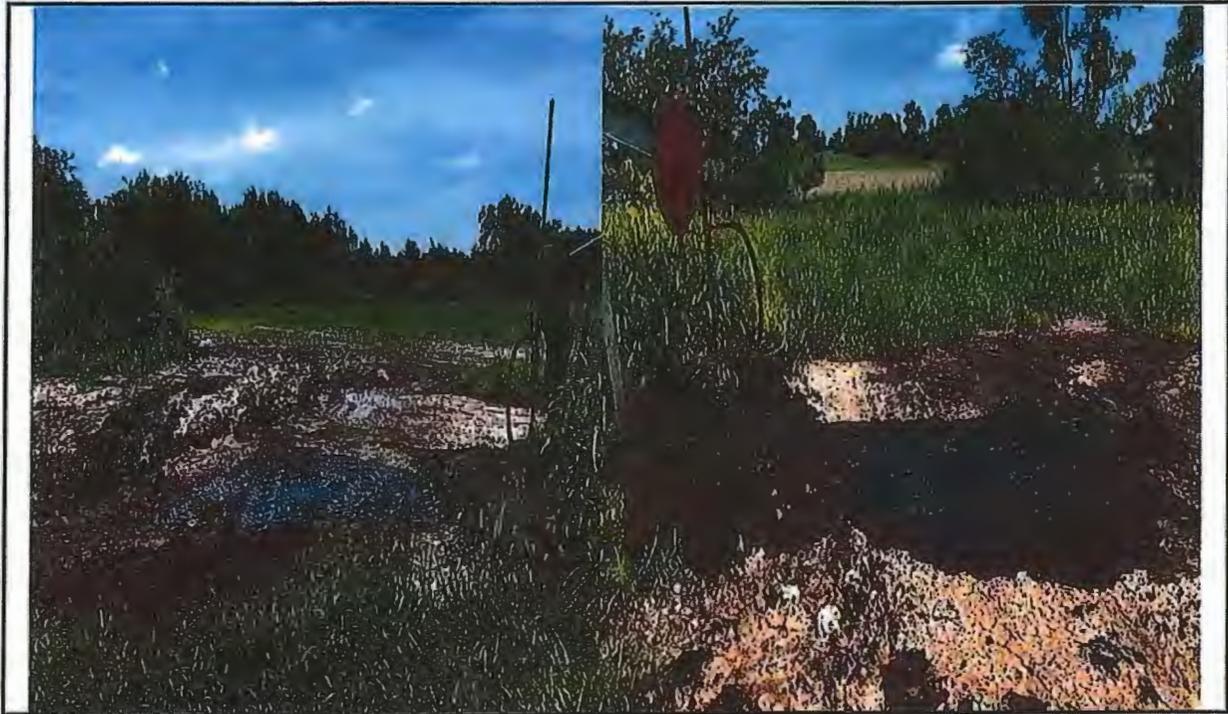
KLN: 32461
Legal: 22-20-20E
PIC ID#: 30T PIC 1 AND 2
PIC Orientation:
Latitude: 38.293734
Longitude: -95.185658

Additional Information: This picture is of well location 30-T. This location has a 10' by 10' new spill and 40' by 75' old spill. The well is leaking up the production string and is not equipped with a stuffing box. The well is equipped for production but was not producing at the time of the lease inspection.

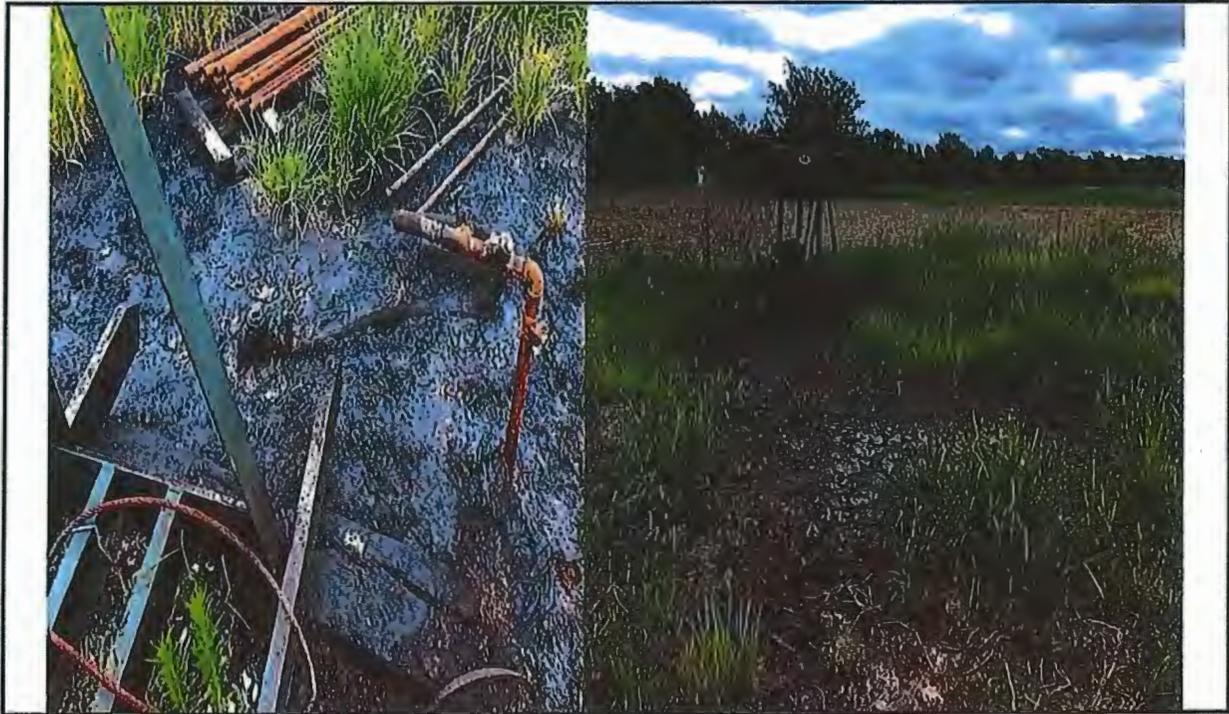
Additional Information: This picture is of well location 31-T. This location has a 20' by 20' old spill. At the time of inspection well was not equipped for production. The well is shut in.

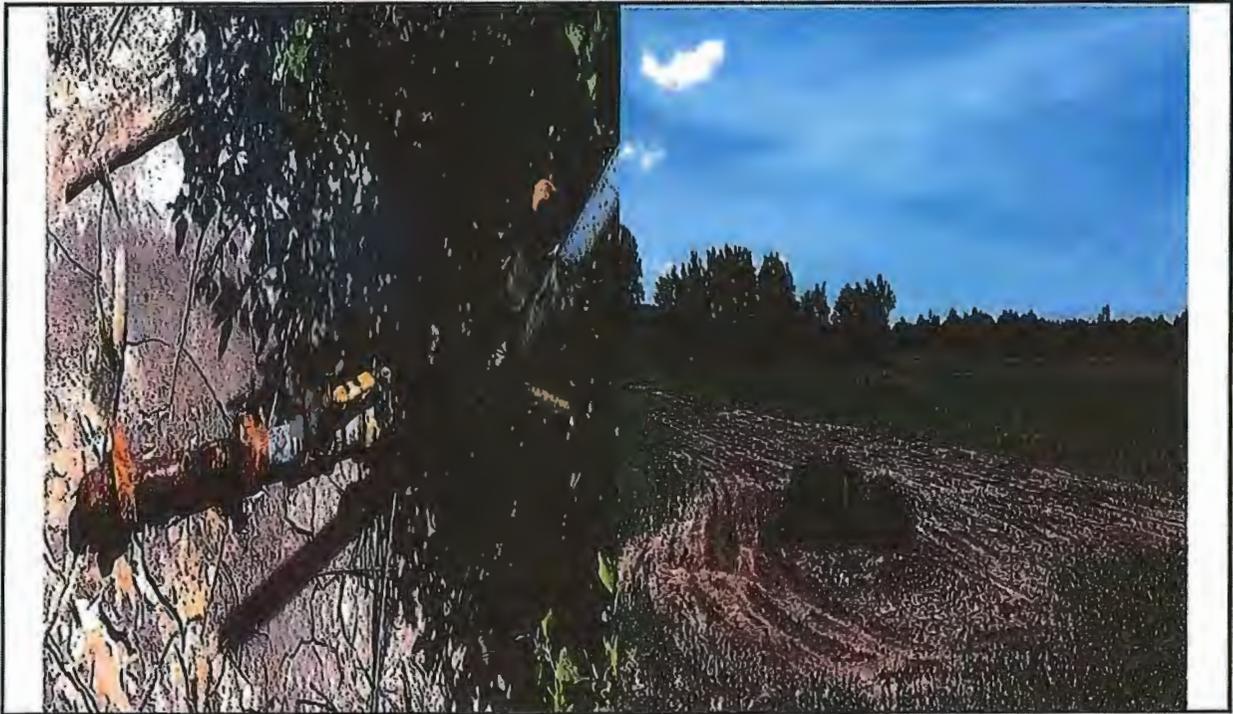
KLN: 32461
Legal: 22-20-20E
PIC ID#: 14-IWL PIC 1 AND 2
PIC Orientation:
Latitude: 38.292701
Longitude: -95.186332

Produced fluids were released in 2019 from the well head of injection well 14-IWL. The fluids flowed to the East then South on the ground surface. The brine impacted an area approximately .40 of an acre in size (See Map). The following recommendations for the ***initial treatment of this area should be completed by 5 pm on December 11, 2019*** for the remediation of this spill.

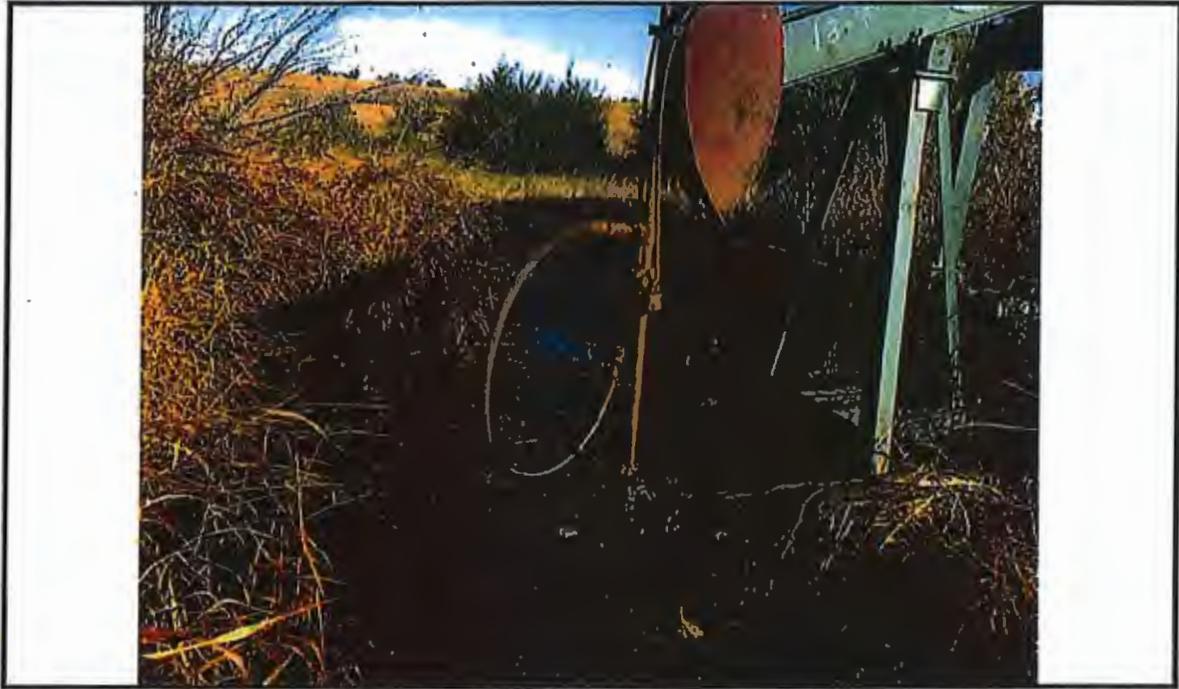
Additional Information: This picture is of well location 18-T and spill/kill area. This location has a spill and kill area outlined with GPS waypoints. The well is leaking up the production string and is not equipped with a stuffing box. The well is equipped for production but was not producing at the time of the lease inspection.

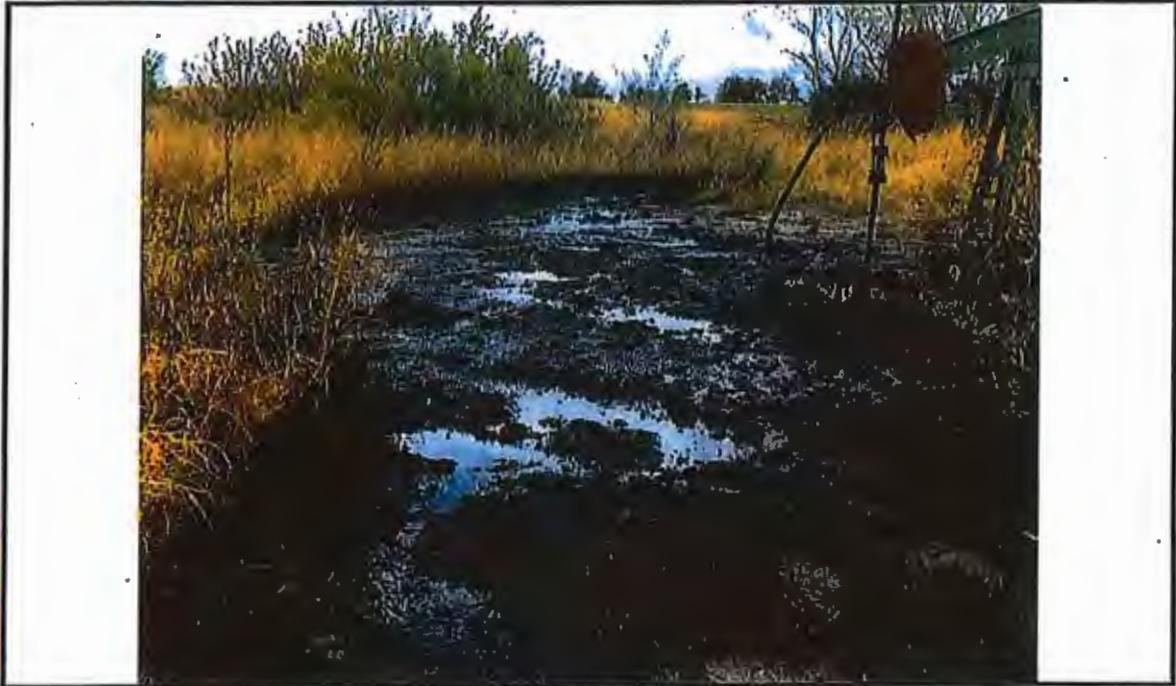
Additional Information: This picture is of well location 22-T and spill/kill area. This location has a spill and kill area outlined by GPS waypoints. The well is leaking up the production string and is not equipped with a stuffing box. The well is equipped for production but was not producing at the time of the lease inspection.

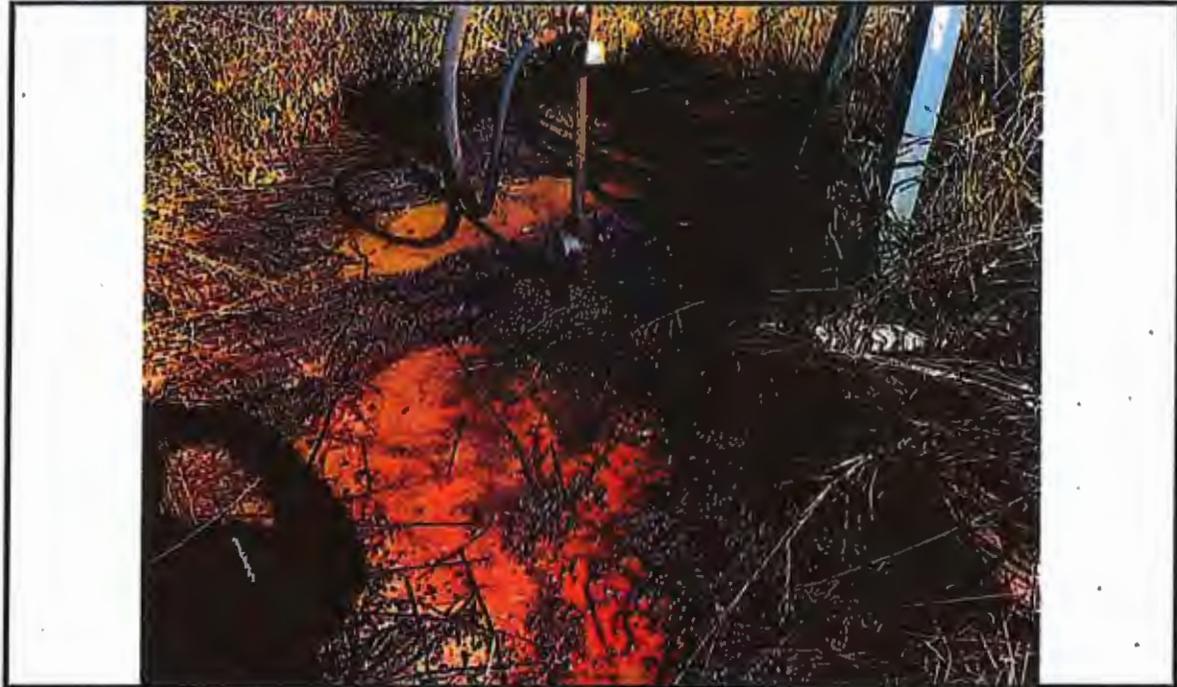
KLN: 32461
Legal: 22-20-20E
PIC ID#: 25-T Pic 2
PIC Orientation:
Latitude: 38.292224
Longitude: -95.190282

Additional Information: This picture is of well location 25-T. This location has a spill and kill area outlined by GPS waypoints. The well is leaking up the production string and is not equipped with a stuffing box. The well is equipped for production but was not producing at the time of the lease inspection.

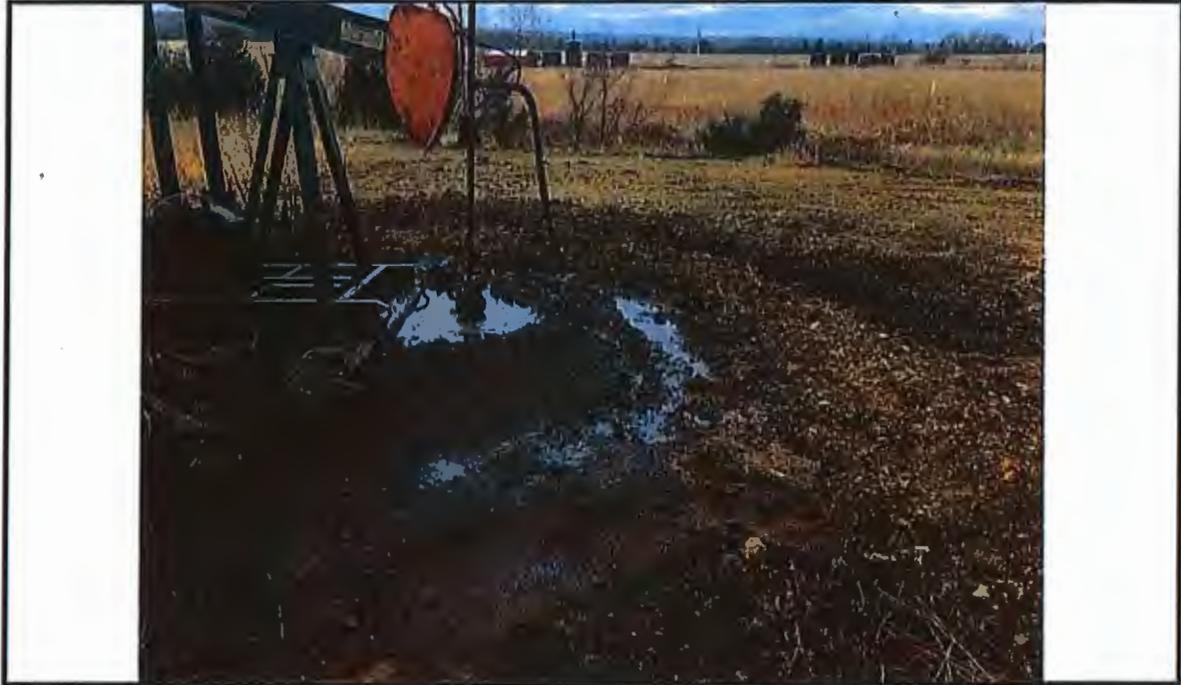
KLN: 32461
Legal: 22-20-20E
PIC ID#: 13-T Pic 1
PIC Orientation:
Latitude: 38.293350
Longitude: -95.188350

Additional Information: This picture is of well # 13-T. The well is leaking oil between the 1" production string and the casing, the oil has traveled approximately ten (10) feet from the well and is not equipped with proper surface control allowing the oil to continue to leak on the ground. The well is equipped for production but was not producing at the time of the lease inspection.

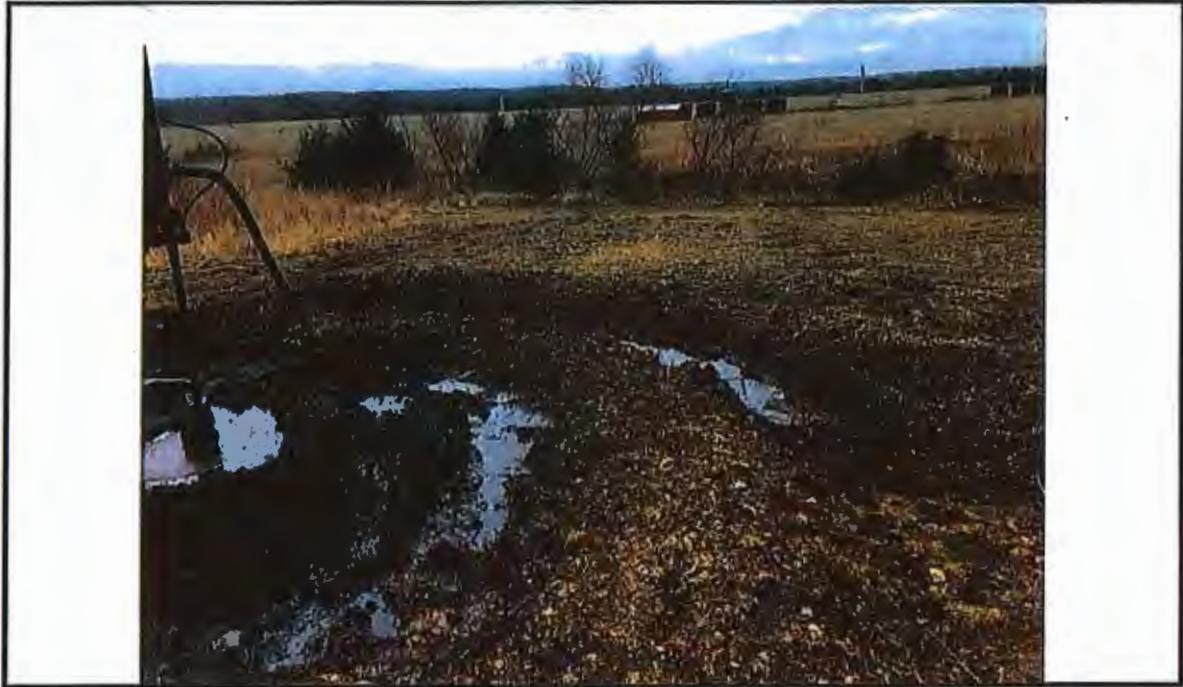
KLN: 32461
Legal: 22-20-20E
PIC ID#: 13-T Pic 2
PIC Orientation:
Latitude: 38.293350
Longitude: -95.188350

Additional Information: This picture is of well #13-T. The well does not have proper surface control and is leaking oil on the ground. The well is equipped for production but was not producing at the time of the lease inspection.

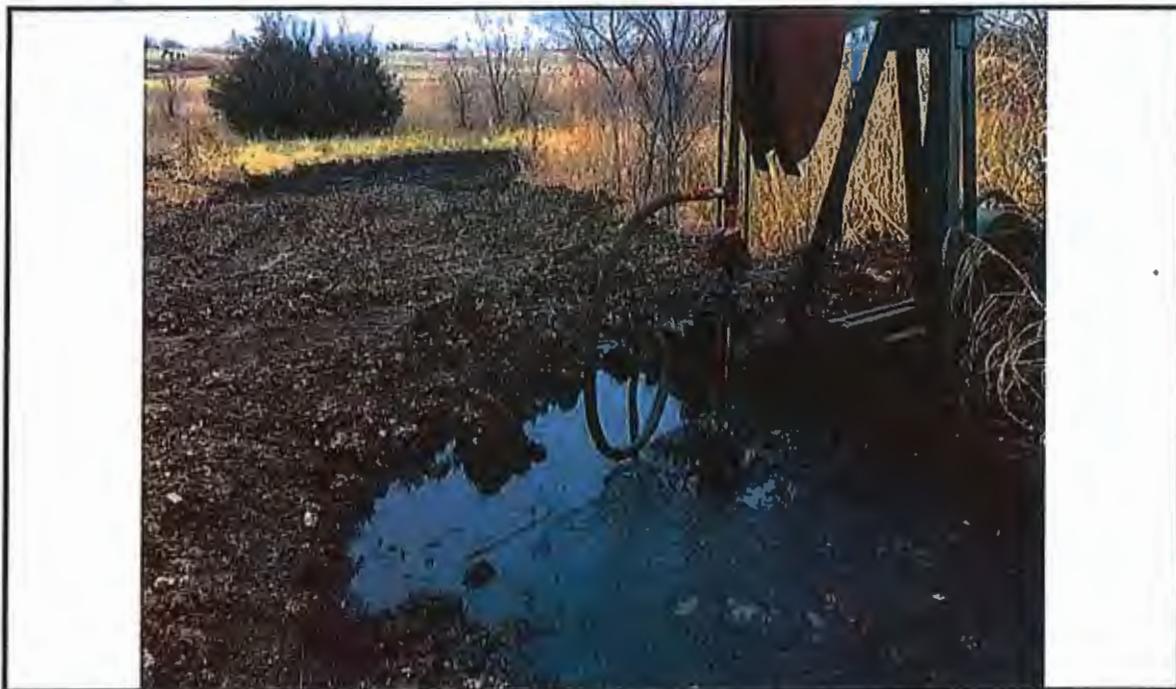
Additional Information: This picture is of well #18-T. This location has a spill and kill area more than 50' from the well. The oil is leaking between the 1" production string and the casing, It is not equipped with proper surface control and continues to leak oil on the ground and leach out of the soil 50' from the well. The well is equipped for production but was not producing at the time of the lease inspection.

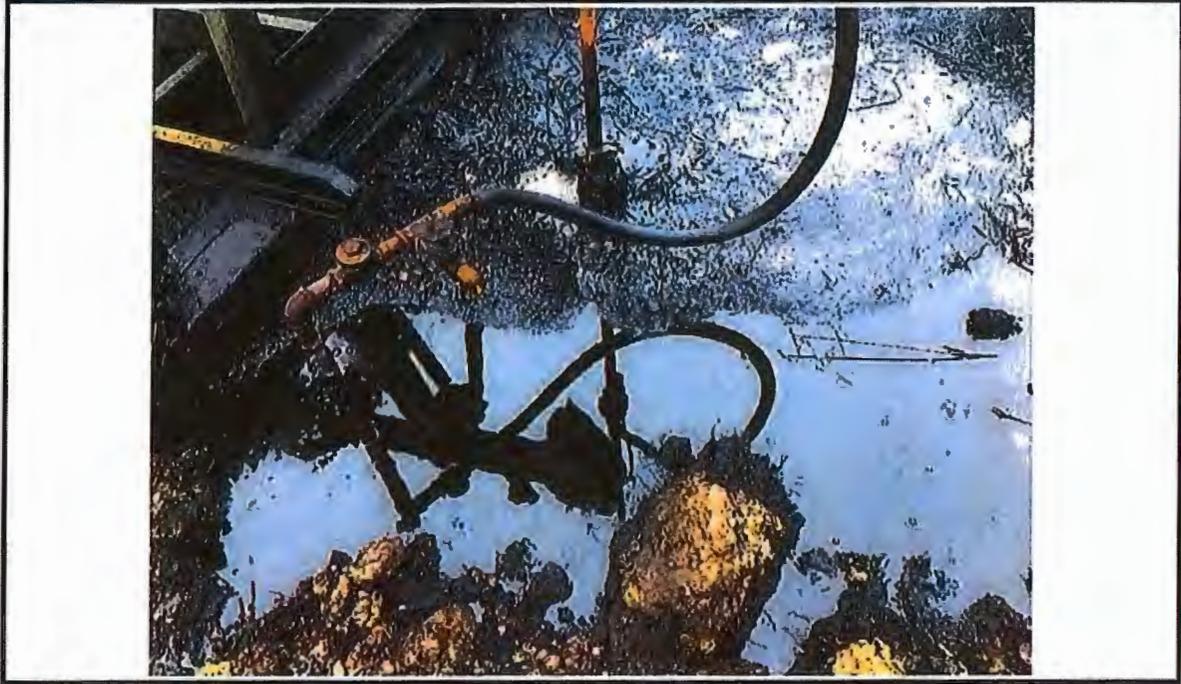
Additional Information: This picture is of well #18-T. The oil is leaking between the 1" production string and the casing, it is not equipped with proper surface control and continues to leak oil on the ground. The well is equipped for production but was not producing at the time of the lease inspection.

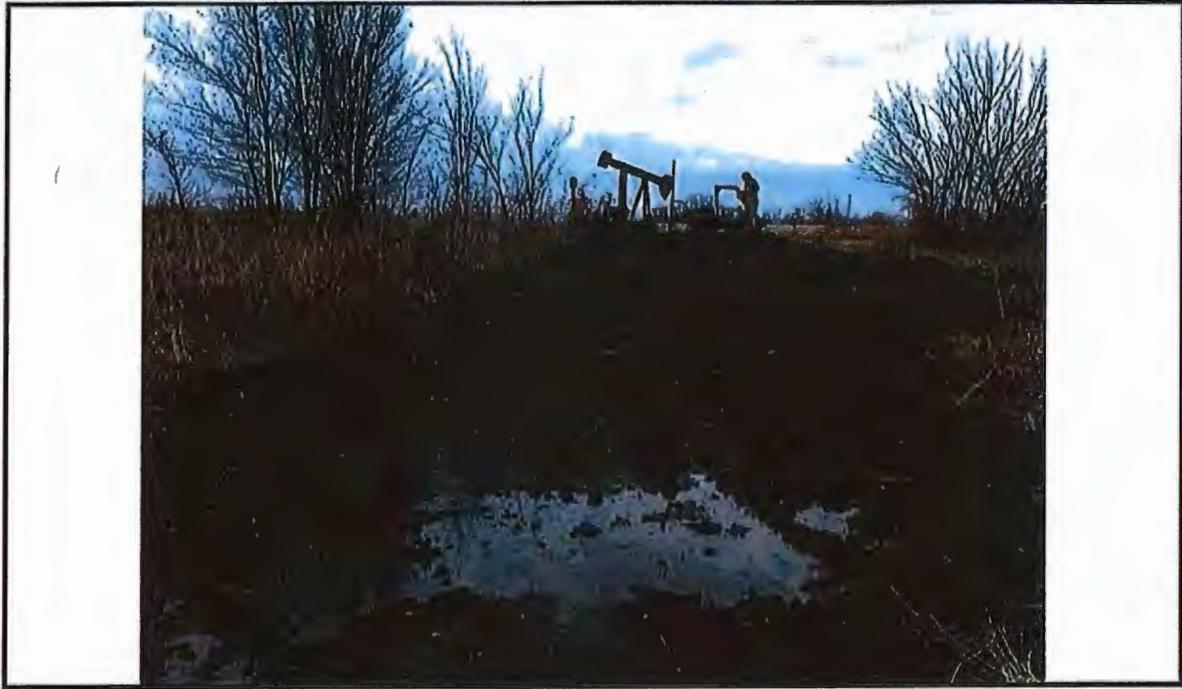
Additional Information: This picture is of well #18-T. The oil is leaking between the 1st production string and the casing, it is not equipped with proper surface control and continues to leak oil on the ground, the oil is leaching out away from the well.

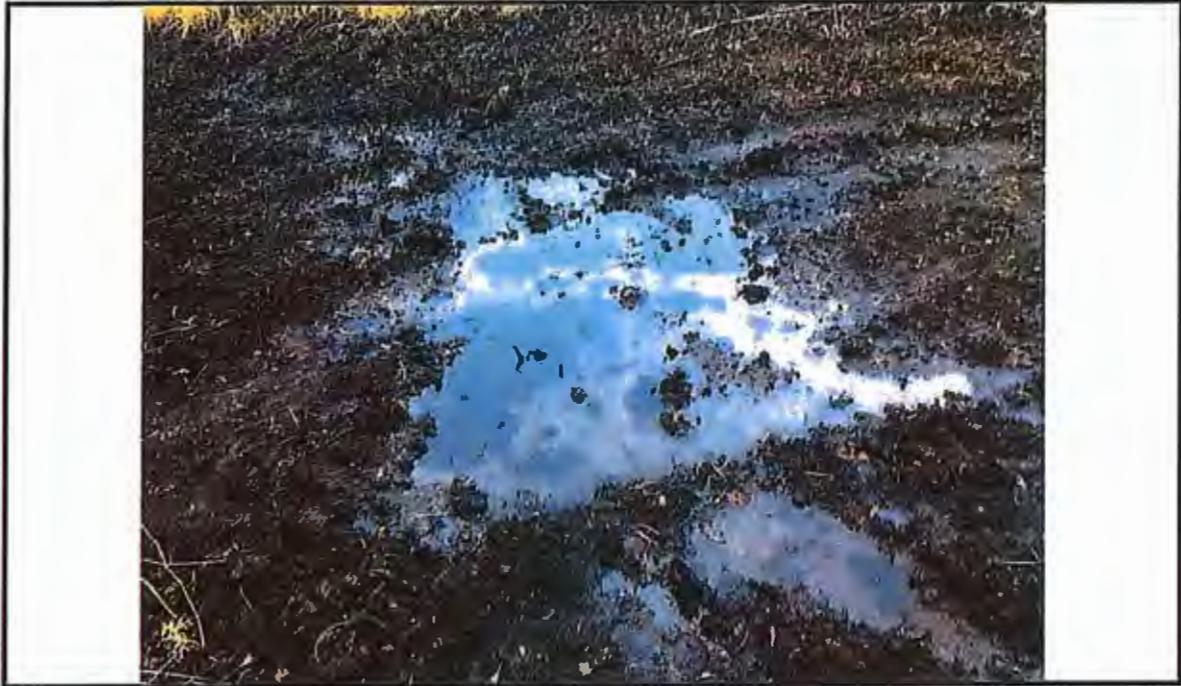
KLN: 32461
Legal: 22-20-20E
PIC ID#: 18-T Pic 4
PIC Orientation:
Latitude: 38.293060
Longitude: -95.191486

Additional Information: This picture is of well #18-T. The oil is leaking between the 1st production string and the casing, it is not equipped with proper surface control and continues to leak oil on the ground, the oil is leaching out approximately 50' from the well. The well is equipped for production but was not producing at the time of the lease inspection.

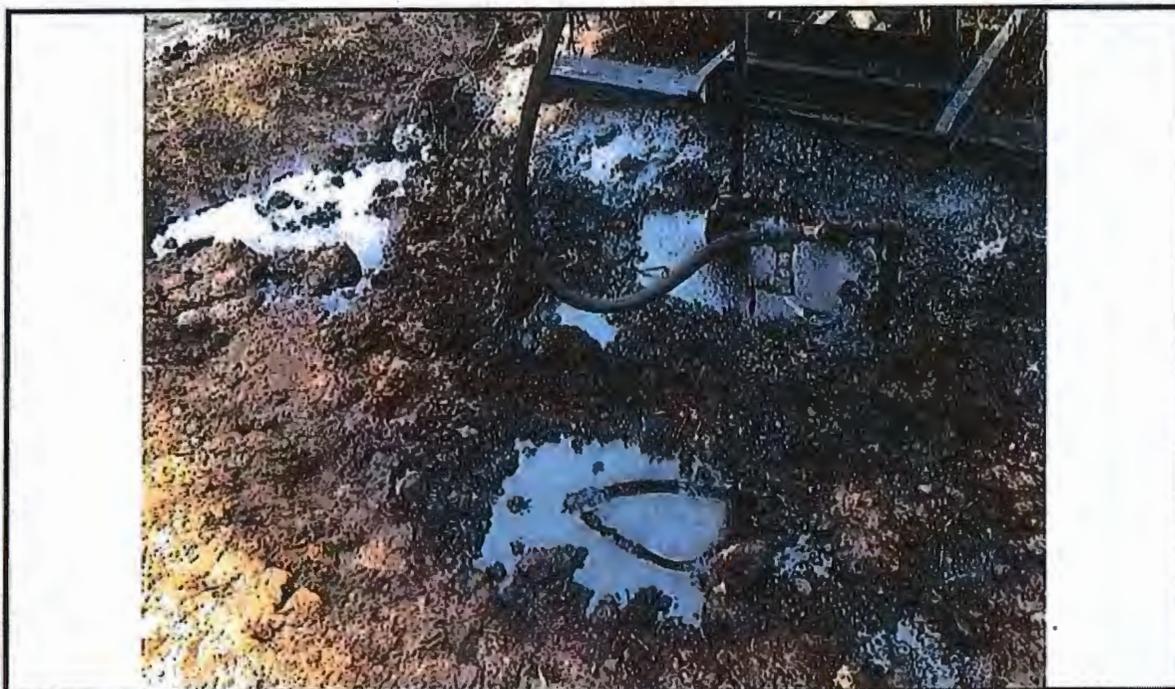
Additional Information: This picture is of well #22-T. The oil is leaking between the 1" production string and the casing, it is not equipped with proper surface control and continues to leak oil on the ground 15' from the well. The well is equipped for production but was not producing at the time of the lease inspection.

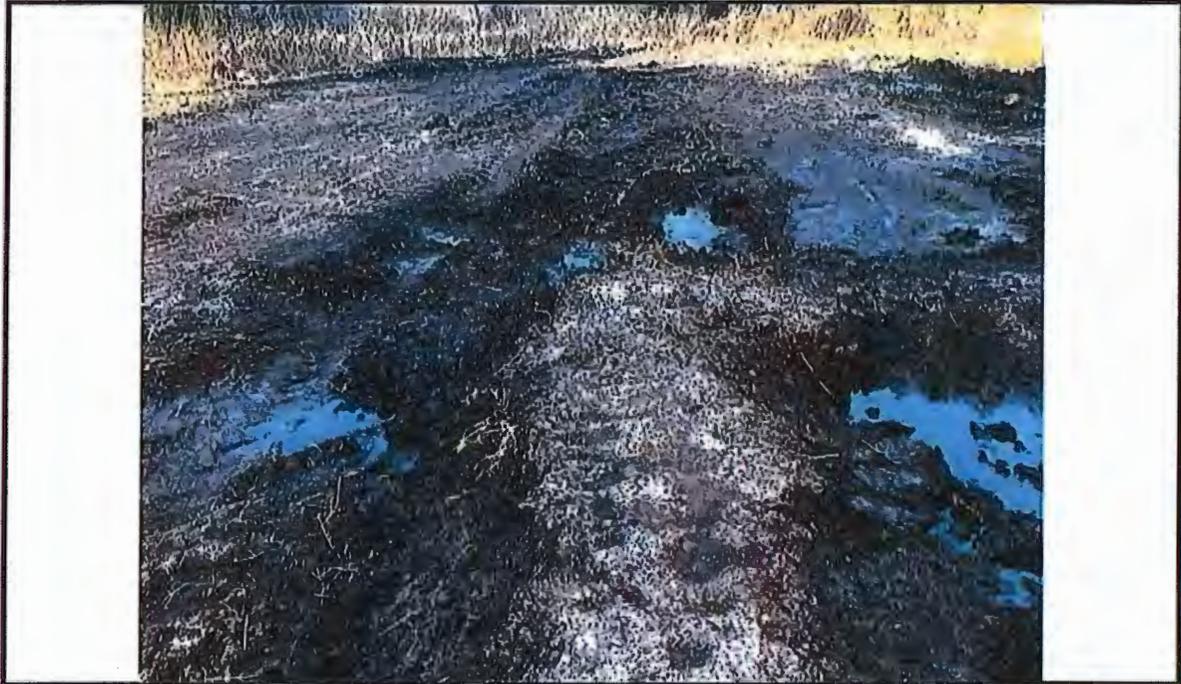
Additional information: This picture is of well #22-T. The oil is leaking between the 1st production string and the casing, it is not equipped with proper surface control and continues to leak oil on the ground 15' from the well. The well is equipped for production but was not producing at the time of the lease inspection.

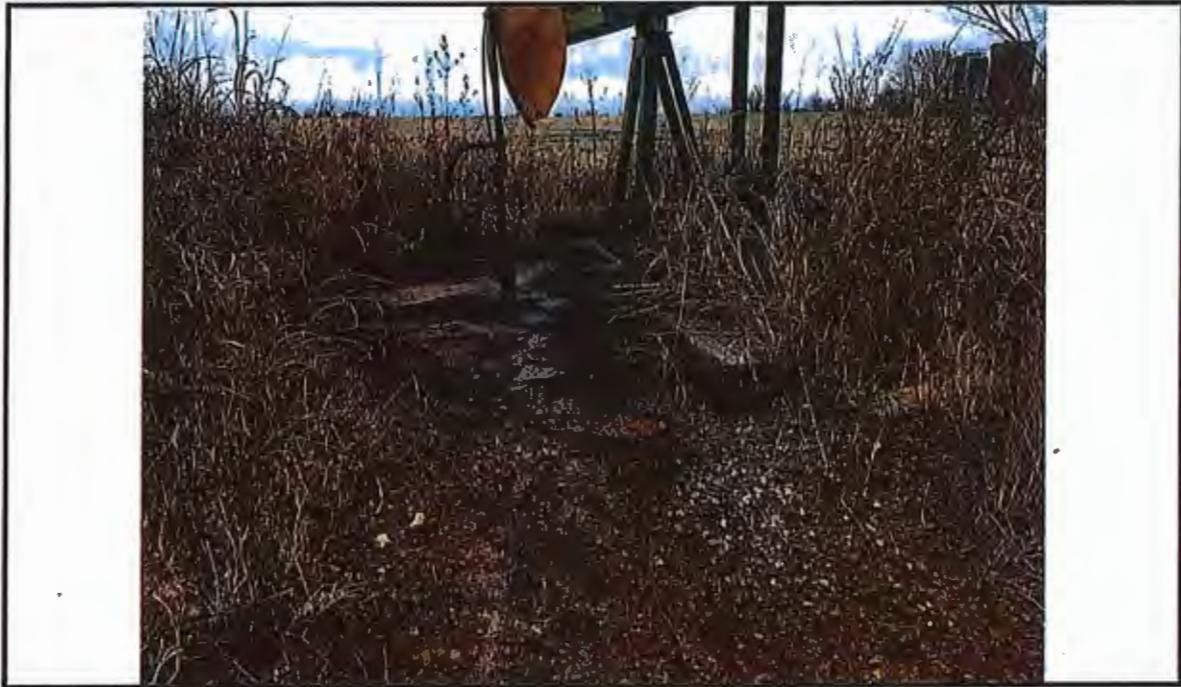
Additional Information: This picture is of well location 25-T. This location has a spill and kill area more than 50' from the well, a water sample collected at 50' from the well tested at 11,000 ppm chlorides. The well is leaking fluids between the 1st production string and the casing, it is not equipped with proper surface control and continues to leak saltwater on the ground more than 50' away from the well into the crop field.

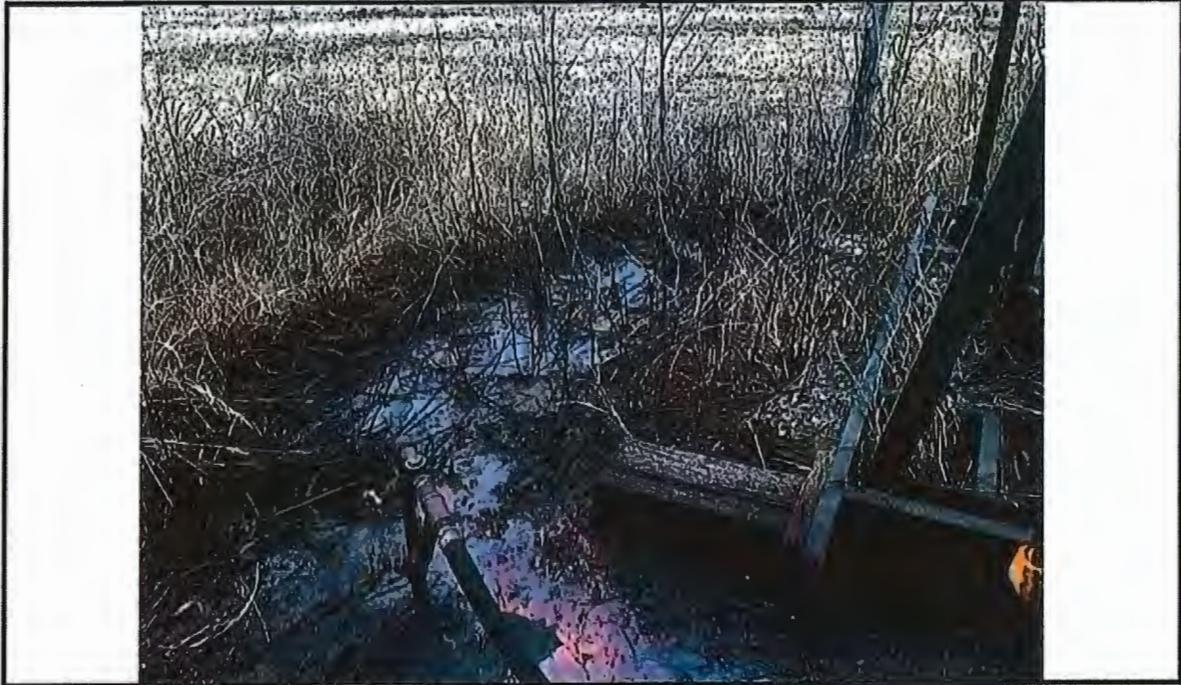
Additional Information: This picture is of well #25-T. The well is leaking fluids between the 1" production string and the casing, it is not equipped with proper surface control and continues to leak saltwater on the ground more than 50' away from the well into the crop field.
