NOTICE OF PENALTY ASSESSMENT
21-CONS-3032-CPEN

August 27, 2020

Re: Unreported Spills and Failure to Cleanup Spills on the South Kempnich lease located in Section 22, Township 20 South, Range 20 East, Anderson County, Kansas.

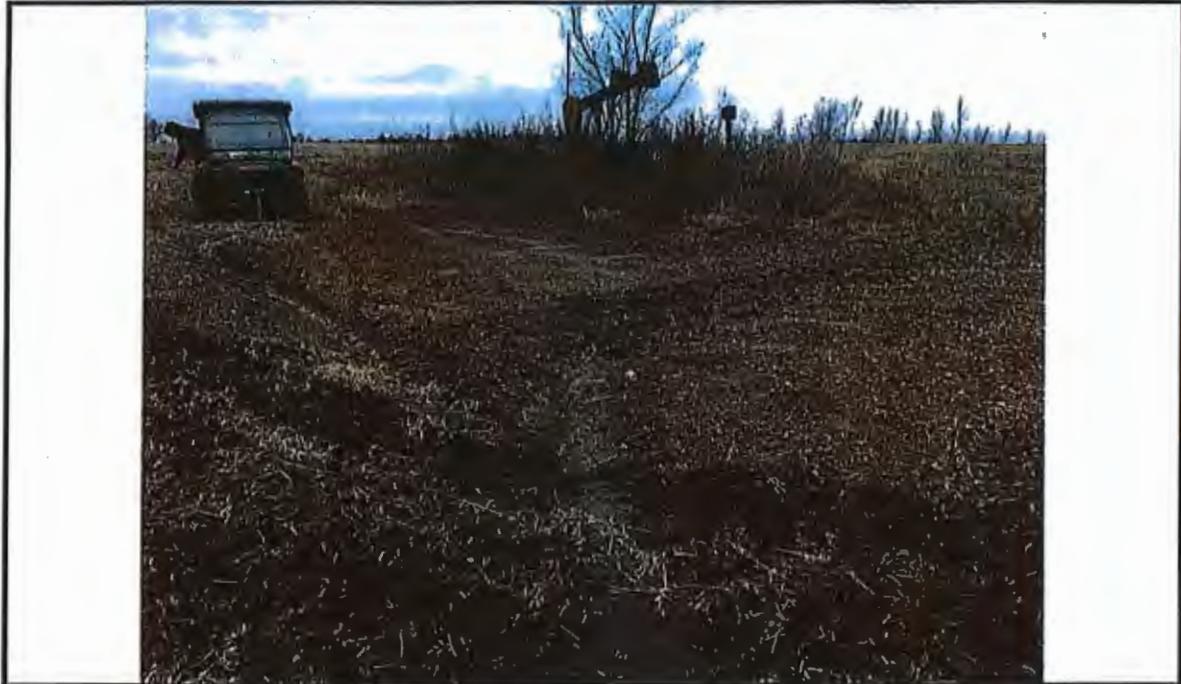
KLN: 32461
Legal: 22-20-20E
PIC ID#: 25-T Pic 3
PIC Orientation:
Latitude: 38.292224
Longitude: -95.190282

Additional Information: This picture is of well #25-T. The well is leaking fluids between the 1" production string and the casing, it is not equipped with proper surface control and continues to leak saltwater on the ground more than 50' away from the well, the water sample was collected from the fluids in the lower portion of this picture and tested at 11,000 ppm chlorides.

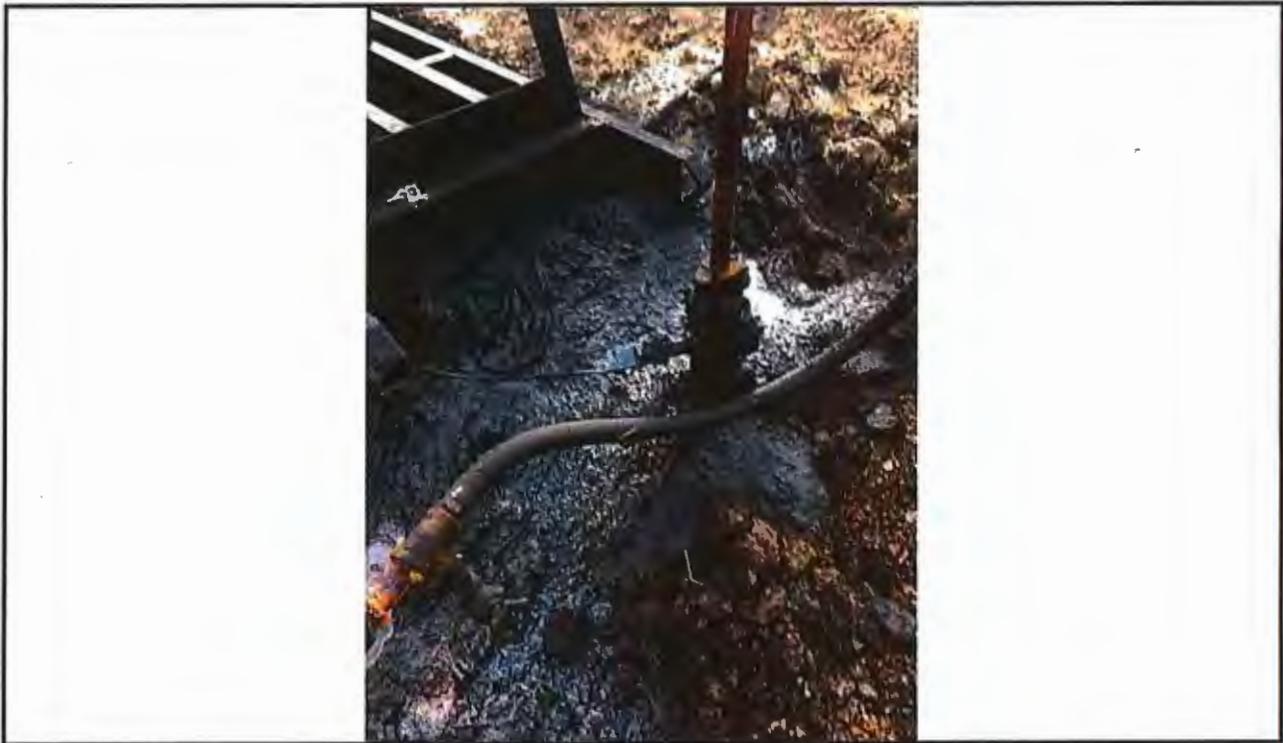
Picture #1 shows well #20-T seeping oil from the casing, the well does not have surface control.

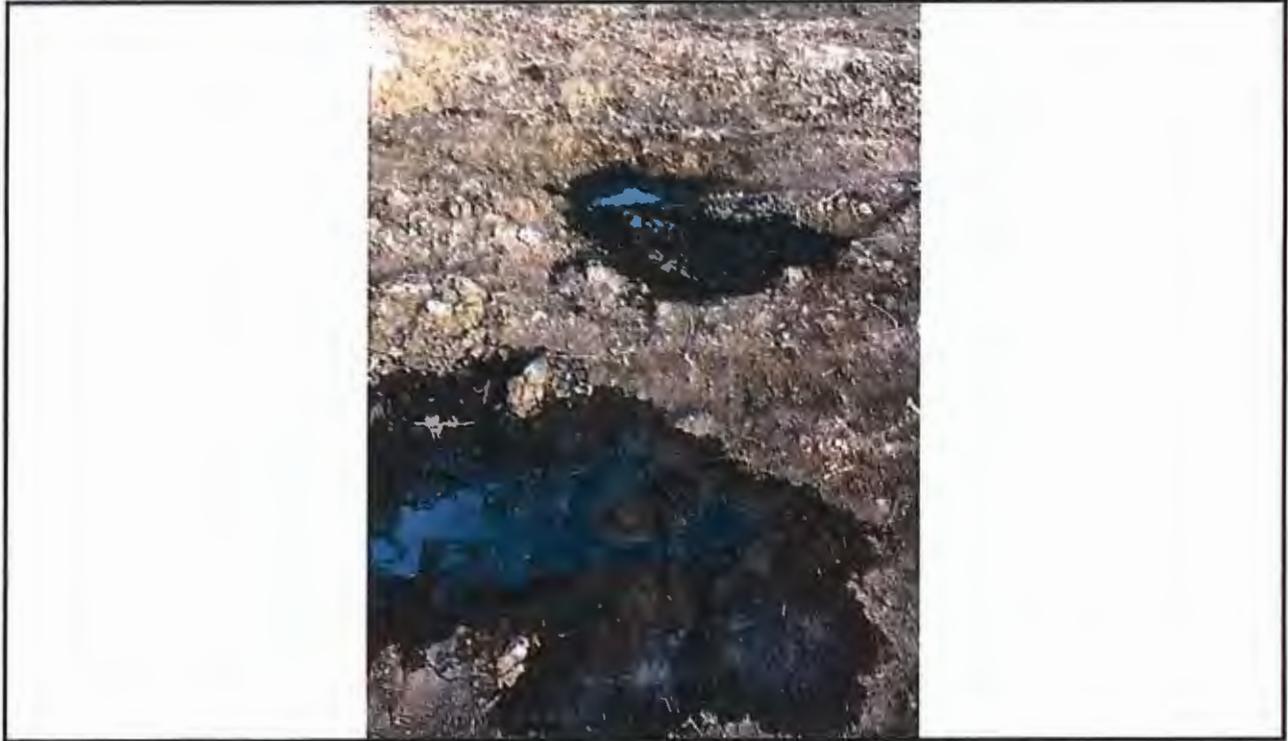
Picture #2 shows well #26-T seeping oil from the casing and away from the well, the well does not have surface control.

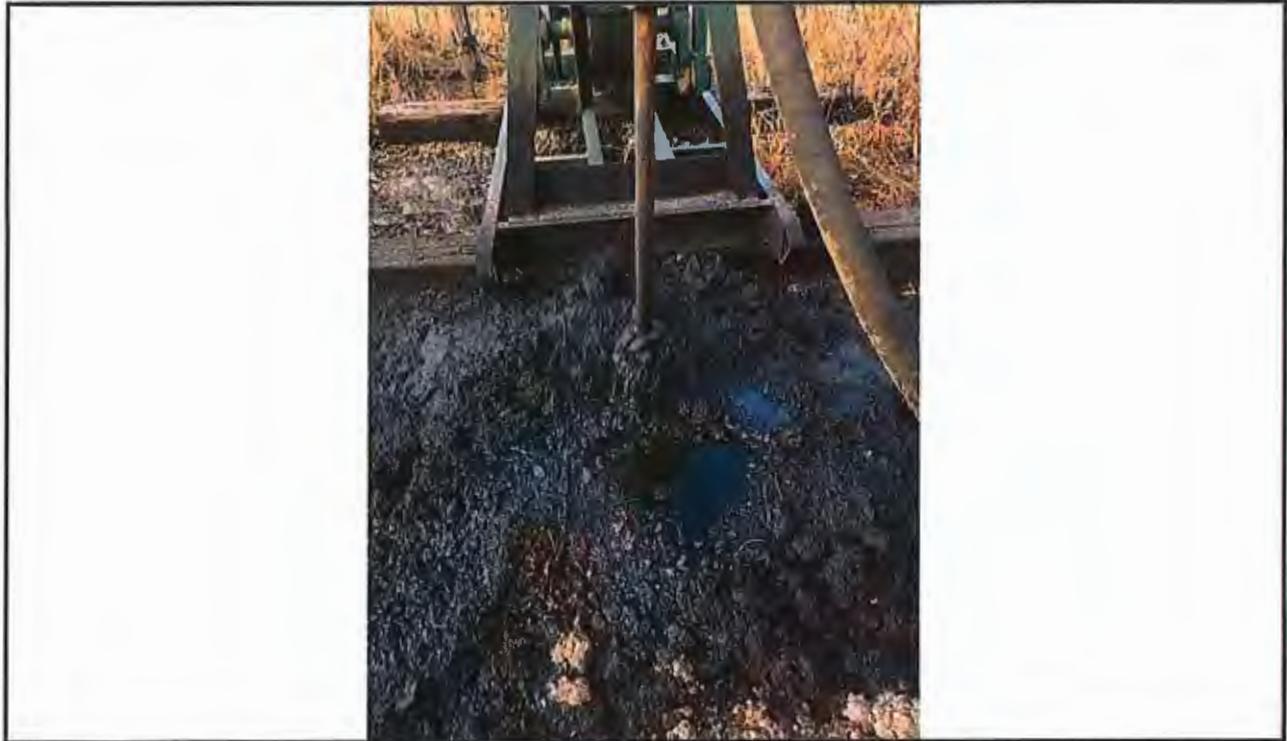
Additional Information: Picture #3

Picture #3 shows well #26-T seeping oil from the casing, the well does not have surface control.

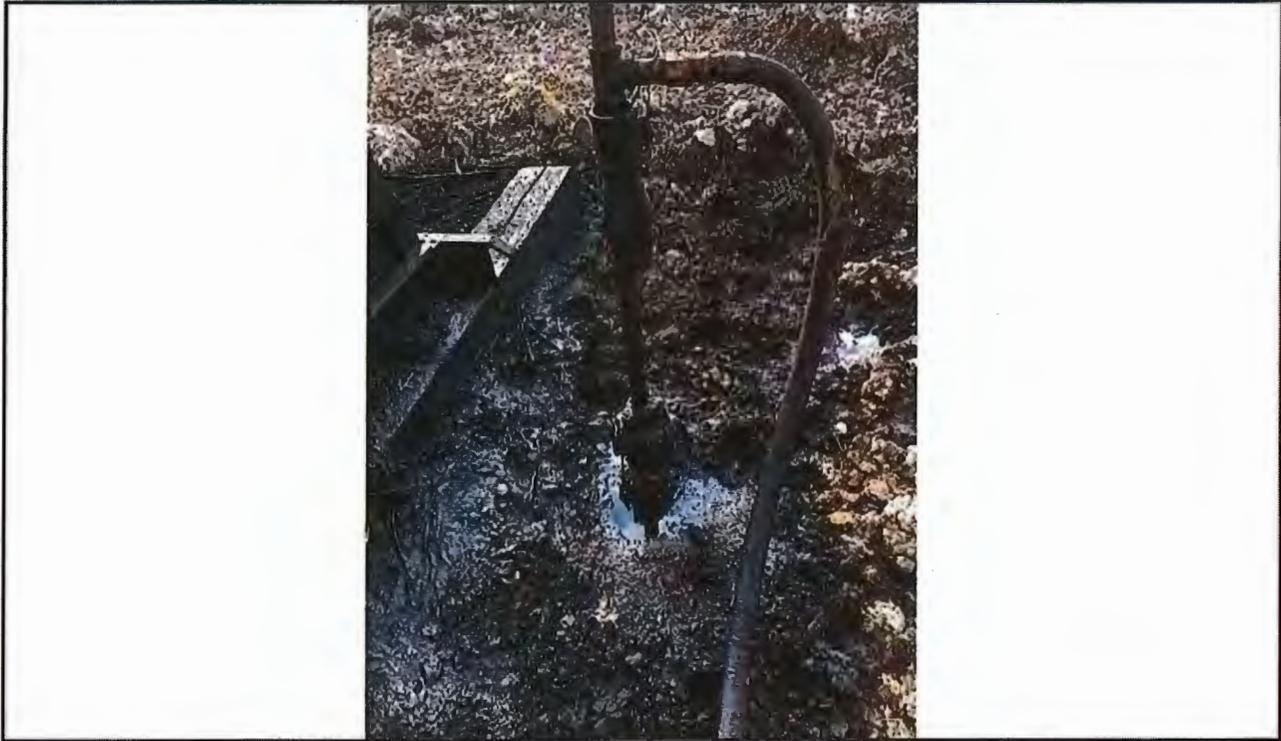
Additional Information: Picture #4

Picture #4 shows well #27-T seeping oil and water from the casing, the well does not have surface control.

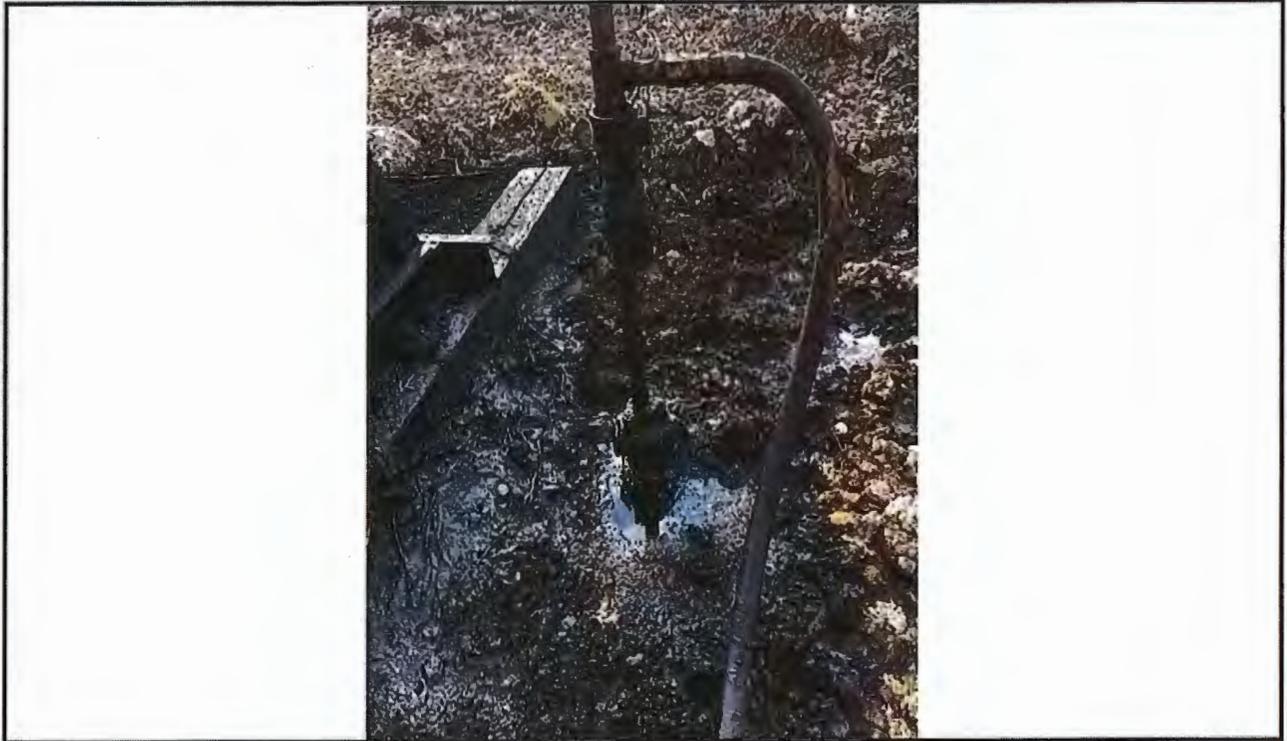
Additional Information: Picture #5

Picture #5 shows well #30-T seeping oil from the casing, the well does not have surface control.

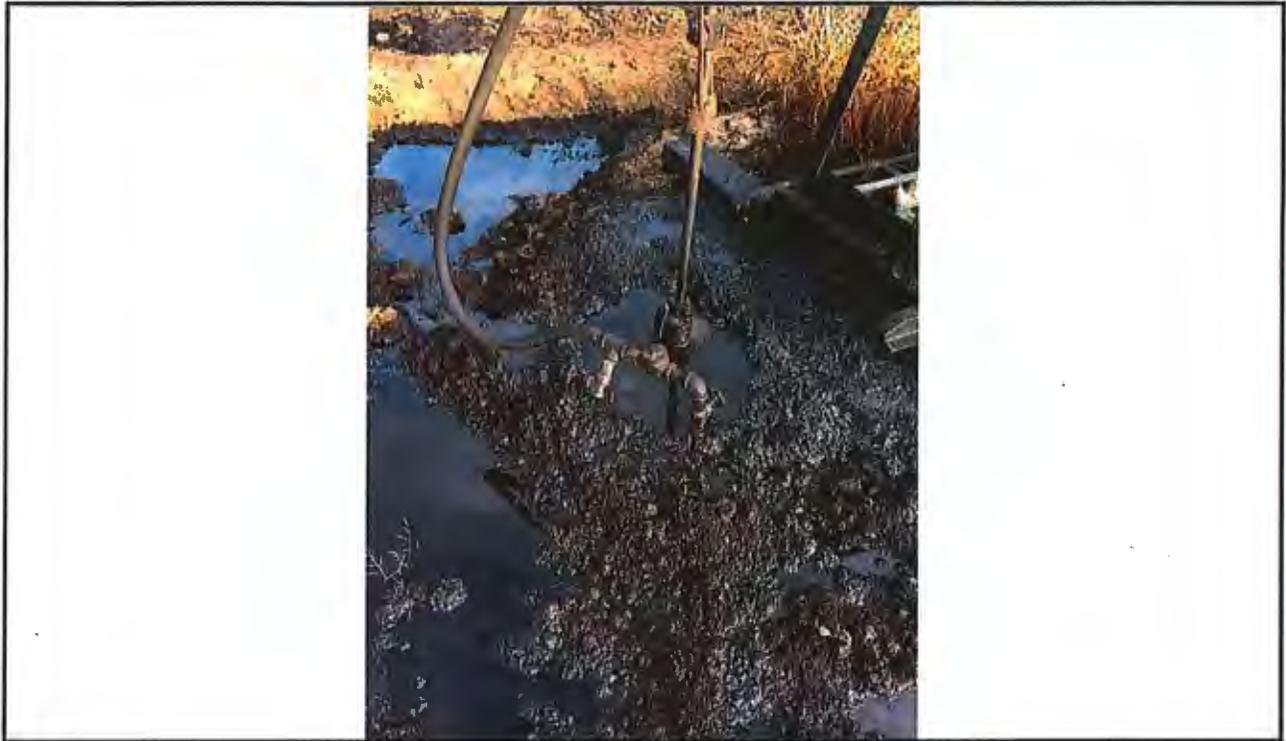
Additional Information: Picture #6

Picture #6 shows well #22-T seeping oil from the casing, the well does not have surface control.

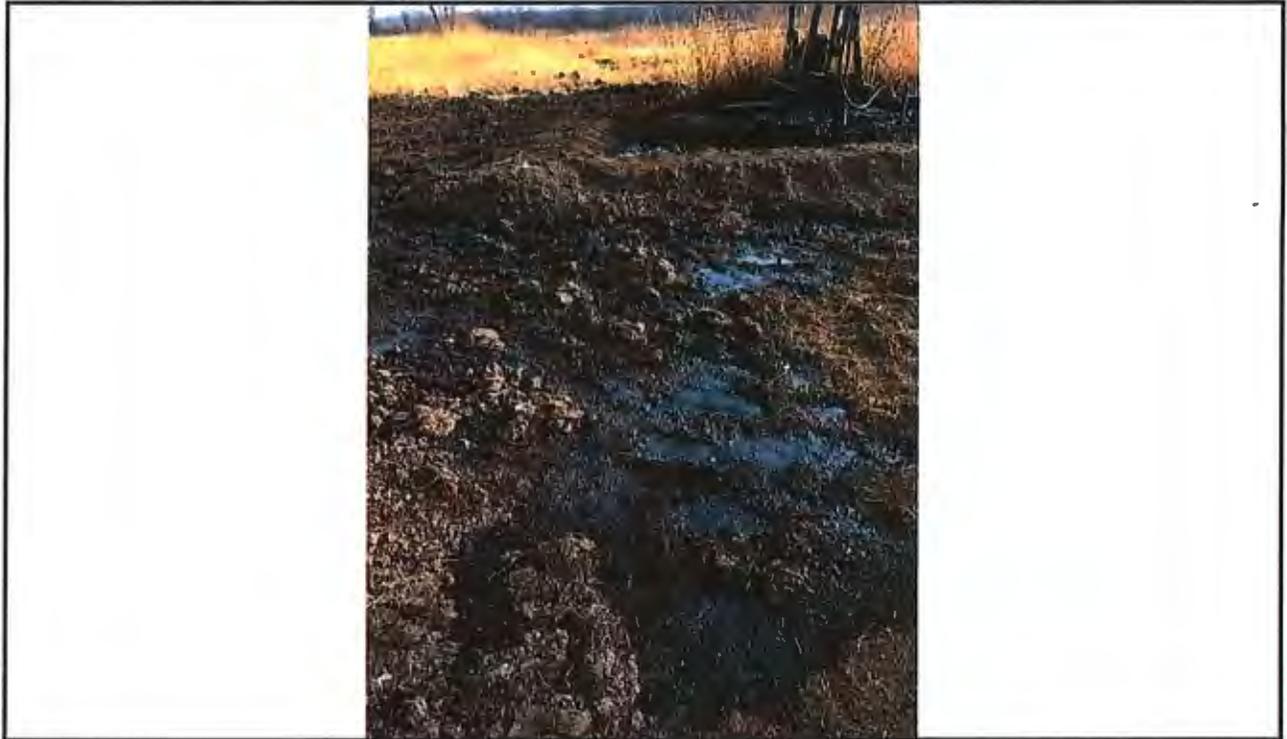
Additional Information: Picture #7

Picture #7 shows well #22-T seeping oil from the casing, the well does not have surface control. The oil has ran more than 20 feet from the well.

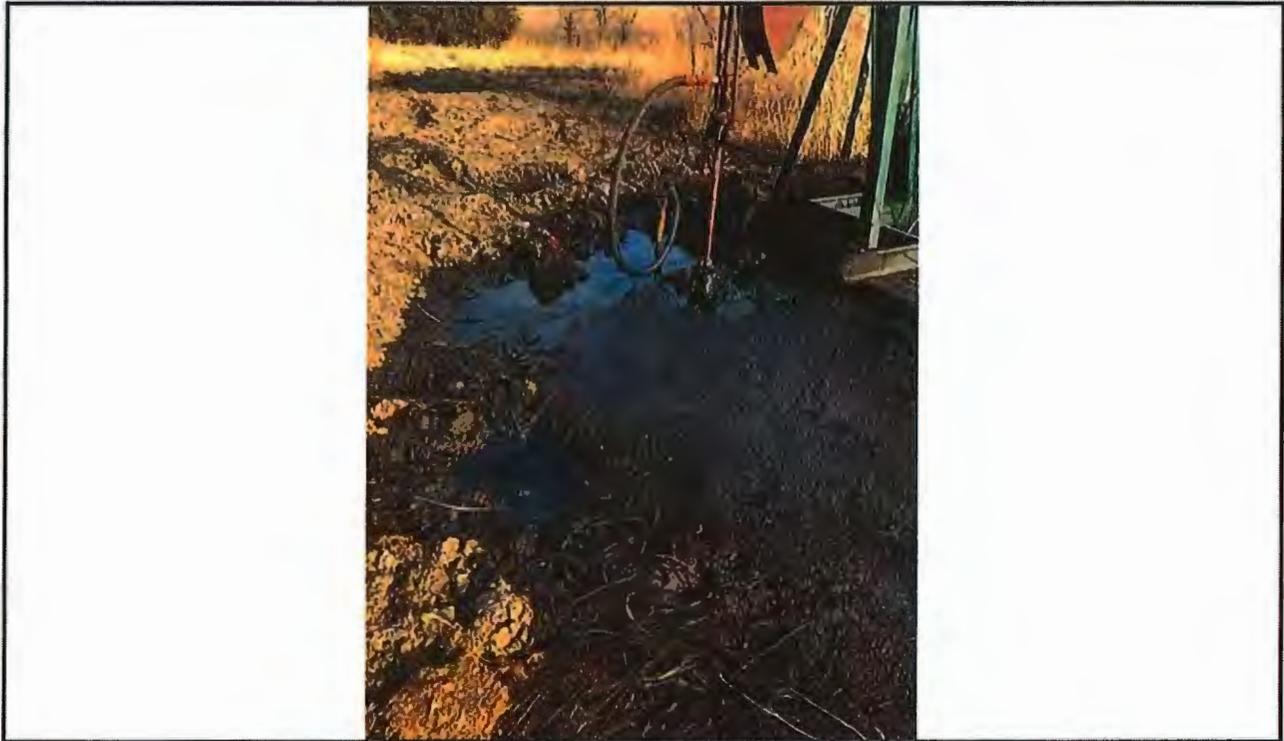
Additional Information: Picture #8

Picture #8 shows well #18-T seeping oil from the casing, the well does not have surface control.

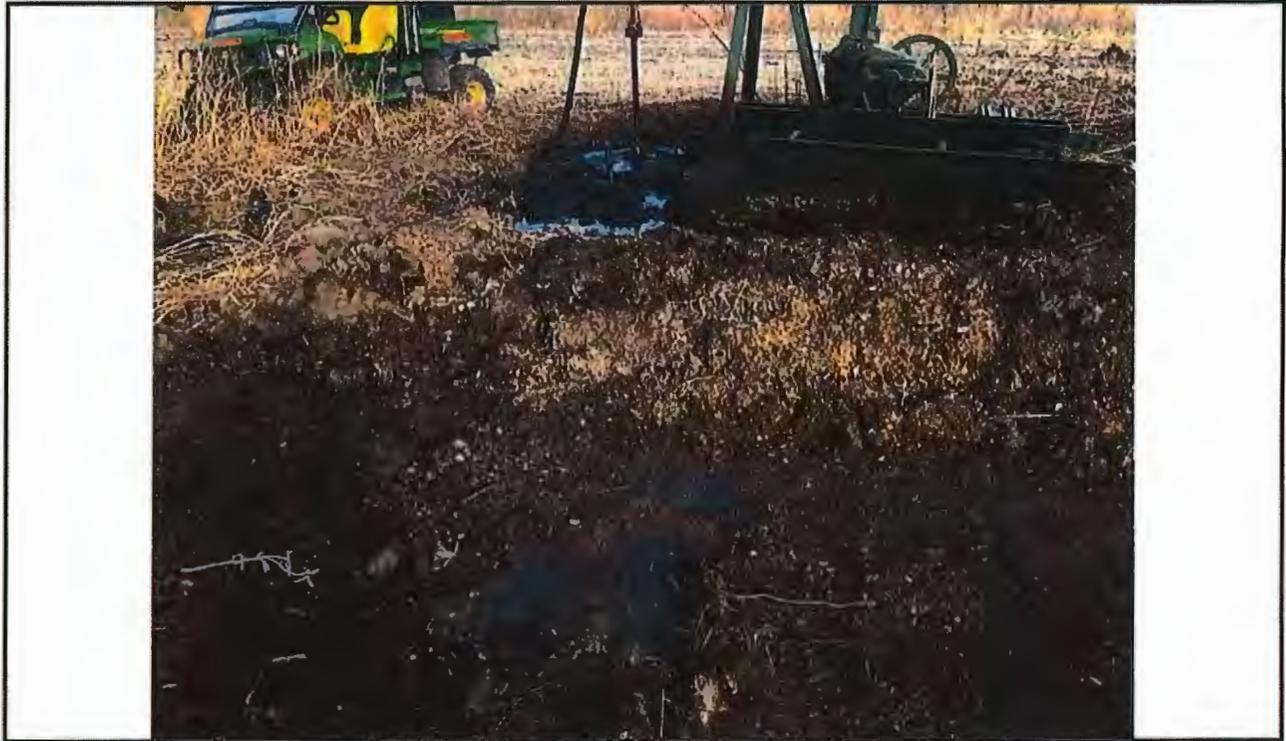
Additional Information: Picture #9

Picture #9 shows well #17-T seeping oil from the casing, the well does not have surface control.

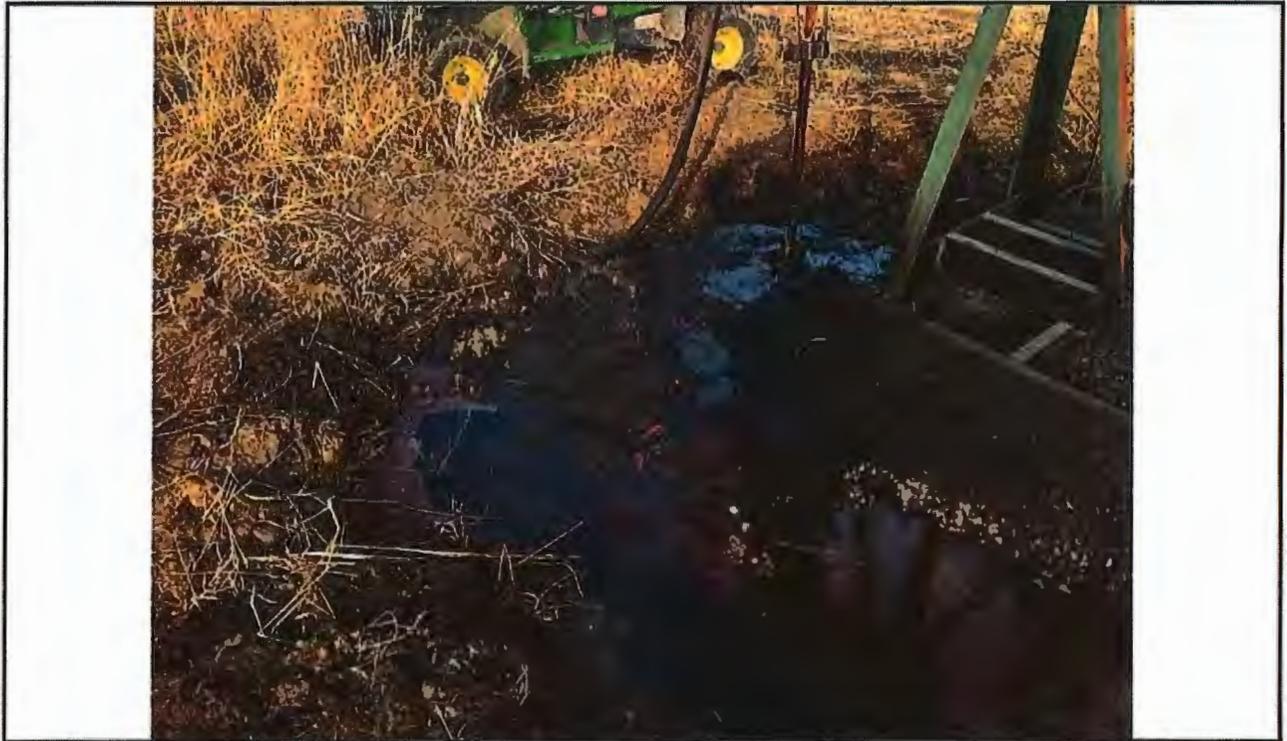
Additional Information: Picture #10

Picture #10 shows well #17-T seeping oil from the casing, the well does not have surface control.

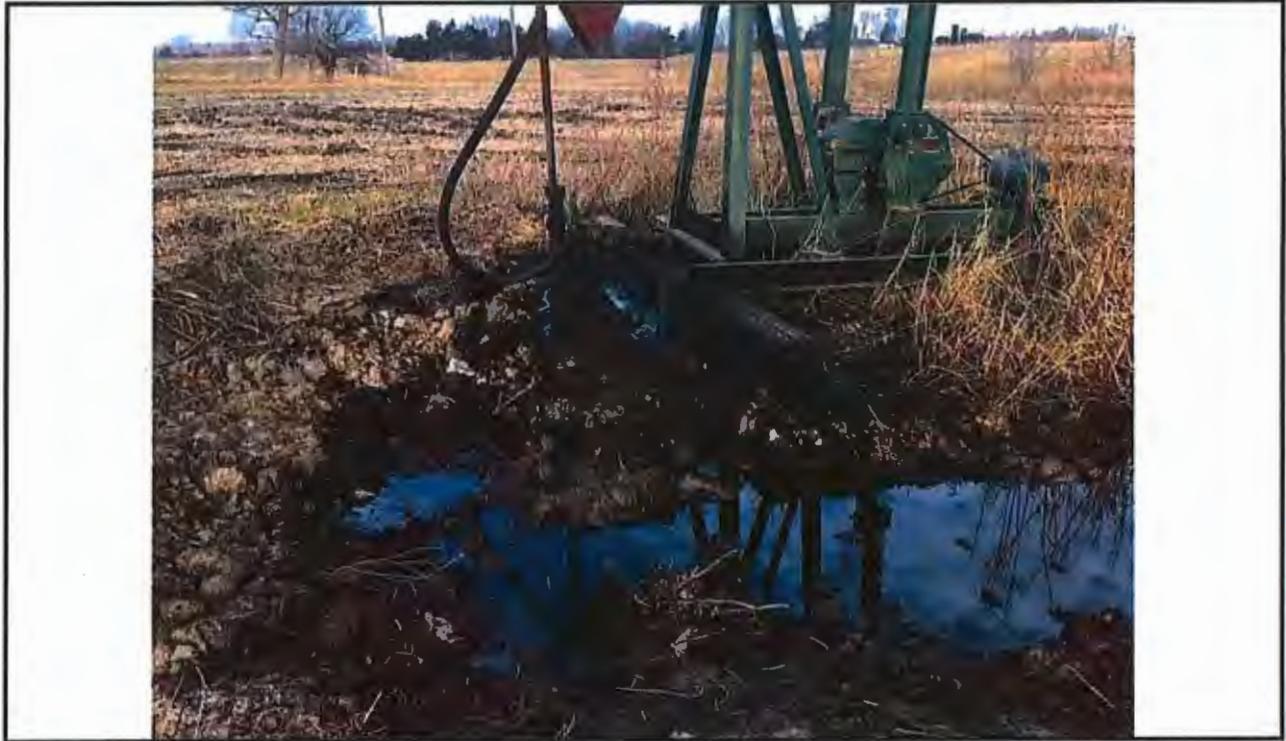
Additional Information: Picture #11

Picture #11 shows well #16-T seeping oil from the casing, the well does not have surface control.

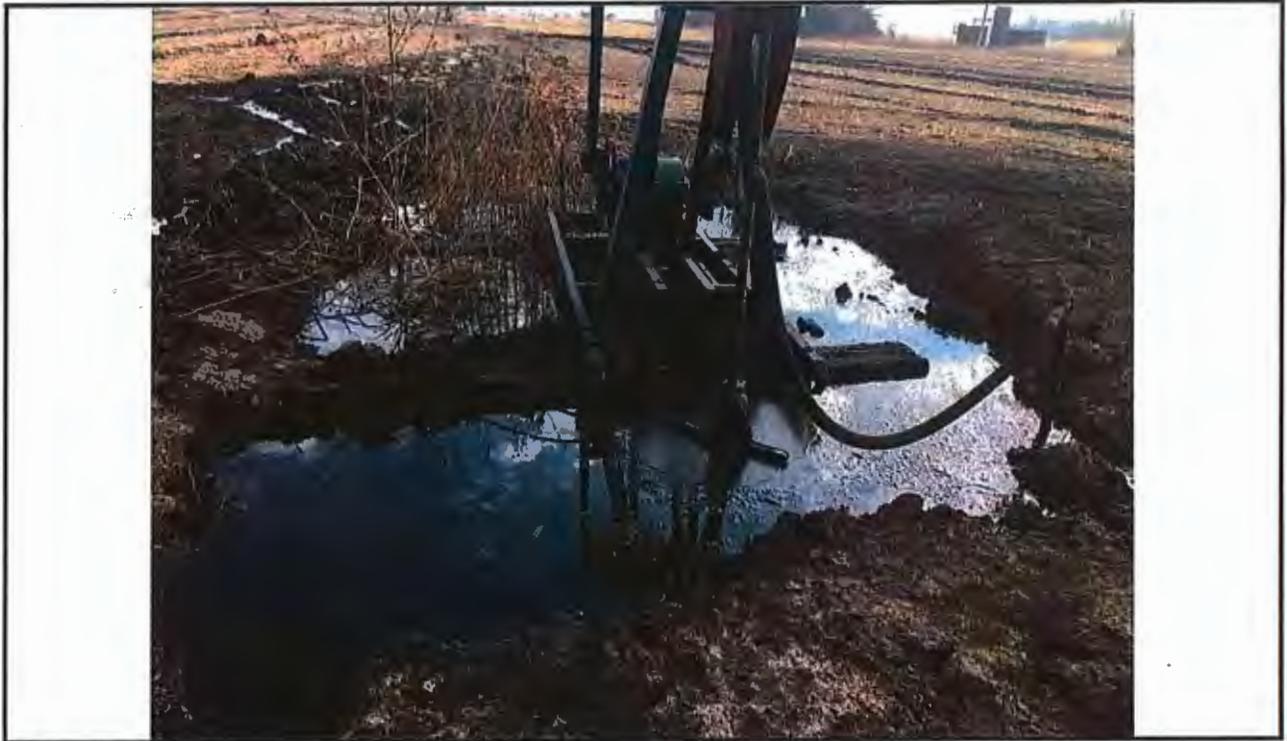
Additional Information: Picture #12

Picture #12 shows well #28-T at the well looking East, oil and water leaking from the casing, the well does not have surface control.

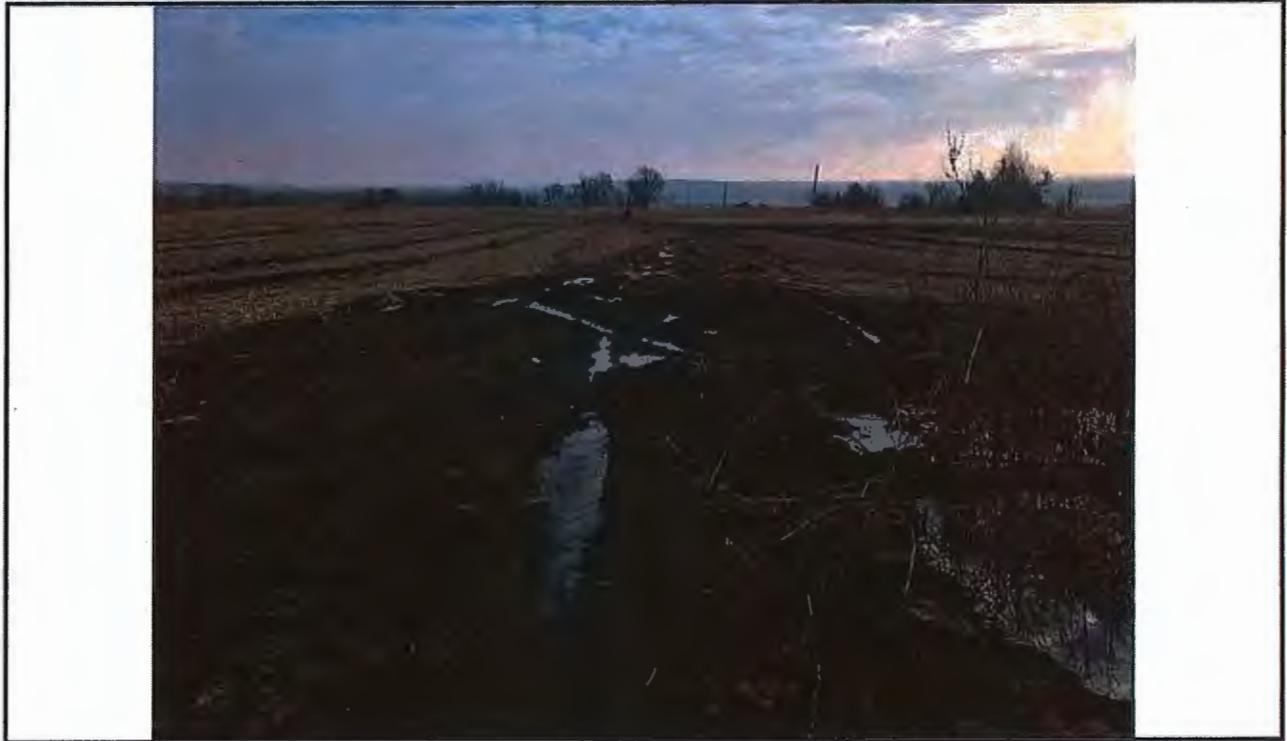
Additional Information: Picture #13

Picture #13 shows well #28-T at the well looking East, East of the well, oil and water leaking from the casing, the well does not have surface control. The fluid has ran more than 100 feet from the well.

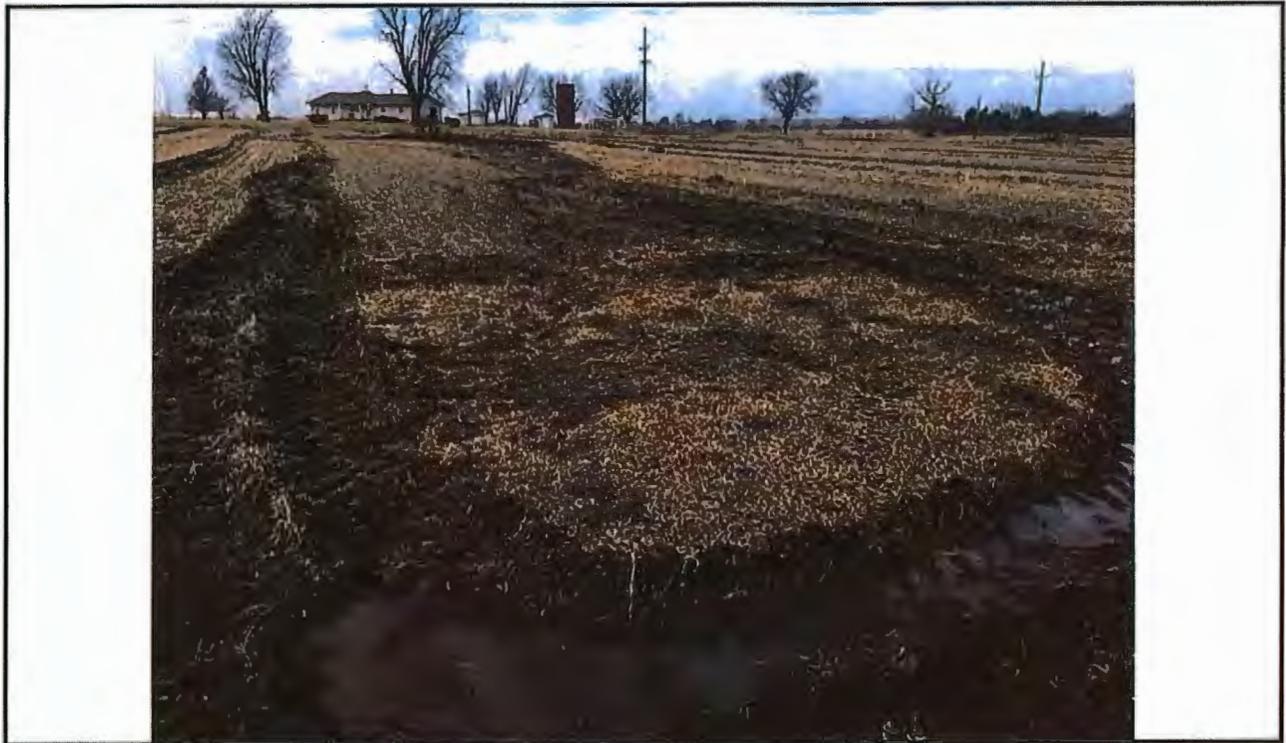
Additional Information: Picture #14

Picture #14 shows well #28-T approximately 100 feet East of the well looking West, oil and water leaking from the casing, the well does not have surface control. The fluid has ran more than 100 feet from the well, at water sample was collected from this location, the water sample was tested for chlorides at the Chanute District #3 office and the chlorides were 17,000 ppm. The operator will be required to remediate the impacted area.

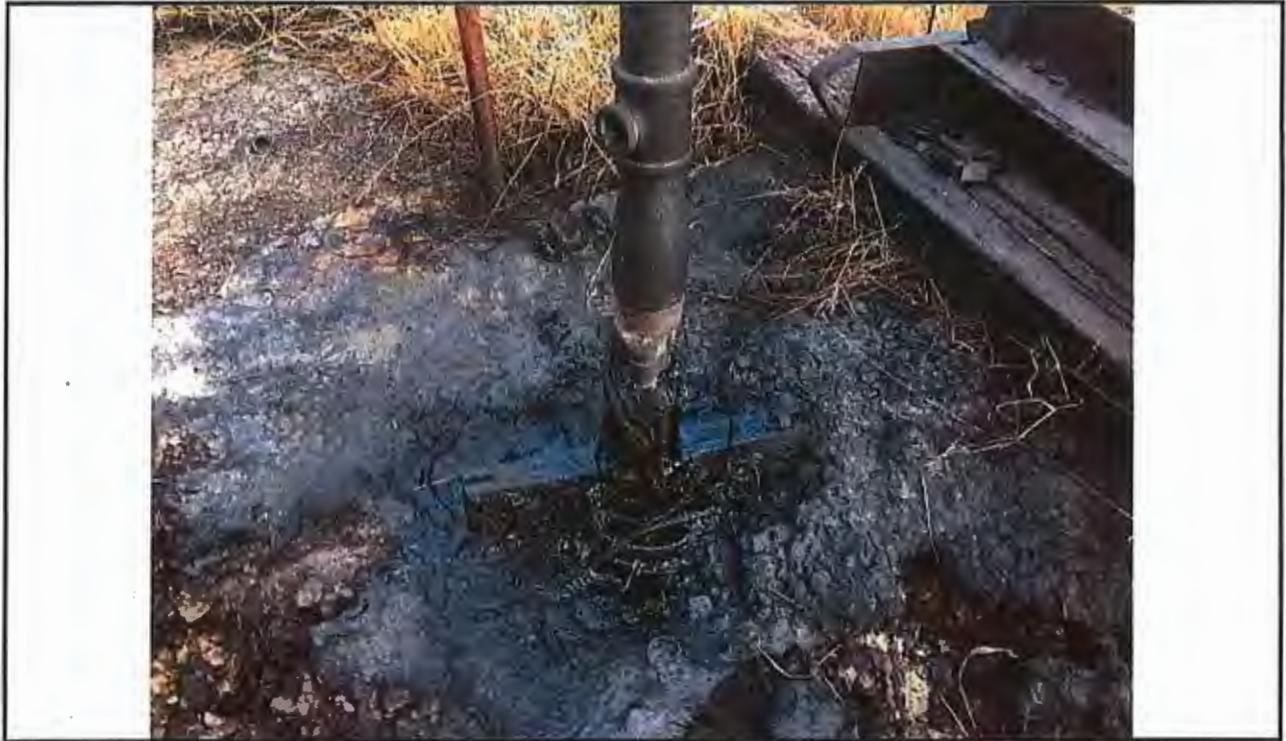
Additional Information: Picture #15

Picture #15 shows well #23-T oil seeping from the casing, the well does not have surface control.

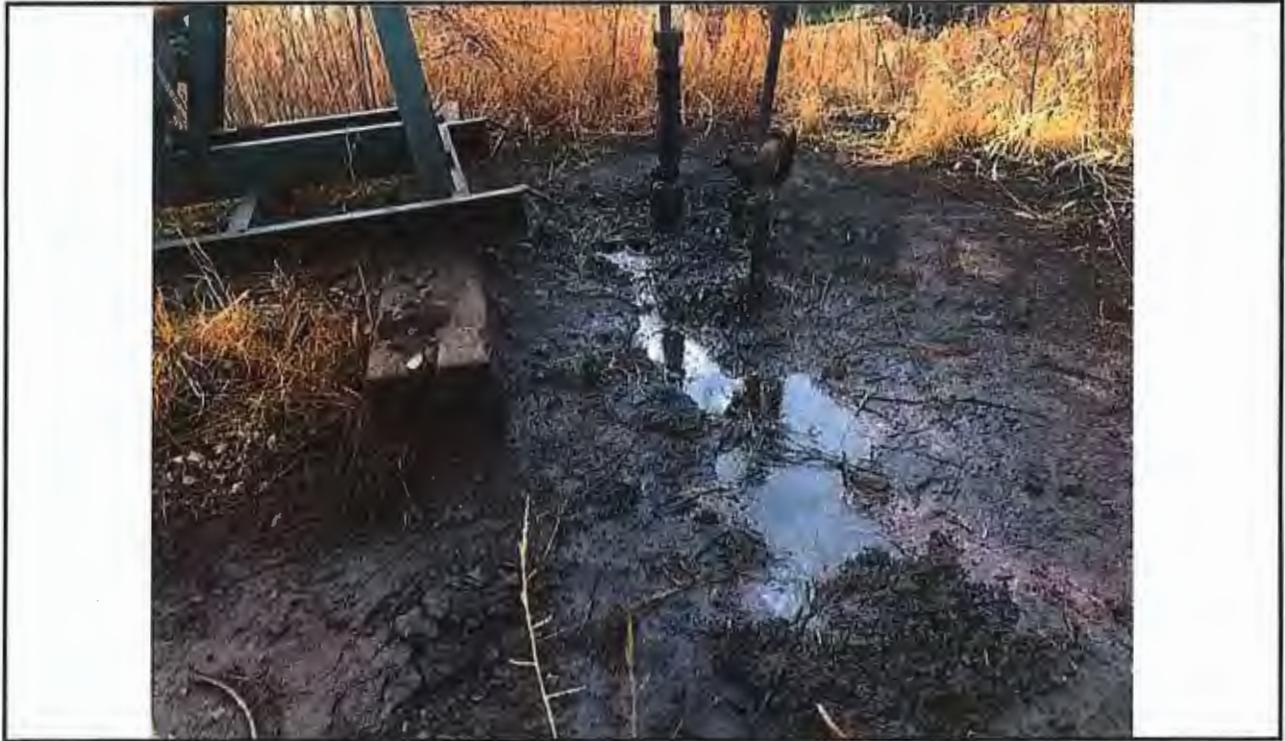
Additional Information: Picture #16

Picture #16 shows well #24-T oil seeping from the casing, the well does not have surface control.

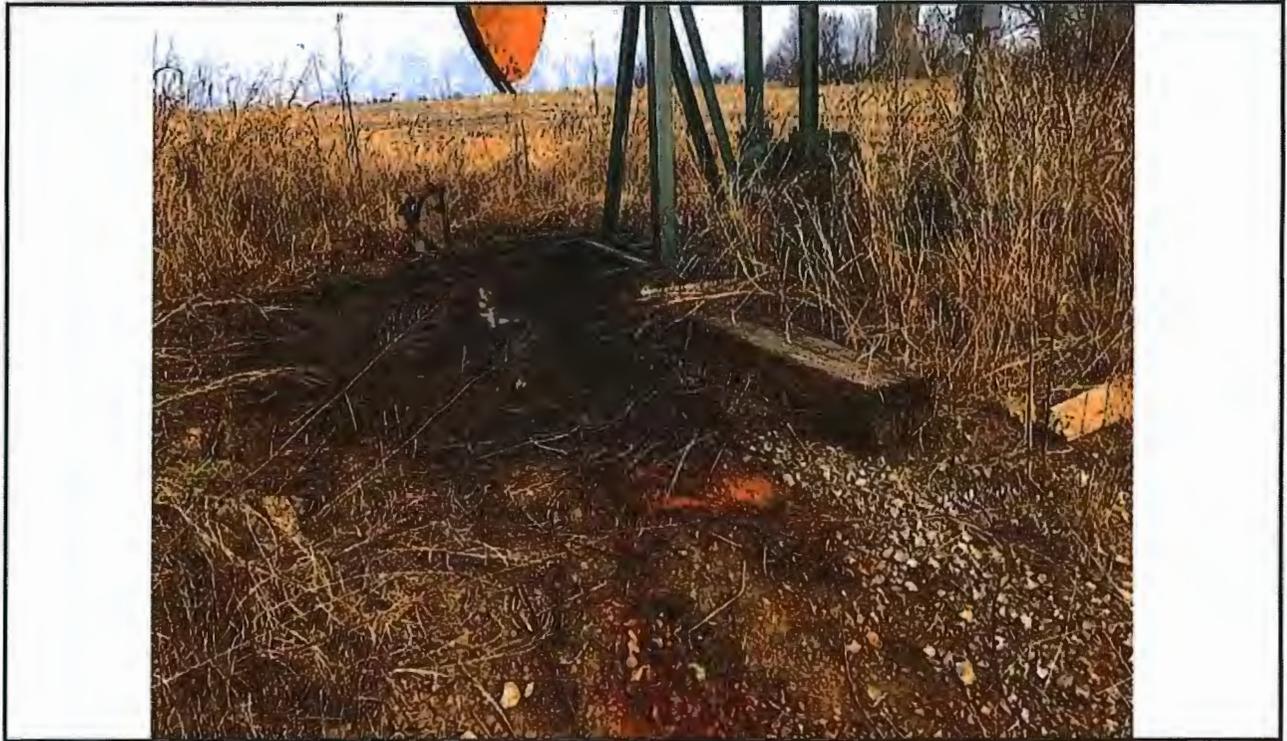
Additional Information: Picture #17

Picture #17 shows well #25-T has been cleaned up and is shut in with a swage and valve.

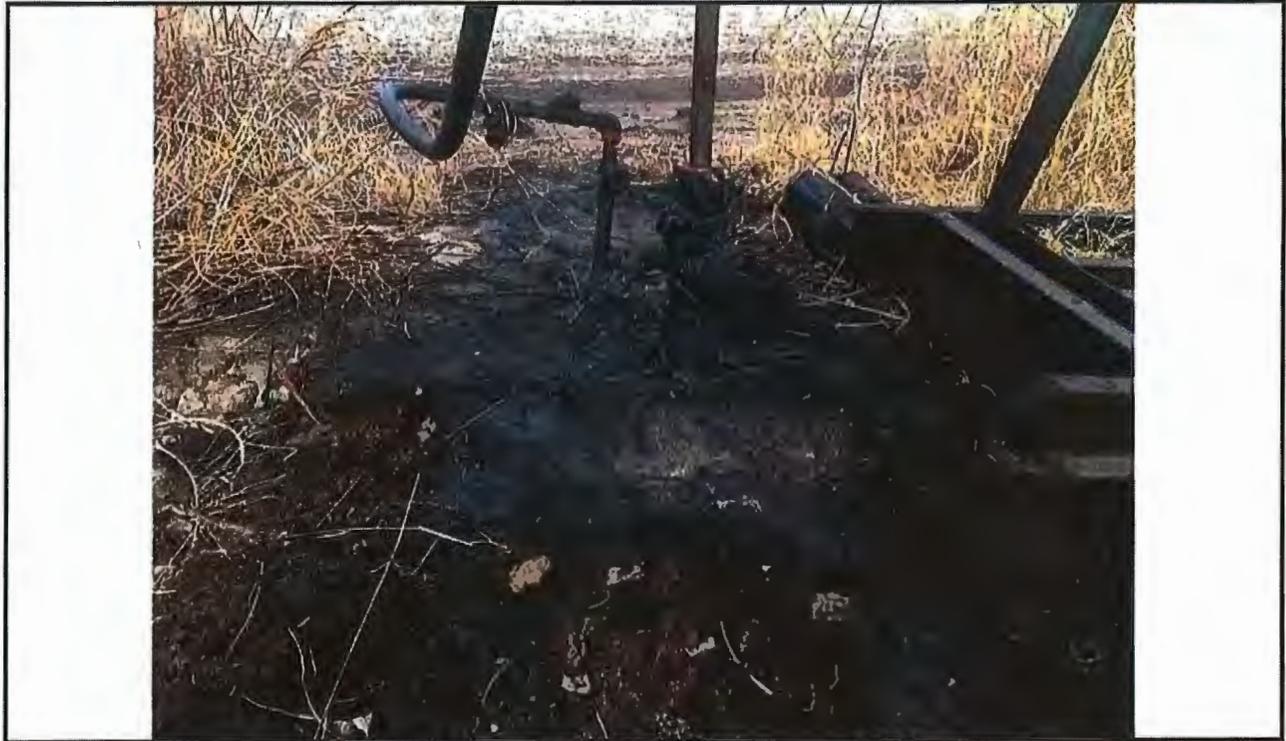
KLN: 32461
Legal: Sec. 22, Twp. 20 South, Rge. 20 East
PIC ID#: Picture #18
PIC Orientation: Facing North
Latitude:
Longitude:
Time: 11:20 am

Picture #18 shows well #3-T is not shut with surface control, the well is seeping oil from the casing.

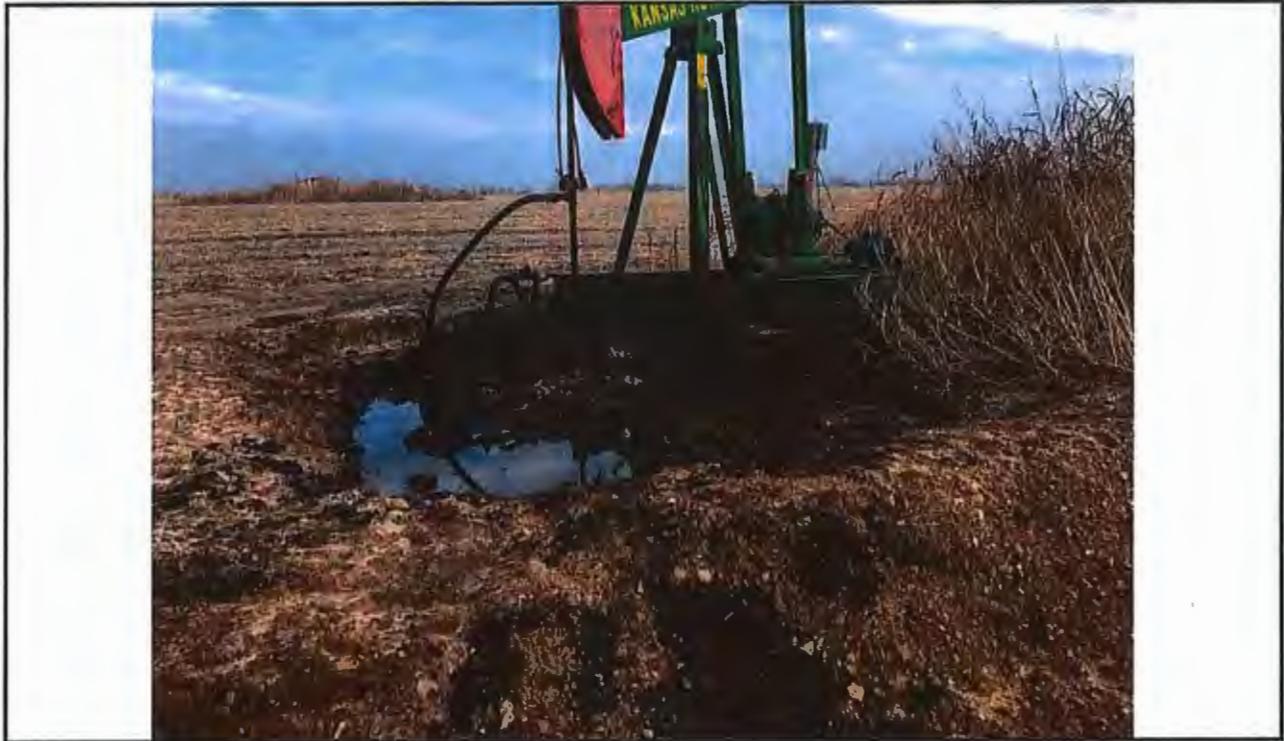
KLN: 32461
Legal: Sec. 22, Twp. 20 South, Rge. 20 East
PIC ID#: Picture #19
PIC Orientation: Facing West
Latitude:
Longitude:

Picture #19 shows well #4-T oil and water leaking from the casing, the well does not have surface control, oil seeping through the berm area.

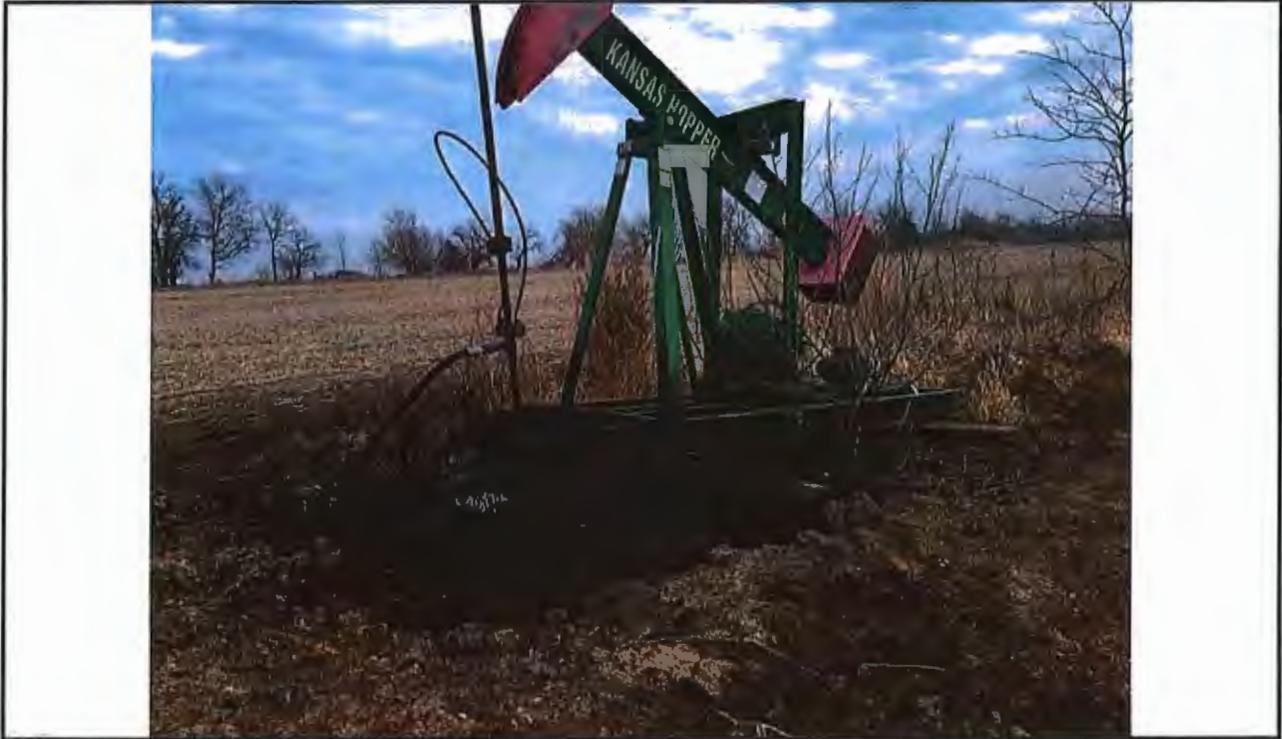
KLN: 32461
Legal: Sec. 22, Twp. 20 South, Rge. 20 East
PIC ID#: Picture #20
PIC Orientation: Facing North
Latitude:
Longitude:

Picture #20 shows well #5-T oil and water leaking from the casing, the well does not have surface control.

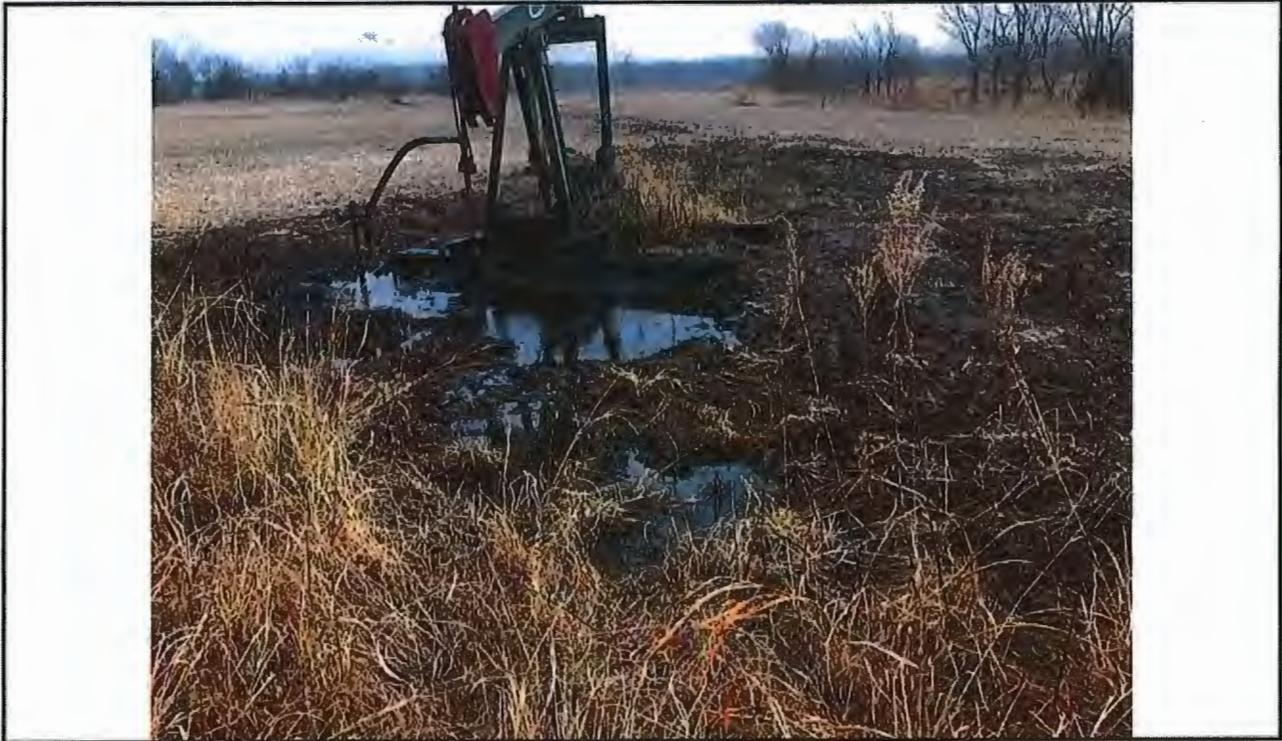
KLN: 32461
Legal: Sec. 22, Twp. 20 South, Rge. 20 East
PIC ID#: Picture #21
PIC Orientation: Facing North
Latitude:
Longitude:

Picture #21 shows well #15-T oil and water leaking from the casing, the well does not have surface control. The fluids have ran 20 feet from the well.

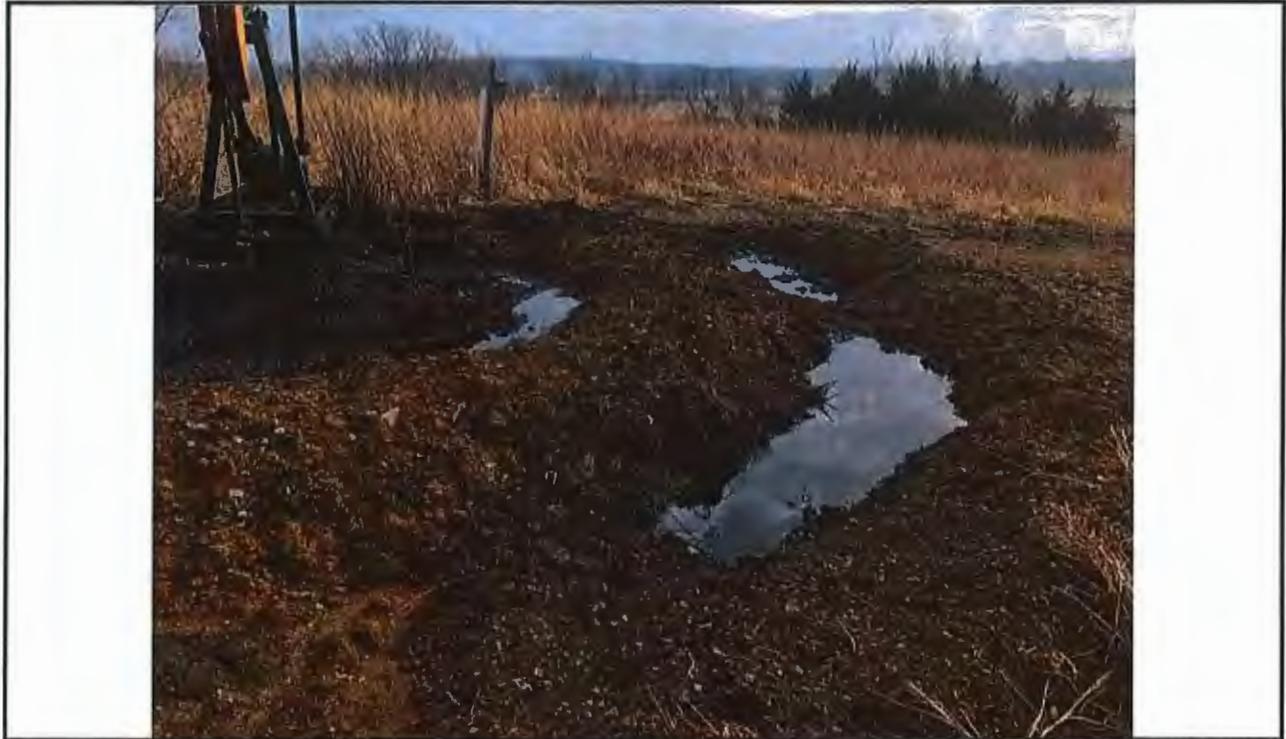
KLN: 32461
Legal: Sec. 22, Twp. 20 South, Rge. 20 East
PIC ID#: Picture #22
PIC Orientation: Facing North
Latitude:
Longitude:

Picture #22 shows well #13-T oil and water leaking from the casing, the well does not have surface control. The fluids have seeped through the berm area and 10 feet from the well.
