NOTICE OF PENALTY ASSESSMENT
21-CONS-3032-CPEN

August 27, 2020

Re: Unreported Spills and Failure to Cleanup Spills on the South Kempnich lease located in Section 22, Township 20 South, Range 20 East, Anderson County, Kansas.

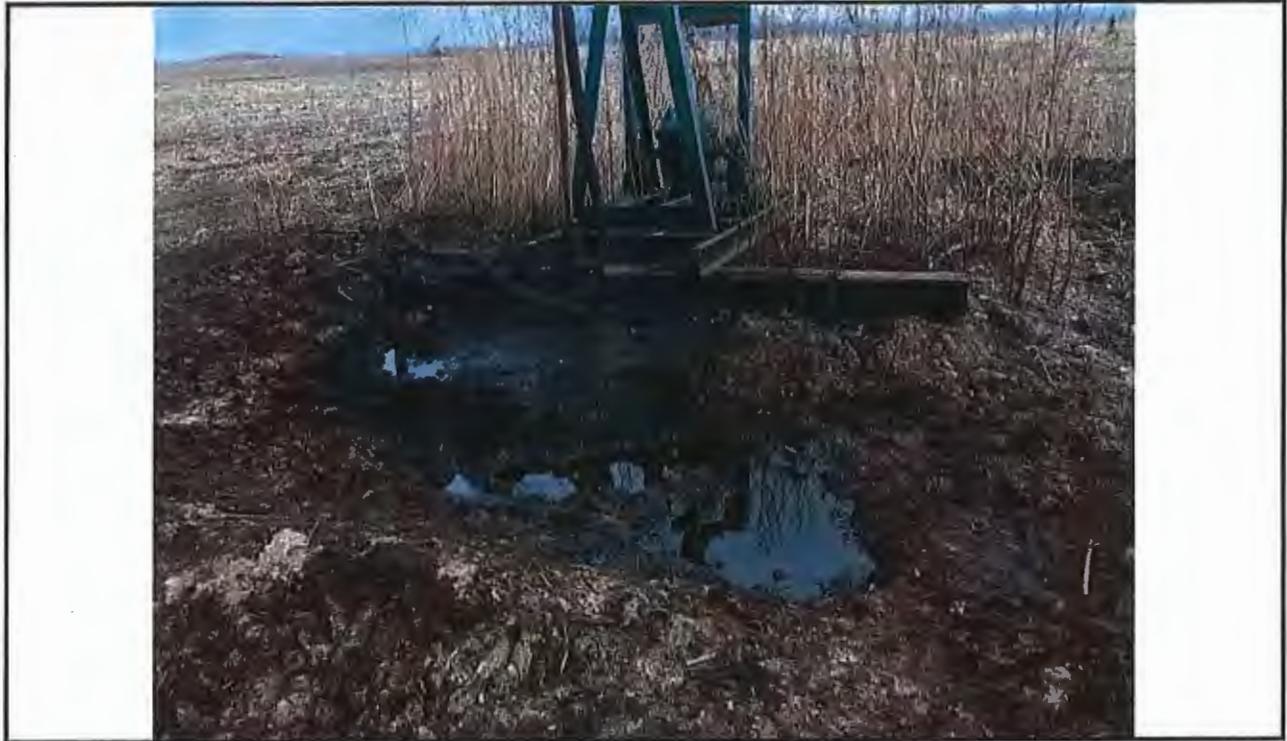
KLN: 32461
Legal: Sec. 22, Twp. 20 South, Rge. 20 East
PIC ID#: Picture #23
PIC Orientation: Facing North
Latitude:
Longitude:

Picture #23 shows well #9-T oil and water leaking from the casing, the well does not have surface control.

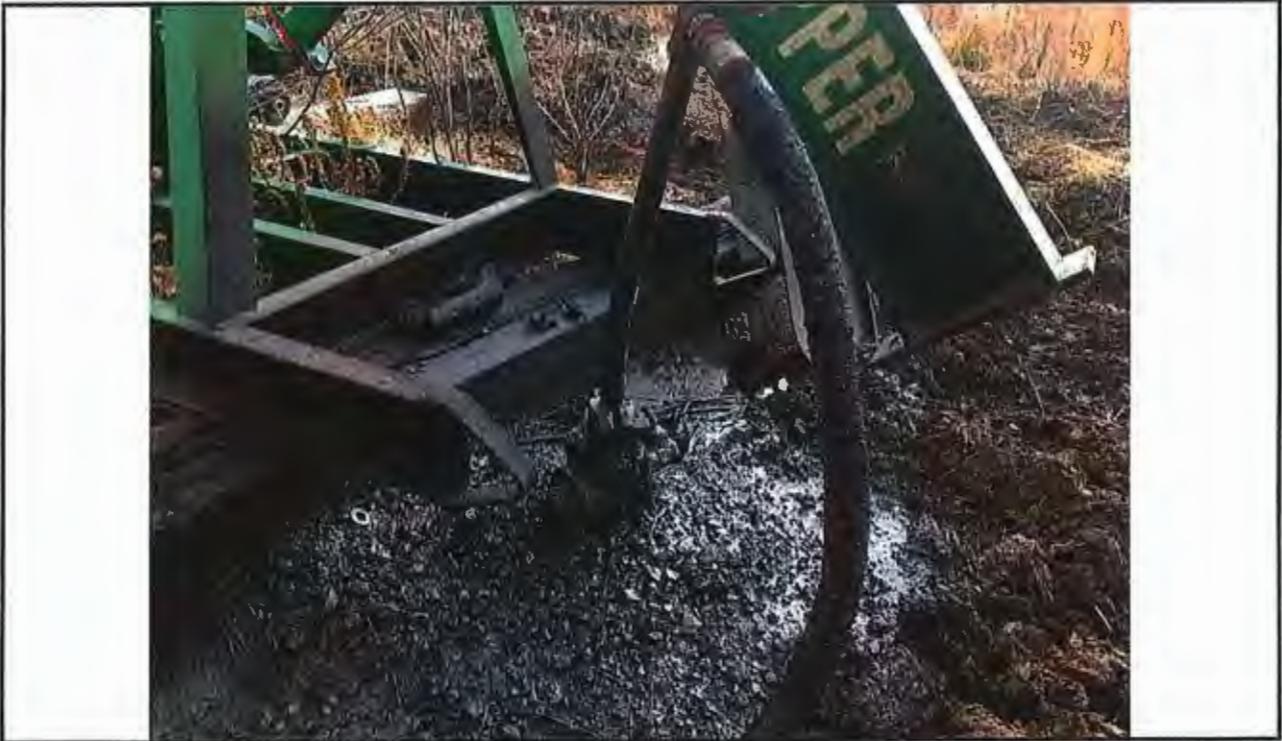
KLN: 32461
Legal: Sec. 22, Twp. 20 South, Rge. 20 East
PIC ID#: Picture #24
PIC Orientation: Facing North
Latitude:
Longitude:

Picture #24 shows well #8-T oil seeping from the casing, the well does not have surface control.

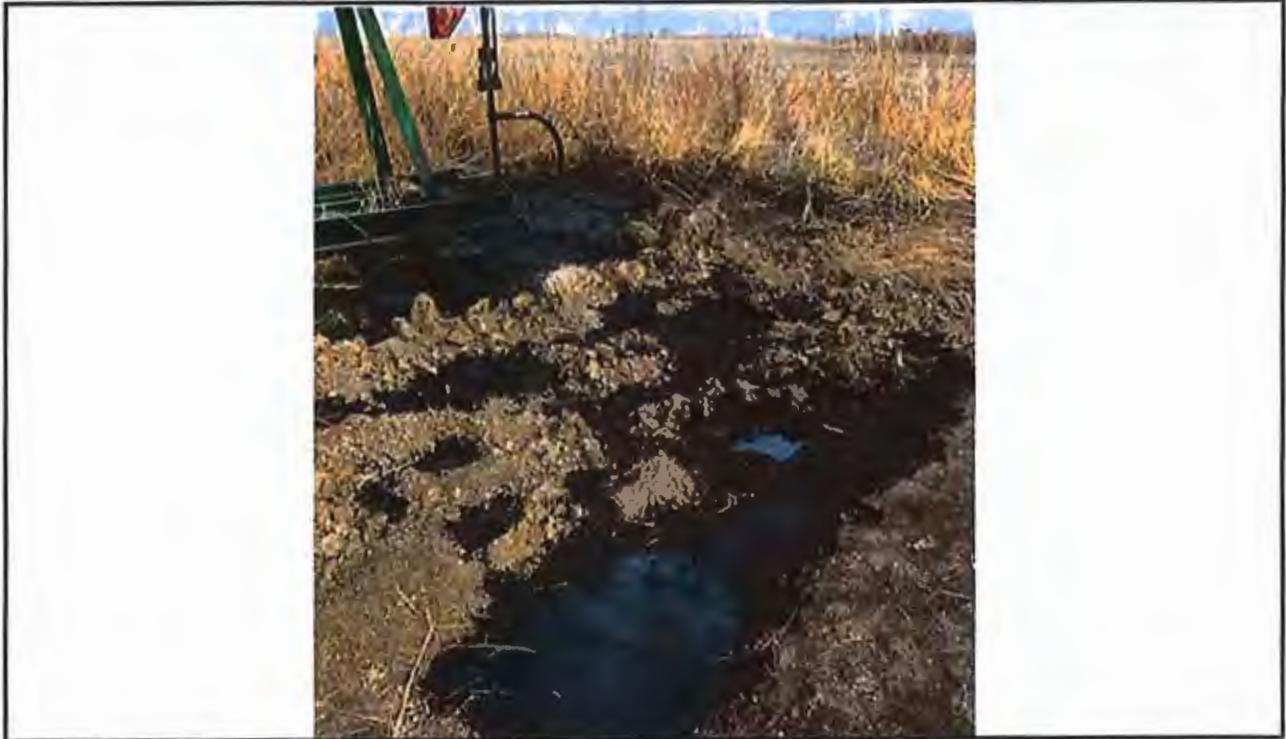
KLN: 32461
Legal: Sec. 22, Twp. 20 South, Rge. 20 East
PIC ID#: Picture #25
PIC Orientation: Facing Northeast
Latitude:
Longitude:

Picture #25 shows well #7-T oil seeping from the casing, the well does not have surface control, oil has ran more than 15 feet from the well.

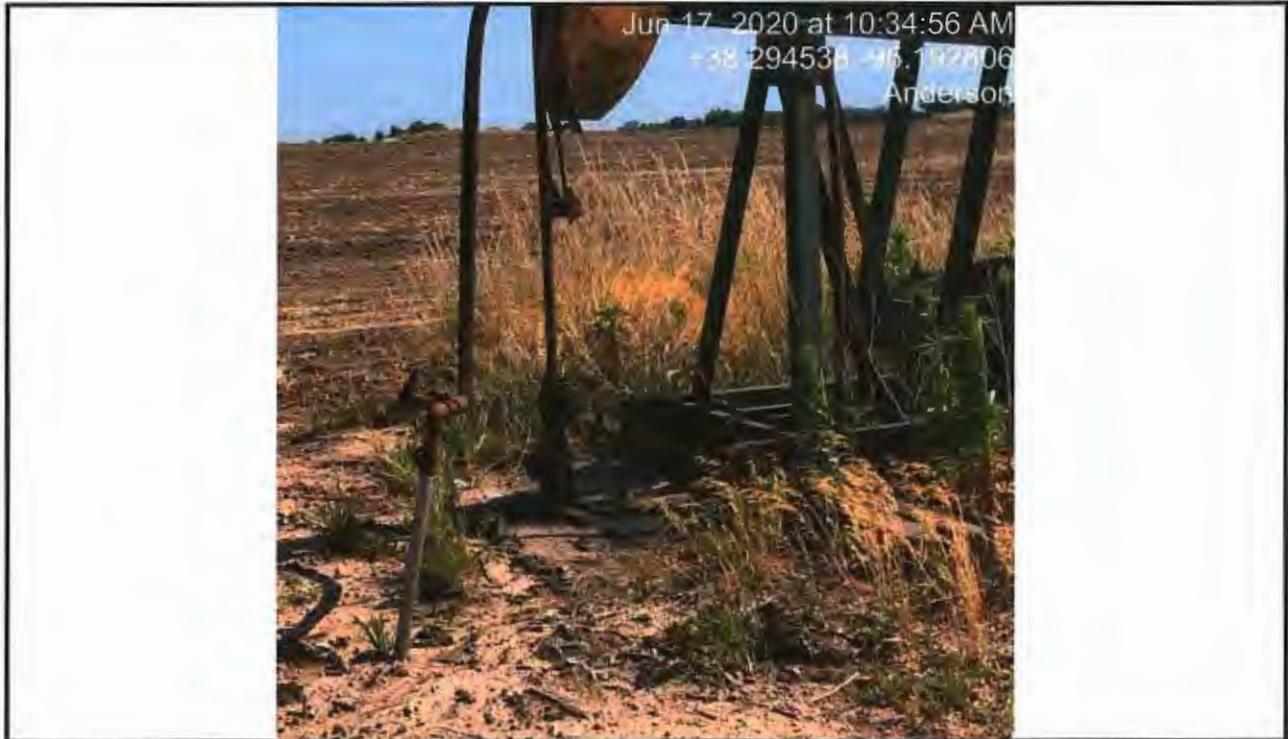
KLN: 32461
Legal: 22-20-20E
PIC ID#: 2-T
PIC Orientation:
Latitude: 38.294633
Longitude: -95.192783

15-003-24646-00-00 #2-T This well is inactive. This well has a rag and clamp sealing it in. This well wasn't leaking at the time of inspection. The 1 inch is hanging on the clamp and is disconnected from the pump jack. This well doesn't have proper surface control.

Additional Information: This picture is of well location 2-T. The well is not equipped with a stuffing box. It has a rag and clamp trying to seal the well in. At the time of inspection well was not equipped for production. The 1 inch is disconnected from the pump jack.

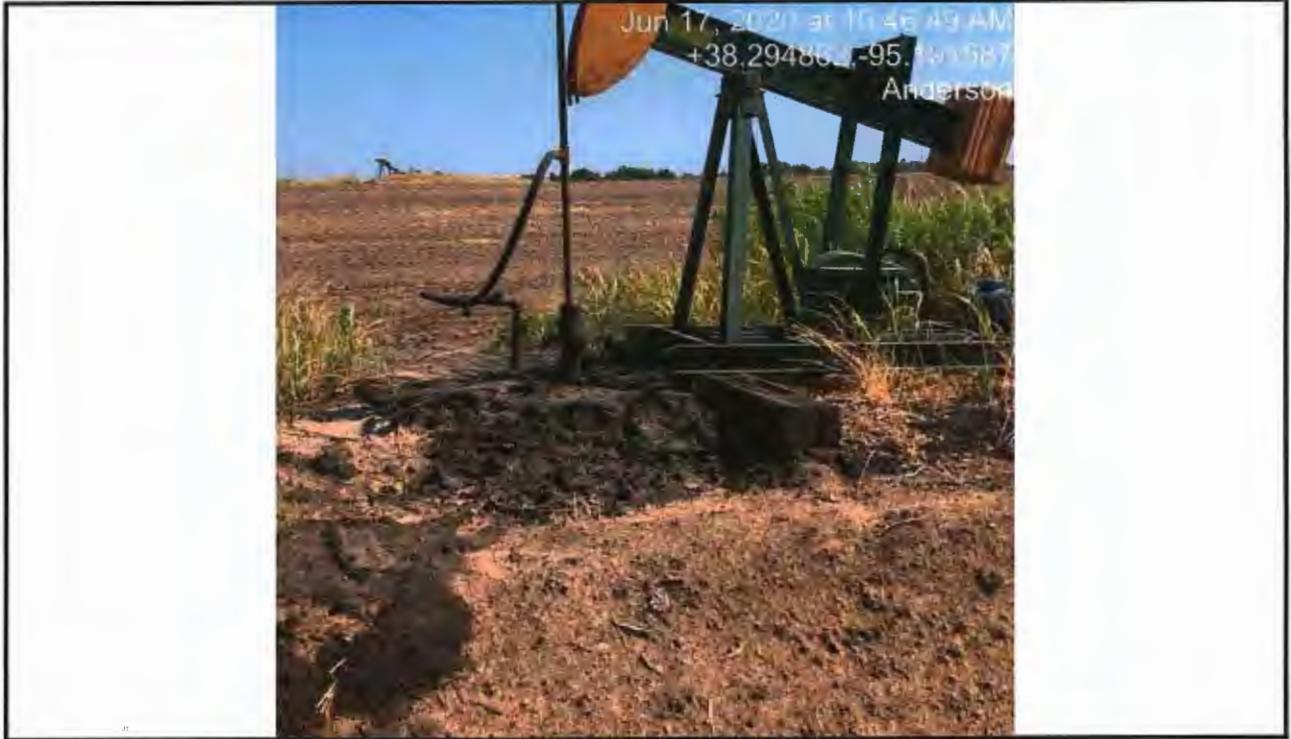
KLN: 32461
Legal: 22-20-20E
PIC ID#: 3-T
PIC Orientation:
Latitude: 38.294933
Longitude: -95.191616

15-003-24647-00-00 #3-T This well is inactive. This well has a rag and clamp sealing it in. This well wasn't leaking at the time of inspection. The 1 inch is hanging on the clamp and is disconnected from the pump jack. It is also missing the belt from the electric motor to the pump jack. This well doesn't have proper surface control.

Additional Information: This picture is of well location 3-T. This well is trying to be sealed in with a rag and clamp. At the time of inspection well was not equipped for production. The pump jack was disconnected from the 1 inch and the pump jack is missing a belt.

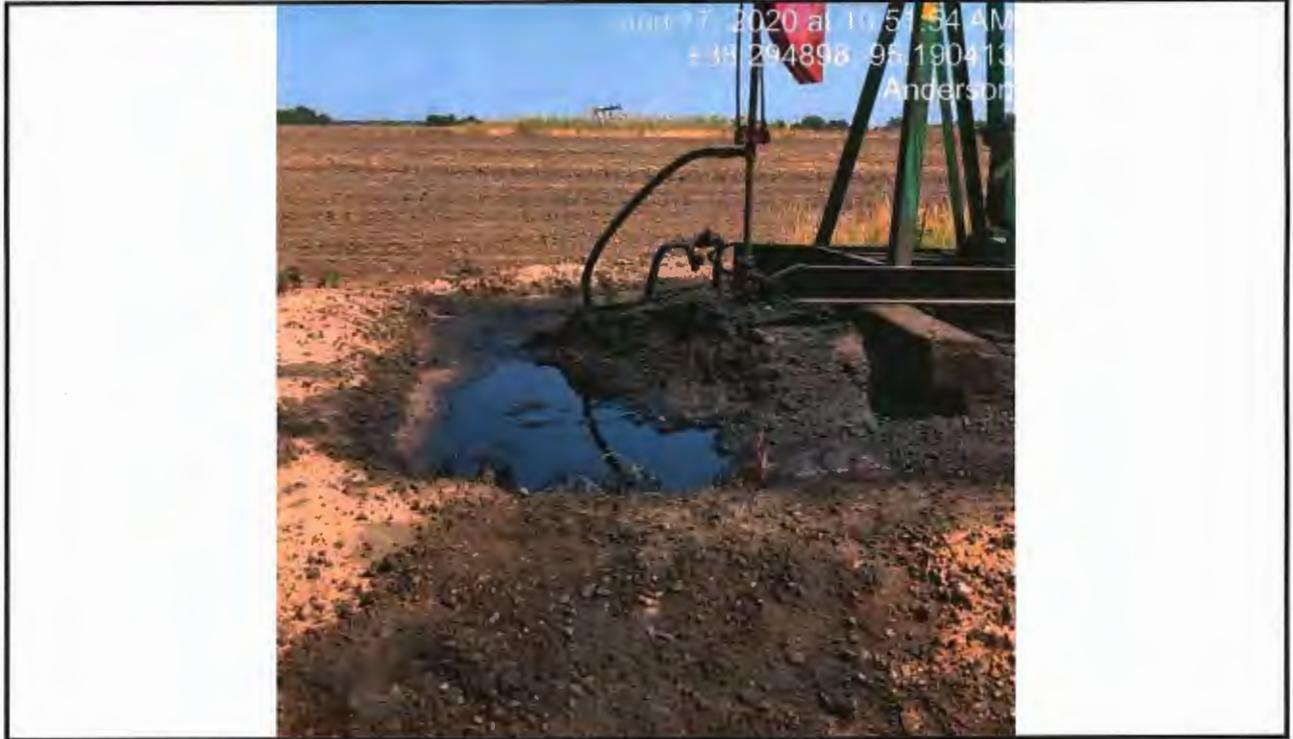
KLN:	32461
Legal:	22-20-20E
PIC ID#:	4-T
PIC Orientation:	
Latitude:	38.294950
Longitude:	-95.190450

15-003-24648-00-00 #4-T This well is inactive. They are trying to seal this well in with a rag and clamp. This well is leaking but is contained in the berm pushed up around the well. This well doesn't have proper surface control.

Additional Information: This picture is of well location 4-T. This well is trying to be sealed in with a rag and clamp. The well was leaking at the time of inspection. The spill is being contained in the berm right now but shows signs of where it has ran over the berm before. This well is inactive due to the rag and clamp.

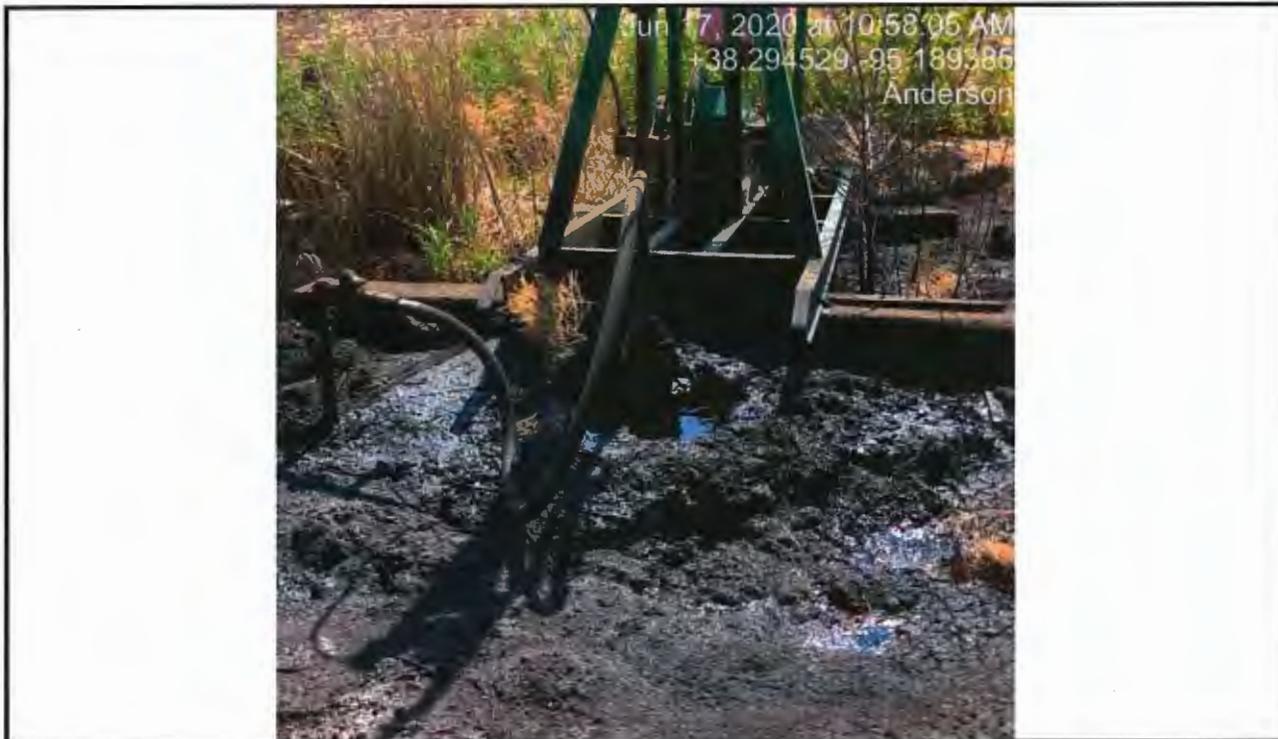
KLN: 32461
Legal: 22-20-20E
PIC ID#: 5-T Pic 1
PIC Orientation:
Latitude: 38.294550
Longitude: -95.189333

15-003-24649-00-00 #5-T This well is inactive. The 1 inch is unhooked from the pump jack. The pump jack is also missing the belt. They are trying to seal this well in with a rag and clamp. The well is leaking crude oil that has escaped from within the berm pushed up around the well. The new spill area is 30 ft. by 30ft. This well doesn't have proper surface control.

Additional Information: This picture is of well location 5-T. The well is leaking up the production string and is not equipped with a stuffing box it is trying to be sealed in with a rag and clamp. The oil has escaped the berm pushed up around the well and has caused a new spill of approximately 30 ft by 30 ft. At the time of inspection well was not equipped for production. The 1 inch is unhooked from the pump jack and the pump jack is missing the belt.

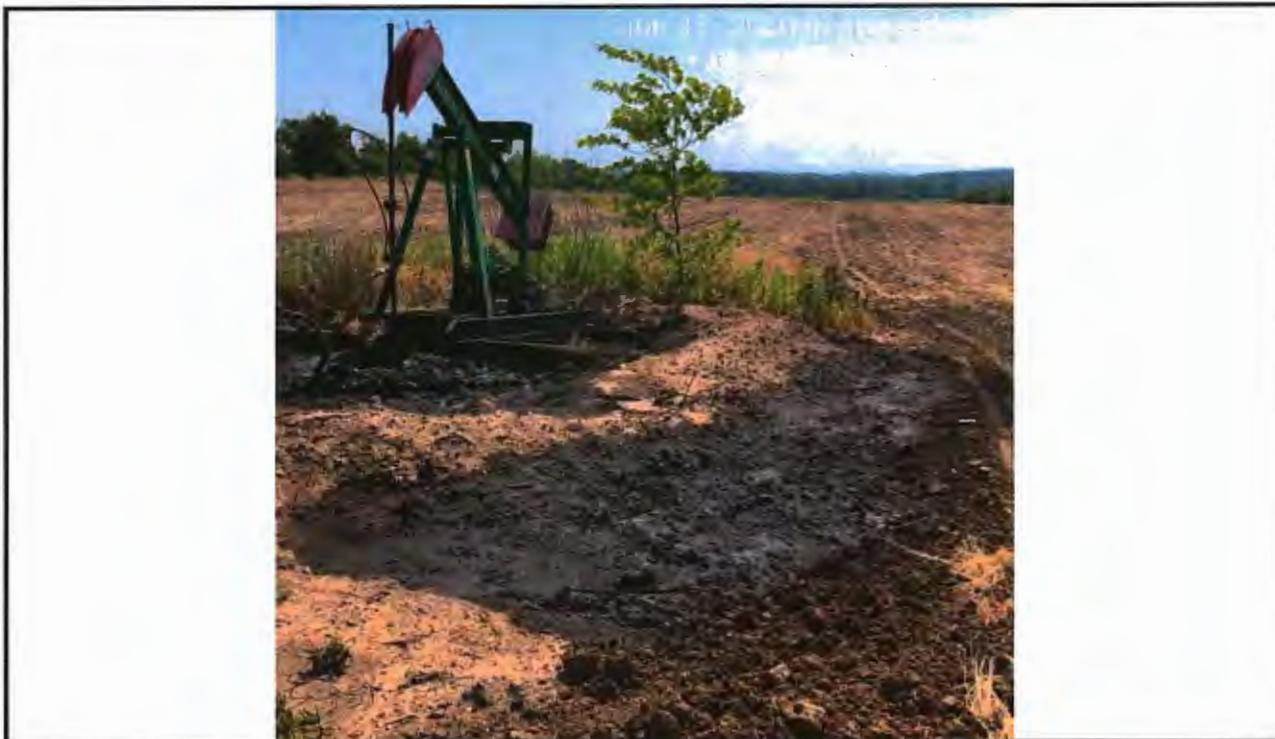
KLN: 32461
Legal: 22-20-20E
PIC ID#: 5-T Pic 2
PIC Orientation:
Latitude: 38.294550
Longitude: -95.189333

Additional Information: This picture is of well location 5-T. The well is leaking up the production string and is not equipped with a stuffing box it is trying to be sealed in with a rag and clamp. The oil has escaped the berm pushed up around the well and has caused a new spill of approximately 30 ft by 30 ft. At the time of inspection well was not equipped for production. The 1 inch is unhooked from the pump jack and the pump jack is missing the belt.

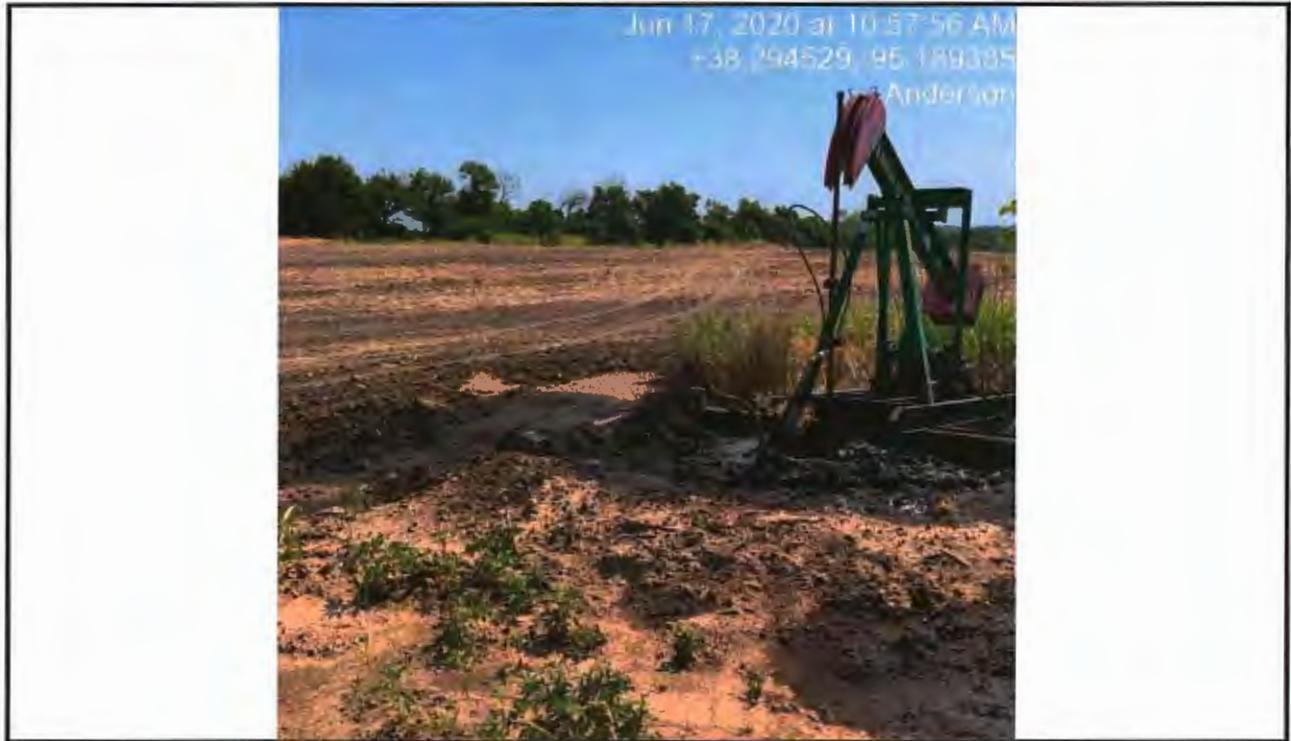
KLN: 32461
Legal: 22-20-20E
PIC ID#: 5-T Pic 3
PIC Orientation:
Latitude: 38.294550
Longitude: -95.189333

Additional Information: This picture is of well location 5-T. The well is leaking up the production string and is not equipped with a stuffing box it is trying to be sealed in with a rag and clamp. The oil has escaped the berm pushed up around the well and has caused a new spill of approximately 30 ft by 30 ft. At the time of inspection well was not equipped for production. The 1 inch is unhooked from the pump jack and the pump jack is missing the belt.

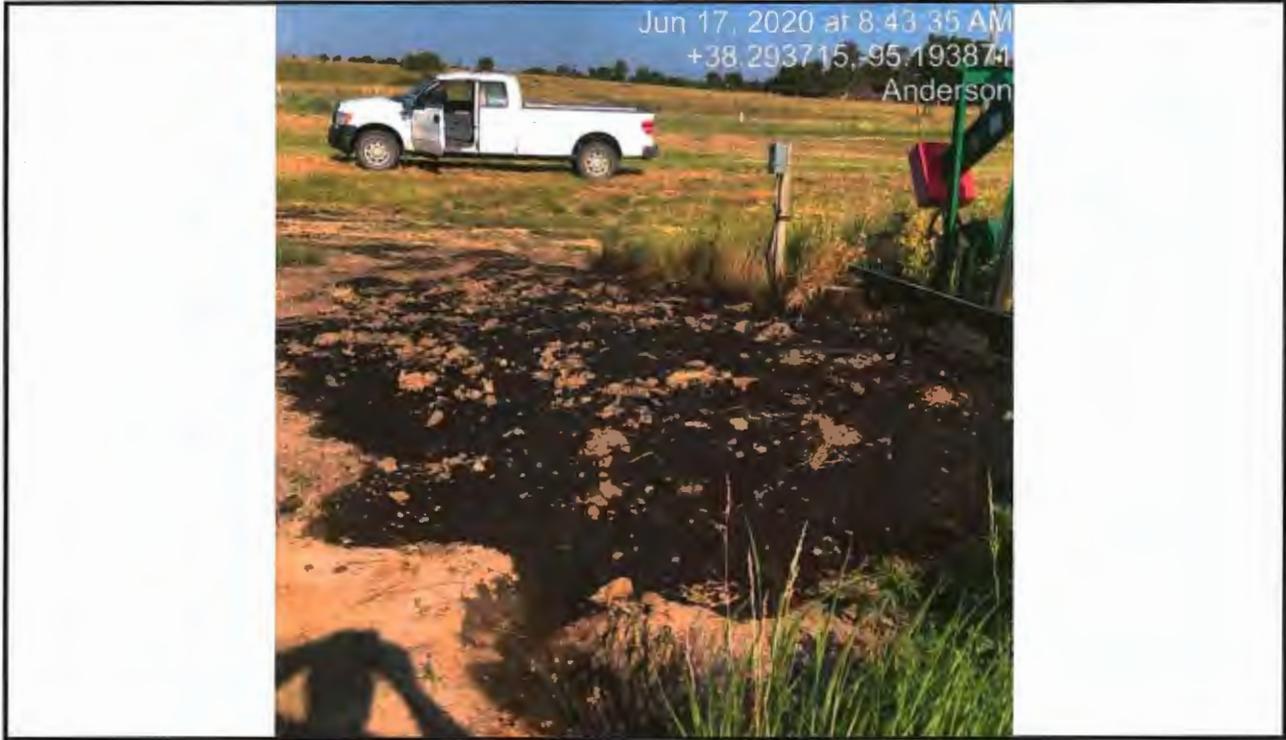
KLN: 32461
Legal: 22-20-20E
PIC ID#: 7-T PIC 1
PIC Orientation:
Latitude: 38.293766
Longitude: -95.193816

15-003-24651-00-00 #7-T This well is inactive. The one inch is on a clamp and is unhooked from the pump jack. They have tried to shut this well in with a rag and clamp. The well is still leaking. This site has a new spill approximately 15 ft. by 30 ft. with an old spill approximately 30 ft. by 60 ft. This well does not have proper surface control.

Additional Information: This picture is of well location 7-T. This location has a new spill approximately 15' by 30'. The well is leaking up the production string and is not equipped with a stuffing box. They have tried to seal the well in with a rag and a clamp. The well is inactive. The 1 inch is unhooked from the pump jack. There is an old kill area approximately 30' x 60'.

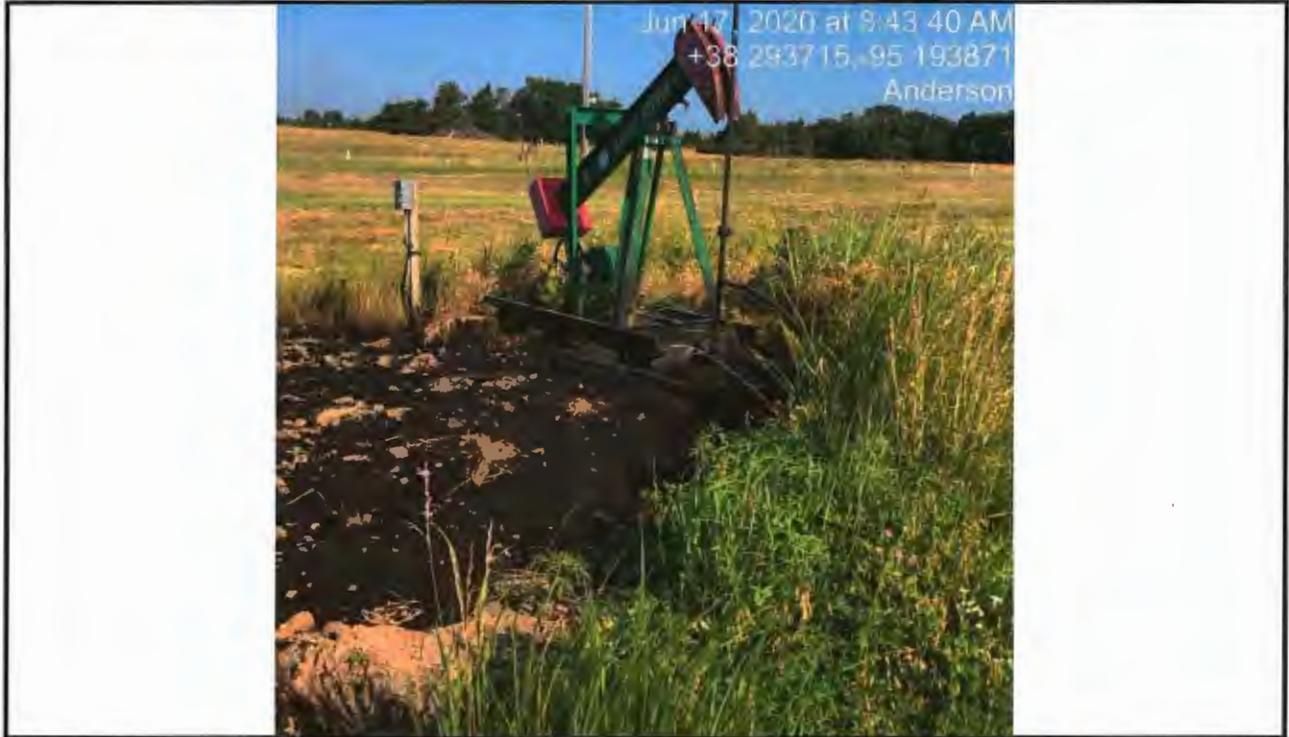
KLN: 32461
Legal: 22-20-20E
PIC ID#: 7-T PIC 2
PIC Orientation:
Latitude: 38.293766
Longitude: -95.193816

Additional Information: This picture is of well location 7-T. This location has a new spill approximately 15' by 30'. The well is leaking up the production string and is not equipped with a stuffing box. They have tried to seal the well in with a rag and a clamp. The well is inactive. The 1 inch is unhooked from the pump jack. There is an old kill area approximately 30' x 60'.

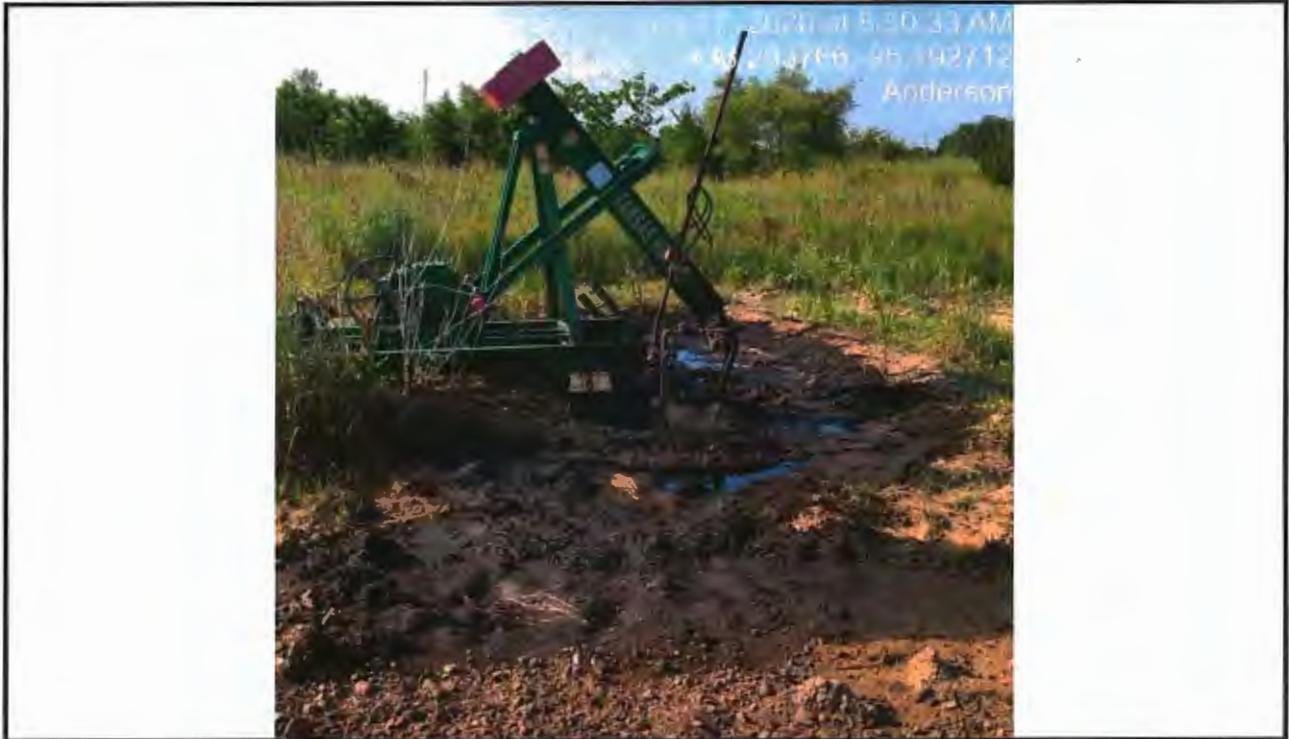
KLN: 32461
Legal: 22-20-20E
PIC ID#: 8-T PIC 1
PIC Orientation:
Latitude: 38.293700
Longitude: -95.192733

15-003-24652-00-00 #8-T This well is inactive. The pump jack is disconnected from the 1 inch and the pump jack is in disrepair. They have tried to shut this well in with a rag and clamp. The well is still leaking. Fresh crude oil is on the ground within the berm, the operator has pushed dirt up around the producing wells on the lease. This well does not have proper surface control.

Additional Information: This picture is of well location 8-T. This location has berm pushed up around the well and the oil is being contained in the berm so far. The well is leaking up the production string and is not equipped with a stuffing box. The well is trying to be sealed in by a rag and a clamp on the 1 inch. At the time of inspection well was not equipped for production. The pump jack was broke.

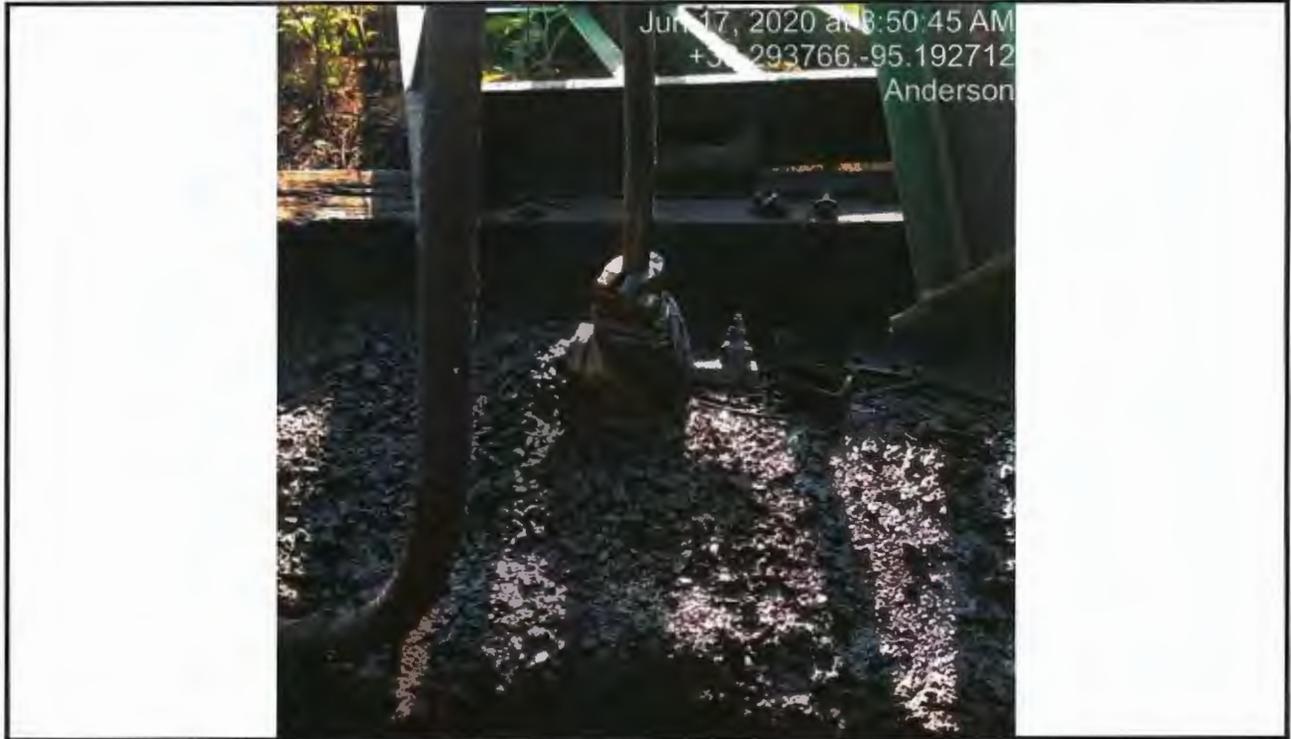
KLN: 32461
Legal: 22-20-20E
PIC ID#: 8-T PIC 2
PIC Orientation:
Latitude: 38.293700
Longitude: -95.192733

Additional Information: This picture is of well location 8-T. This location has berm pushed up around the well and the oil is being contained in the berm so far. The well is leaking up the production string and is not equipped with a stuffing box. The well is trying to be sealed in by a rag and a clamp on the 1 inch. At the time of inspection well was not equipped for production. The pump jack was broke.

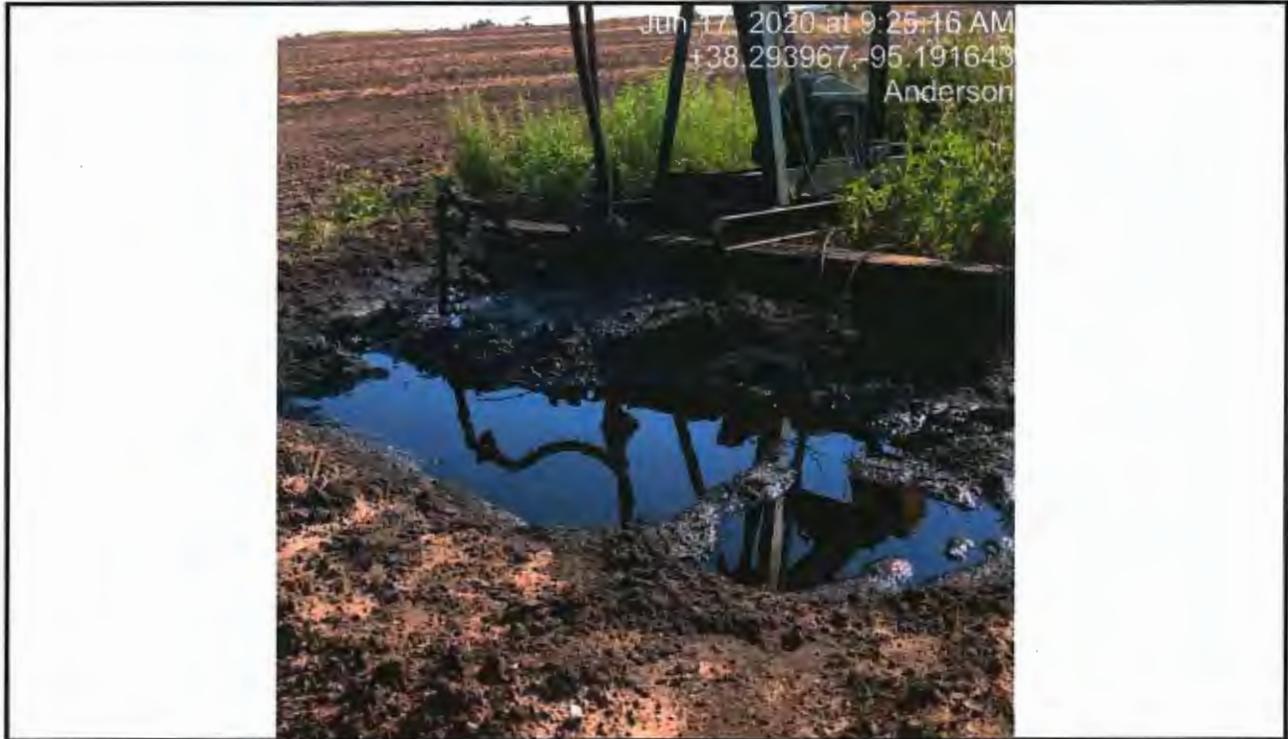
KLN:	32461
Legal:	22-20-20E
PIC ID#:	9-T Pic 1
PIC Orientation:	
Latitude:	38.294066
Longitude:	-95.191650

15-003-24653-00-00 #9-T This well is inactive. The pump jack is disconnected from the 1 inch. The pump jack is also missing the electric motor and the belt. The 1 inch is on a clamp with a rag trying to seal it off. This well is leaking fluid but it is within the berm, the operator has pushed dirt up around the well. This well does not have proper surface control.

Additional Information: This picture is of well location 9-T. This location has spill but is contained in the berm pushed up around the well. The well is leaking up the production string and is equipped with a stuffing box but it is unscrewed and is above the rag and clamp. They have tried to seal the well in with a rag and a clamp. At the time of inspection well was not equipped for production. The pump jack is missing the electric motor and the drive belt.

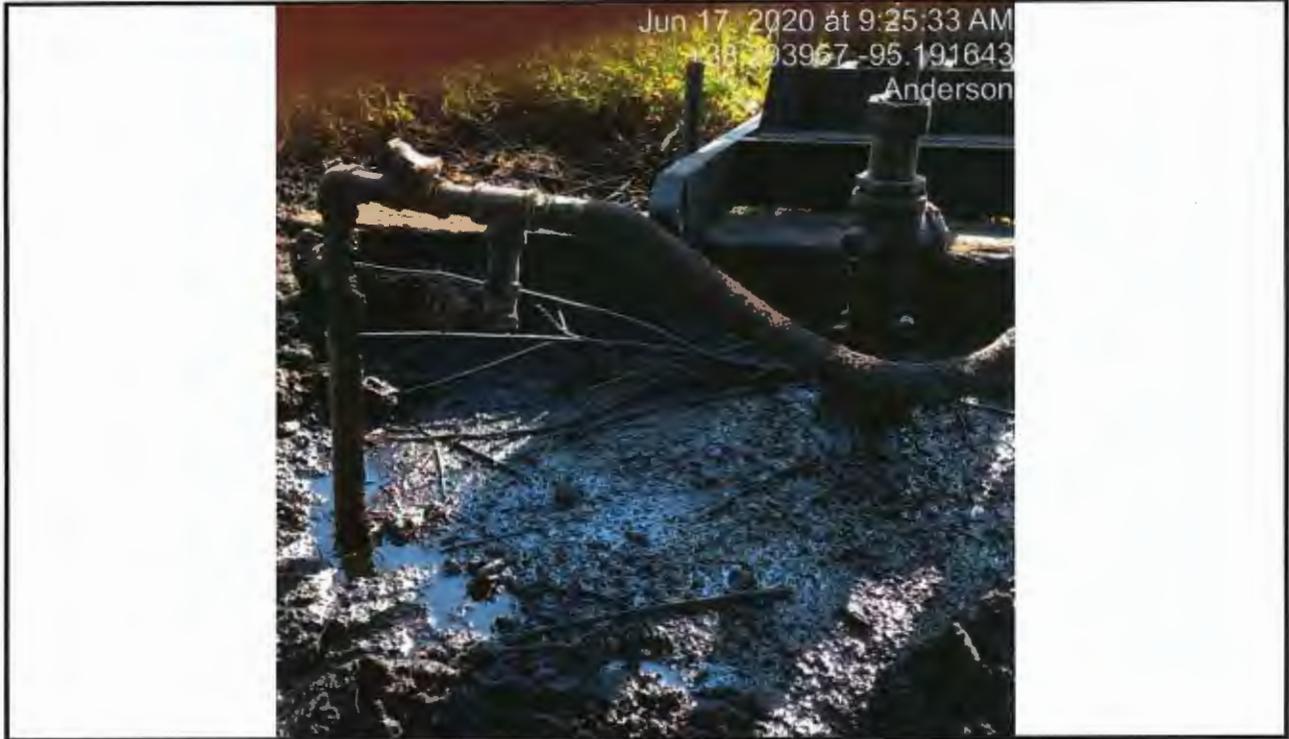
KLN:	32461
Legal:	22-20-20E
PIC ID#:	9-T Pic 2
PIC Orientation:	
Latitude:	38.294066
Longitude:	-95.191650

Additional Information: This picture is of well location 9-T. This location has spill but is contained in the berm pushed up around the well. The well is leaking up the production string and is equipped with a stuffing box but it is unscrewed and above the rag and clamp. They have tried to seal the well in with a rag and a clamp. At the time of inspection well was not equipped for production. The pump jack is missing the electric motor and the drive belt.

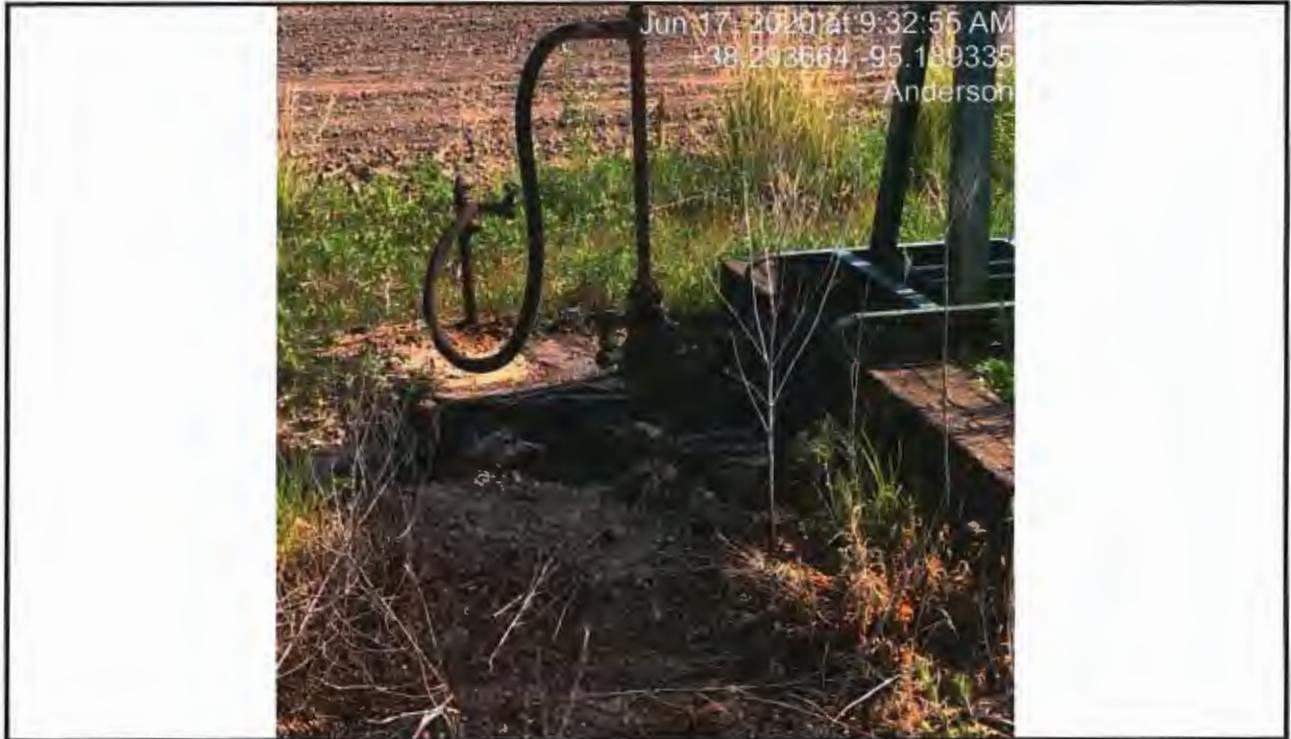
KLN: 32461
Legal: 22-20-20E
PIC ID#: 11-T
PIC Orientation:
Latitude: 38.293700
Longitude: -95.189316
Time: 9:32 AM

15-003-24655-00-00 #11-T This well is inactive. The 1 inch is hanging on a rag and clamp trying to seal the well in. This well has a small leak, the well does not have proper surface control.

Additional Information: This picture is of well location 11-T. The well is not equipped with a stuffing box. At the time of inspection well was not equipped for production because the 1 inch is on a rag and clamp trying to seal the well in. This well has a small leak coming from the production casing.

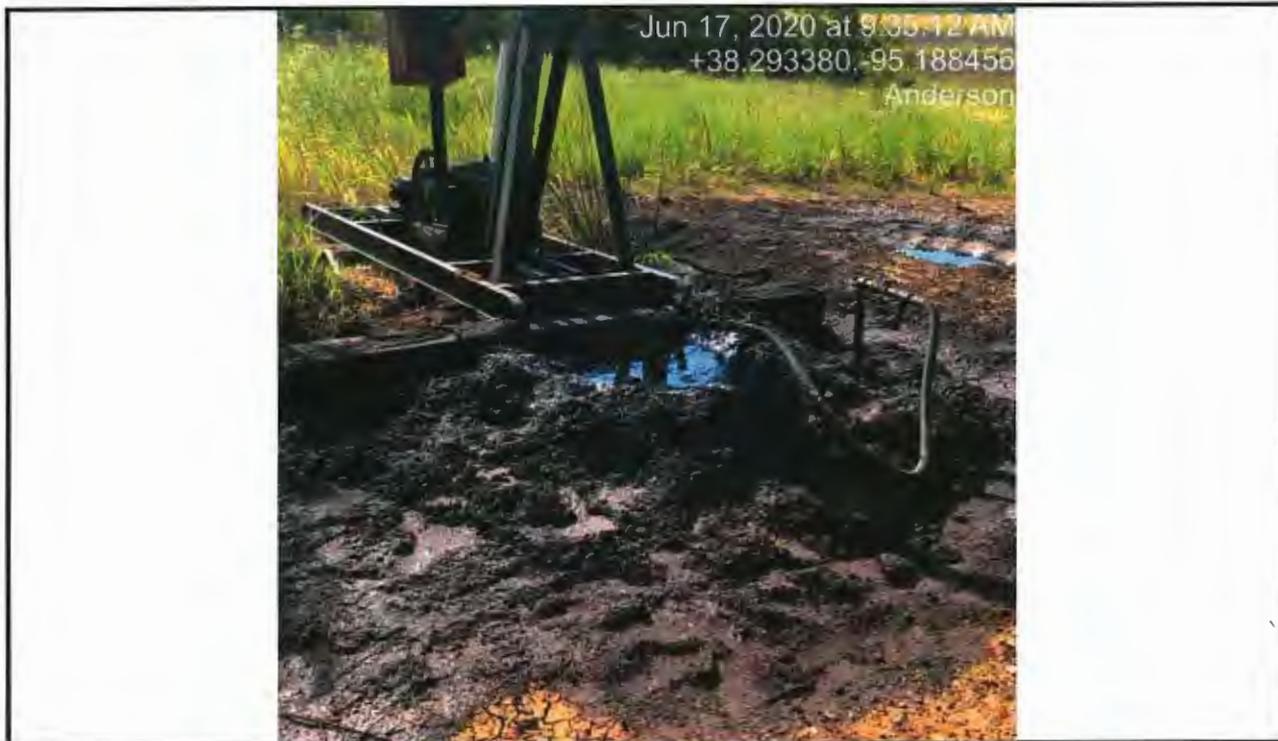
KLN: 32461
Legal: 22-20-20E
PIC ID#: 13-T PIC 1
PIC Orientation:
Latitude: 38.293350
Longitude: -95.188350

15-003-24687-00-00 #13-T This well is inactive there is no 1 inch in the hole. This well is hooked into the flow line. This well did not appear to be leaking at the time of inspection but it has leaked in the past. This well has a big spill area of approximately 24 ft. by 30 ft. it has also ran out of the berm pushed up around the well and down the hillside towards a waterway. This well site also has a very big kill area of approximately 70 feet by 100 feet on the hillside.

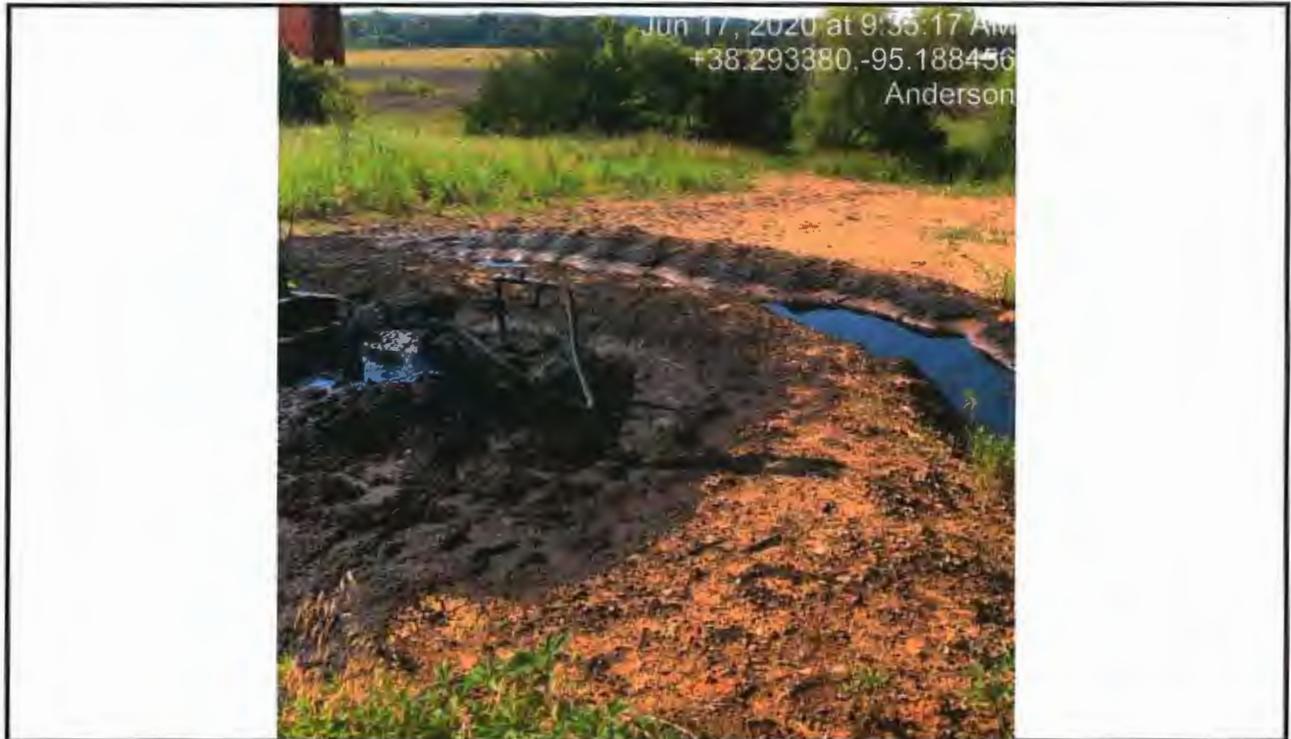
KLN: 32461
Legal: 22-20-20E
PIC ID#: 13-T PIC 2
PIC Orientation:
Latitude: 38.293350
Longitude: -95.188350

Additional Information: This picture is of well location 13-T. This location has approximately 24' by 30' new spill and approximately 70' by 100' old kill area. The well is hooked into the flow line. This well wasn't currently leaking at the time of inspection but it has leaked in the past.

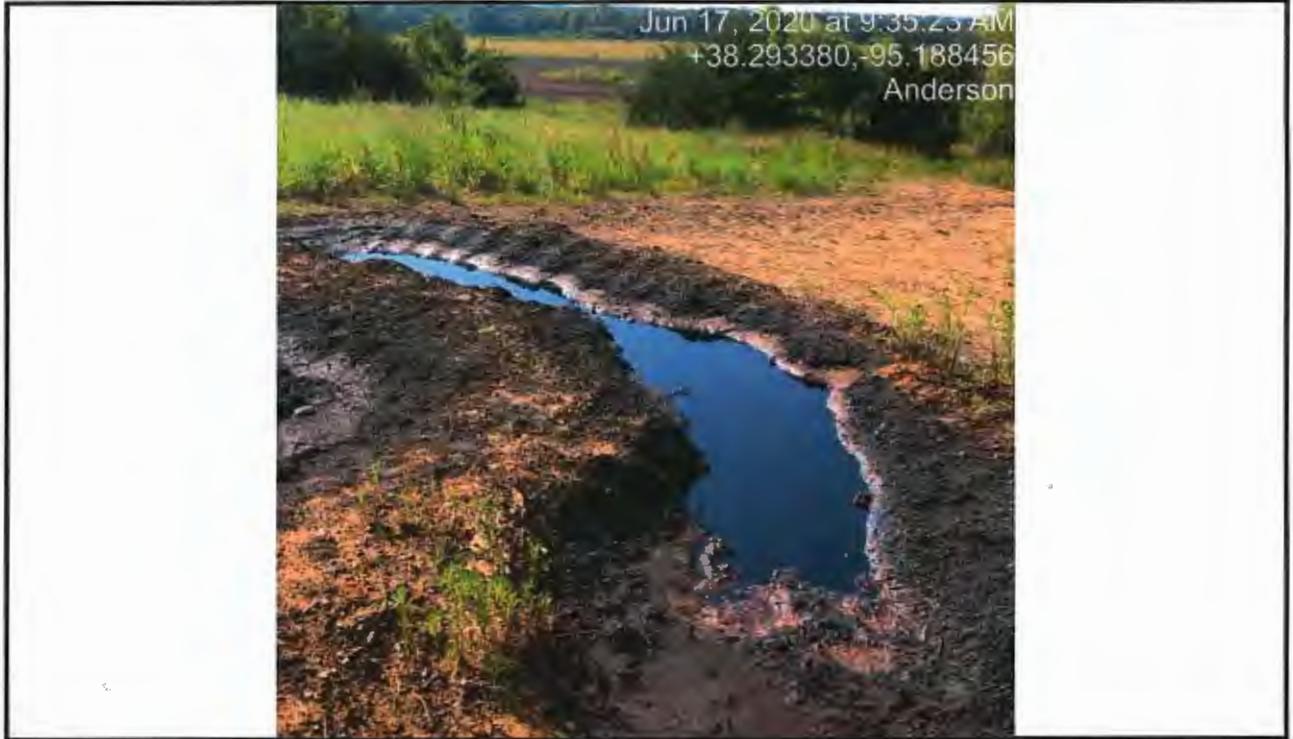
KLN:	32461
Legal:	22-20-20E
PIC ID#:	13-T PIC 3
PIC Orientation:	
Latitude:	38.293350
Longitude:	-95.188350

Additional Information: This picture is of well location 13-T. This location has approximately 24' by 30' new spill and approximately 70' by 100' old kill area. The well is hooked into the flow line. This well wasn't currently leaking at the time of inspection but it has leaked in the past.

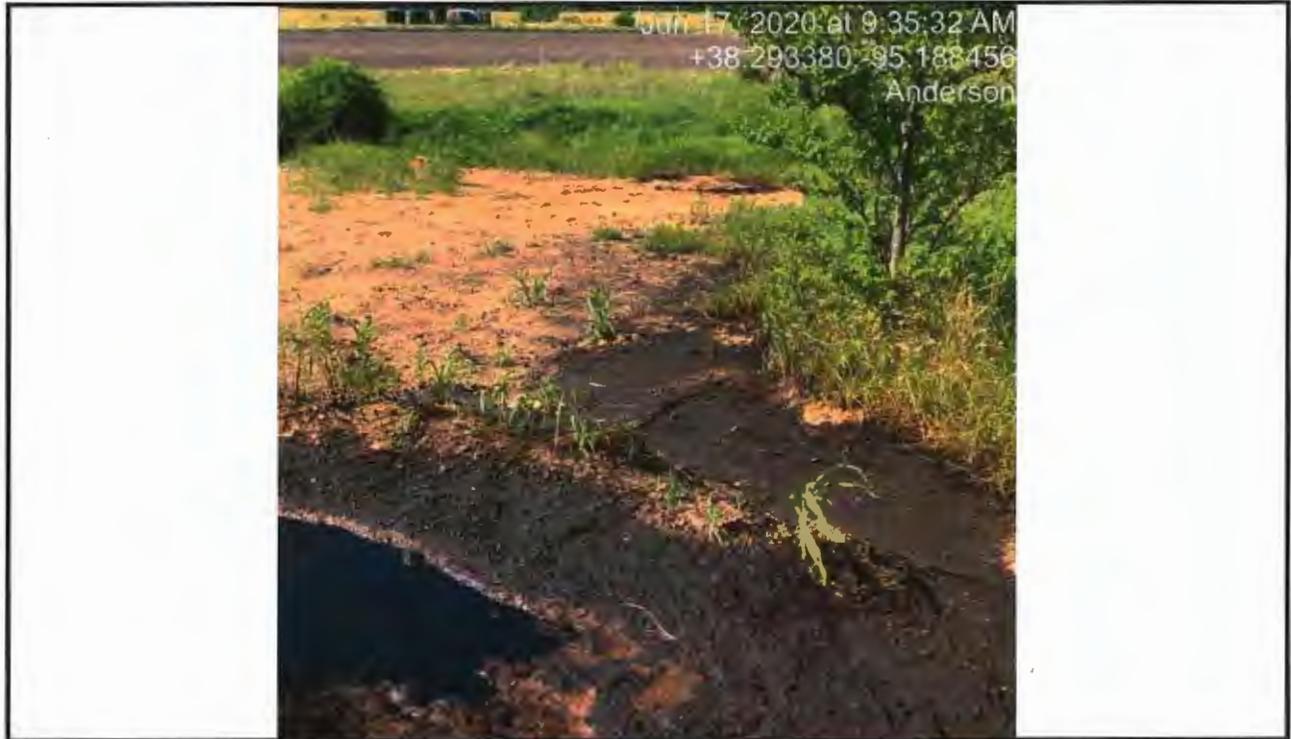
KLN: 32461
Legal: 22-20-20E
PIC ID#: 13-T PIC 4
PIC Orientation:
Latitude: 38.293350
Longitude: -95.188350

Additional Information: This picture is of well location 13-T. This location has approximately 24' by 30' new spill and approximately 70' by 100' old kill area. The well is hooked into the flow line. This well wasn't currently leaking at the time of inspection but it has leaked in the past.
