NOTICE OF PENALTY ASSESSMENT
21-CONS-3032-CPEN

August 27, 2020

Re: Unreported Spills and Failure to Cleanup Spills on the South Kempnich lease located in Section 22, Township 20 South, Range 20 East, Anderson County, Kansas.

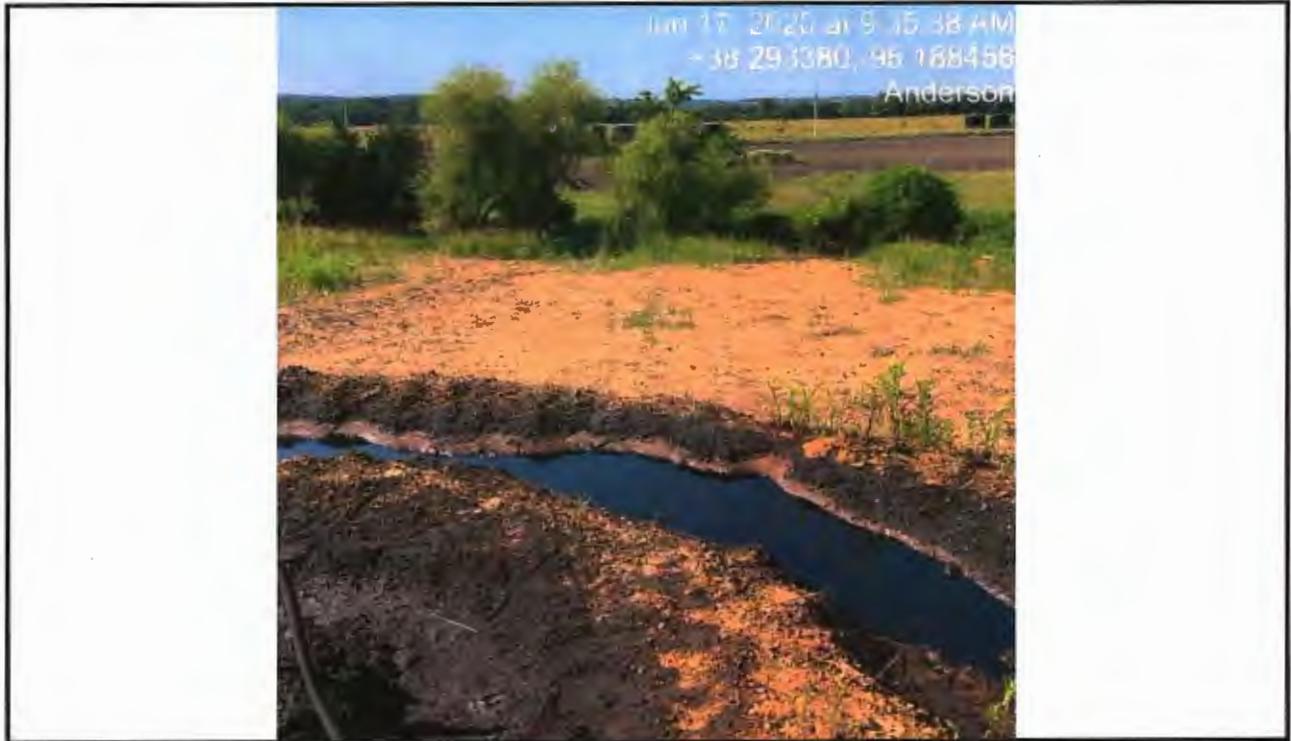
KLN: 32461
Legal: 22-20-20E
PIC ID#: 13-T PIC 5
PIC Orientation:
Latitude: 38.293350
Longitude: -95.188350

Additional Information: This picture is of well location 13-T. This location has approximately 24' by 30' new spill and approximately 70' by 100' old kill area. The well is hooked into the flow line. This well wasn't currently leaking at the time of inspection but it has leaked in the past.

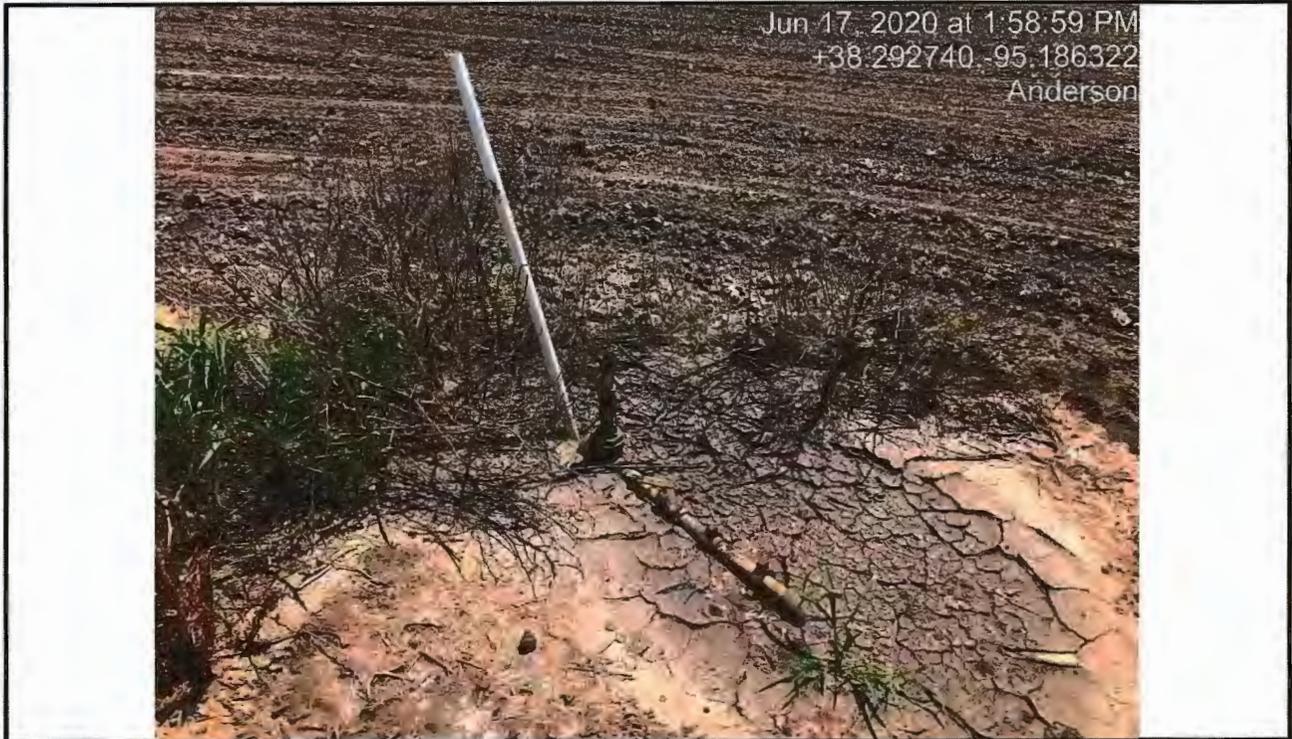
KLN: 32461
Legal: 22-20-20E
PIC ID#: 14-IWL
PIC Orientation:
Latitude: 38.292701
Longitude: -95.186332

Additional Information: This picture is of well location 14-IWL. This well is hooked up for injection purposes. This well has an old spill area that Taylor Herman District #3 Geologist took soil samples of.

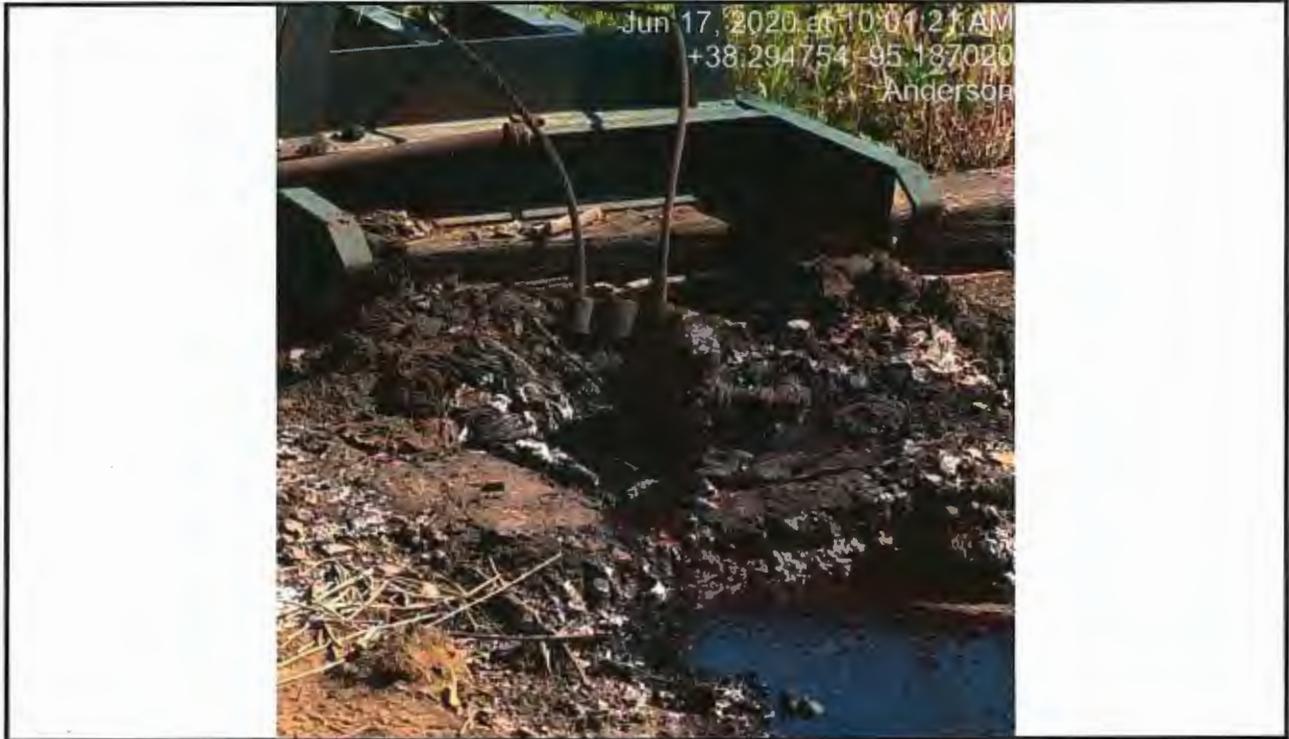
KLN: 32461
Legal: 22-20-20E
PIC ID#: 14-T PIC 1
PIC Orientation:
Latitude: 38.294775
Longitude: -95.187011

Additional Information: This picture is of well location 14-T. The well is shut in but is leaking through the 2 inch plug in the top of the "T" on top of the well head. This well is leaking saltwater but has stayed in the berm so far. This well is not equipped for production. There is no 1 inch in the hole and the pump jack is missing the belt.

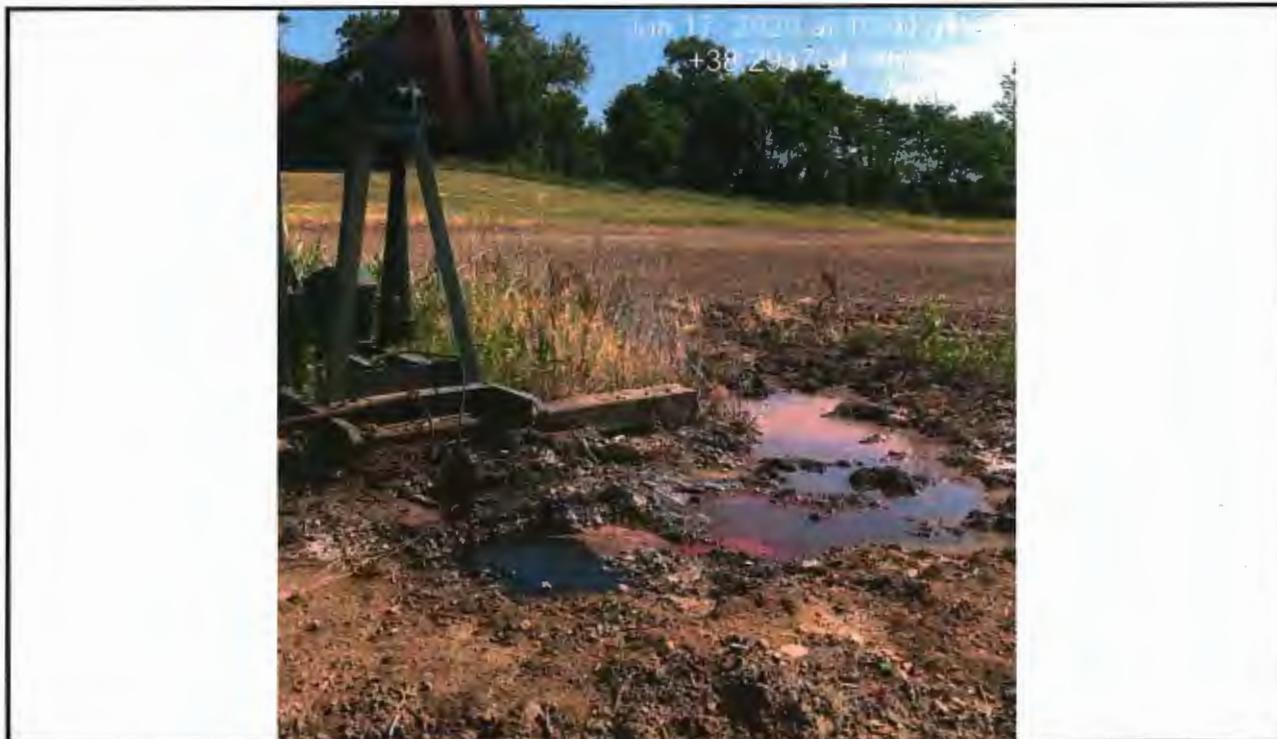
KLN: 32461
Legal: 22-20-20E
PIC ID#: 14-T PIC 2
PIC Orientation:
Latitude: 38.294775
Longitude: -95.187011

Additional Information: This picture is of well location 14-T. The well is shut in but is leaking through the 2 inch plug in the top of the "T" on top of the well head. This well is leaking saltwater but has stayed in the berm so far. This well is not equipped for production. There is no 1 inch in the hole and the pump jack is missing the belt.

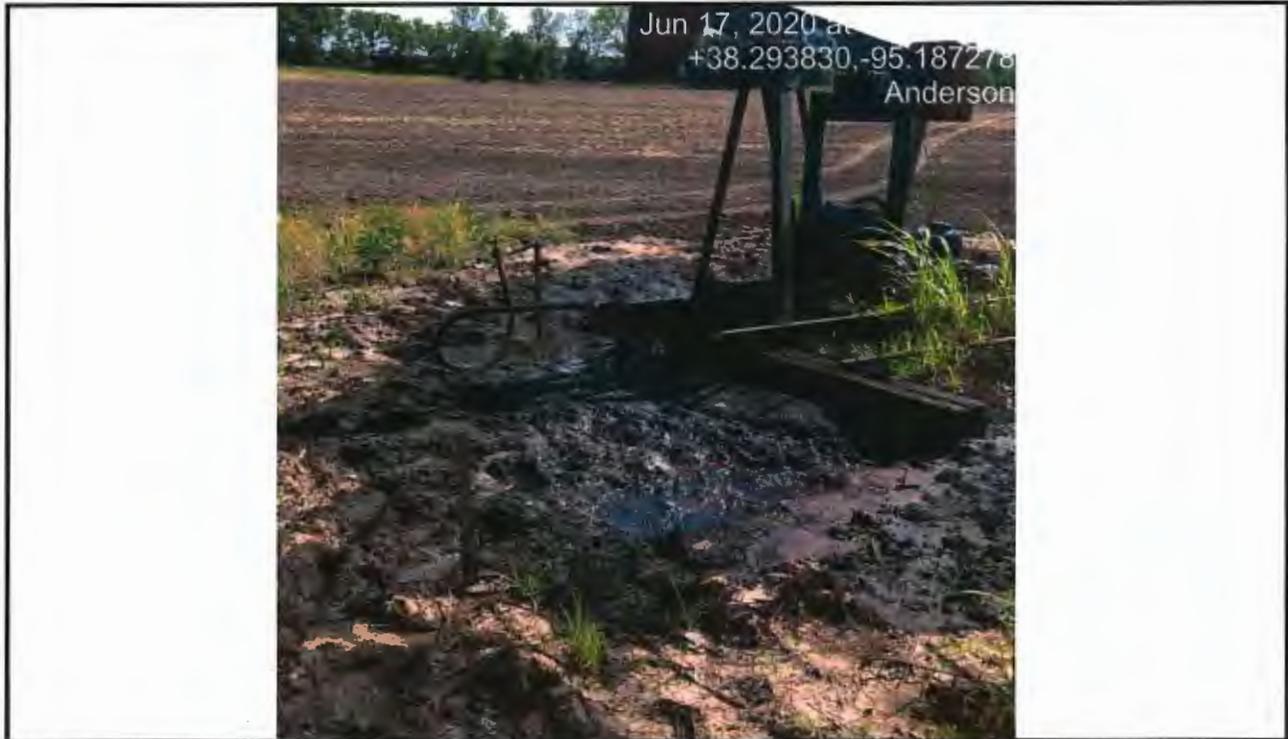
KLN:	32461
Legal:	22-20-20E
PIC ID#:	15-T
PIC Orientation:	
Latitude:	38.293852
Longitude:	-95.187184

Additional Information: This picture is of well location 15-T. This well is leaking but the oil has stayed in the berm pushed up around the well. This well is hooked into the flow line. This well is not equipped for production as the well doesn't have 1 inch in the hole and the pump jack is missing the drive belt.

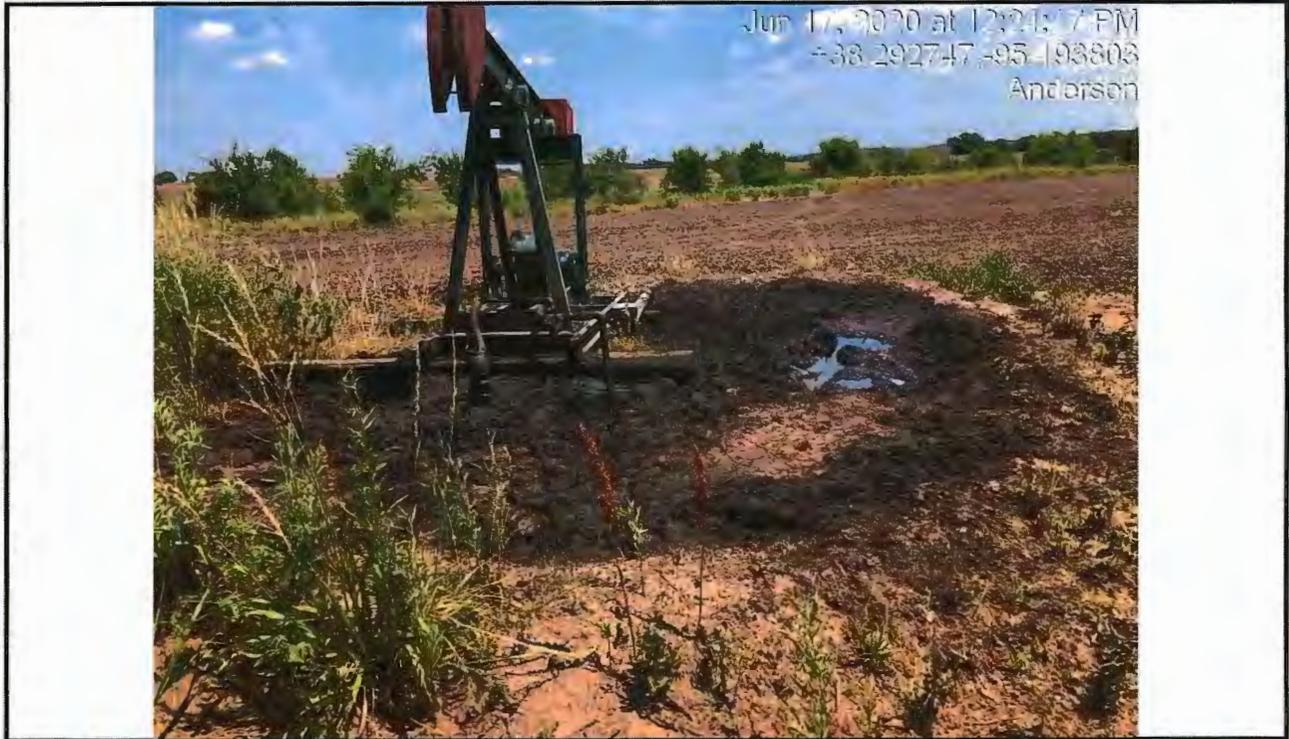
KLN: 32461
Legal: 22-20-20E
PIC ID#: 16-T
PIC Orientation:
Latitude: 38.292802
Longitude: -95.193730

Additional Information: This picture is of well location 16-T. This well is inactive. The well doesn't have 1 inch in the hole and the pump jack is missing the belt. There is oil in the berm pushed up around the well where the well has leaked in the past. At the time of the inspection I didn't see the well leaking.

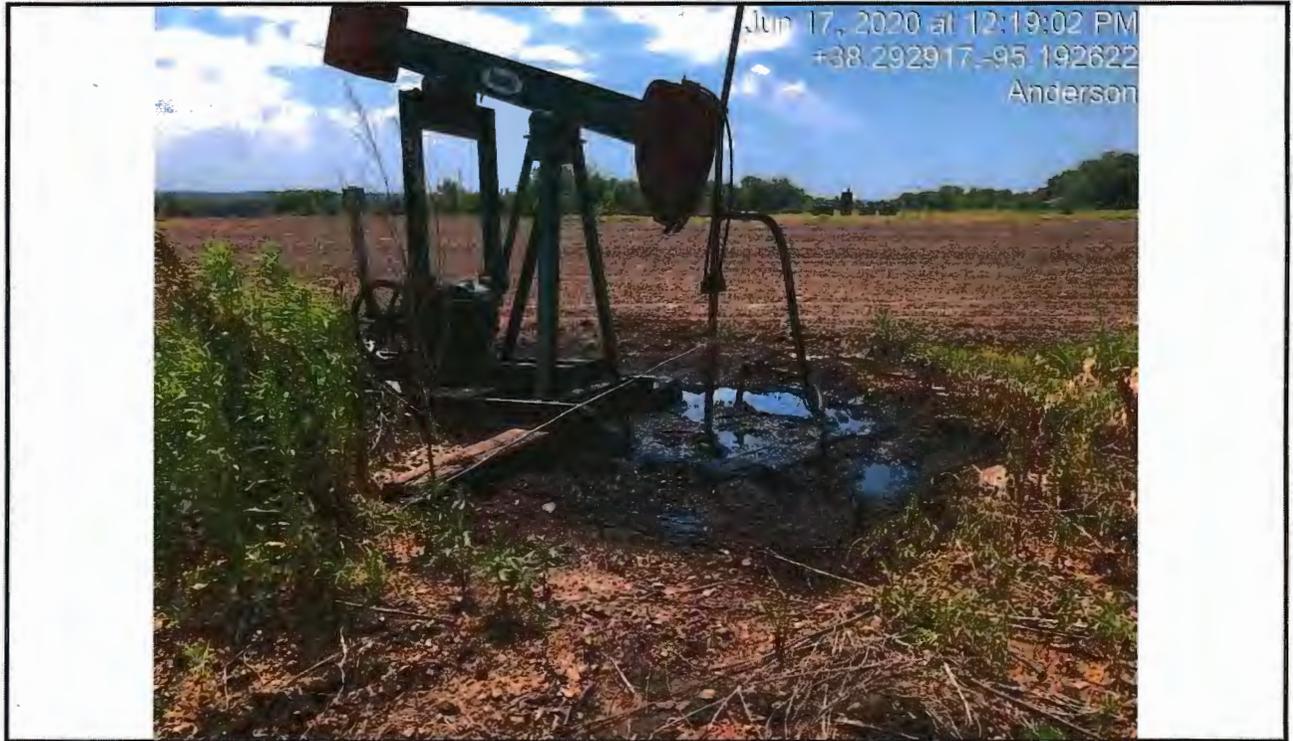
KLN: 32461
Legal: 22-20-20E
PIC ID#: 17-T Pic 1
PIC Orientation:
Latitude: 38.292890
Longitude: -95.192602

Additional Information: This picture is of well location 17-T. The well is leaking up the production string and is not equipped with a stuffing box the well is trying to be sealed in with a rag and clamp. The spill is being contained inside the berm pushed up around the well for now. At the time of inspection well was not equipped for production. The pump jack did not have a motor or a belt.

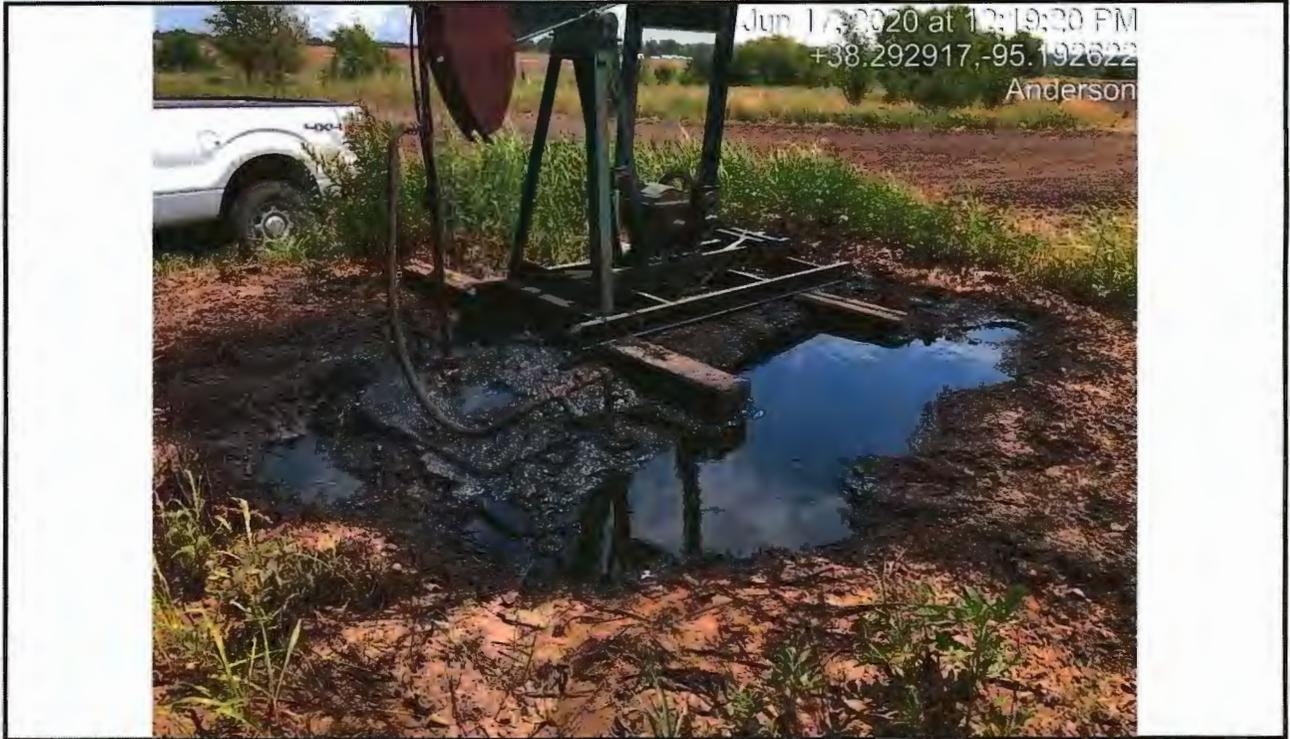
KLN: 32461
Legal: 22-20-20E
PIC ID#: 17-T Pic 2
PIC Orientation:
Latitude: 38.292890
Longitude: -95.192602

Additional Information: This picture is of well location 17-T. The well is leaking up the production string and is not equipped with a stuffing box the well is trying to be sealed in with a rag and clamp. The spill is being contained inside the berm pushed up around the well for now. At the time of inspection well was not equipped for production. The pump jack did not have a motor or a belt.

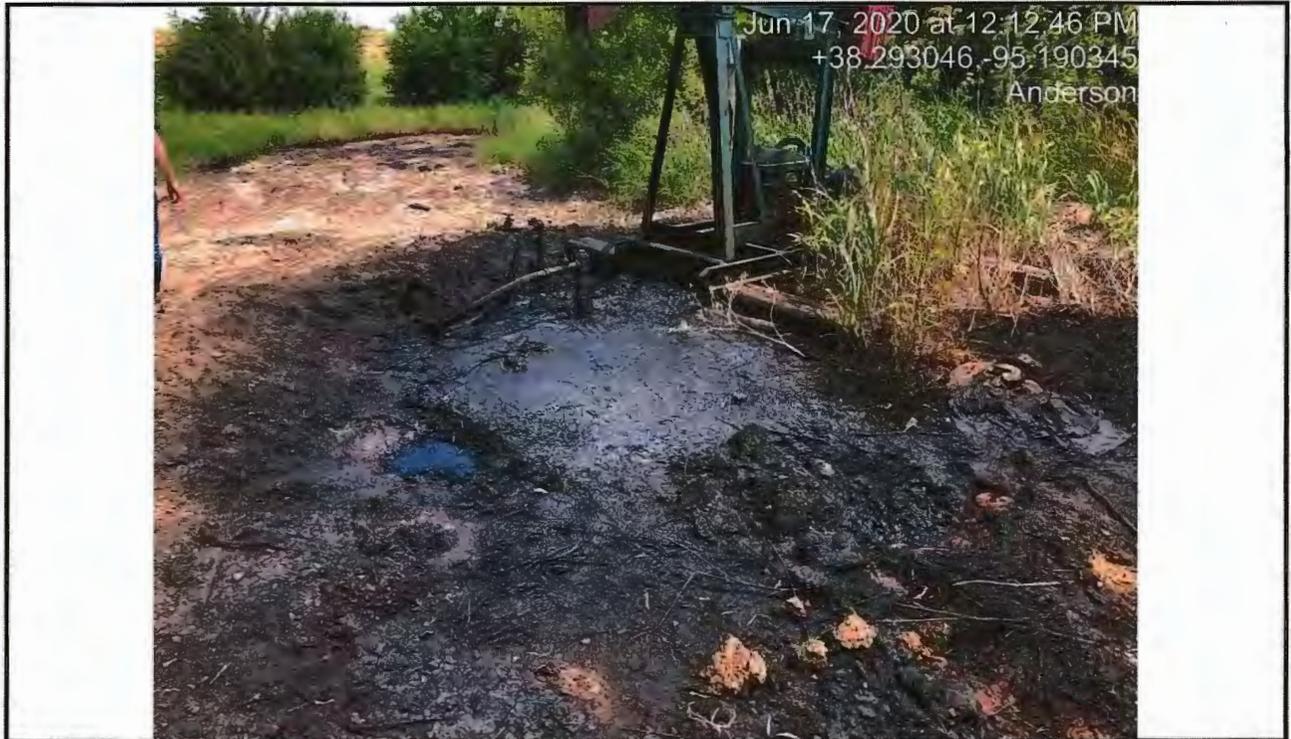
KLN: 32461
Legal: 22-20-20E
PIC ID#: 18-T
PIC Orientation:
Latitude: 38.293060
Longitude: -95.191486

15-003-25021-00-00 #18-T This well is inactive. This well is hooked into flow. This well did not appear to be leaking at the time of inspection but it has leaked in the past.

Additional Information: This picture is of well location 18-T. This well is hooked into the flow line. This well is inactive because there is no 1 inch in the hole. This well has leaked in the past.

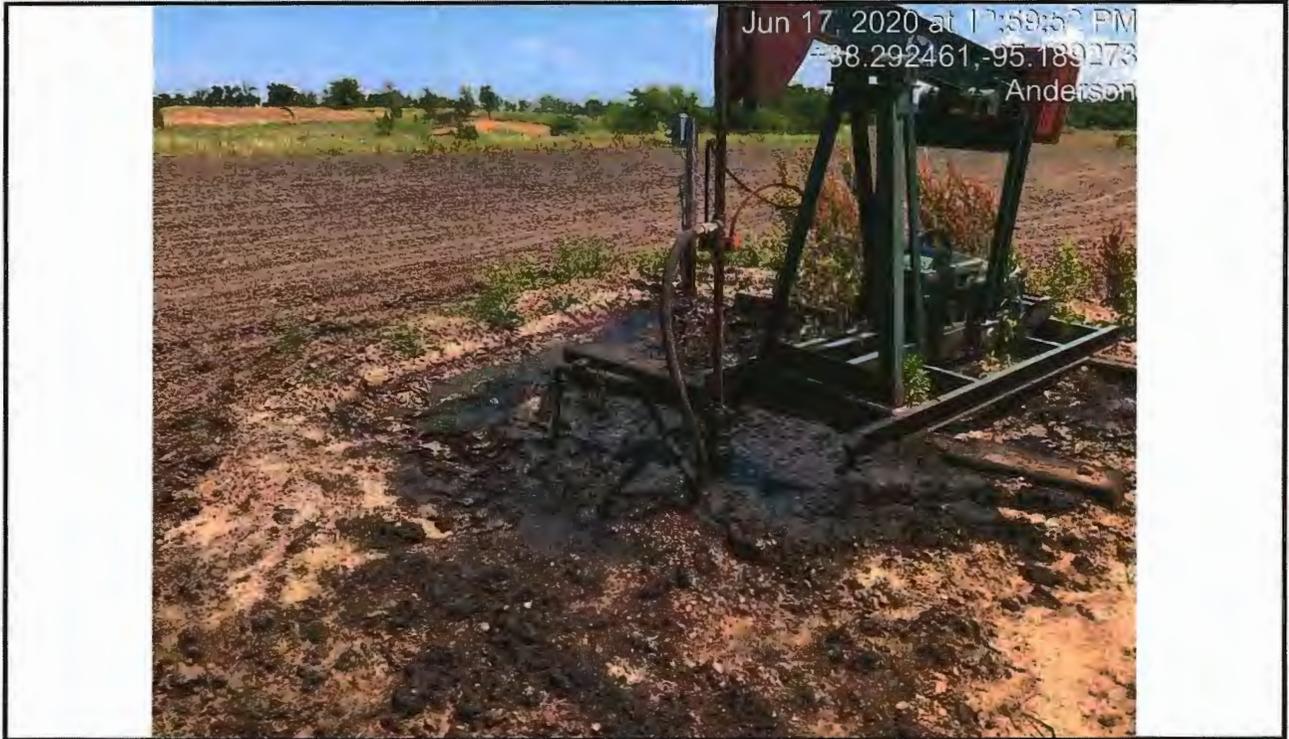
KLN: 32461
Legal: 22-20-20E
PIC ID#: 20-T
PIC Orientation:
Latitude: 38.292492
Longitude: -95.189185

Additional Information: This picture is of well location 20-T. This well is inactive as the 1 inch is unhooked from the pump jack. The well is leaking up the production string and is not equipped with a stuffing box. The well is trying to be sealed in with a rag and clamp. This well is seeping but the spill is being contained inside the berm pushed up around the well.

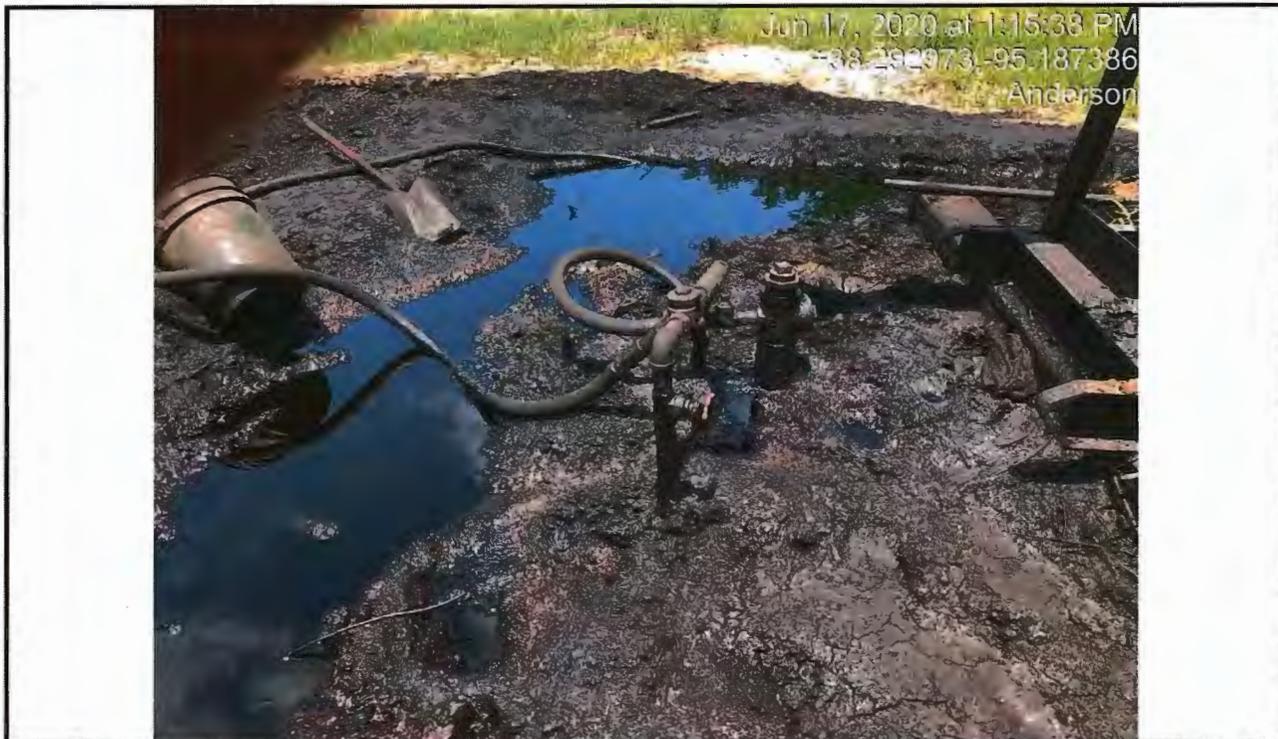
KLN:	32461
Legal:	22-20-20E
PIC ID#:	22-T PIC 1
PIC Orientation:	
Latitude:	38.292983
Longitude:	-95.187395

Additional Information: This picture is of well location 22-T. The well is in active as it has no 1 inch in the hole and the pump jack is missing a belt. The well is hooked into the flow line and doesn't appear to be leaking at the time of the inspection but this well has leaked in the past causing oil in the berm and it has escaped the berm causing a new 20 ft by 30 ft spill area.

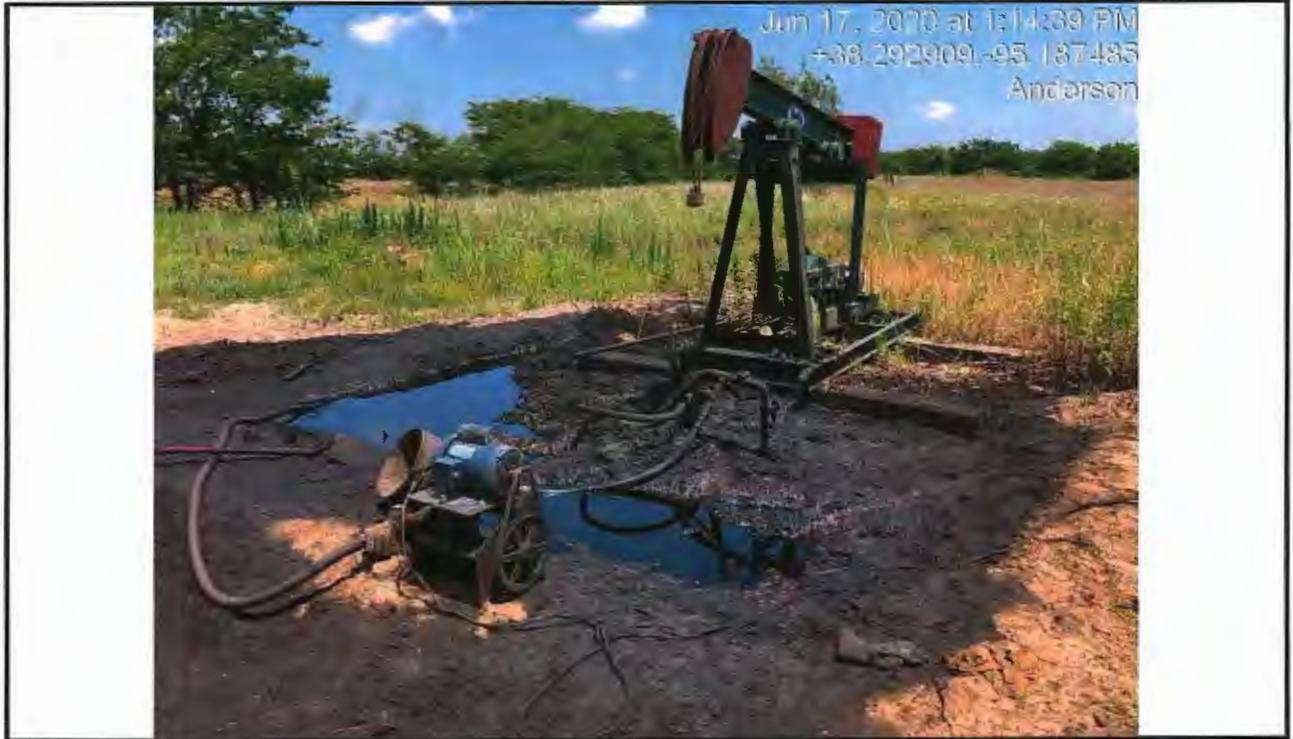
KLN:	32461
Legal:	22-20-20E
PIC ID#:	22-T PIC 2
PIC Orientation:	
Latitude:	38.292983
Longitude:	-95.187395

Additional Information: This picture is of well location 22-T. The well is in active as it has no 1 inch in the hole and the pump jack is missing a belt. The well is hooked into the flow line and doesn't appear to be leaking at the time of the inspection but this well has leaked in the past causing oil in the berm and it has escaped the berm causing a new 20 ft by 30 ft spill area.

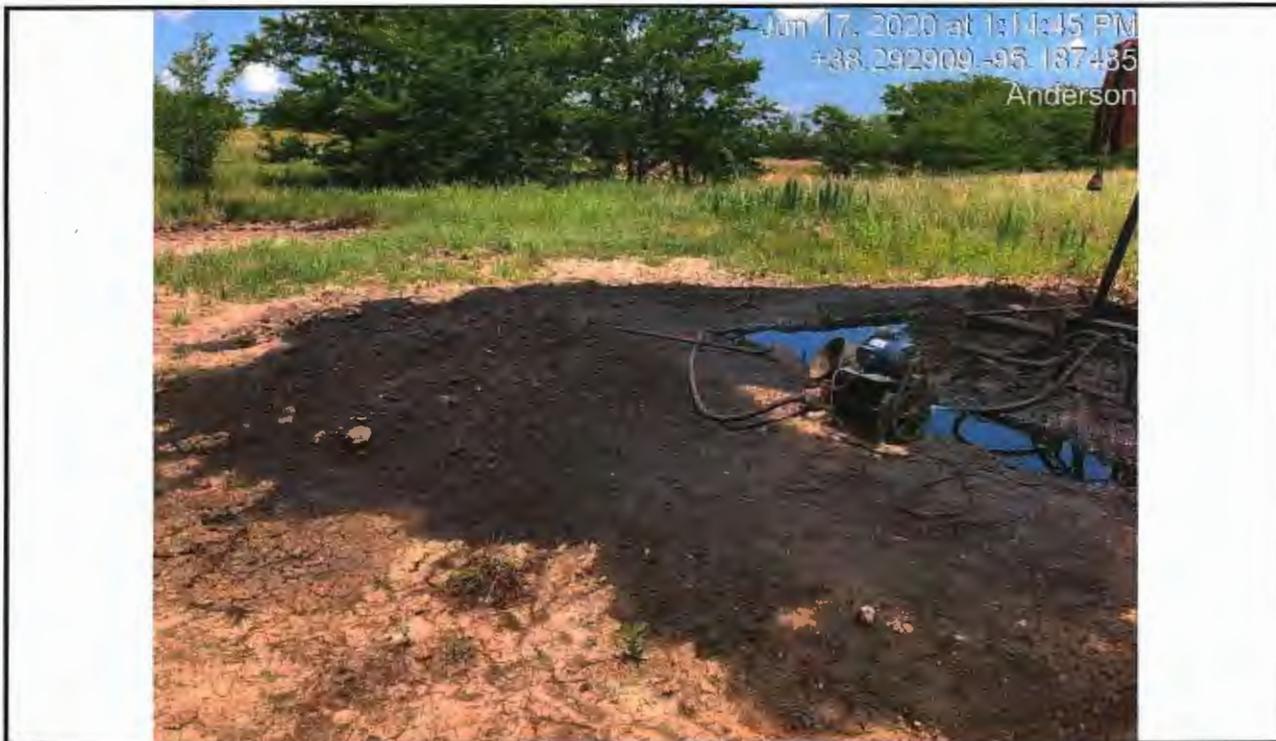
KLN: 32461
Legal: 22-20-20E
PIC ID#: 22-T PIC 3
PIC Orientation:
Latitude: 38.292983
Longitude: -95.187395

Additional Information: This picture is of well location 22-T. The well is in active as it has no 1 inch in the hole and the pump jack is missing a belt. The well is hooked into the flow line and doesn't appear to be leaking at the time of the inspection but this well has leaked in the past causing oil in the berm and it has escaped the berm causing a new 20 ft by 30 ft spill area.

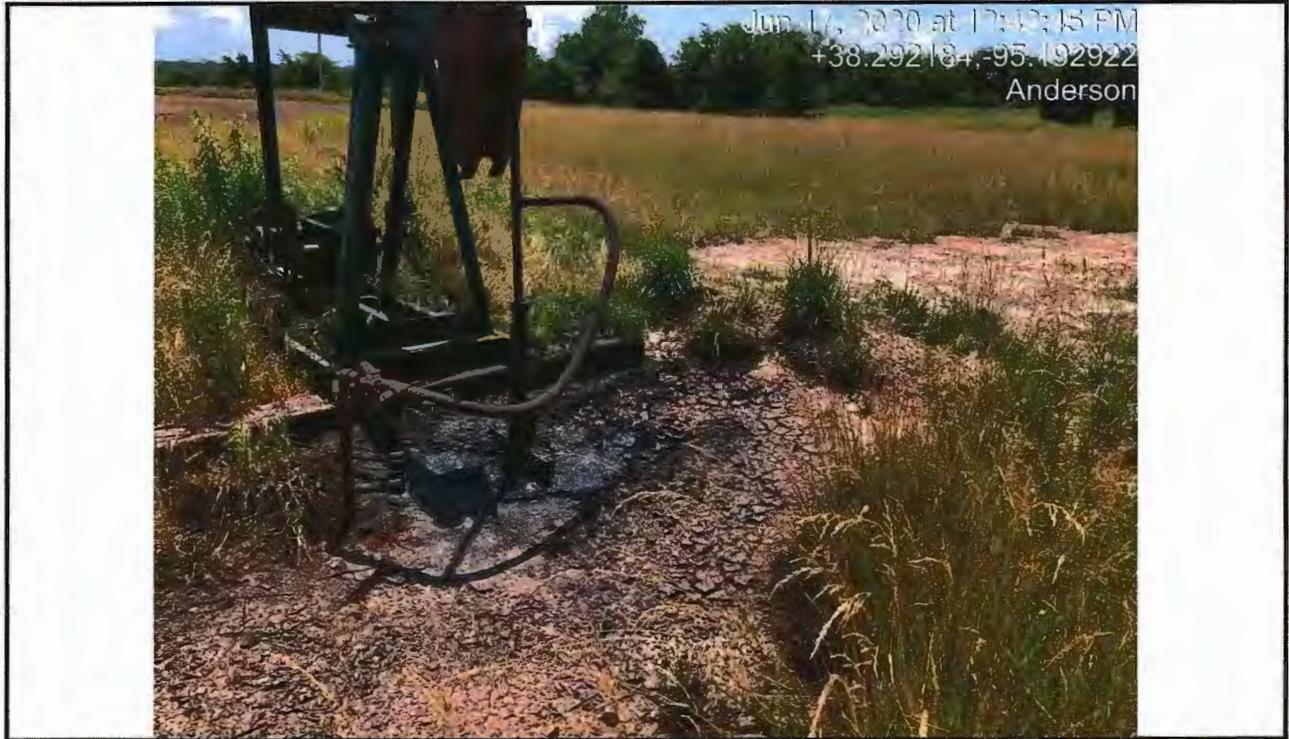
KLN: 32461
Legal: 22-20-20E
PIC ID#: 23-T Pic 1
PIC Orientation:
Latitude: 38.292160
Longitude: -95.192661

Additional Information: This picture is of well location 23-T. This location has a 10' by 30' old kill area. The well is leaking up the production string and is not equipped with a stuffing box. The well is trying to be sealed in with a rag and clamp. This well is inactive as the 1 inch is unhooked from the pump jack. While at this well location the well started leaking crude oil out on the ground. The leak has stayed inside the berm pushed up around the well.

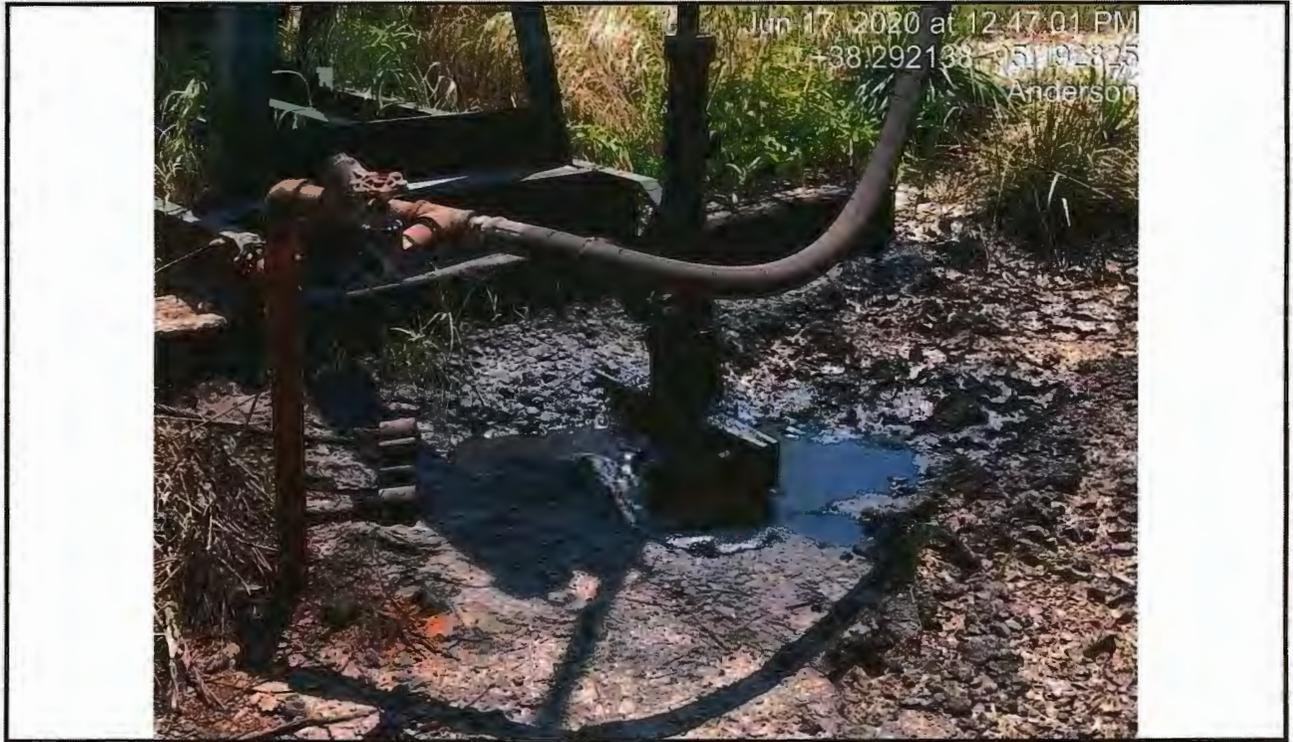
KLN:	32461
Legal:	22-20-20E
PIC ID#:	23-T Pic 2
PIC Orientation:	
Latitude:	38.292160
Longitude:	-95.192661

Additional Information: This picture is of well location 23-T. This location has a 10' by 30' old kill area. The well is leaking up the production string and the stuffing box has been unscrewed from the well head. The well is trying to be sealed in with a rag and clamp. This well is inactive as the 1 inch is unhooked from the pump jack. While at this well location the well started leaking crude oil out on the ground. The leak has stayed inside the berm pushed up around the well.

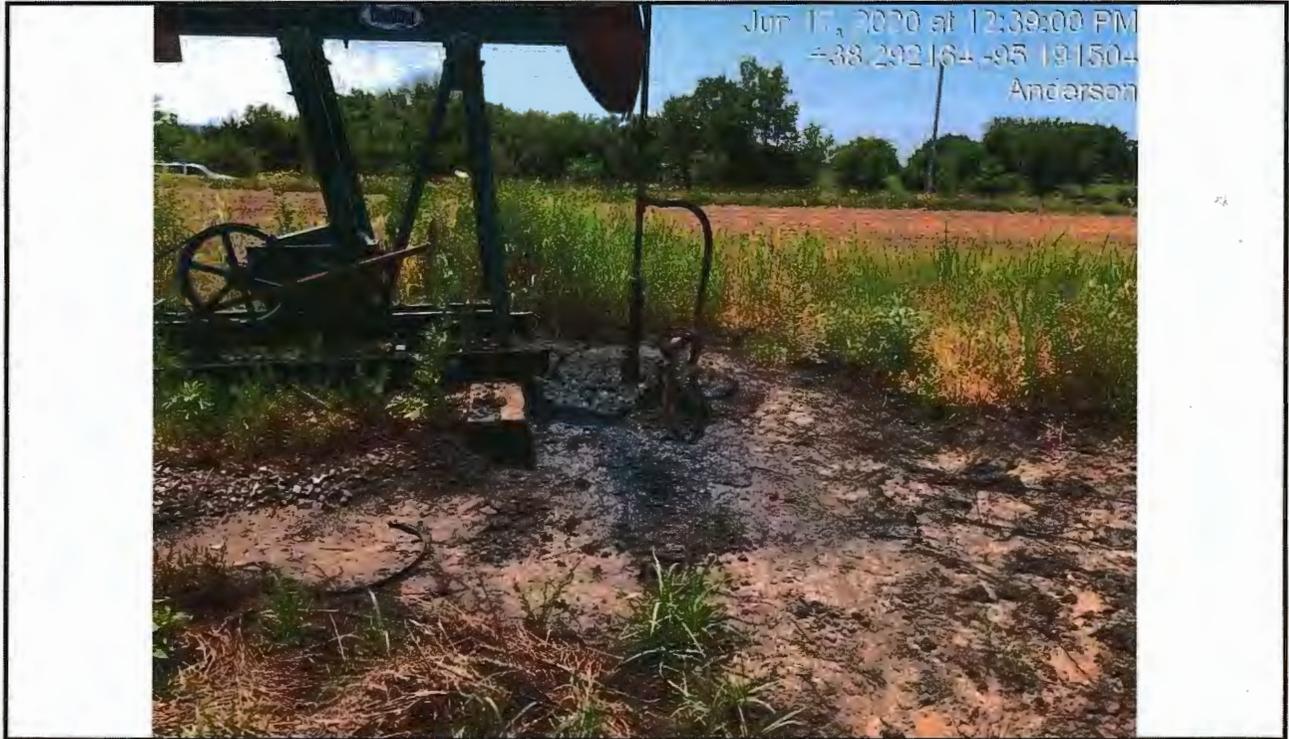
KLN: 32461
Legal: 22-20-20E
PIC ID#: 24-T
PIC Orientation:
Latitude: 38.292158
Longitude: -95.191511

Additional Information: This picture is of well location 24-T. This well is inactive because the 1 inch is hanging on a rag and clamp. They have unscrewed the stuffing box and placed a rag and clamp underneath of it to try to seal the well in. This well has a small leak right around the well head where it is seeping.

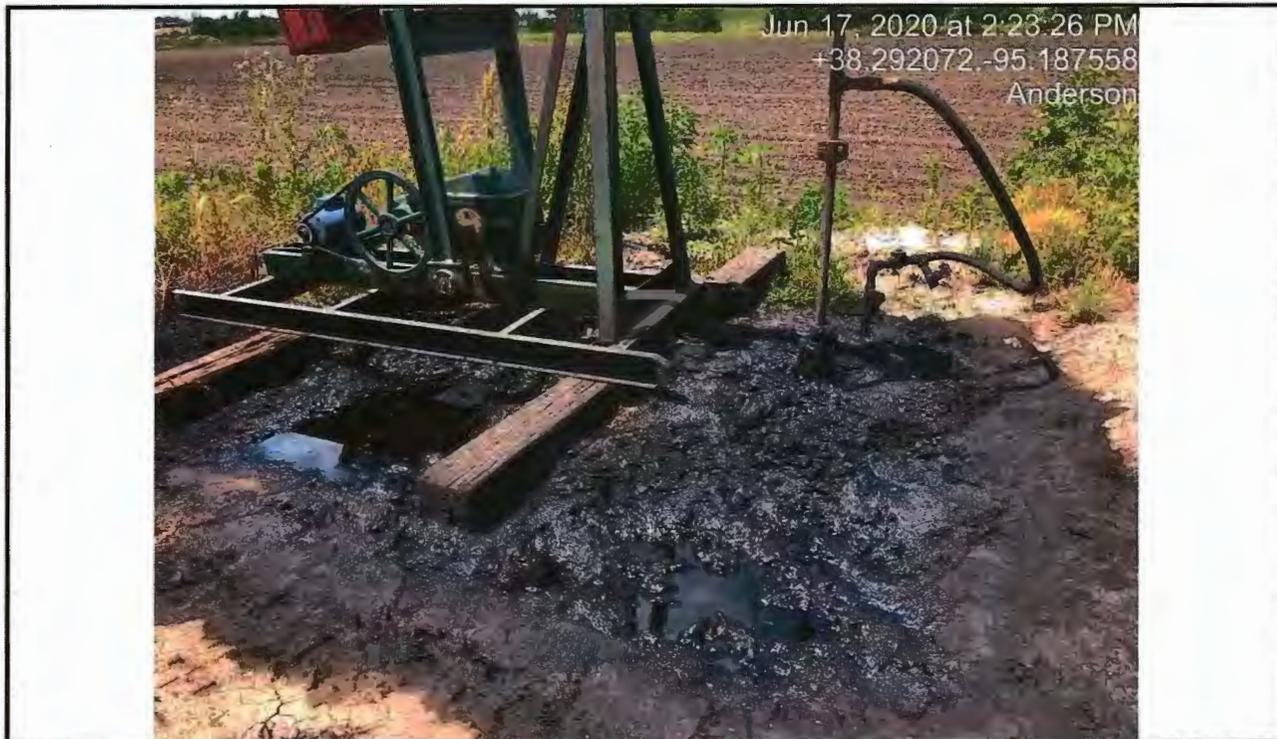
KLN: 32461
Legal: 22-20-20E
PIC ID#: 26-T Pic 1
PIC Orientation:
Latitude: 38.292139
Longitude: -95.187582

Additional Information: This picture is of well location 26-T. This well is inactive as the one inch is on a clamp and disconnected from the pump jack. The well is leaking up the production string and is not equipped with a stuffing box. The well is trying to be sealed in with a rag and clamp. The well is leaking and has caused oil pooled inside the berm that has been pushed up around the well. Oil has escaped the berm at some time in the past causing a new spill of approximately 20 ft by 30 ft.

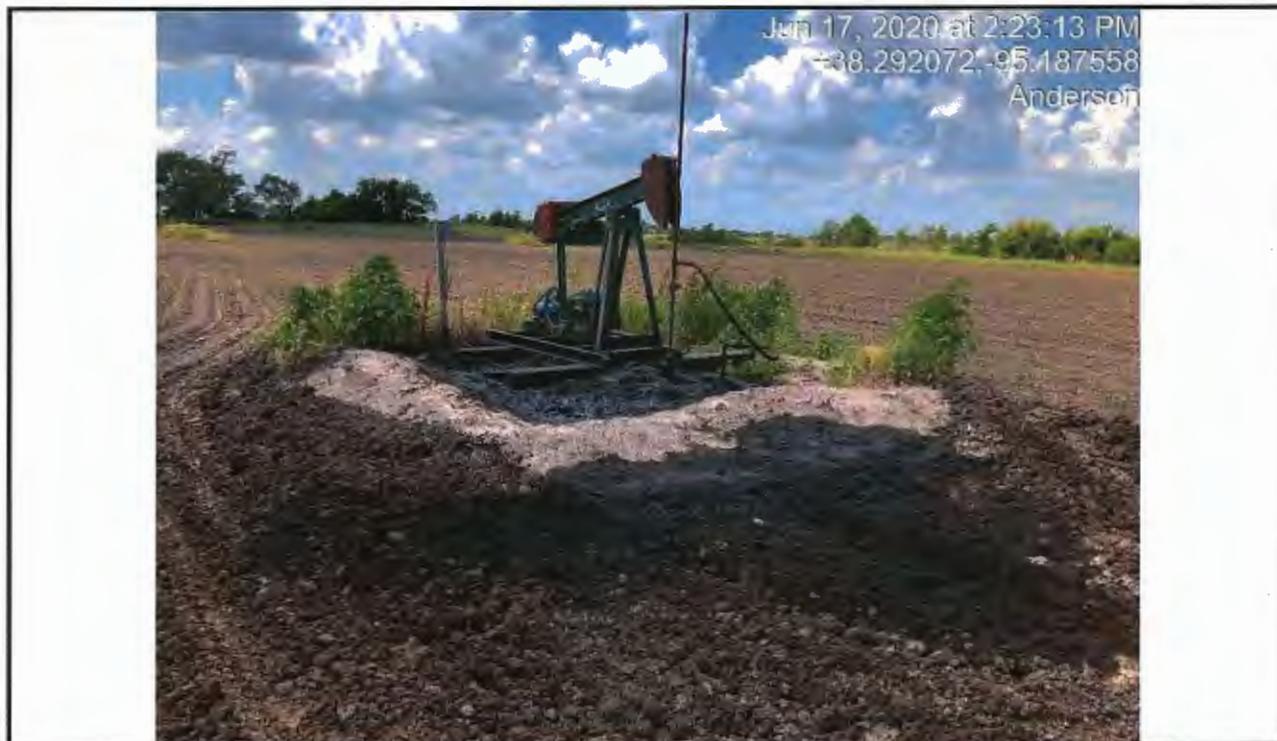
KLN: 32461
Legal: 22-20-20E
PIC ID#: 26-T Pic 2
PIC Orientation:
Latitude: 38.292139
Longitude: -95.187582

Additional Information: This picture is of well location 26-T. This well is inactive as the one inch is on a clamp and disconnected from the pump jack. The well is leaking up the production string and is not equipped with a stuffing box. The well is trying to be sealed in with a rag and clamp. The well is leaking and has caused oil pooled inside the berm that has been pushed up around the well. Oil has escaped the berm at some time in the past causing a new spill of approximately 20 ft by 30 ft.

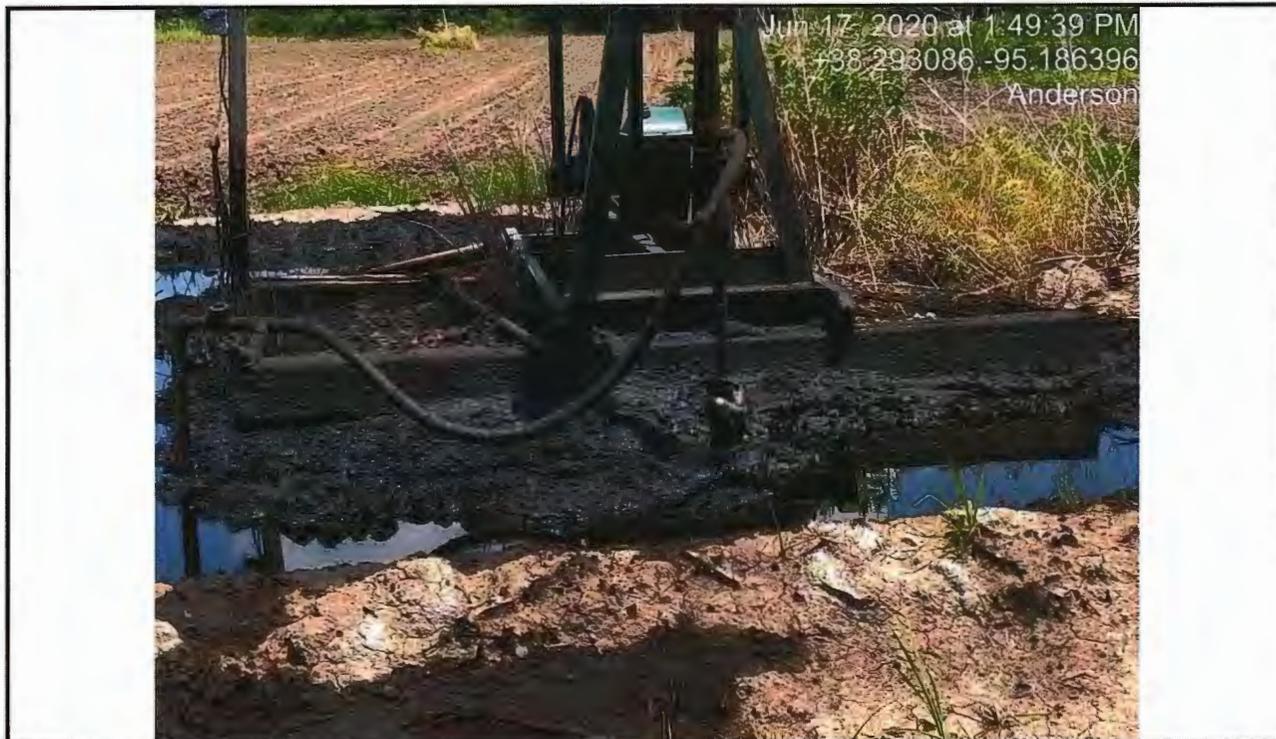
KLN: 32461
Legal: 22-20-20E
PIC ID#: 27-T Pic 1
PIC Orientation:
Latitude: 38.293082
Longitude: -95.186288

Additional Information: This picture is of well location 27-T. This well is leaking up the production string and is missing the stuffing box. The well is trying to be sealed in with a rag and clamp but the well is leaking. The spill is being contained inside the berm pushed up around the well but the berm is almost full of fluid. The well shows signs that oil has escaped the berm before.

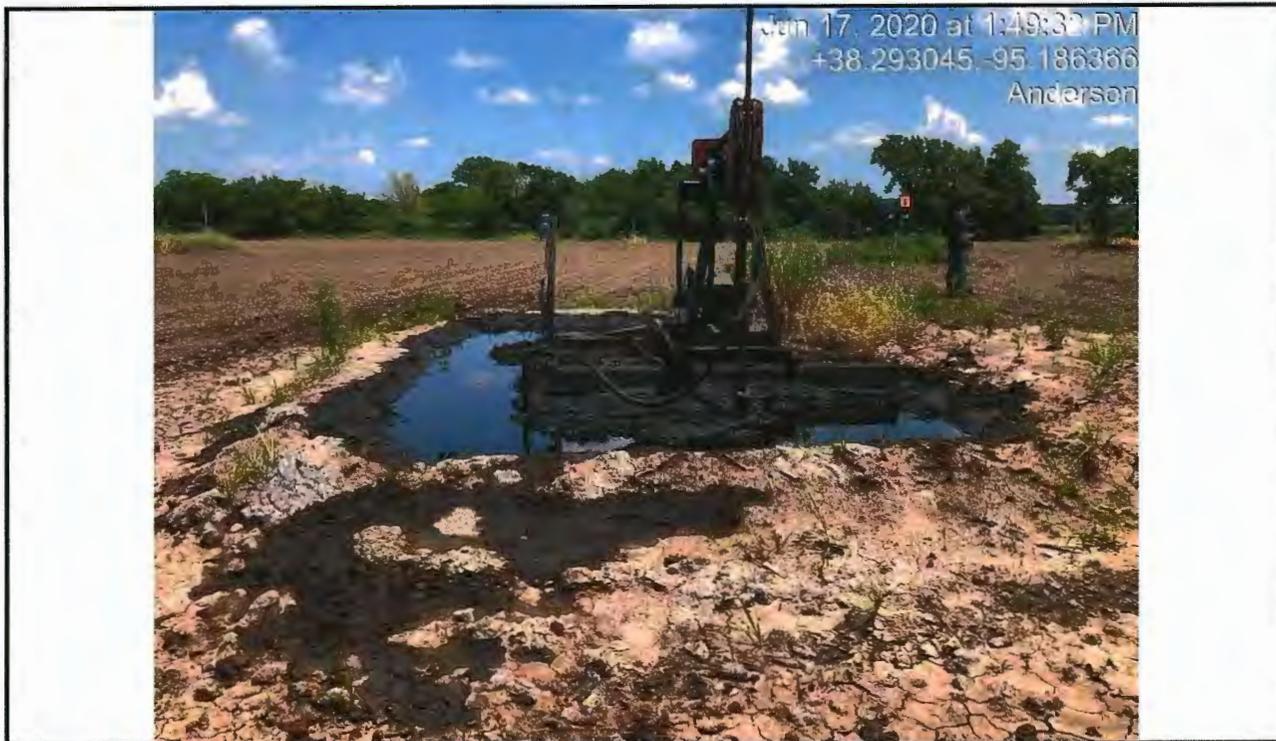
KLN:	32461
Legal:	22-20-20E
PIC ID#:	27-T Pic 2
PIC Orientation:	
Latitude:	38.293082
Longitude:	-95.186288

Additional Information: This picture is of well location 27-T. This well is leaking up the production string and is missing the stuffing box. The well is trying to be sealed in with a rag and clamp but the well is leaking. The spill is being contained inside the berm pushed up around the well but the berm is almost full of fluid. The well shows signs that oil has escaped the berm before.

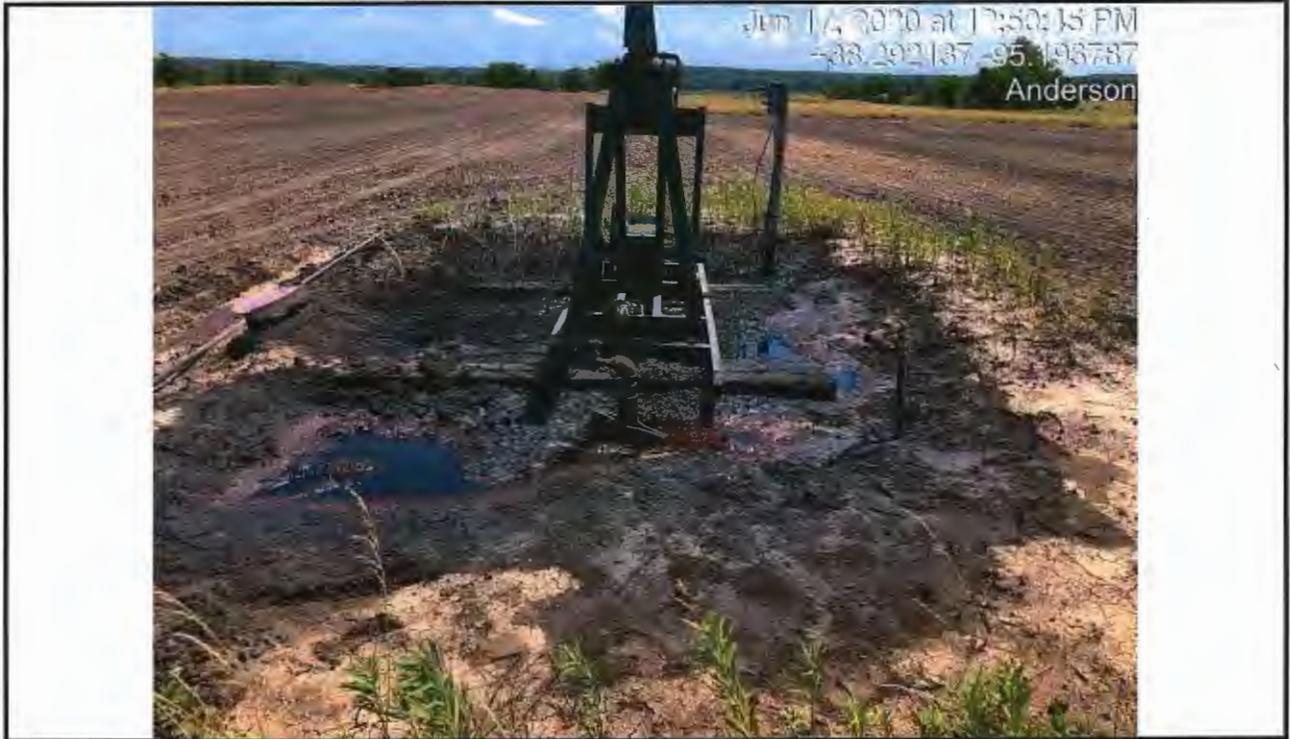
KLN: 32461
Legal: 22-20-20E
PIC ID#: 28-T
PIC Orientation:
Latitude: 38.292164
Longitude: -95.193730

Additional Information: This picture is of well location 28-T. This well is shut in with a valve and swedge. The well was not leaking at the time of inspection but it has leaked in the past as there is oil inside the berm pushed up around the well.
