NOTICE OF PENALTY ASSESSMENT
21-CONS-3032-CPEN

August 27, 2020

Re: Unreported Spills and Failure to Cleanup Spills on the South Kempnich lease located in Section 22, Township 20 South, Range 20 East, Anderson County, Kansas.

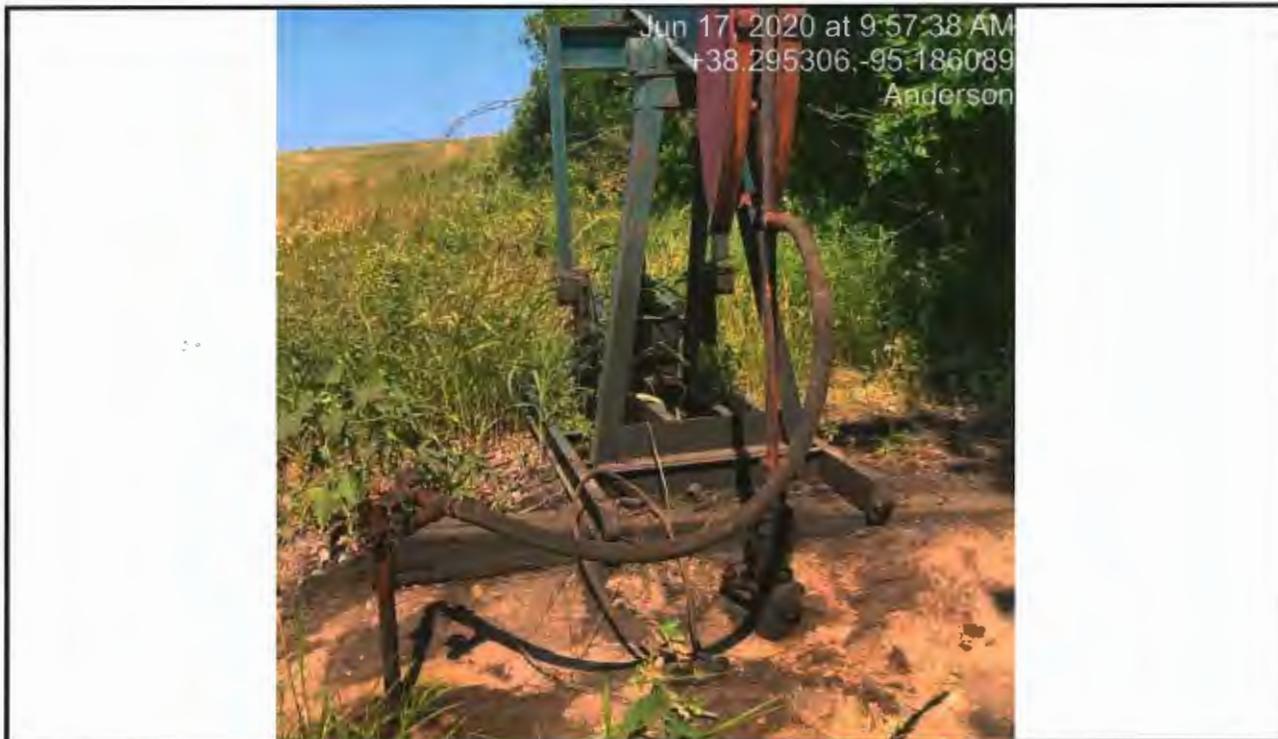
KLN: 32461
Legal: 22-20-20E
PIC ID#: 29-T
PIC Orientation:
Latitude: 38.295265
Longitude: -95.186136

Additional Information: This picture is of well location 29-T. The well is equipped with a stuffing box. At the time of inspection this well was inactive. This well has a rag and clamp above the stuffing box trying to seal the well in. The 1 inch is disconnected from the pump jack and the pump jack is missing a belt.

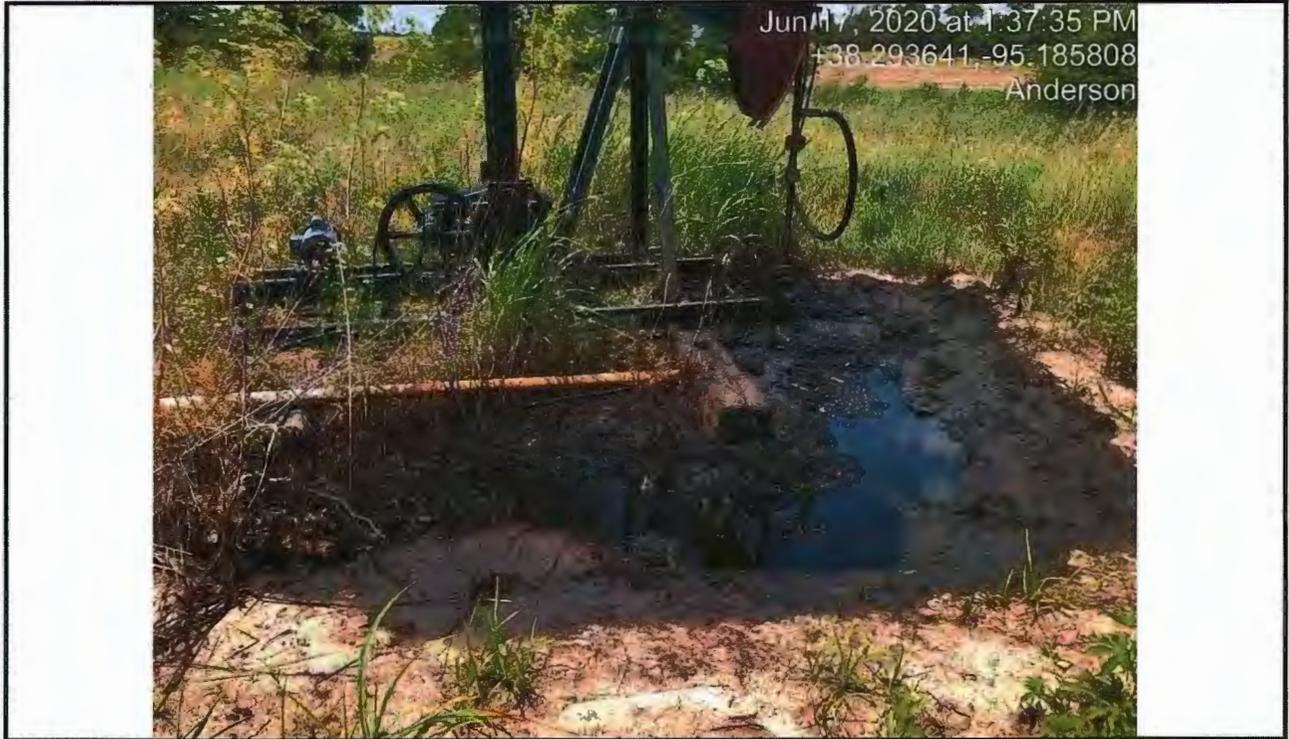
KLN: 32461
Legal: 22-20-20E
PIC ID#: 30-T
PIC Orientation:
Latitude: 38.293734
Longitude: -95.185658

Additional Information: This picture is of well location 30-T. The well is leaking up the production string and is not equipped with a stuffing box. The well is trying to be sealed in with a rag and clamp. The spill is being contained in the berm pushed up around the well. The well is inactive as the pump jack is missing the belt.

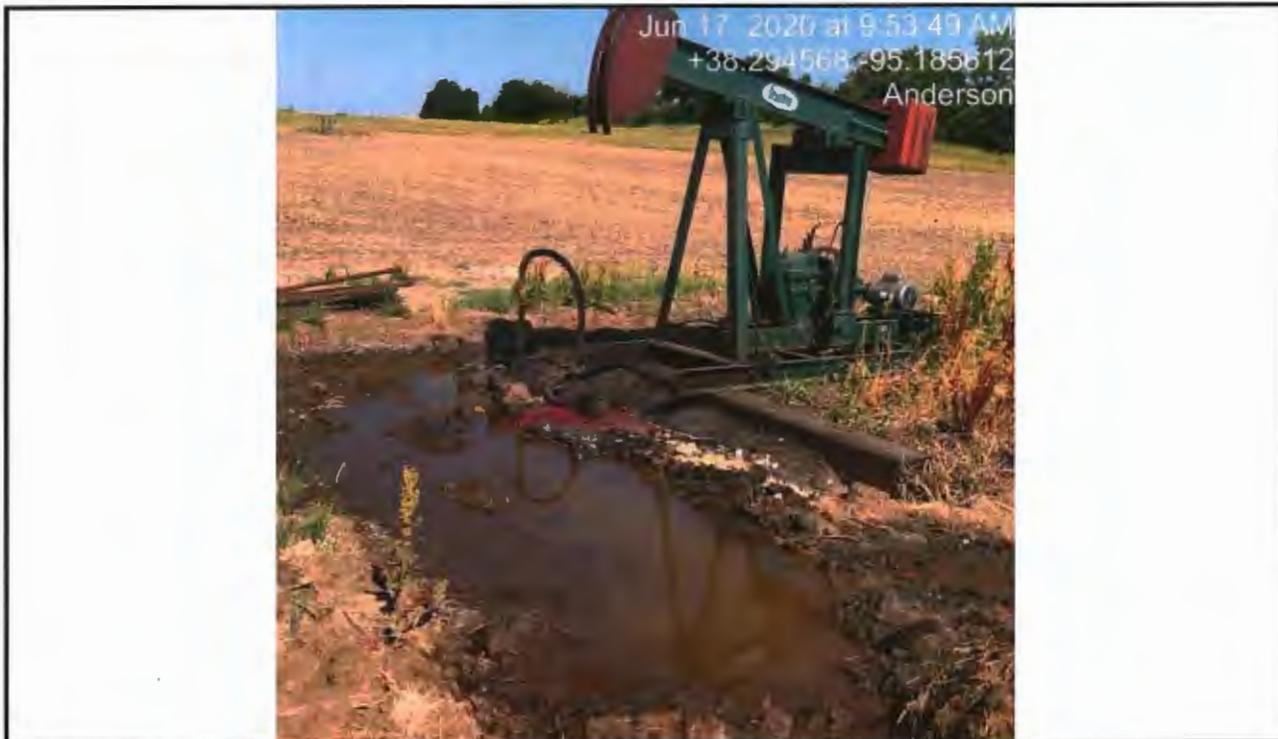
KLN: 32461
Legal: 22-20-20E
PIC ID#: 31-T
PIC Orientation:
Latitude: 38.294575
Longitude: -95.185669

Additional Information: This picture is of well location 31-T. This well shows signs of a production water leak. The spill is being contained in the berm pushed up around the well. This well is not equipped for production as the well doesn't have 1 inch in the hole and the pump jack is missing the belt.

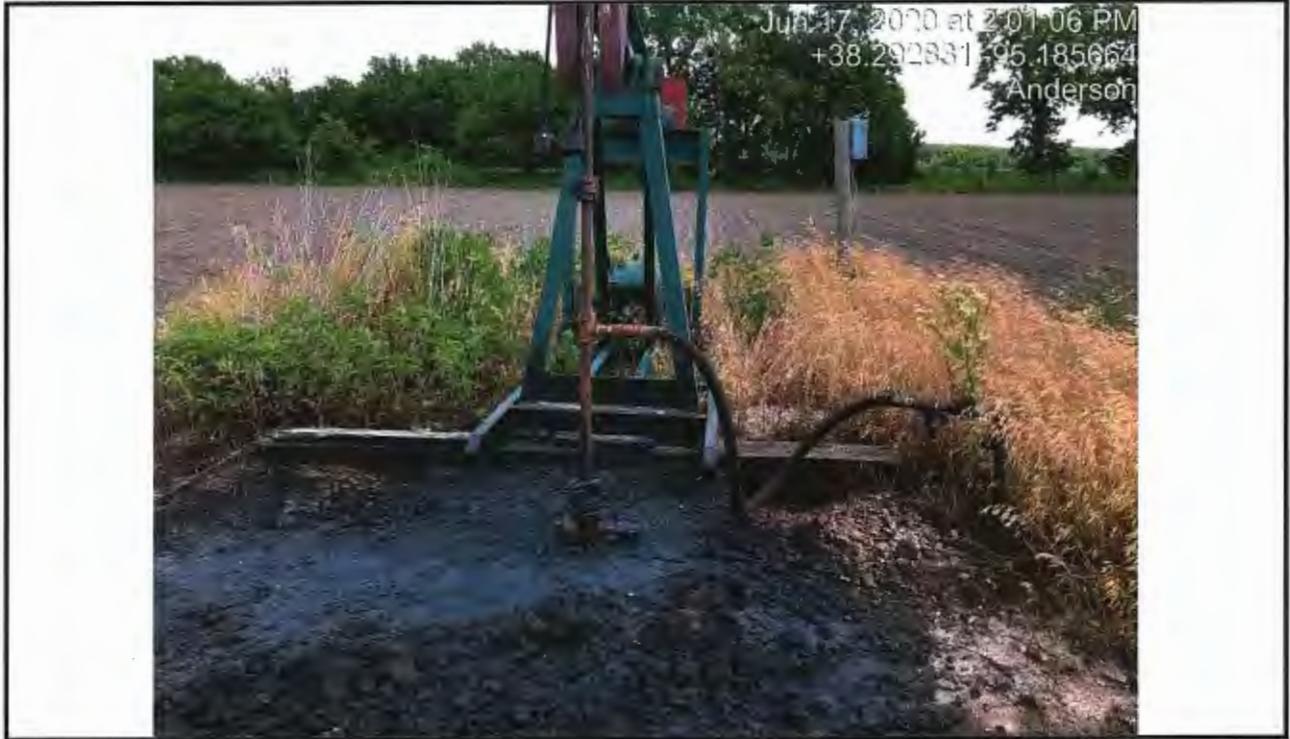
KLN: 32461
Legal: 22-20-20E
PIC ID#: 32 T
PIC Orientation:
Latitude: 38.292822
Longitude: -95.185660

Additional Information: This picture is of well location 32-T. The well is not equipped with a stuffing box and is trying to be sealed in with a rag and clamp. At the time of inspection well was not equipped for production as the 1 inch is unhooked from the pump jack and the 1 inch is on a clamp. The well is seeping but the spill is small and is within 6 feet of the well head.
