**BEFORE THE STATE CORPORATION COMMISSION
OF THE STATE OF KANSAS**

In the matter of the failure of Tailwater, Inc.)	Docket No. 21-CONS-3032-CPEN
(Operator) to comply with K.A.R. 82-3-603 at)	
the South Kempnich Lease in Anderson County,)	CONSERVATION DIVISION
Kansas.)	
_____)	License No. 32461

PRE-FILED DIRECT TESTIMONY

KEITH CARSWELL

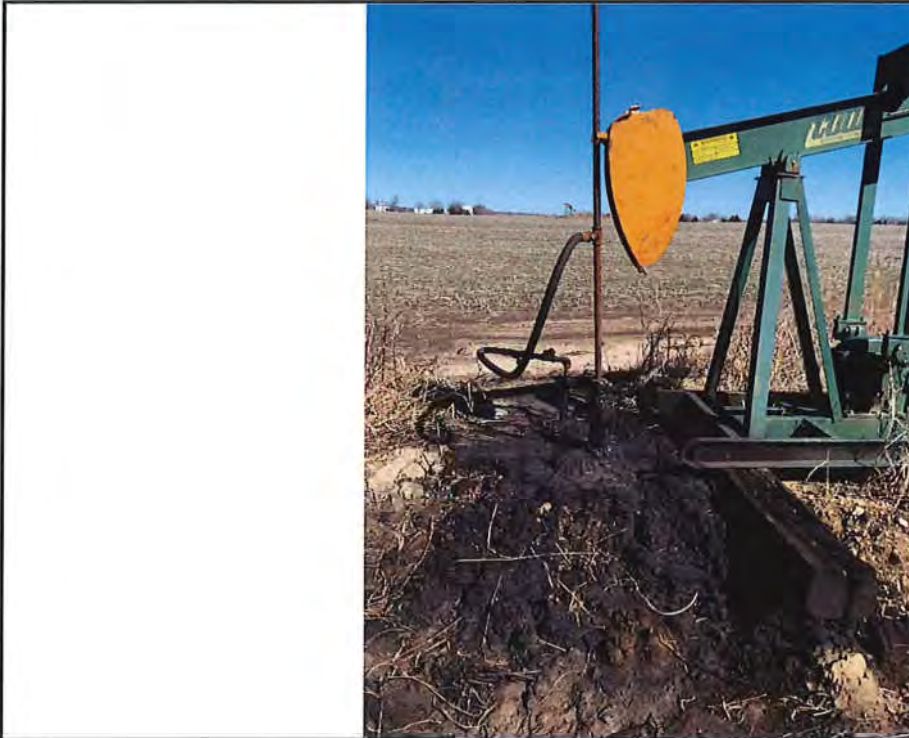
15-003-24647-00-00 #3-T This well is inactive. This well has a rag and clamp trying to seal it in. This well had started seeping through the rag and leaking at the time of inspection. The 1 inch is hanging on the clamp and is disconnected from the pump jack. It is also missing the belt from the electric motor to the pump jack. This well doesn't have proper surface control. This well has a denied CP-111 filed for lack of surface control.

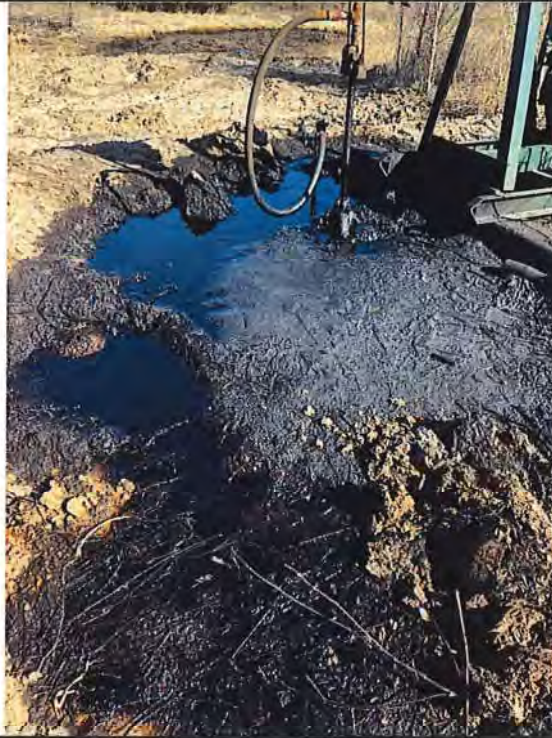
This is an updated picture of the South Kempnich well #18-T. The well is abandon and is not shut with the proper surface control, the well continues to leak crude oil on the ground.

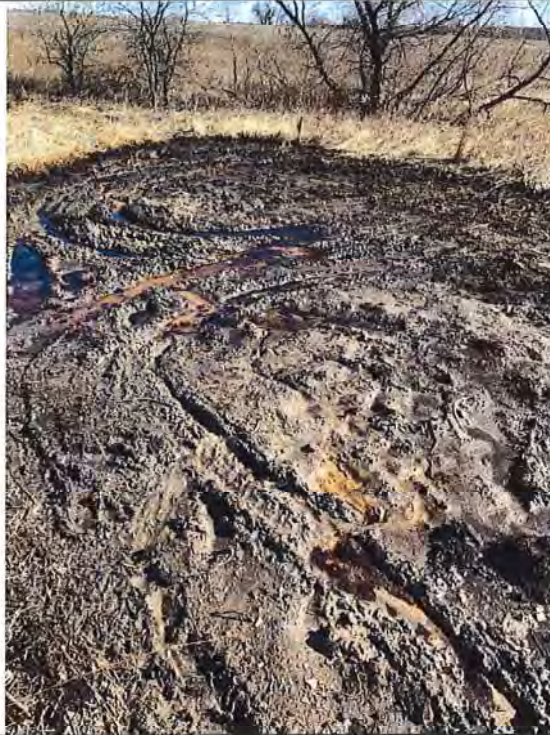
This is an updated picture of the South Kempnich well #18-T. The well is abandon and is not shut with the proper surface control, the well continues to leak crude oil on the ground. Picture 2 of 2 shows an area North of the well approximately 75' that is saturated with crude oil and saltwater.

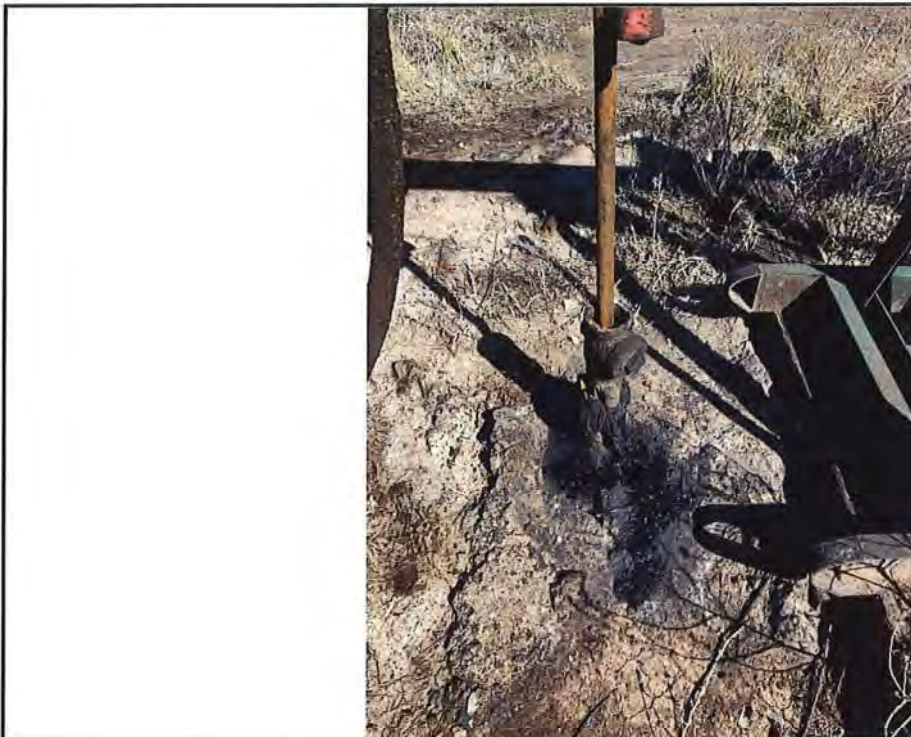
This is an updated picture of the South Kempnich well #2-T. The well is abandon and is not shut with the proper surface control, the well continues to seep crude oil on the ground and saturate the soil in front of and South of the well. The operator has done nothing to stop the spillage since the last inspection and has made no effort to clean up the spillage.

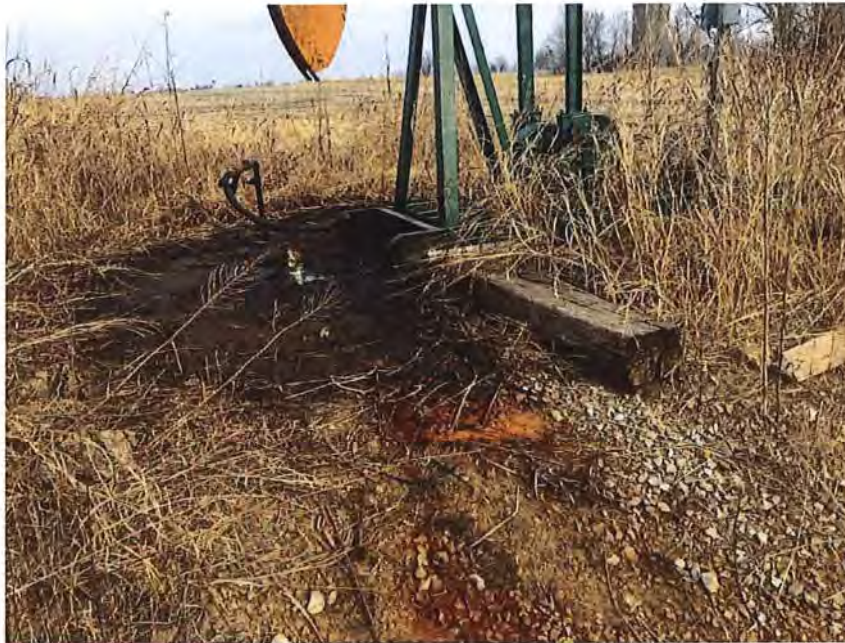
This is an updated picture of well #25-T has been shut in but no remediation has been done.

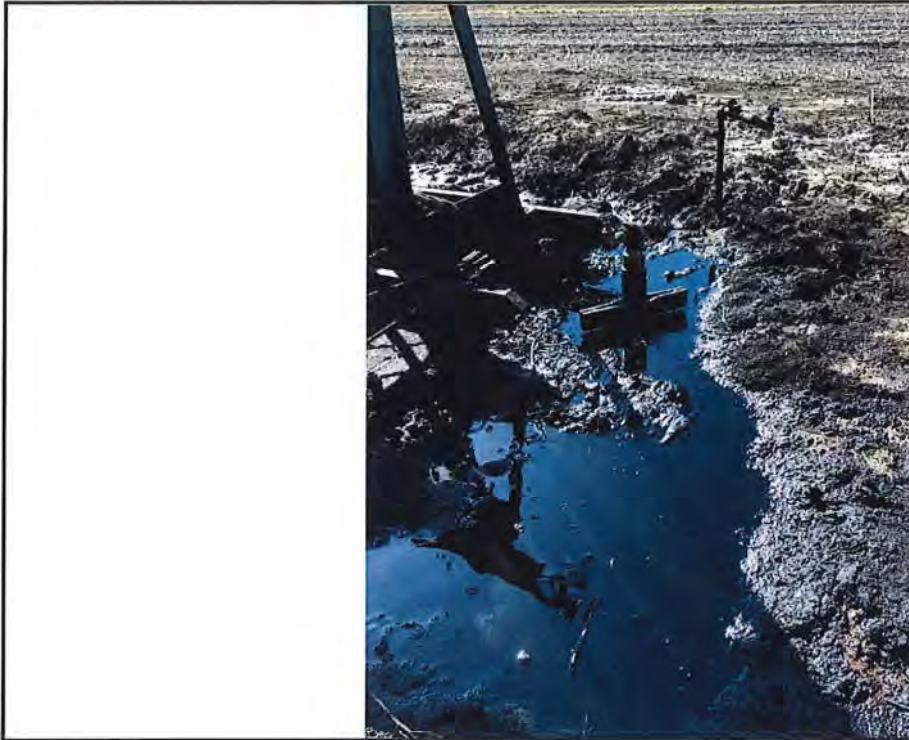
This is an updated picture of the South Kempnich well #28-T. The well is abandon, since the last inspection the operator has installed a new swage and valve on the casing of the well but they have not cleaned up the crude oil that leaked from the well that continues to saturate the soil in the area in front of and on the Northside of the well.

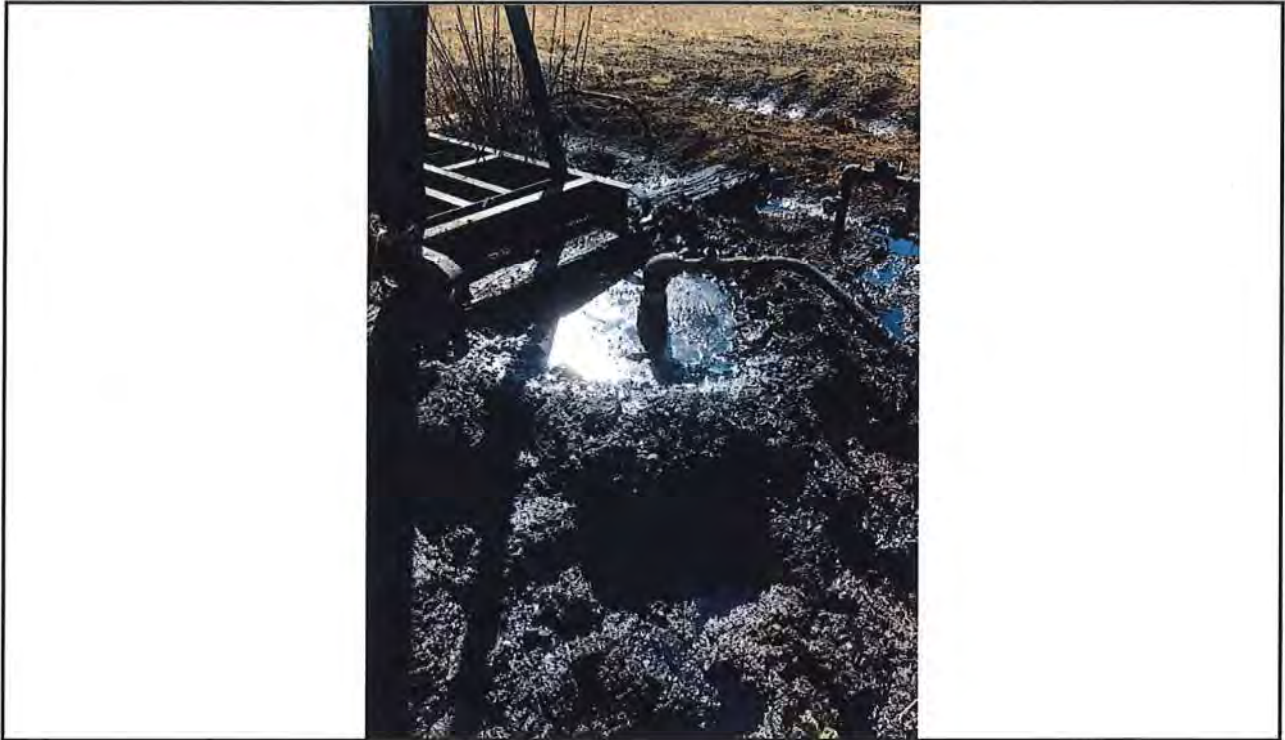
This is an updated picture of the South Kempnich well #13-T. The well is abandon, since the last inspection the operator has installed a swage and valve on the casing of the well but has not cleaned up the crude oil that has saturated the soil in the area in front of and South the well.

15-003-24687-00-00 #13-T This well is inactive there is no 1 inch in the hole. This well is hooked into the flow line. This well was leaking at the time of inspection. The well was leaking out of the threads on the swedge screwed into the well trying to shut the well in. This well had fluid inside the berms pushed up around the well by the operator trying to contain the spills. This well has a denied CP-111 filed on it for lack of surface control.

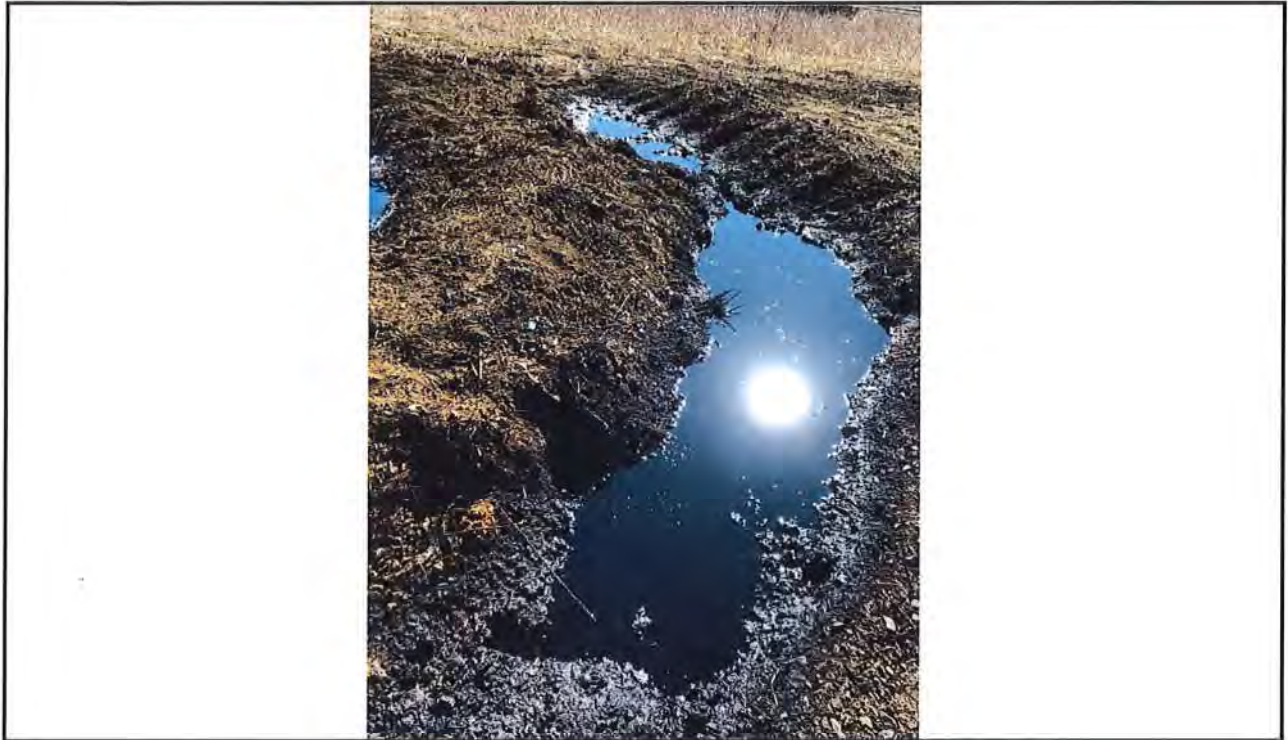
This is an updated picture of the South Kempnich well #13-T. The well is abandon, the operator has not cleaned up the crude oil that has saturated the soil in the area in front of and South the well.

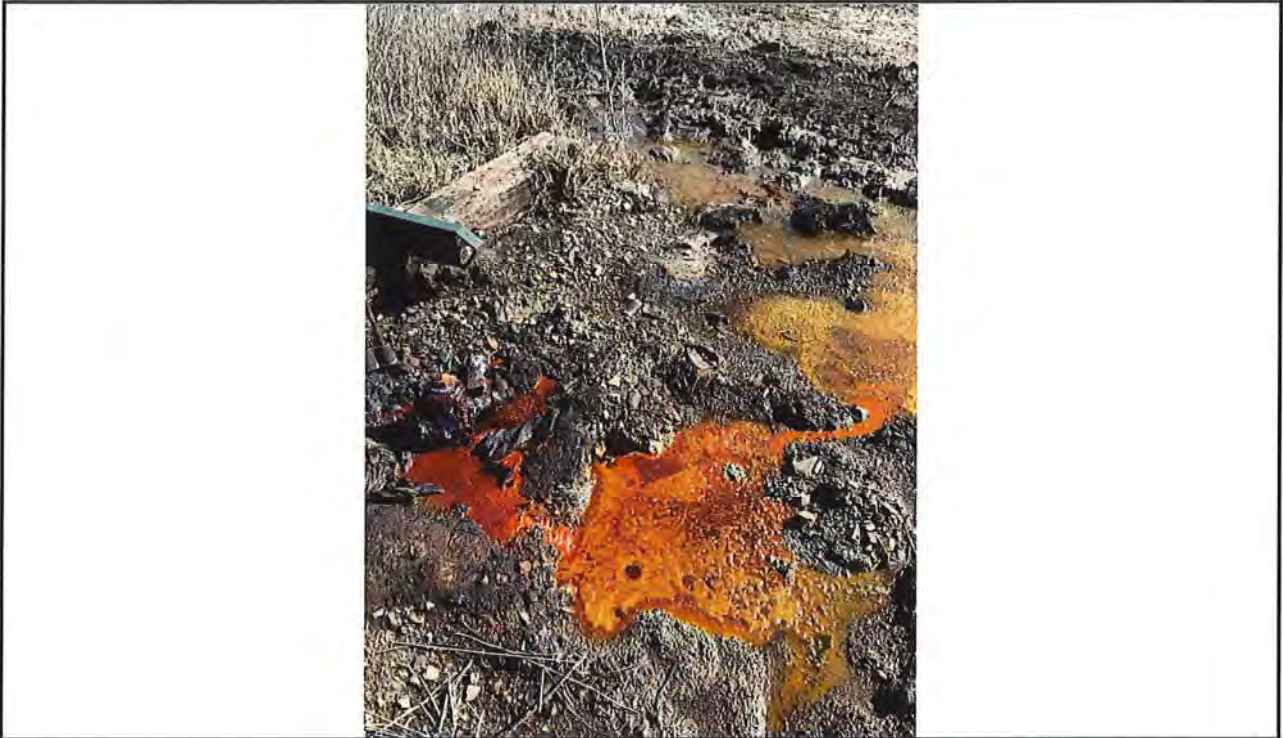
This is an updated picture of the South Kempnich well #14-T. The well is abandon, the operator installed a plug in the casing tee several months ago, however the saltwater continues to leak from the plug and saturate the soil in front of the well and East of the well. The operator has done nothing to stop the spillage since the last inspection and has made no effort to clean up the spillage or remediate the impacted area.

15-003-25017-00-00 #14-T This well is inactive. This well has no 1 inch in the casing and is missing the belt on the pump jack. This well is shut in with a "T" and 2 inch pipe plugs screwed in. There is saltwater leaking through the threads of the 2 inch pipe plugs. The leak has been contained into the berm pushed up around the well. This well has a denied CP-111 filed on it for lack of surface control.

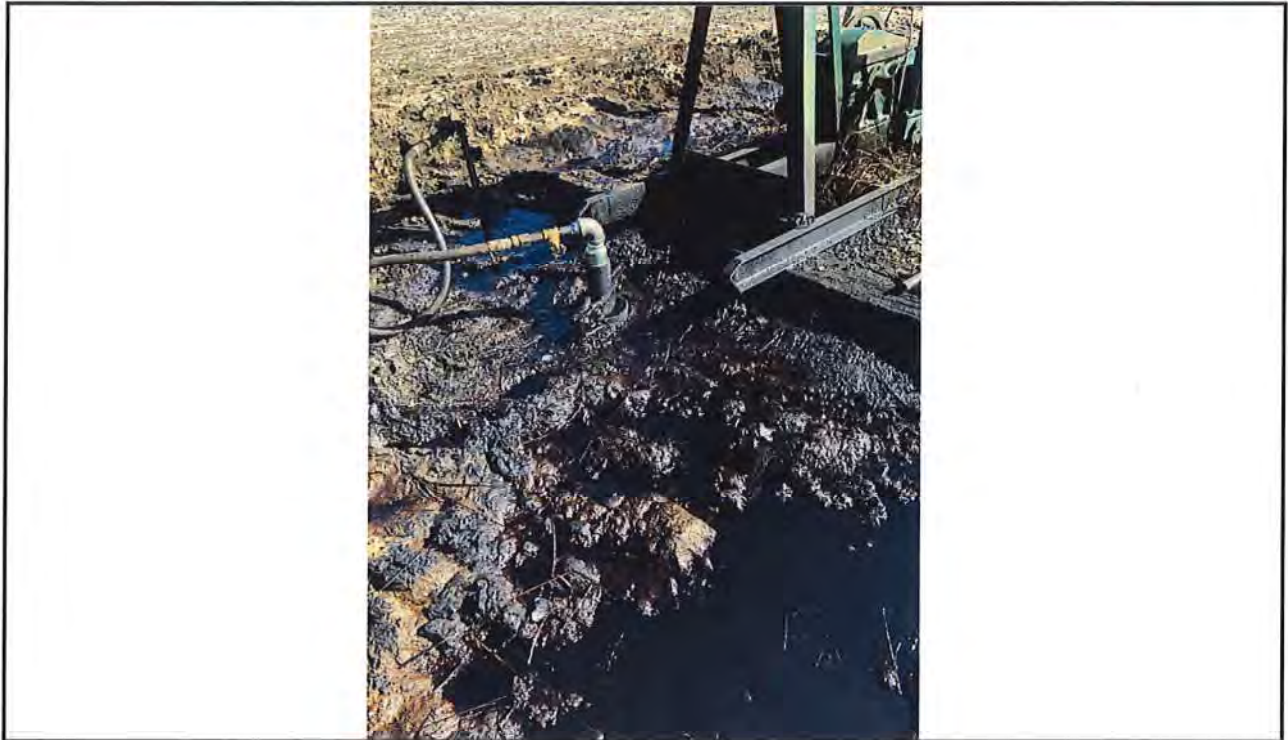
This is an updated picture of the South Kempnich well #15-T. The well is abandon, the operator has installed a new swage and valve on the casing of the well since the last inspection but has not cleaned up the crude oil that has saturated the soil in the area in front of and North of the well.

15-003-25018-00-00 #15-T This well is inactive there is no 1 inch in the casing and there is no belt on the electric motor. This well is hooked into the flow line. There is oil residue inside the berm. This well doesn't appear to be leaking at the time of inspection. This well has an approved CP-111 filed on it.

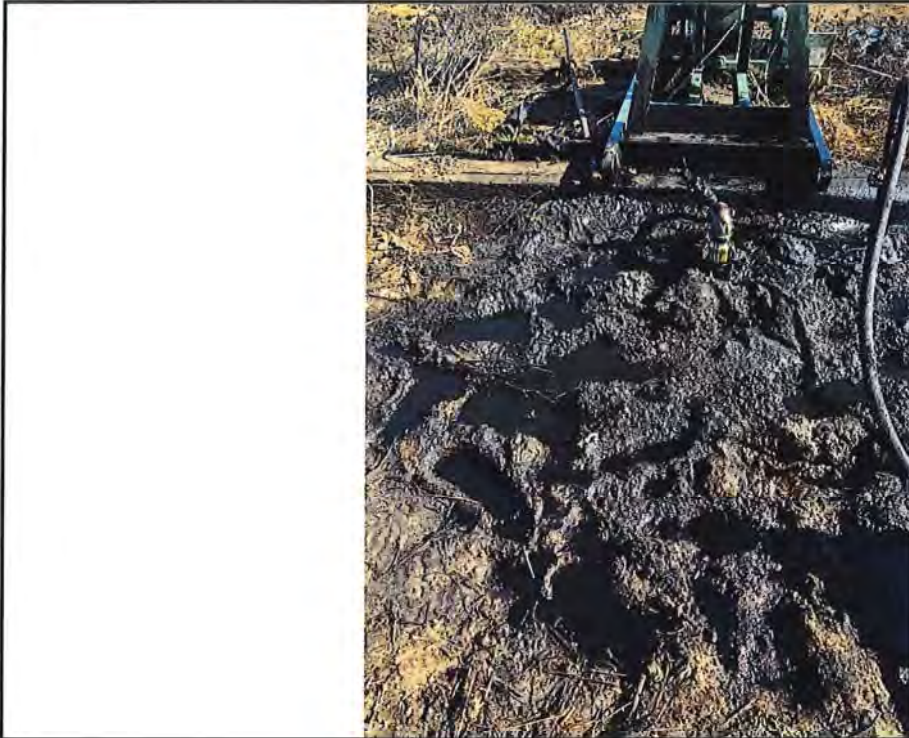
This is an updated picture of the South Kempnich well #16-T. The well is abandon, sometime since the last inspection the operator has installed a new swage and valve on the casing of the well to shut in the well, however they did not cleanup the crude oil that leaked from the well that continues to saturate the soil in the area in front of the well.

15-003-25019-00-00 #16-T This well is inactive. The well doesn't have 1 inch in the casing. The well is hooked into the flow line. I didn't see this well leaking at the time of inspection but the well has leaked at some point because there is oil inside the berm pushed up around the well. This well does have an approved CP-111 filed on it.

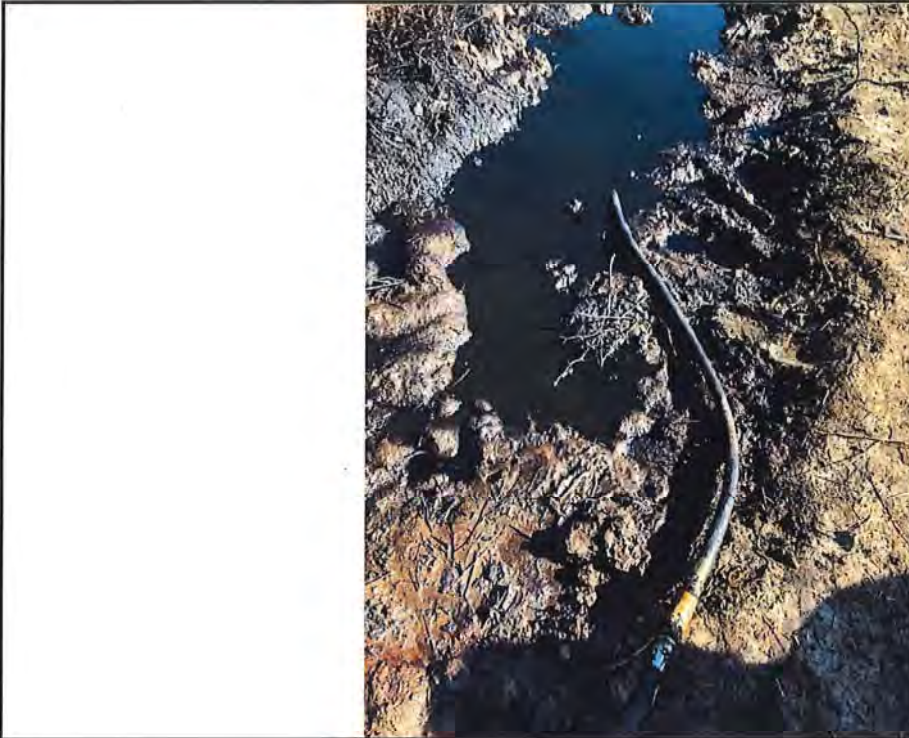
This is an updated picture of the South Kempnich well #16-T. The well is abandon, the operator has not cleaned up the crude oil that leaked from the well that continues to saturate the soil in the area on the Southside of the well.

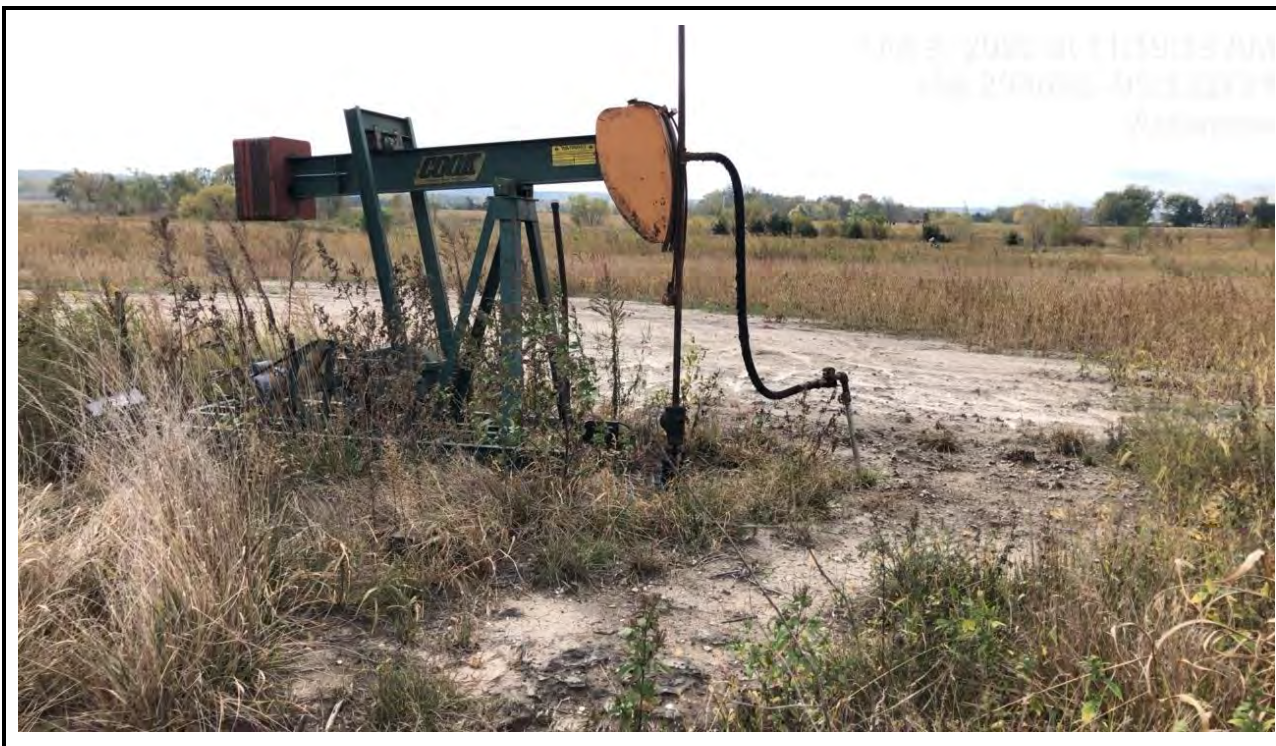
Operator: Tailwater, Inc.	KLN: 32461
Lease: South Kempnich	Legal: 22-20-20E
County: Anderson	PIC ID#: 2-T
Subject: 2-T	PIC Orientation:
FSL: 2375	Latitude: 38.294633
FEL: 4863	Longitude: -95.192783
API#: 15-003-24646-00-00	
Date: 10/09/2020	Time: 11:19 AM
Staff: Keith Carswell

Additional Information: This picture is of well location 2-T. The well is not equipped with a stuffing box. It has a rag and clamp trying to seal the well in. At the time of inspection the well was not equipped for production. The 1 inch was hanging on a rag and clamp.

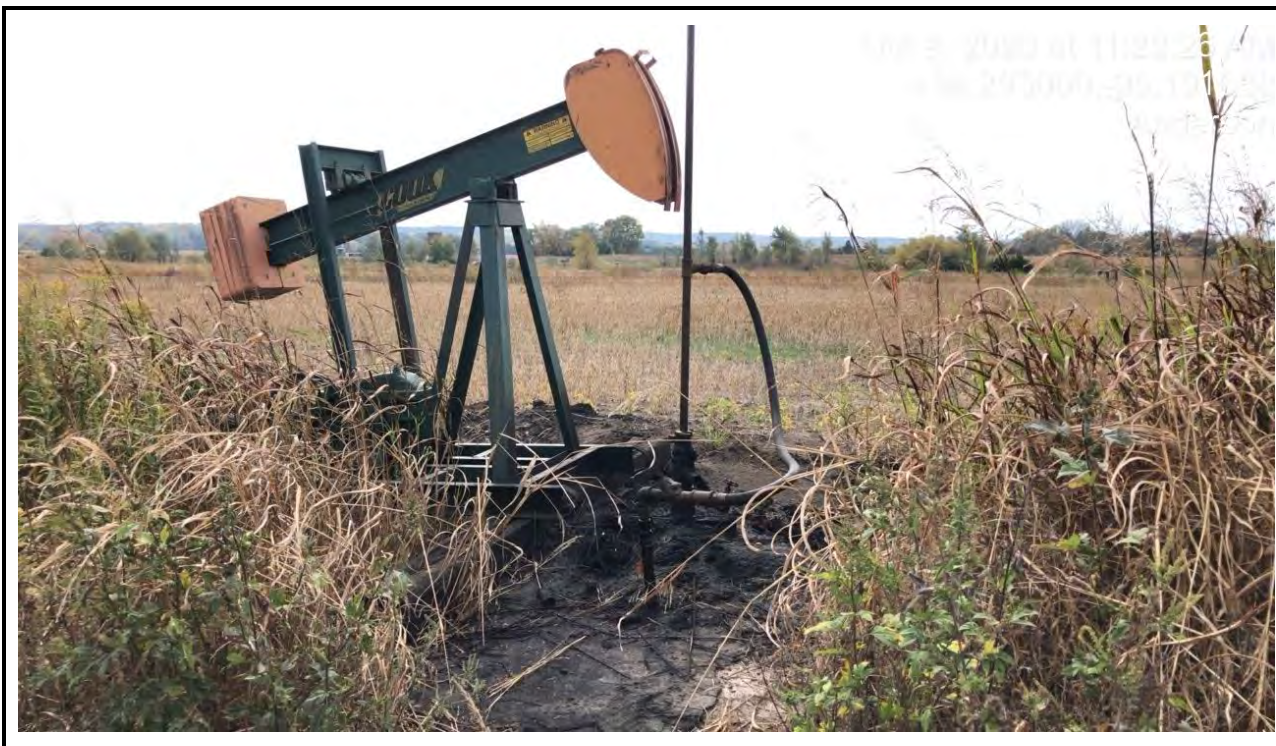
Operator: Tailwater, Inc.	KLN: 32461
Lease: South Kempnich	Legal: 22-20-20E
County: Anderson	PIC ID#: 3-T
Subject: 3-T	PIC Orientation:
FSL: 2488	Latitude: 38.294933
FEL: 4528	Longitude: -95.191616
API#: 15-003-24647-00-00	
Date: 10/09/2020	Time: 11:22 AM
Staff: Keith Carswell

Additional Information: This picture is of well location 3-T. This well is trying to be sealed in with a rag and clamp. At the time of inspection well was not equipped for production. The pump jack was disconnected from the 1 inch and the pump jack is missing a belt.

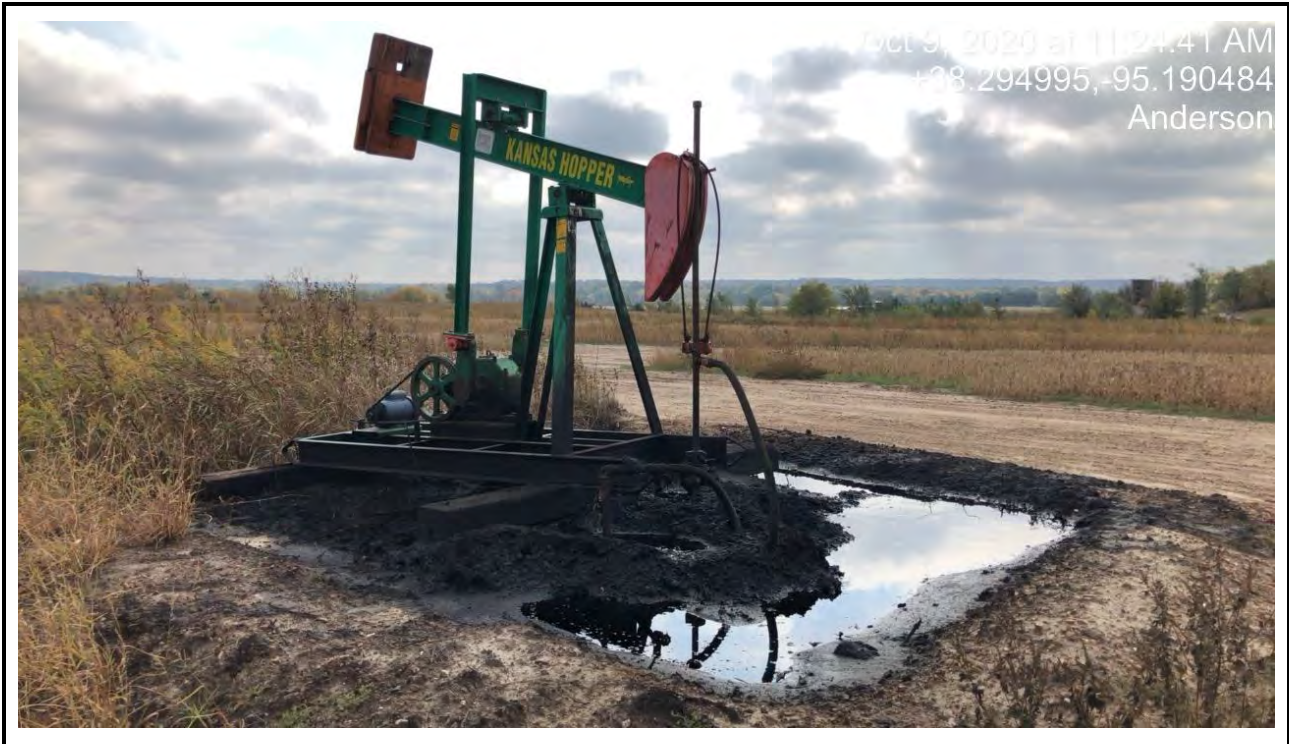
Operator:	Tailwater, Inc.
Lease:	South Kempnich
County:	Anderson
Subject:	4-T
FSL:	2498
FEL:	4193
API#:	15-003-24648-00-00
Date:	10/09/2020
Staff:	Keith Carswell

15-003-24648-00-00 #4-T This well is inactive. They are trying to seal this well in with a rag and clamp. This well is leaking but is contained in the berm pushed up around the well. This well doesn't have proper surface control. This well doesn't have a CP-111 filed.

Additional Information: This picture is of well location 4-T. This well is trying to be sealed in with a rag and clamp. The well was leaking at the time of inspection. The spill is being contained in the berm but shows signs of where it has ran over the berm. This well is inactive due to the rag and clamp.

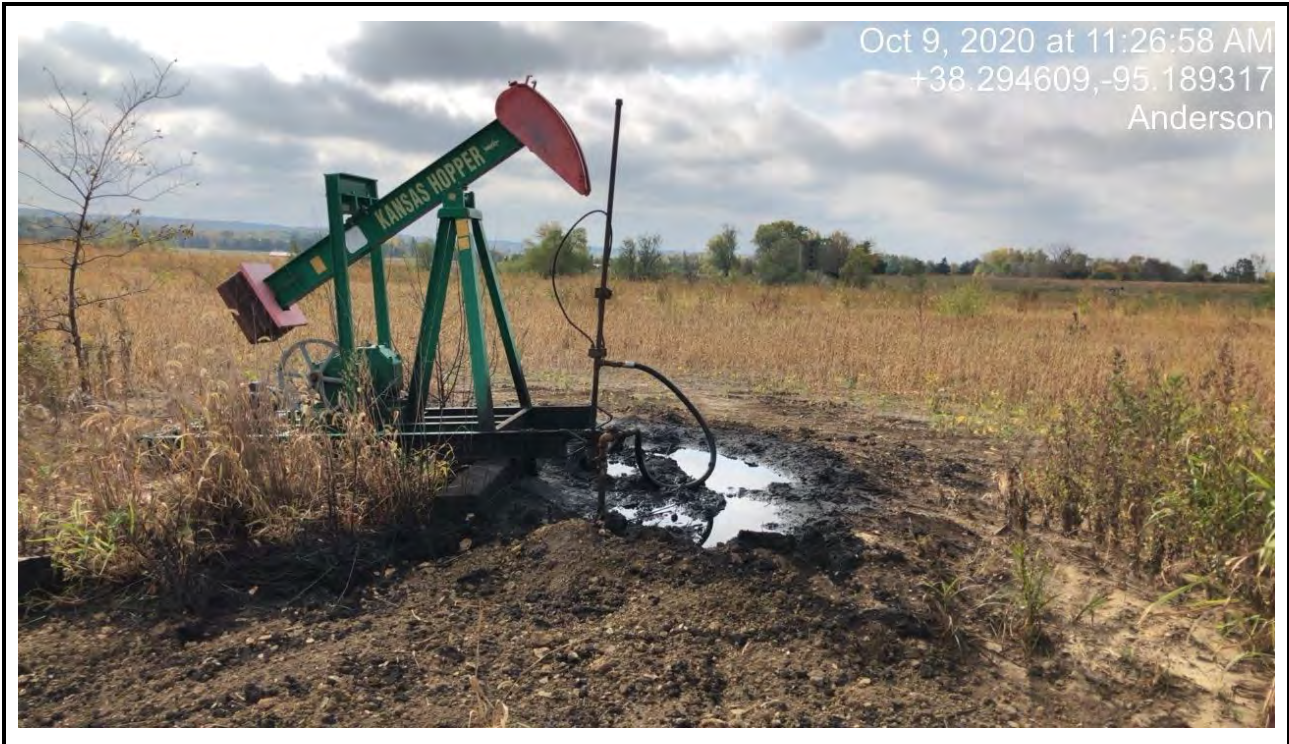
Operator:	Tailwater, Inc.
Lease:	South Kempnich
County:	Anderson
Subject:	5-T
FSL:	2356
FEL:	3873
API#:	15-003-24649-00-00
Date:	10/09/2020
Staff:	Keith Carswell

15-003-24649-00-00 #5-T This well is inactive. The 1 inch is unhooked from the pump jack. The pump jack is also missing the belt. They are trying to seal this well in with a rag and clamp. The well is leaking crude oil that has escaped the berm. This is one of the locations that had fresh dirt trying to cover the spill area. This well doesn't have proper surface control. This well has a denied CP-111 filed for lack of proper surface control.

Additional Information: This picture is of well location 5-T. The well is leaking up the production string and is not equipped with a stuffing box it is trying to be sealed in with a rag and clamp. This is one spot that Dan and his helper tried covering up the spill that escaped the berm that's pushed up around the well with fresh dirt. At the time of inspection well was not equipped for production. The 1 inch is unhooked from the pump jack and the pump jack is missing the belt.

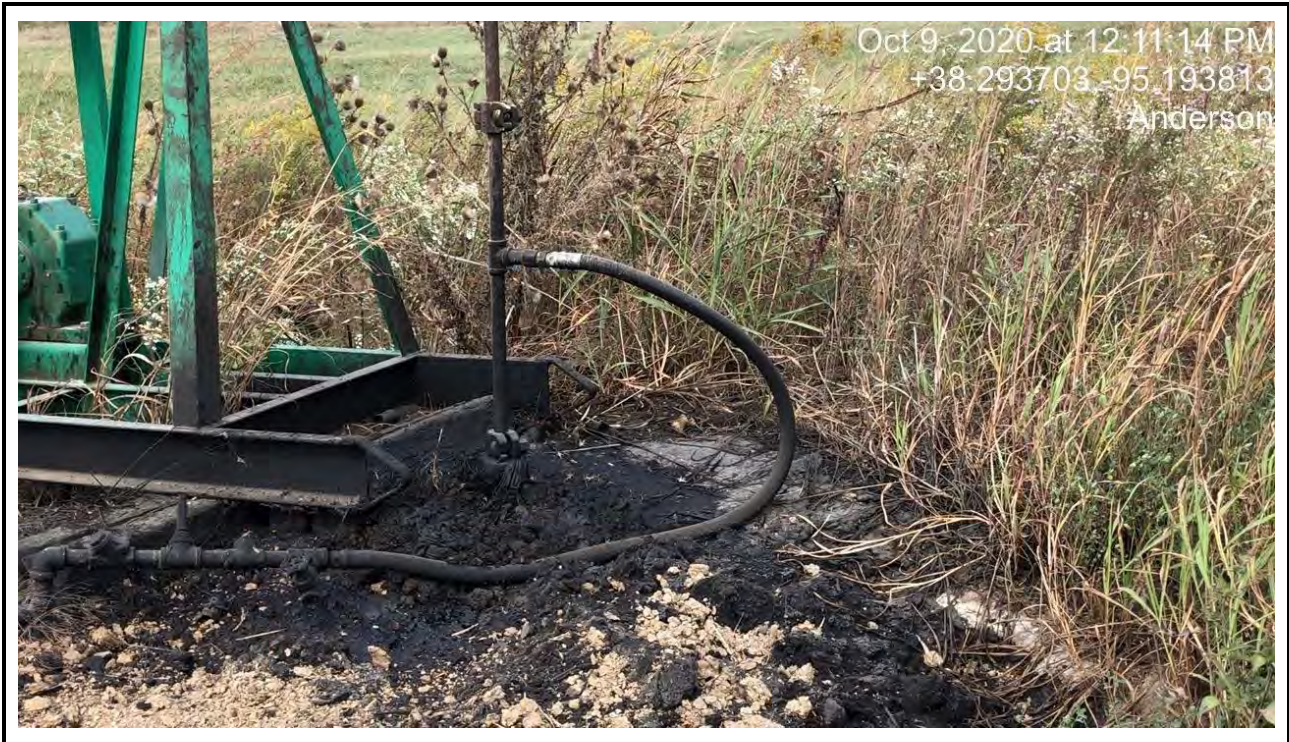
Operator: Tailwater, Inc.	KLN: 32461
Lease: South Kempnich	Legal: 22-20-20E
County: Anderson	PIC ID#: 7-T
Subject: 7-T	PIC Orientation:
FSL: 2056	Latitude: 38.293766
FEL: 5160	Longitude: -95.193816
API#:15-003-24651-00-00	
Date: 10/09/2020	Time: 12:11 PM
Staff: Keith Carswell

15-003-24651-00-00 #7-T This well is inactive. The one inch is on a clamp and is unhooked from the pump jack. They have tried to shut in this well in with a rag and clamp. The well is still leaking. This is one of the locations that Dan and his helper had tried covering up the spill area with fresh dirt. This well does not have proper surface control. This well doesn't have a CP-111 filed on it.

Additional Information: This picture is of well location 7-T. This location has a new spill area that has tried to be covered up by throwing fresh dirt on it with a shovel. The well is leaking up the production string and is not equipped with a stuffing box. They have tried to seal the well in with a rag and a clamp. The well is inactive. The 1 inch is unhooked from the pump jack and the pump jack is missing the belt.

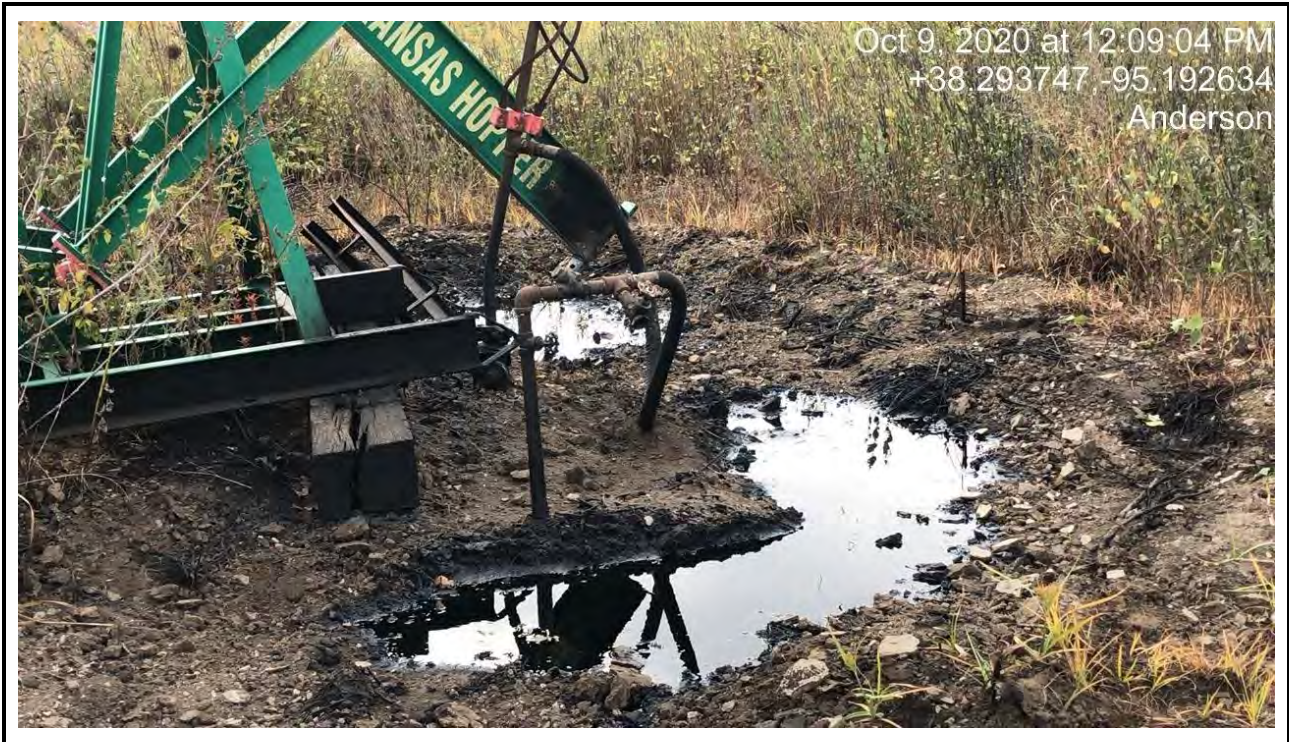
Operator: Tailwater, Inc.	KLN: 32461
Lease: South Kempnich	Legal: 22-20-20E
County: Anderson	PIC ID#: 8-T
Subject: 8-T	PIC Orientation:
FSL: 2036	Latitude: 38.293700
FEL: 4849	Longitude: -95.192733
API#: 15-003-24652-00-00	
Date: 10/09/2020	Time: 12:09 PM
Staff: Keith Carswell

15-003-24652-00-00 #8-T This well is inactive. The pump jack is disconnected from the 1 inch and the pump jack is in disrepair. They have tried to shut this well in with a rag and clamp. The well is still leaking. Fresh crude oil is on the ground within the berm, the operator has pushed dirt up around the producing wells on the lease. This well does not have proper surface control. This well has a denied CP-111 filed on it for lack of surface control.

Additional Information: This picture is of well location 8-T. This location has berm pushed up around the well and the oil is being contained in the berm. The well is leaking up the production string and is not equipped with a stuffing box. The well is trying to be sealed in by a rag and a clamp on the 1 inch. At the time of inspection well was not equipped for production. The pump jack was broke.

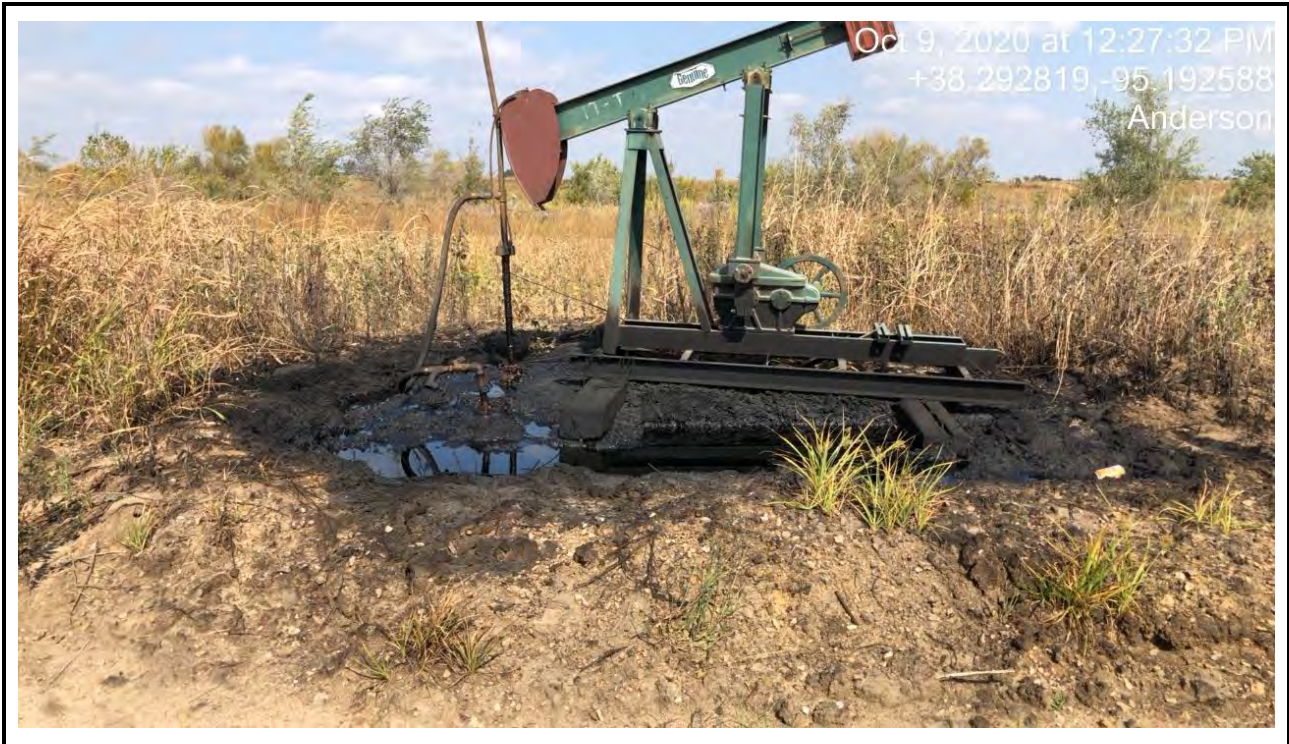
Operator: Tailwater, Inc.	KLN: 32461
Lease: South Kempnich	Legal: 22-20-20E
County: Anderson	PIC ID#: 16-T
Subject: 16-T	PIC Orientation:
FSL: 1705	Latitude: 38.292802
FEL: 5136	Longitude: -95.193730
API#: 15-003-25019-00-00	
Date: 10/09/2020	Time: 12:23 PM
Staff: Keith Carswell

Additional Information: This picture is of well location 16-T. This well is inactive. The well doesn't have 1 inch in the casing and the pump jack is missing the belt. There is oil in the berm pushed up around the well where the well has leaked in the past. At the time of the inspection I didn't see the well leaking.

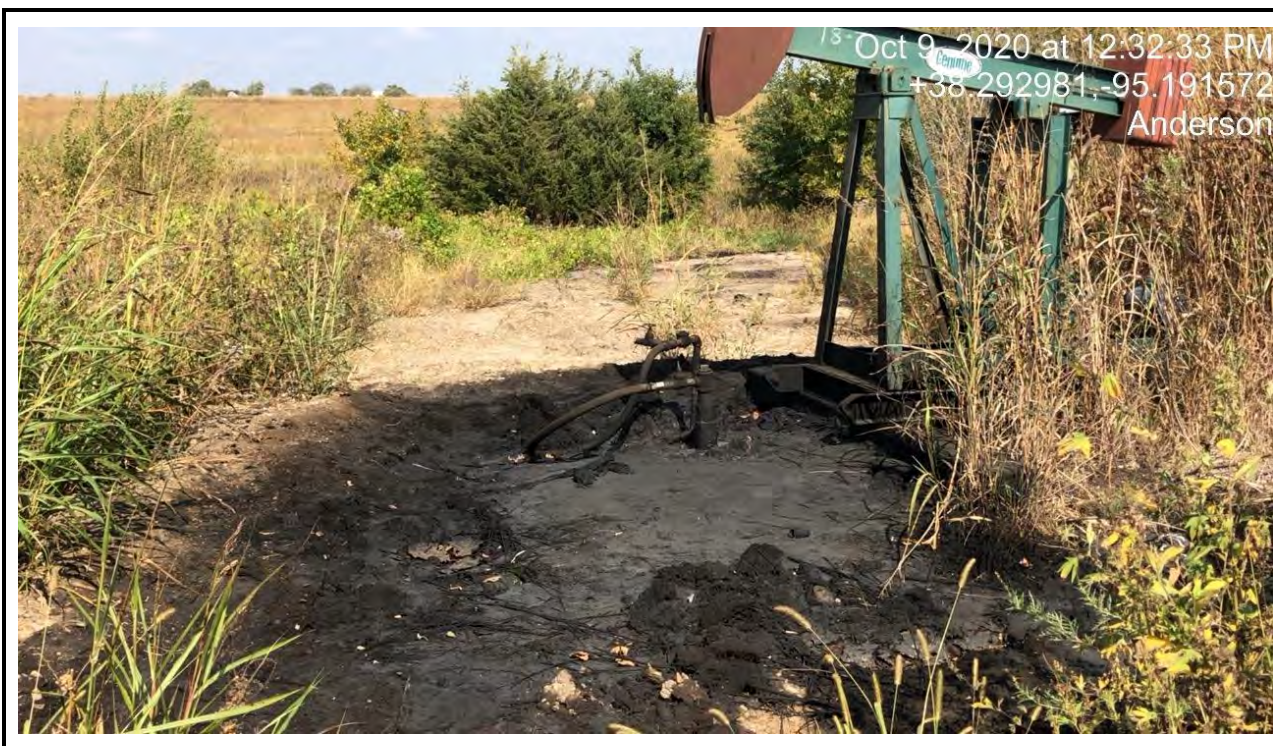
Operator: Tailwater, Inc.	KLN: 32461
Lease: South Kempnich	Legal: 22-20-20E
County: Anderson	PIC ID#: 17-T Pic 1
Subject: 17-T	PIC Orientation:
FSL: 1741	Latitude: 38.292890
FEL: 4812	Longitude: -95.192602
API#: 15-003-25020-00-00	
Date: 10/09/2020	Time: 12:27 PM
Staff: Keith Carswell

Additional Information: This picture is of well location 17-T. The well is leaking up the production string and is not equipped with a stuffing box the well is trying to be sealed in with a rag and clamp. The spill is being contained inside the berm pushed up around the well for now. At the time of inspection well was not equipped for production. The pump jack did not have a motor or a belt.

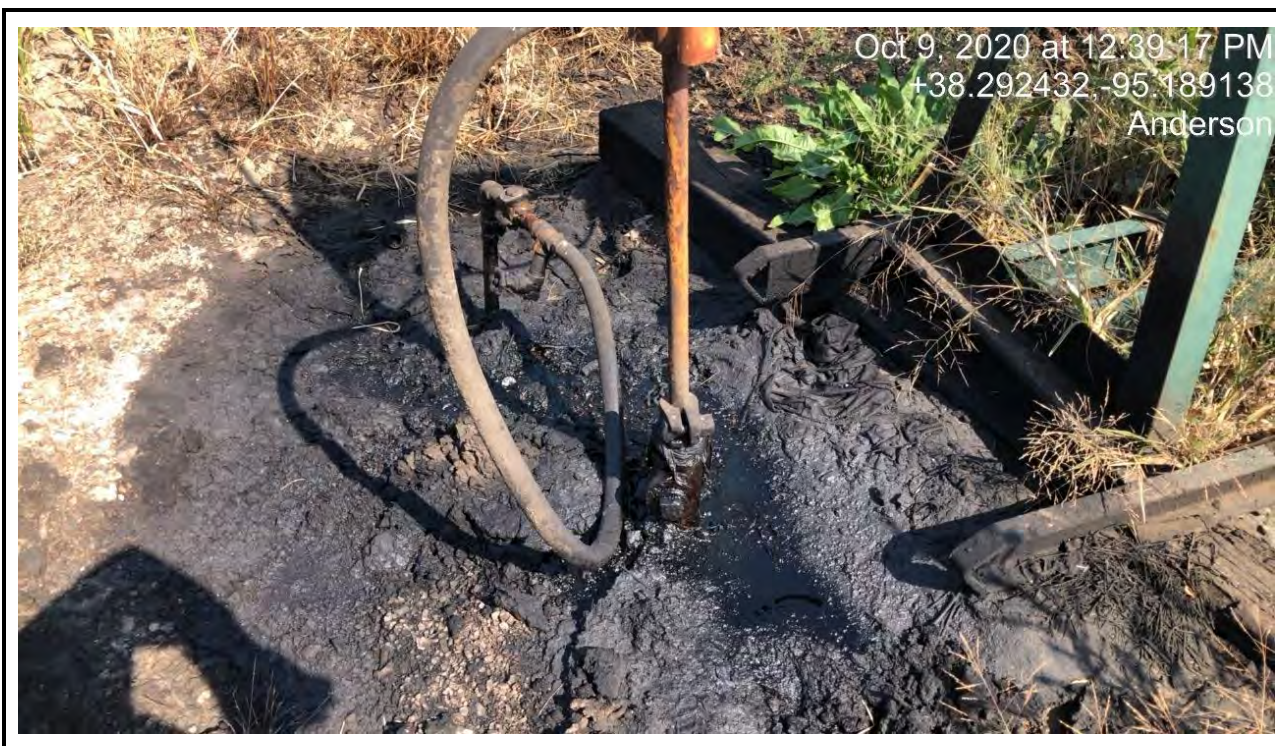
Operator: Tailwater, Inc.	KLN: 32461
Lease: South Kempnich	Legal: 22-20-20E
County: Anderson	PIC ID#: 18-T
Subject: 18-T	PIC Orientation:
FSL: 1807	Latitude: 38.293060
FEL: 4492	Longitude: -95.191486
API#: 15-003-25021-00-00	
Date: 10/09/2020	Time: 12:32 PM
Staff: Keith Carswell

Additional Information: This picture is of well location 18-T. This well is hooked into the flow line. This well is inactive because there is no 1 inch in the casing. This well wasn't leaking at the time of the inspection but has leaked in the past because of the oil residue on the ground in the berm.

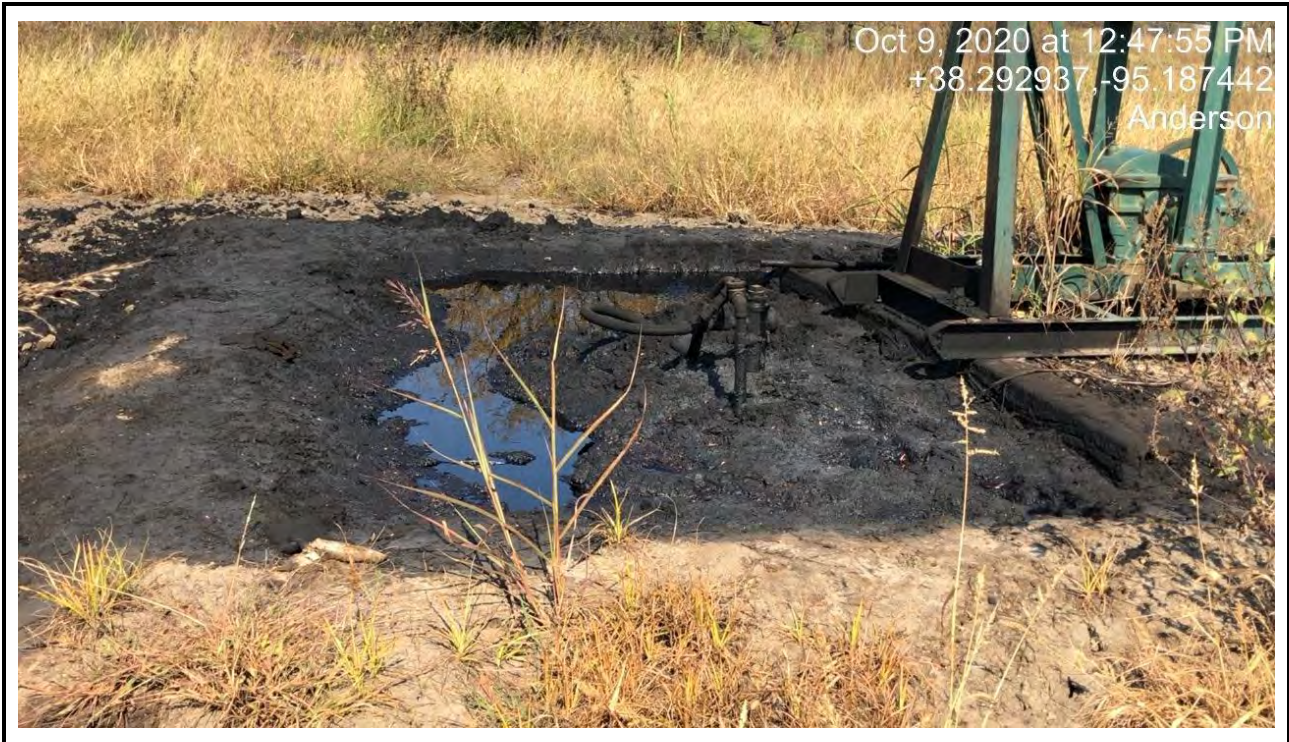
Operator: Tailwater, Inc.	KLN: 32461
Lease: South Kempnich	Legal: 22-20-20E
County: Anderson	PIC ID#: 20-T
Subject: 20-T	PIC Orientation:
FSL: 1607	Latitude: 38.292492
FEL: 3832	Longitude: -95.189185
API#: 15-003-25023-00-00	
Date: 10/09/2020	Time: 12:39 PM
Staff: Keith Carswell

Additional Information: This picture is of well location 20-T. This well is inactive as the 1 inch is unhooked from the pump jack. The well is leaking up the production string and is not equipped with a stuffing box. The well is trying to be sealed in with a rag and clamp. This well is seeping but the spill is being contained inside the berm pushed up around the well.

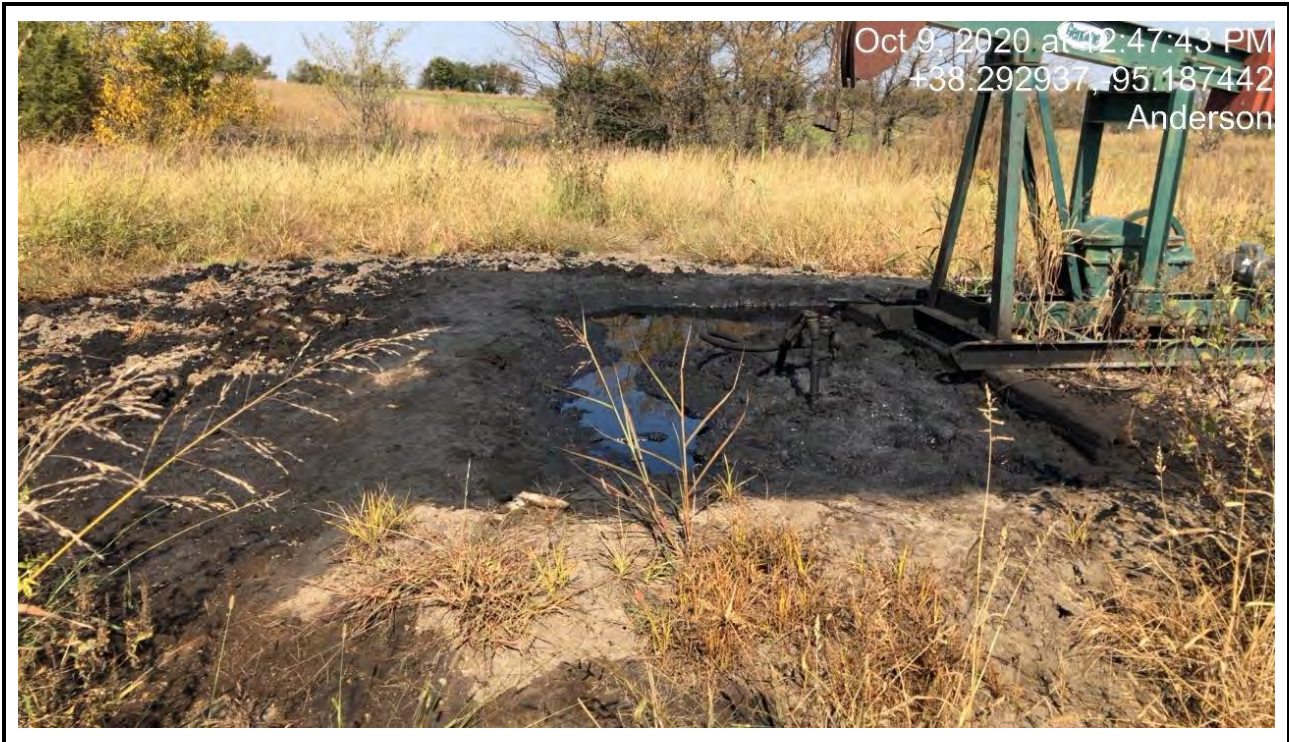
Operator: Tailwater, Inc.	KLN: 32461
Lease: South Kempnich	Legal: 22-20-20E
County: Anderson	PIC ID#: 22-T PIC 1
Subject: 22-T	PIC Orientation:
FSL: 1792	Latitude: 38.292983
FEL: 3318	Longitude: -95.187395
API#: 15-003-25025-00-00	
Date: 10/09/2020	Time: 12:47 PM
Staff: Keith Carswell

Additional Information: This picture is of well location 22-T. The well is in active as it has no 1 inch in the casing and the pump jack is missing a belt. The well is hooked into the flow line but appears to be leaking at the time of the inspection through the threads in the "T" on top of the well. This spillage has ran over the berm sometime in the past. Dan and his helper tried to throw fresh dirt on it to cover it up.
