**BEFORE THE STATE CORPORATION COMMISSION
OF THE STATE OF KANSAS**

In the matter of the failure of Tailwater, Inc.)	Docket No. 21-CONS-3032-CPEN
(Operator) to comply with K.A.R. 82-3-603 at)	
the South Kempnich Lease in Anderson County,)	CONSERVATION DIVISION
Kansas.)	
_____)	License No. 32461

PRE-FILED DIRECT TESTIMONY

KEITH CARSWELL

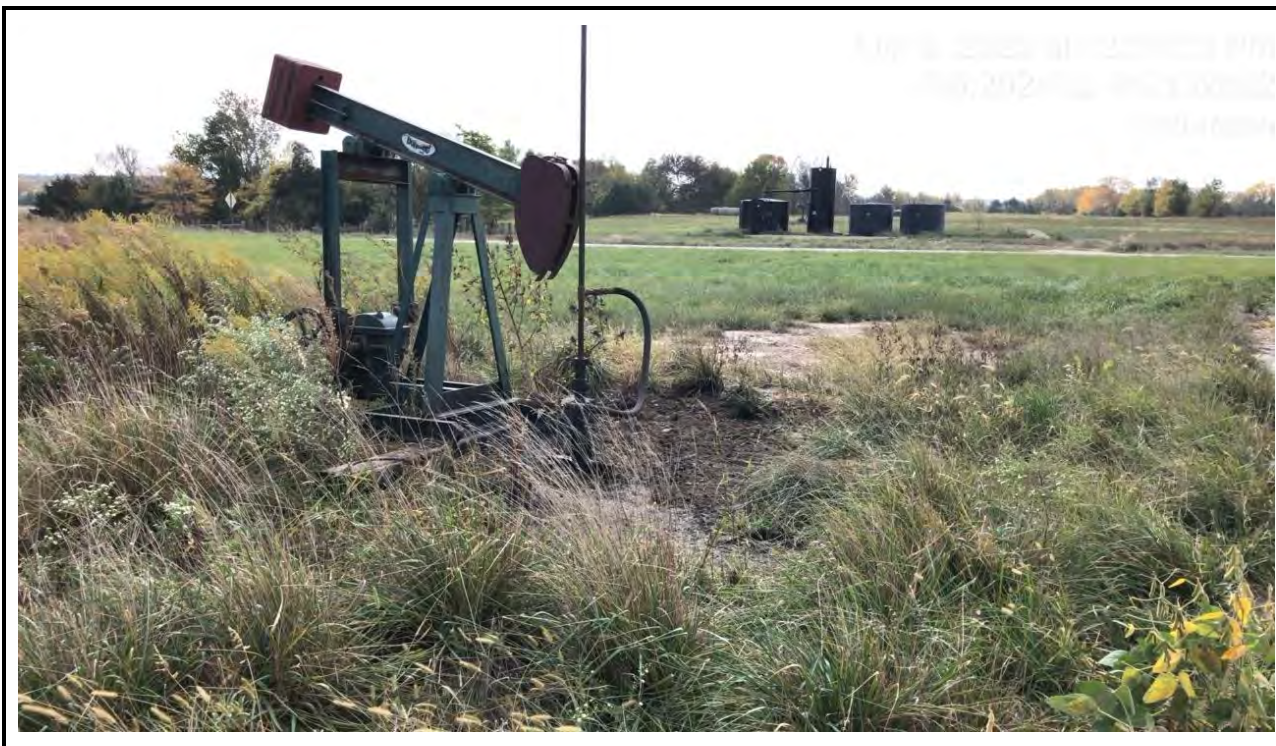
Operator: Tailwater, Inc.	KLN: 32461
Lease: South Kempnich	Legal: 22-20-20E
County: Anderson	PIC ID#: 22-T PIC 2
Subject: 22-T	PIC Orientation:
FSL: 1792	Latitude: 38.292983
FEL: 3318	Longitude: -95.187395
API#: 15-003-25025-00-00	
Date: 10/09/2020	Time: 12:47 PM
Staff: Keith Carswell

Additional Information: This picture is of well location 22-T. The well is in active as it has no 1 inch in the casing and the pump jack is missing a belt. The well is hooked into the flow line but appears to be leaking at the time of the inspection through the threads in the "T" on top of the well. This well has also ran over the berm sometime in the past. Dan and his helper tried to throw fresh dirt on it to cover it up.

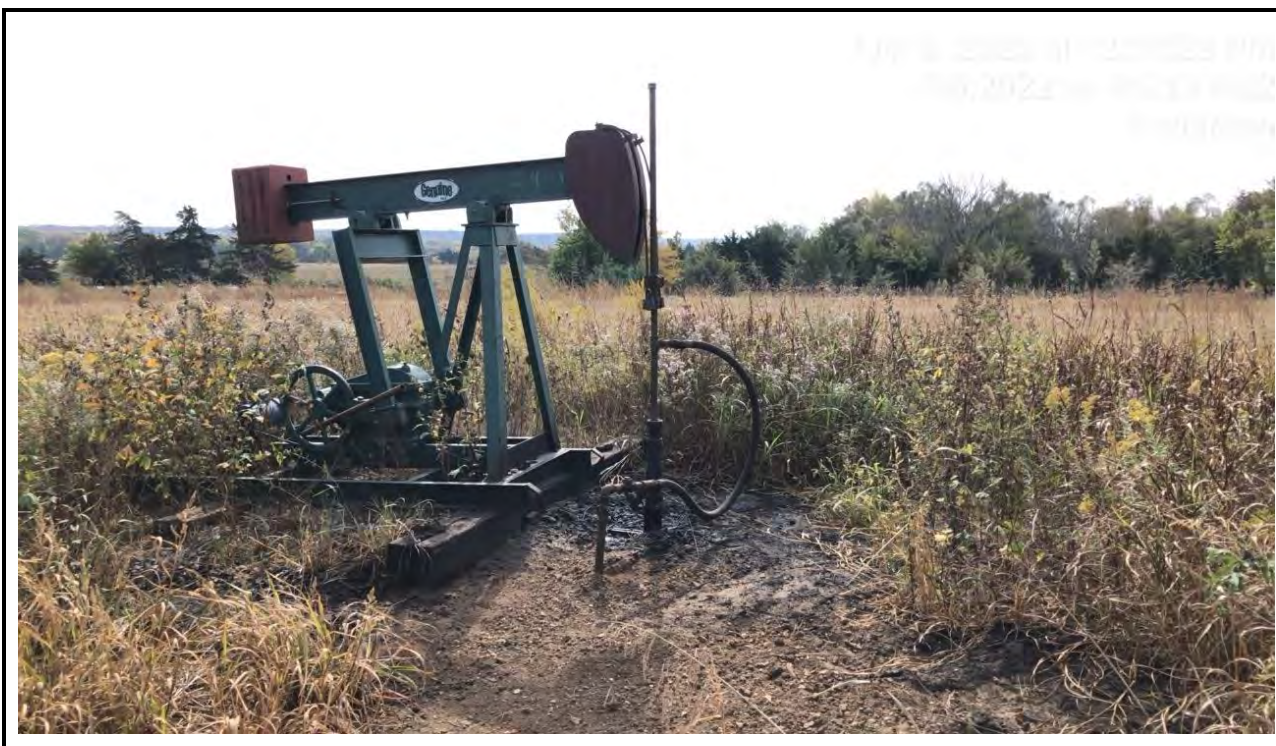
Operator: Tailwater, Inc.	KLN: 32461
Lease: South Kempnich	Legal: 22-20-20E
County: Anderson	PIC ID#: 23-T
Subject: 23-T	PIC Orientation:
FSL: 1475	Latitude: 38.292160
FEL: 4830	Longitude: -95.192661
API#: 15-003-25026-00-00	
Date: 10/09/2020	Time: 12:16 PM
Staff: Keith Carswell

Additional Information: This picture is of well location 23-T. The well is seeping up the production string and is not equipped with a stuffing box so it's leaking through the rag. The well is trying to be sealed in with a rag and clamp. This well is inactive as the 1 inch is unhooked from the pump jack. The spillage has stayed inside the berm pushed up around the well.

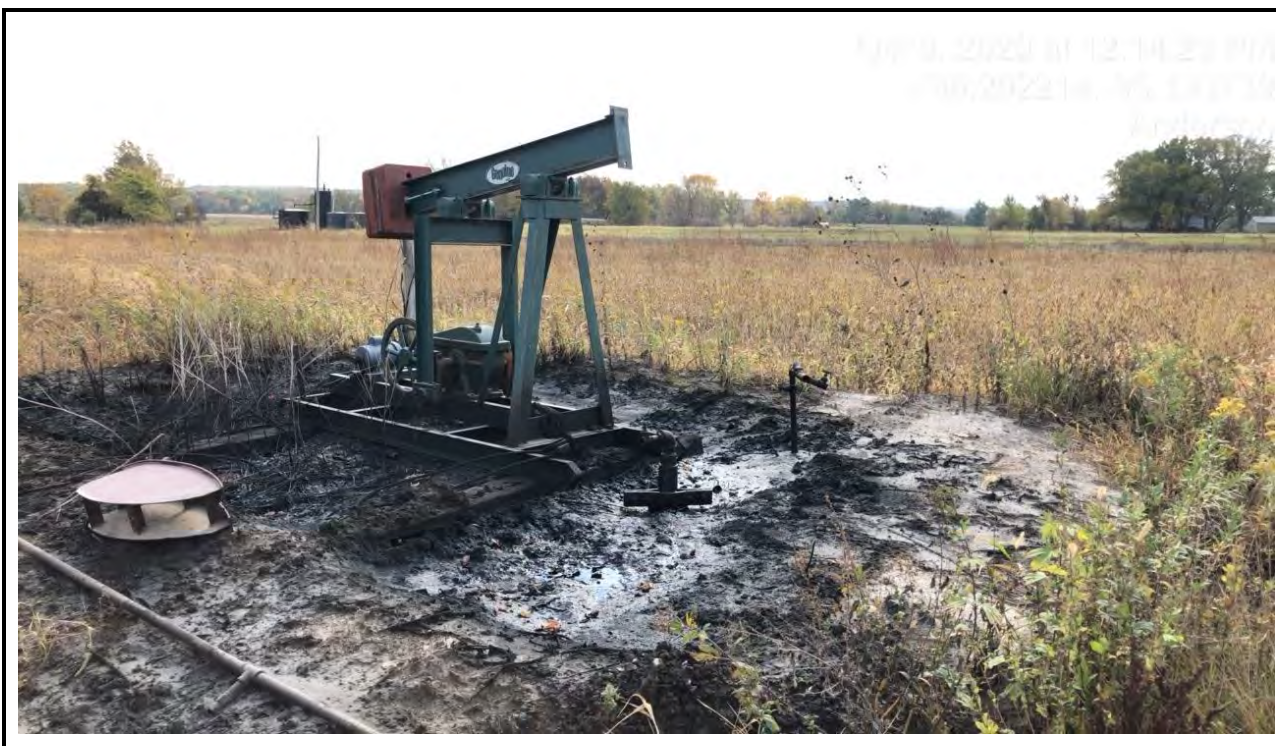
Operator: Tailwater, Inc.	KLN: 32461
Lease: South Kempnich	Legal: 22-20-20E
County: Anderson	PIC ID#: 27-T
Subject: 27-T	PIC Orientation:
FSL: 1832	Latitude: 38.293082
FEL: 3000	Longitude: -95.186288
API#: 15-003-25030-00-00	
Date: 10/09/2020	Time: 12:53 PM
Staff: Keith Carswell

15-003-25030-00-00 #27-T This well is inactive. The 1 inch is hanging on a rag and clamp trying to seal off the well. This well is leaking through the rag. The berm that's pushed up around the well has fluid in it at the time of inspection and it appears it has ran over the berm before. This well doesn't have proper surface control. This well doesn't have a CP-111 filed on it.

Additional Information: This picture is of well location 27-T. This well is leaking up the production string and is missing the stuffing box. The well is trying to be sealed in with a rag and clamp but the well is leaking. The spill is being contained inside the berm pushed up around the well but the berm does show signs the oil has escaped the berm in the past. This well doesn't have proper surface control.

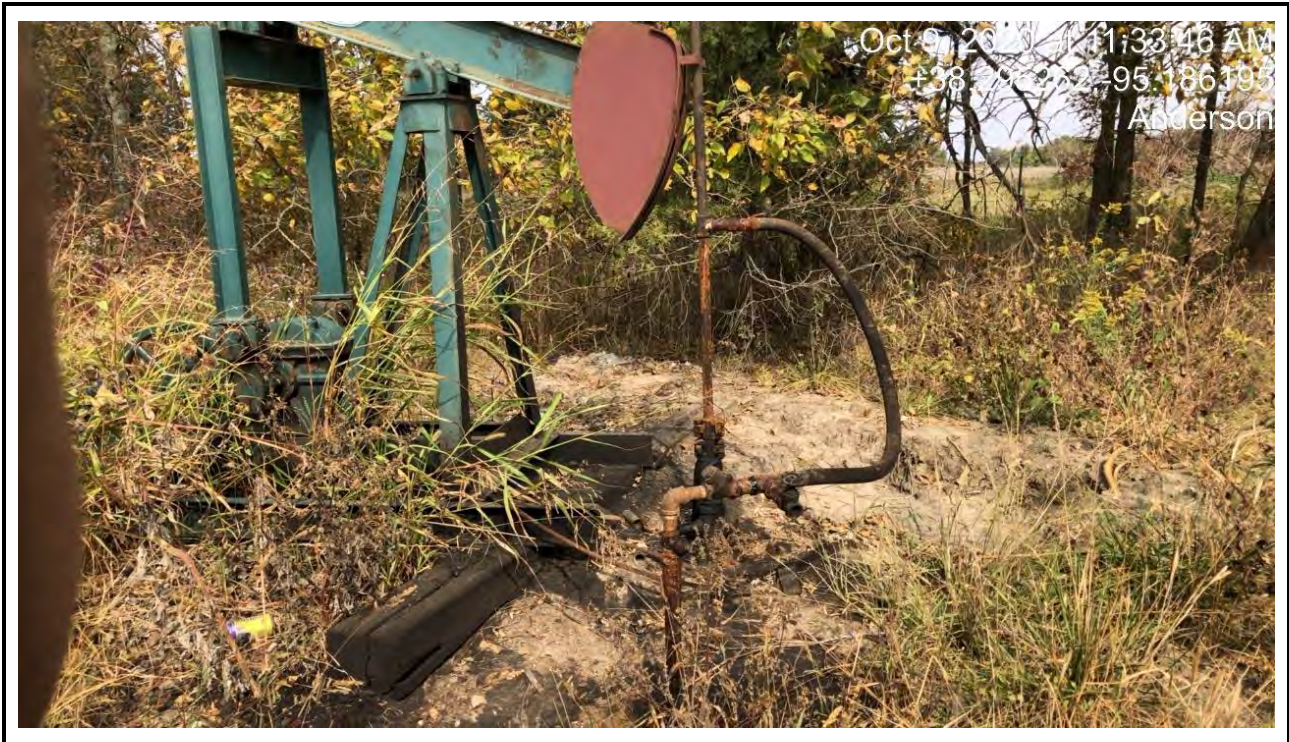
Operator: Tailwater, Inc.	KLN: 32461
Lease: South Kempnich	Legal: 22-20-20E
County: Anderson	PIC ID#: 28-T
Subject: 28-T	PIC Orientation:
FSL: 1473	Latitude: 38.292164
FEL: 5137	Longitude: -95.193730
API#: 15-003-25163-00-00	
Date: 10/09/2020	Time: 12:14 PM
Staff: Keith Carswell

15-003-25163-00-00 #28-T This well is inactive. The well is shut in with a valve and swedge. This well doesn't have 1 inch in the casing and the pump jack is missing the belt from the electric motor. This well doesn't appear to be leaking at the time of inspection but it has at some point as there is oil inside the berm pushed up around the well. This well has an approved CP-111 filed on it.

Additional Information: This picture is of well location 28-T. This well is shut in with a valve and swedge. The well did not appear to be leaking at the time of inspection but it has leaked in the past as there is oil inside the berm pushed up around the well.

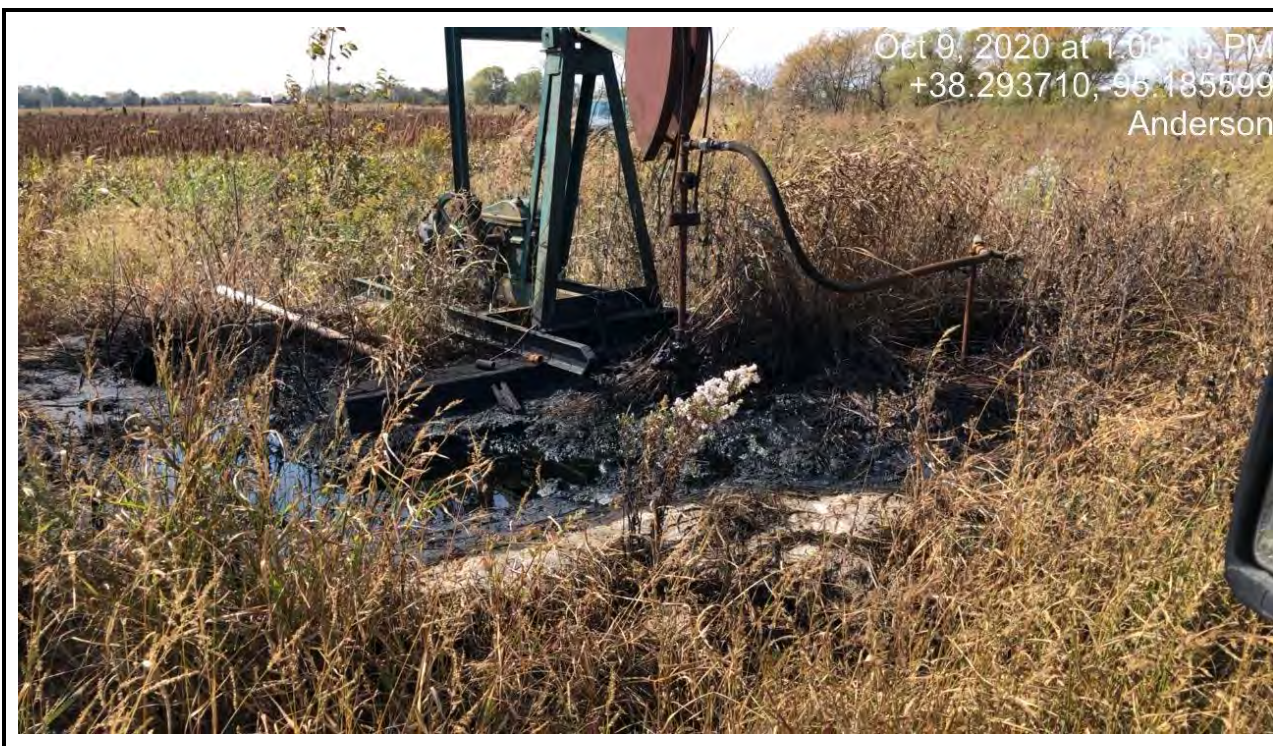
Operator: Tailwater, Inc.	KLN: 32461
Lease: South Kempnich	Legal: 22-20-20E
County: Anderson	PIC ID#: 29-T
Subject: 29-T	PIC Orientation:
FSL: 2627	Latitude: 38.295265
FEL: 2954	Longitude: -95.186136
API#: 15-003-25164-00-00	
Date: 10/09/2020	Time: 11:33 AM
Staff: Keith Carswell

15-003-25164-00-00 #29-T This well is inactive. It has a stuffing box but it also has a rag and clamp above the stuffing box. The 1 inch is unhooked from the pump jack and the pump jack is missing the belt from the electric motor to the pump jack. This well was not leaking at the time of inspection. This well does not have proper surface control as its my opinion the stuffing box is wore out which is why they put a rag and clamp above the stuffing box. This well doesn't have a CP-111 filed on it

Additional Information: This picture is of well location 29-T. The well is equipped with a stuffing box. At the time of inspection this well was inactive. This well has a rag and clamp above the stuffing box trying to seal the well in. The 1 inch is disconnected from the pump jack and the pump jack is missing a belt. This well is missing proper surface control.

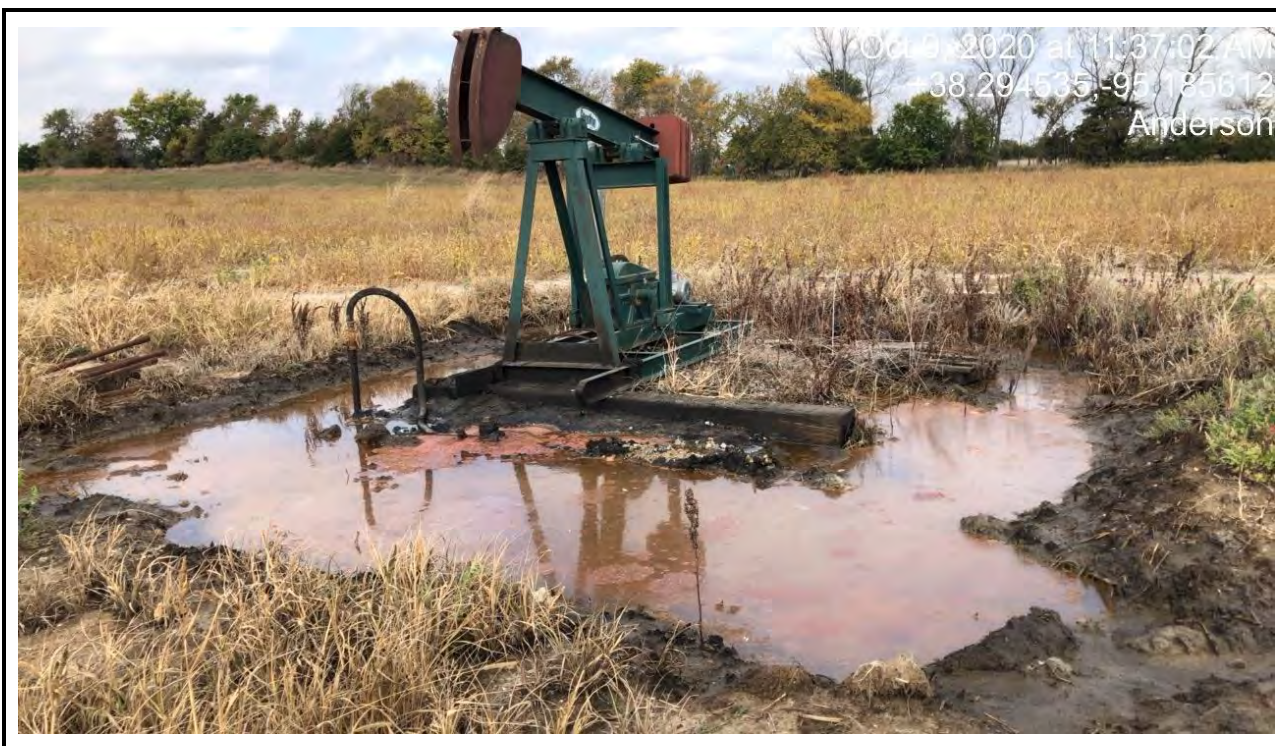
Operator: Tailwater, Inc.	KLN: 32461
Lease: South Kempnich	Legal: 22-20-20E
County: Anderson	PIC ID#: 30-T
Subject: 30-T	PIC Orientation:
FSL: 2072	Latitude: 38.293734
FEL: 2818	Longitude: -95.185658
API#: 15-003-25165-00-00	
Date: 10/09/2020	Time: 1:00 PM
Staff: Keith Carswell

15-003-25165-00-00 #30-T This well is inactive. The one inch is hanging on a rag and clamp trying to seal this well in. The well is leaking through the rag and through the 1 inch pipe but is contained in the berm pushed up around. This well doesn't have proper surface control. This well doesn't have a CP-111 filed on it.

Additional Information: This picture is of well location 30-T. The well is leaking up the production string and is not equipped with a stuffing box. The well is trying to be sealed in with a rag and clamp. The well is leaking through the rag and thru the 1 inch pipe above the rag. The spill is being contained in the berm pushed up around the well. The well is inactive as the pump jack is missing the belt. This well doesn't have proper surface control.

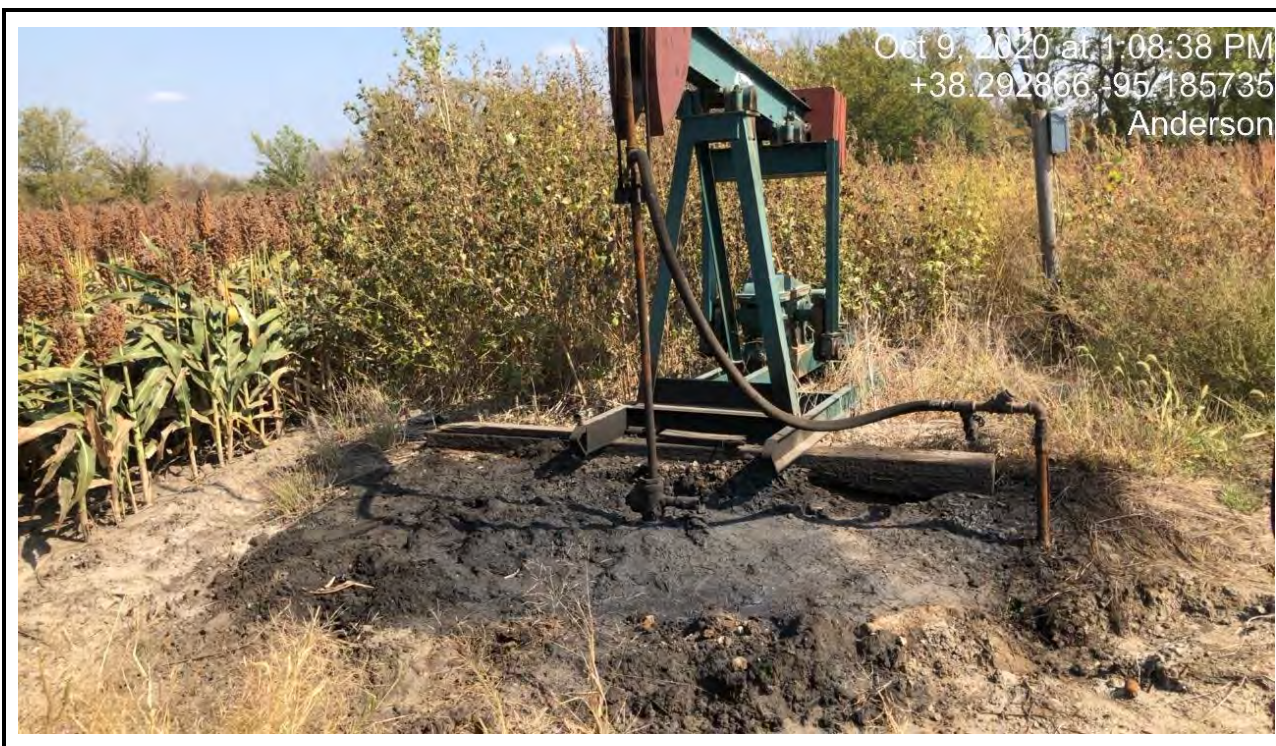
Operator: Tailwater, Inc.	KLN: 32461
Lease: South Kempnich	Legal: 22-20-20E
County: Anderson	PIC ID#: 31-T
Subject: 31-T	PIC Orientation:
FSL: 2378	Latitude: 38.294575
FEL: 2821	Longitude: -95.185669
API#: 15-003-25166-00-00	
Date: 10/09/2020	Time: 11:37 AM
Staff: Keith Carswell

Additional Information: This picture is of well location 31-T. This well is hooked into the flow line with a "T" on top of the well. There is a 2 inch plug screwed into the top of the "T" and the production water is leaking through the threads of the 2 inch plug in the top of the "T". The spill is being contained in the berm pushed up around the well. This well is not equipped for production as the well doesn't have 1 inch in the casing and the pump jack is missing the belt.

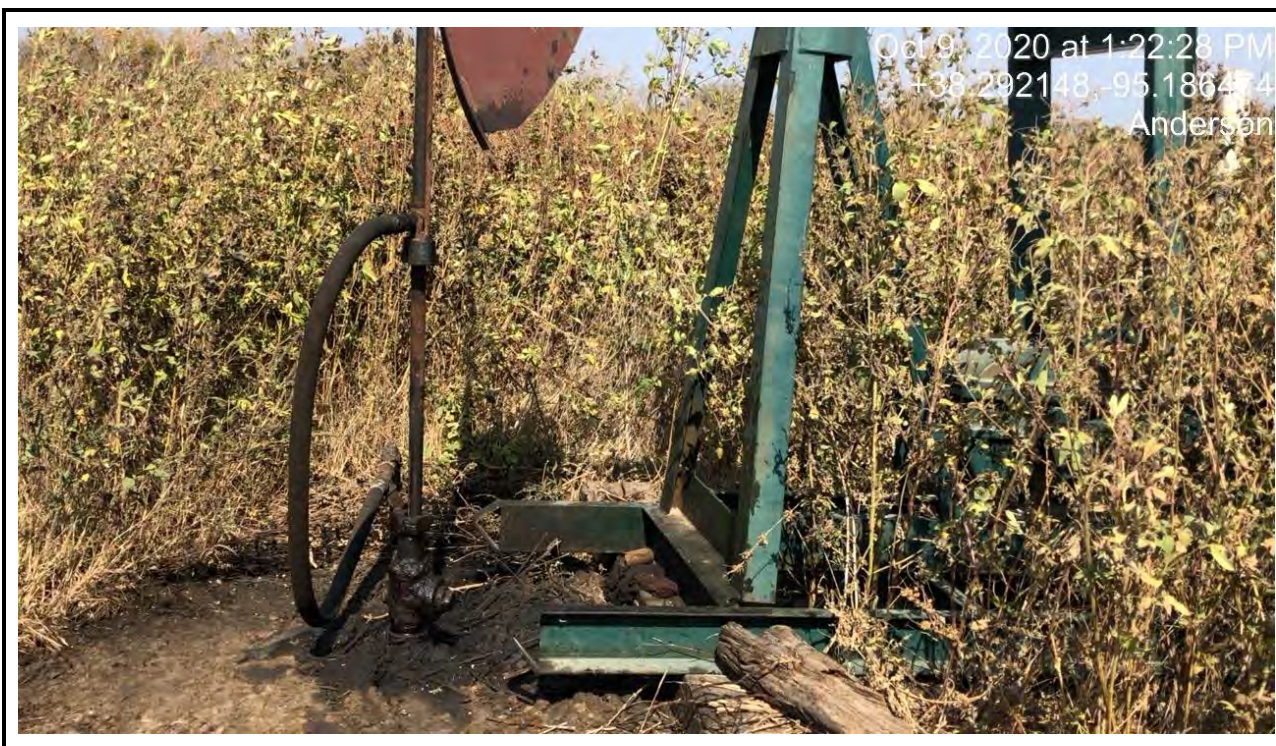
Operator: Tailwater, Inc.	KLN: 32461
Lease: South Kempnich	Legal: 22-20-20E
County: Anderson	PIC ID#: 32 T
Subject: 32-T	PIC Orientation:
FSL: 1740	Latitude: 38.292822
FEL: 2820	Longitude: -95.185660
API#: 15-003-25167-00-00	
Date: 10/09/2020	Time: 1:08 PM
Staff: Keith Carswell

Additional Information: This picture is of well location 32-T. This well was active at the time of the inspection. The well is not equipped with a stuffing box to prevent spills if the well was to go down. The well was not leaking at the time of inspection but has leaked in the past with the oil residue on the ground around the well. This well is missing proper surface control.
